FINAL
Stream Mitigation Plan
Town Creek Restoration Project – Option B

Stanly County, North Carolina
NCEEP Project ID No. 95026, Contract No. 003990
Yadkin Pee-Dee River Basin: 03040105060-040

February 2015

Michael Baker Engineering, Inc.
5550 Seventy-Seven Center Drive
Suite 320
Charlotte, NC 28217
NC Engineering License: F-1084

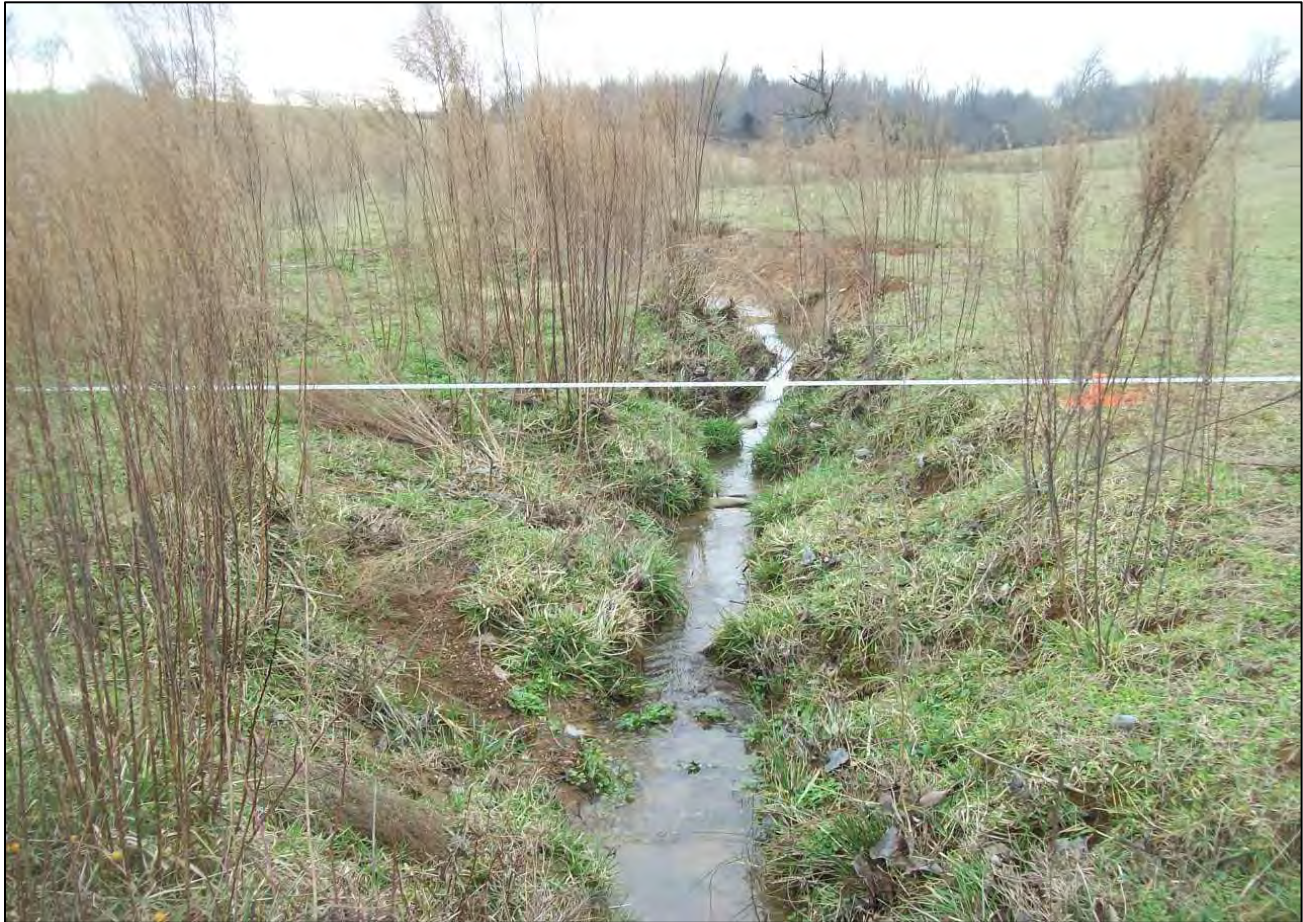
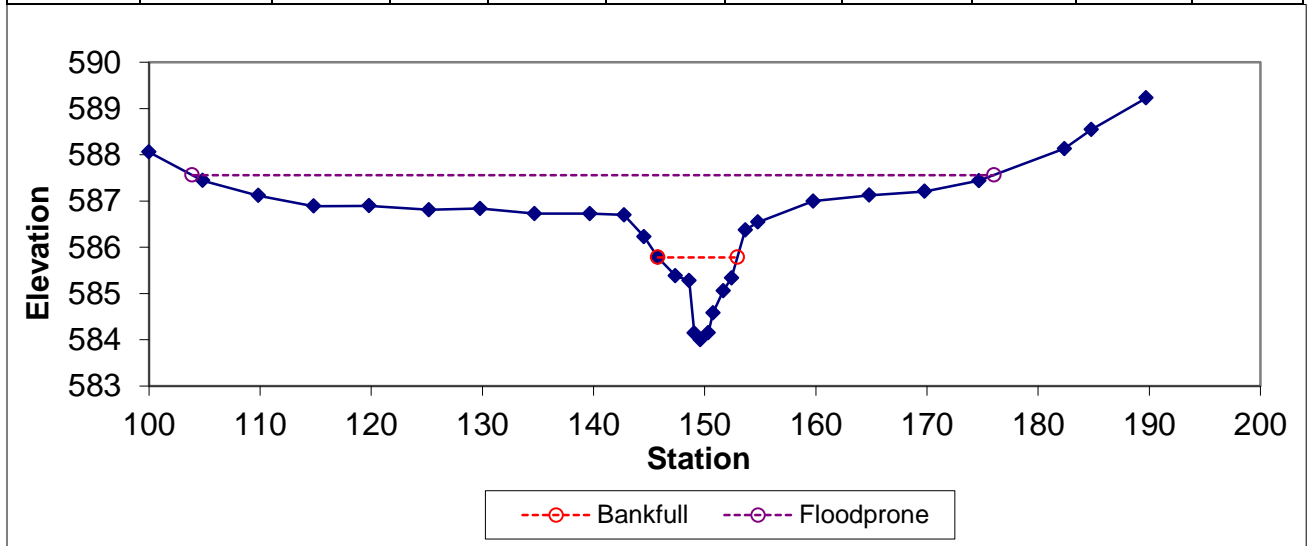
Cross-section 2, Existing Condition Profile - Station 14+73

Feature	Stream Type	BKF Area	BKF Width	BKF Depth	Max BKF Depth	W/D	BH Ratio	ER	BKF Elev	TOB Elev
Riffle	E	5.4	7.16	0.76	1.78	9.43	1.5	10.1	585.78	586.7

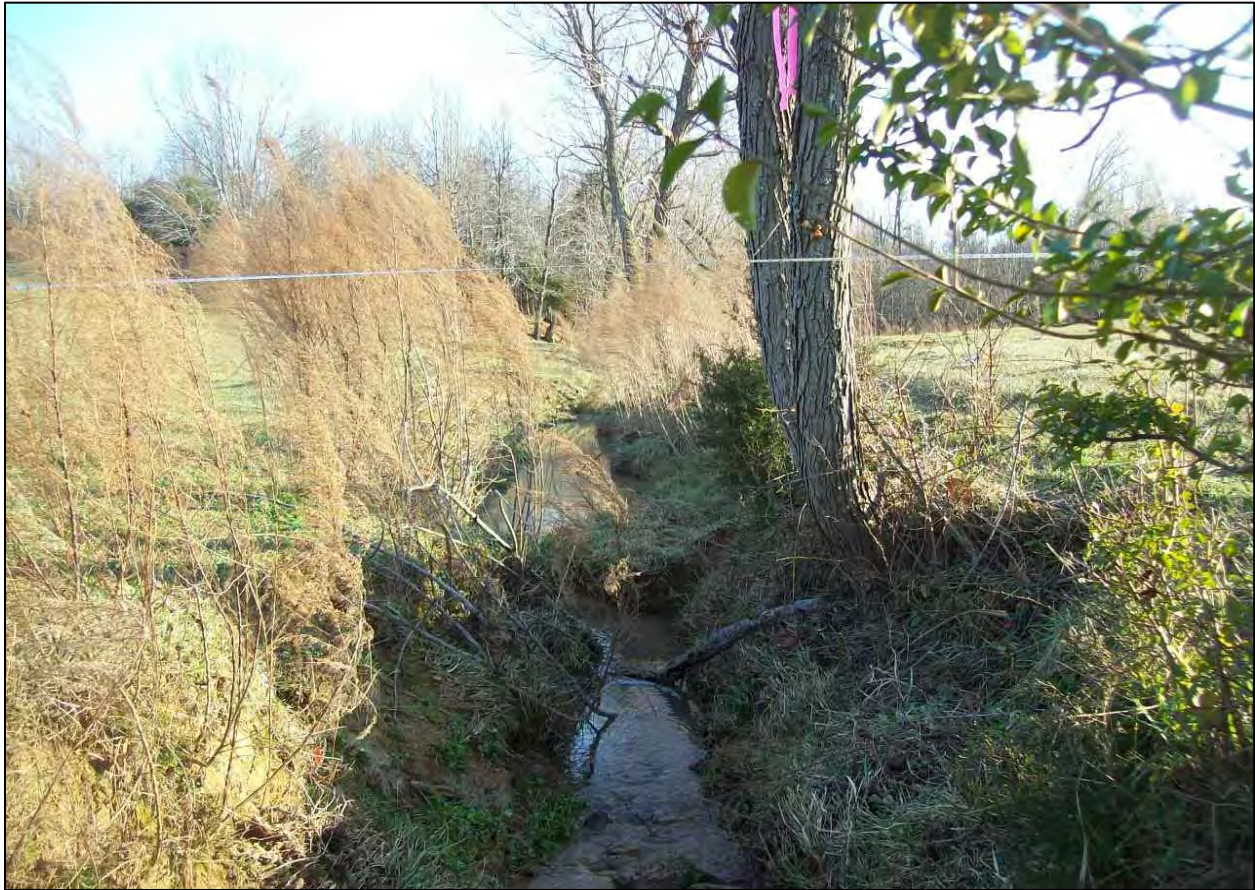
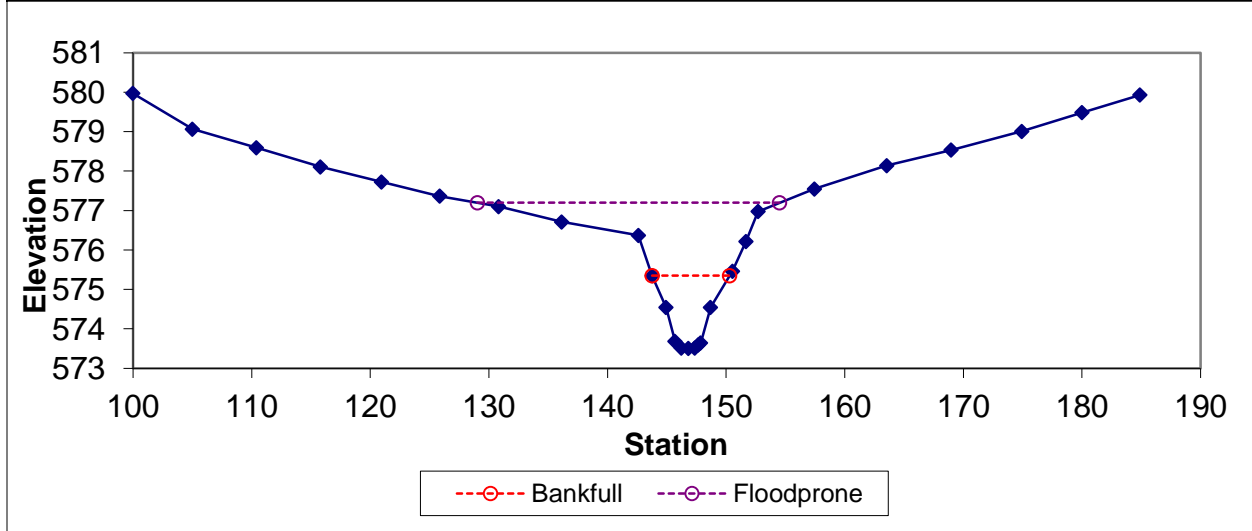
Cross-section 3, Existing Condition Profile - Station 20+28

Feature	Stream Type	BKF Area	BKF Width	BKF Depth	Max BKF Depth	W/D	BH Ratio	ER	BKF Elev	TOB Elev
Riffle	E	6.9	6.55	1.06	1.85	6.17	1.6	3.9	575.35	576.37

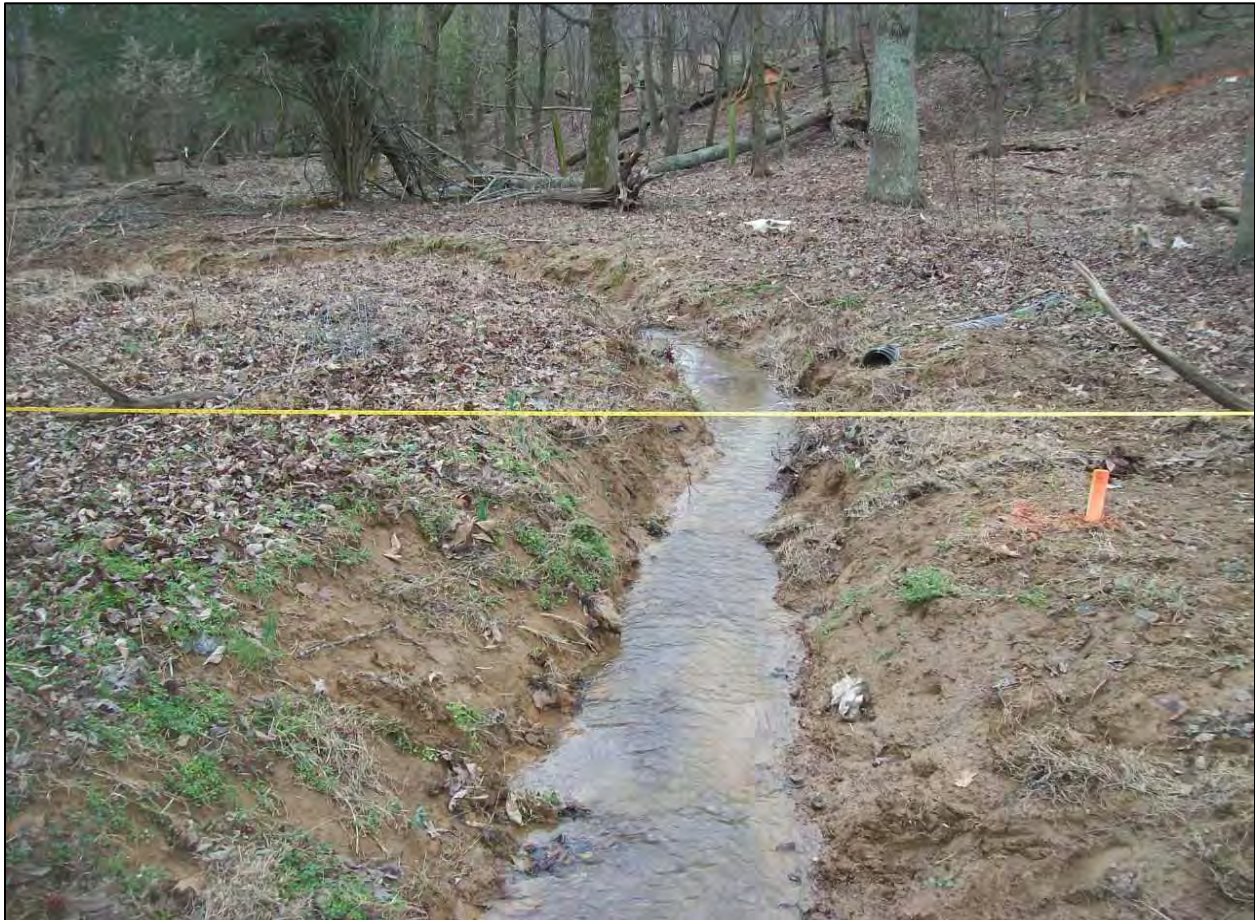
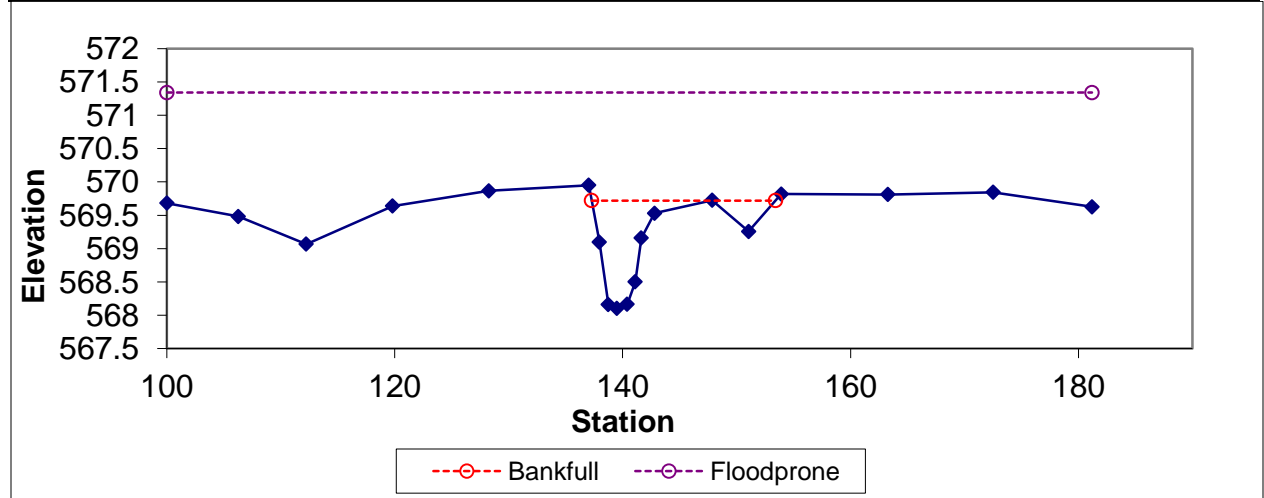
Cross-section 5, Existing Condition Profile - Station 25+71

Feature	Stream Type	BKF Area	BKF Width	BKF Depth	Max BKF Depth	W/D	BH Ratio	ER	BKF Elev	TOB Elev
Riffle	C	7.3	16.14	0.45	1.62	35.57	1.1	5	569.72	569.82

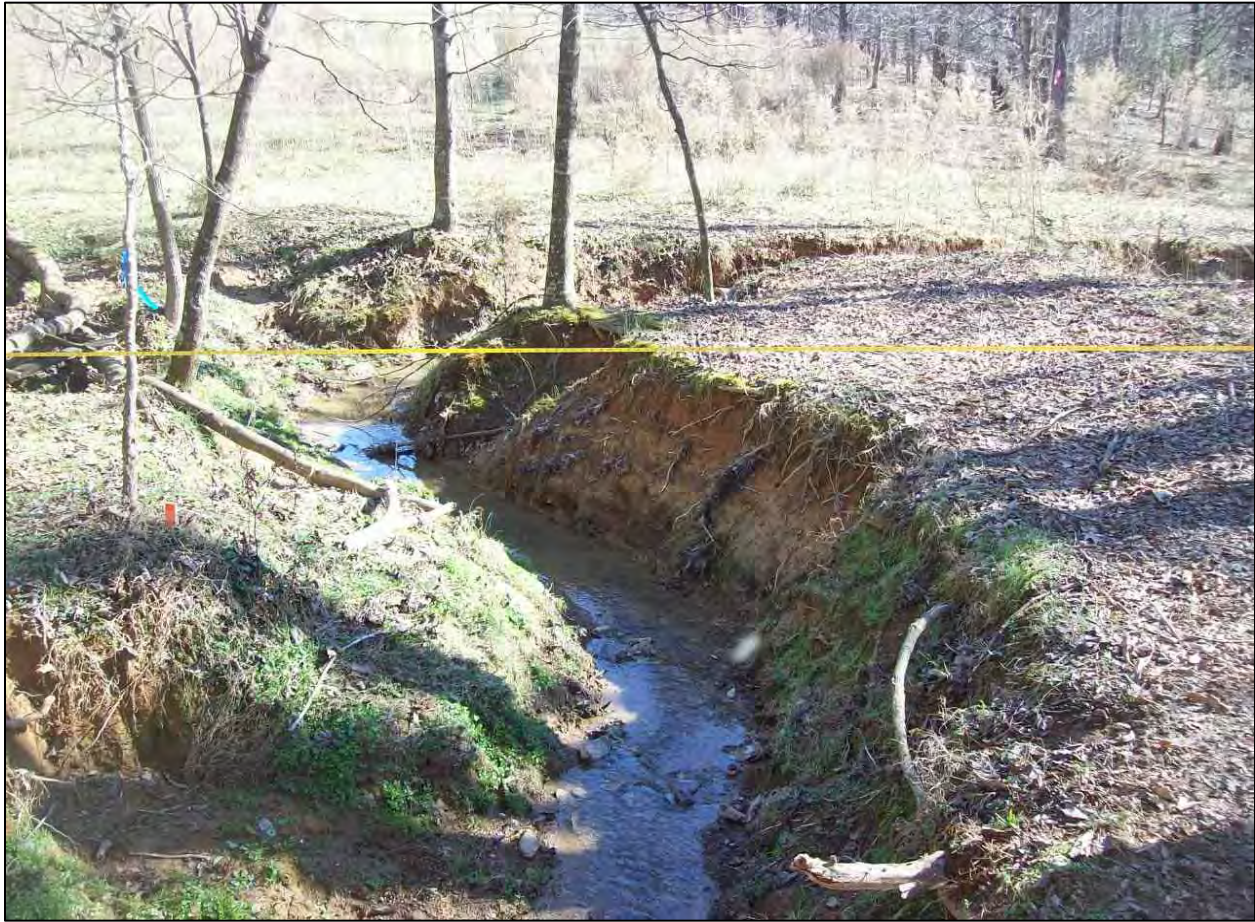
Cross-section 7, Existing Condition Profile - Station 33+36

Feature	Stream Type	BKF Area	BKF Width	BKF Depth	Max BKF Depth	W/D	BH Ratio	ER	BKF Elev	TOB Elev
Riffle	E	7.8	5.97	1.31	1.92	4.57	1.9	5.4	560.77	562.47

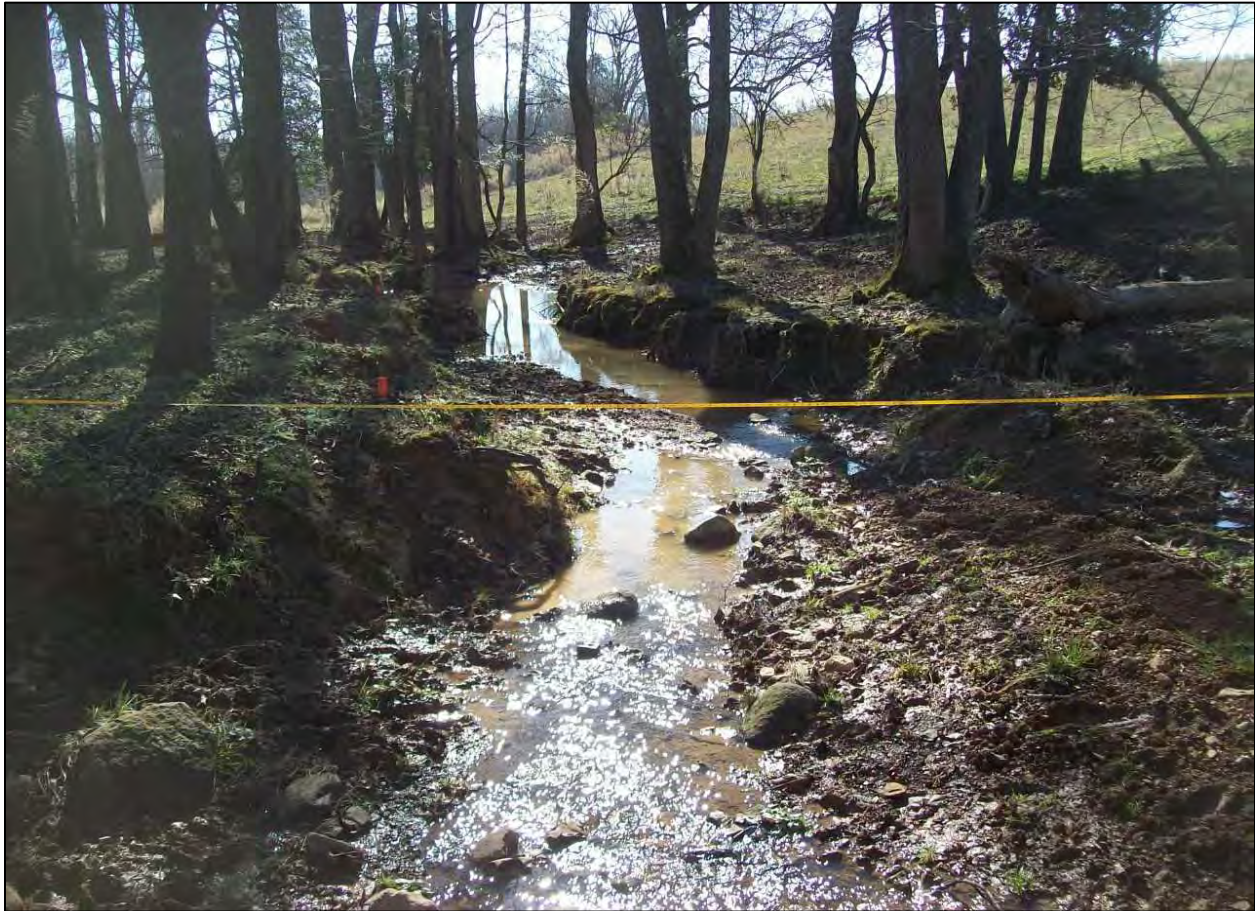
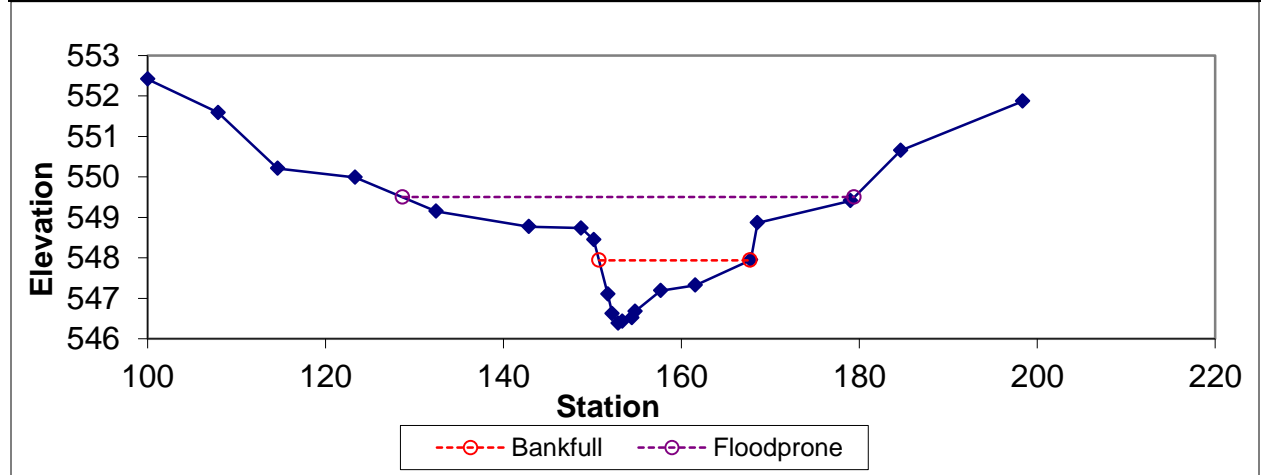
Cross-section 9, Existing Condition Profile - Station 45+36

Feature	Stream Type	BKF Area	BKF Width	BKF Depth	Max BKF Depth	W/D	BH Ratio	ER	BKF Elev	TOB Elev
Riffle	C	12.3	16.98	0.72	1.56	23.47	1.3	3	547.94	548.45

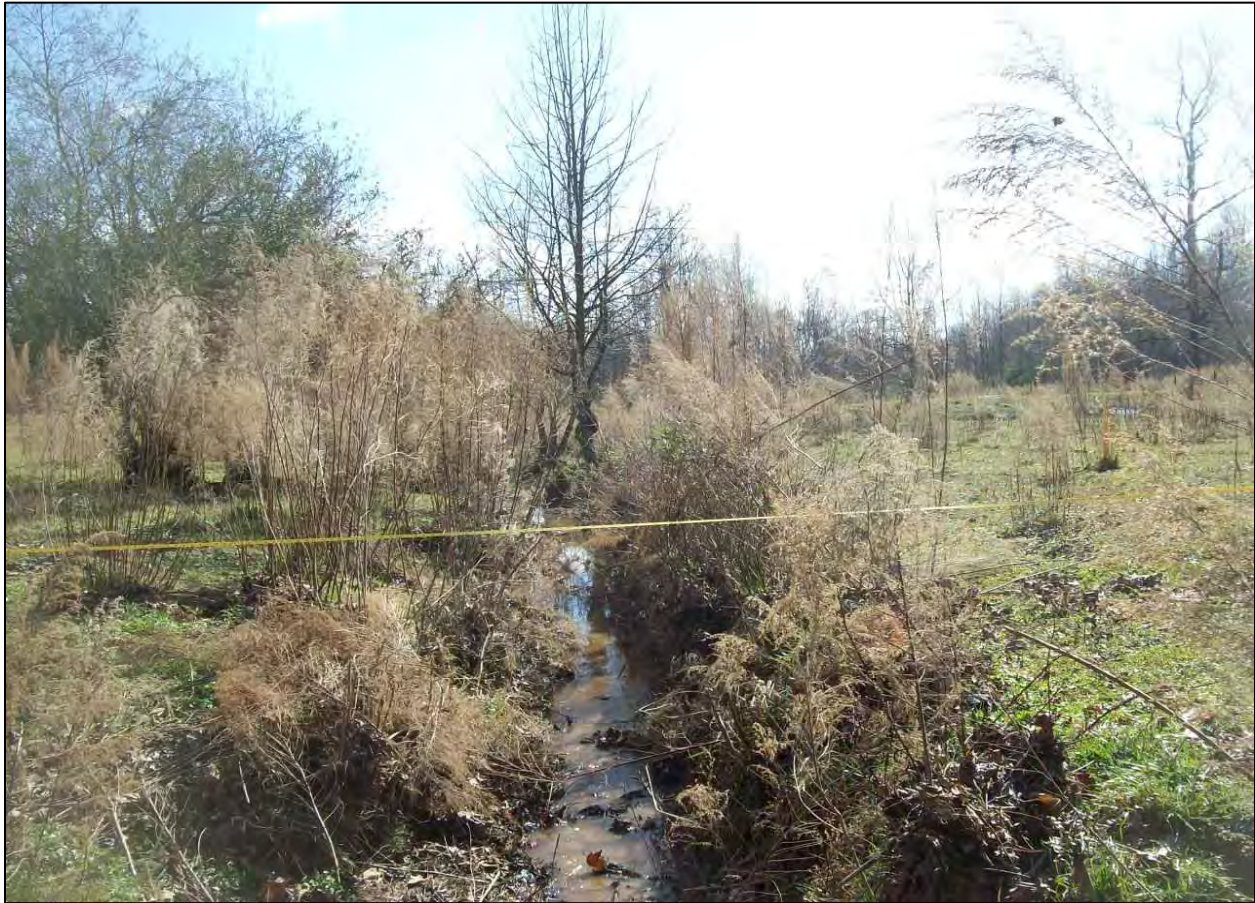
Cross-section 11, Existing Condition Profile - Station 47+82

Feature	Stream Type	BKF Area	BKF Width	BKF Depth	Max BKF Depth	W/D	BH Ratio	ER	BKF Elev	TOB Elev
Riffle	E	9.4	10.1	0.93	2.02	10.9	1.3	8.3	544.96	545.55
