Re: NCIRT Review and USACE Approval of the Tributaries to Wicker Branch Draft Mitigation Plan;
SAW 2013-01680; EEP #95022

SUBJECT: Tributaries to Wicker Branch- NCIRT Comments During 30-day Mitigation Plan Review

NCEEP Project Name: Tributaries of Wicker Branch Restoration Project, Union County, NC

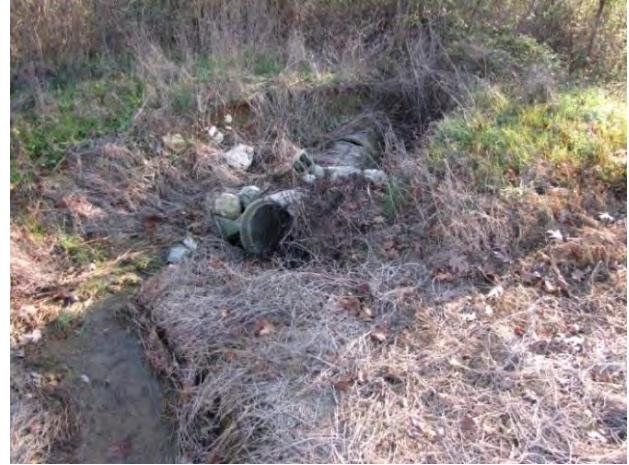
Photo 8: View of damaged culvert separating Tributary 1A and 1B: December 2011
