STREAM AND WETLAND MITIGATION PLAN

TULULA CREEK WETLANDS MITIGATION BANK GRAHAM COUNTY, NORTH CAROLINA

The North Carolina Department of Transportation
Raleigh, North Carolina

September 1997

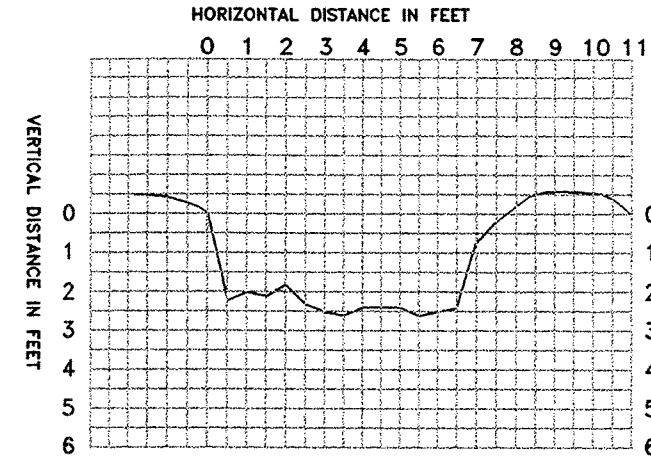
Figure: 8
Drawn By: PJS
Checked By: JWD
Scale: as shown
Project: ER96021.14
Date: July 1997

Measured Cross-Sections Support Medium Sand (D15) To Very Coarse Sand (D50) To Fine Gravel (D84)
 (0.25 - 0.50mm) (1.0 - 2.0mm) (5 - 8mm)

STREAM GEOMETRY AND SUBSTRATE
 TULULA CREEK
 GRAHAM COUNTY, NORTH CAROLINA

The historic stream bed is comprised of coarse sand (D35), very coarse sand (D50), and fine gravel (D85). However, the thalweg resides slightly incised into the cohesive clay subsurface horizon on all measured cross-sections. An infiltration (influent) zone may reside along the surface of this clay layer just above the base flow channel (Section 5.1).
