# ANNUAL REPORT FOR 2003

**Tulula Bog Mitigation Site  
Graham County  
Project No. 6.939004T  
TIP No. A-9WM**

Prepared By:  
Office of Natural Environment & Roadside Environmental Unit  
North Carolina Department of Transportation  
December 2003

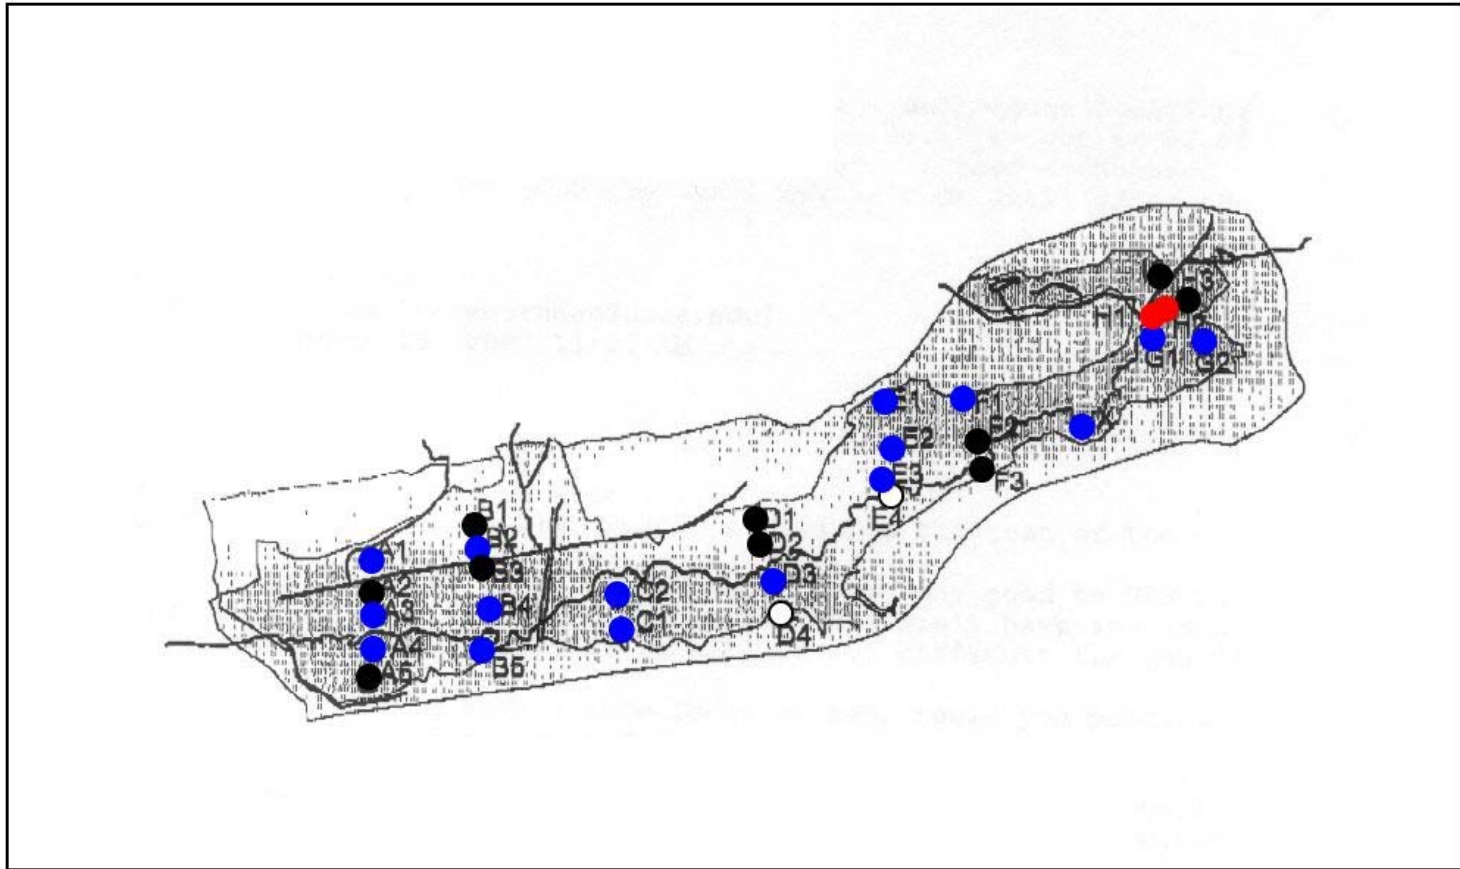
**Figure 3. 2003 Hydrologic Monitoring Gauge Results**

Figure 3 provides a graphical representation of the hydrologic results. Gauges highlighted in blue indicate wetland hydrology for more than 12.5% of the growing season. Gauges highlighted in red show hydrology between 8% and 12.5% of the growing season, while those in green indicate hydrology between 5% and 8%. Gauges highlighted in black indicate no wetland hydrology (less than 5% of the growing season).

During the 2003 monitoring year, twenty-eight of the thirty-groundwater gauges were downloaded. There is no hydrologic data for gauges D4 and E4. The first year of hydrologic data revealed that eighteen of the twenty-eight groundwater gauges met the success criteria for saturation (within 12" of the surface for 5% of the growing season). Conversely, ten gauges recorded saturation for less than 5% of the growing season. NCDOT will investigate these ten gauges to ascertain whether the gauges are representative of conditions in each respective area.

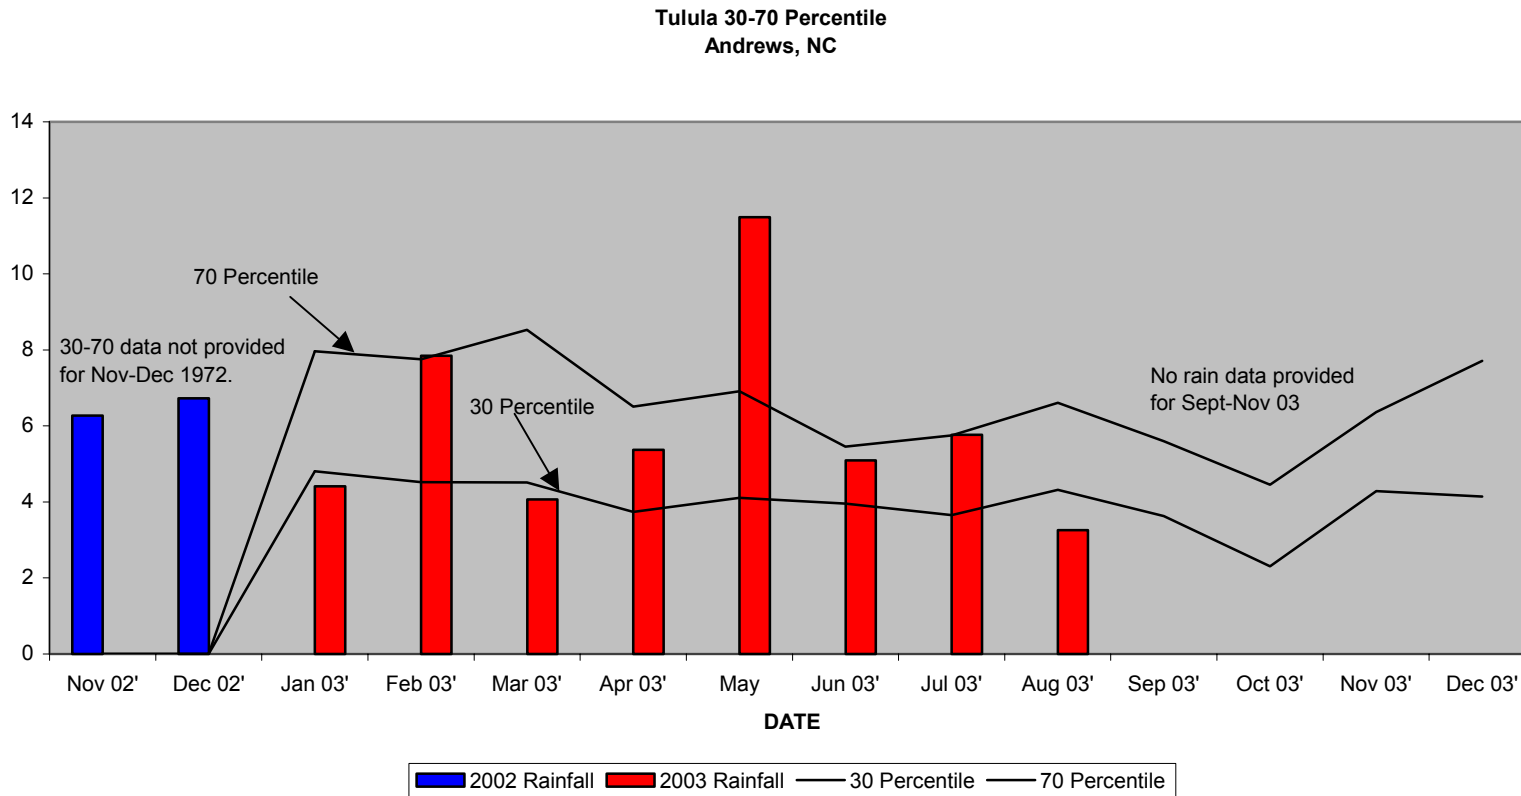
**Figure 4. Tulula Bog 30-70 Graph**

Figure 4 is a comparison of monthly rainfall for the period of November 2002 through August 2003 to historical precipitation (collected between 1972 and 2003) for Andrews, North Carolina. There was no rain data provided by the State Climate Office for the months of September-November 2003. This comparison gives an indication of how 2003 relates to historical data in terms of climate conditions. The NC State Climate Office provided all local rainfall information.

For the 2003-year, the month of May experienced above average rainfall. The months of January, March, and August recorded below average rainfall for the site. February, April, June, and July experienced average rainfall. Overall, 2003 experienced an average rainfall year.
