# Monitoring Report

**Twin Bays Wetland Restoration Site**

**EEP Project Number 95363**

**Monitoring Year 01**

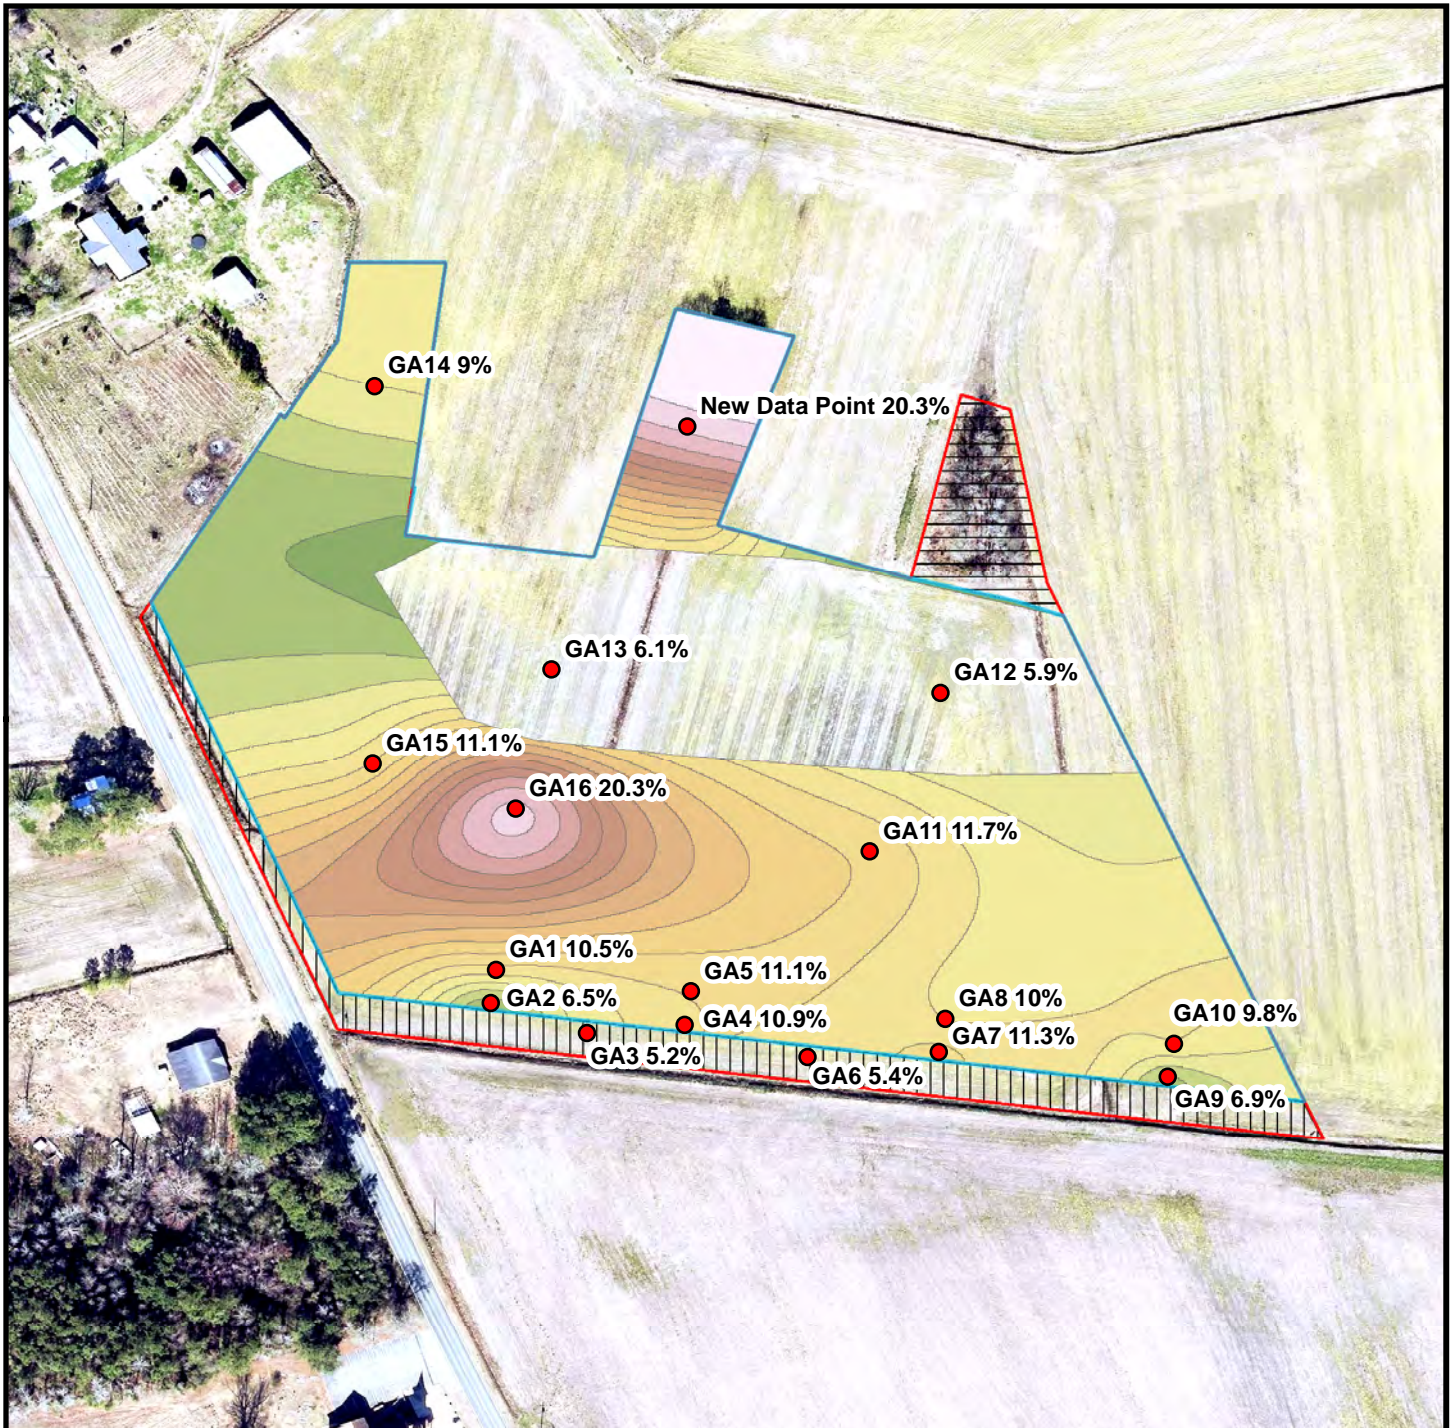
**TWIN BAYS PERCENT SATURATION  
TWIN BAYS RESTORATION SITE  
EEP PROJECT #95363, DUPLIN COUNTY, NC**

During the site's first growing season, all four of the gauges located 75' from the ditch had continuous saturation within 12 inches of the ground surface for 8% (19 days) of the 239 day growing season (March 18 to November 11). Two of the four gauges located 40' from the ditch also met this metric while neither of the two gauges located less than 40' from the ditch achieved 8% continuous saturation. In the restoration area, only two gauges were below 8% saturation. These two gauges, Gauges 12 and 13, both had continuous saturation for approximately 6% of the growing season, only 5 days less than the 8% metric. It is expected that with more establishment time, all of the gauges within the credit bearing area will be above 8% in future monitoring years. Since gauges 12 and 13 were below 6.5% continuous saturation, these gauges were excluded from the analysis to determine the spatial average for the hydrology of the entire site. The exclusion of these two gauges lead to 2.43 acres of the 10.6 acre wetland restoration area being excluded, for a total of 8.17 acres. This analysis is based off percent saturation contours for the restoration area calculated from the gauge data. Because there was not a gauge installed in the central northern portion of the site, an estimated data point was used to create the contours. The percent saturation for this data point is based on comparing observations in this location to the conditions at the other gauges. Since this portion of the site has an active seep, it has more standing water and is the most frequently saturated part of the site. For this reason, the percent saturation for this data point was made to match the highest of all of the established gauges. Before the 2015 growing season begins, an additional gauge will be installed within this part of the site. Following the method described above and as illustrated in the figure in Appendix D, it is determined that based on the spatial average, the attaining portion of the site was continuously saturated for 10.8% of the growing season and met the hydrology success criteria of 8% for the first year of monitoring. As mentioned above, it is expected that the entire site will attain the hydrology success criteria in future years.
