Monitoring Report

Twin Bays Wetland Restoration Site

DMS Project Number 95363

Monitoring Year 03

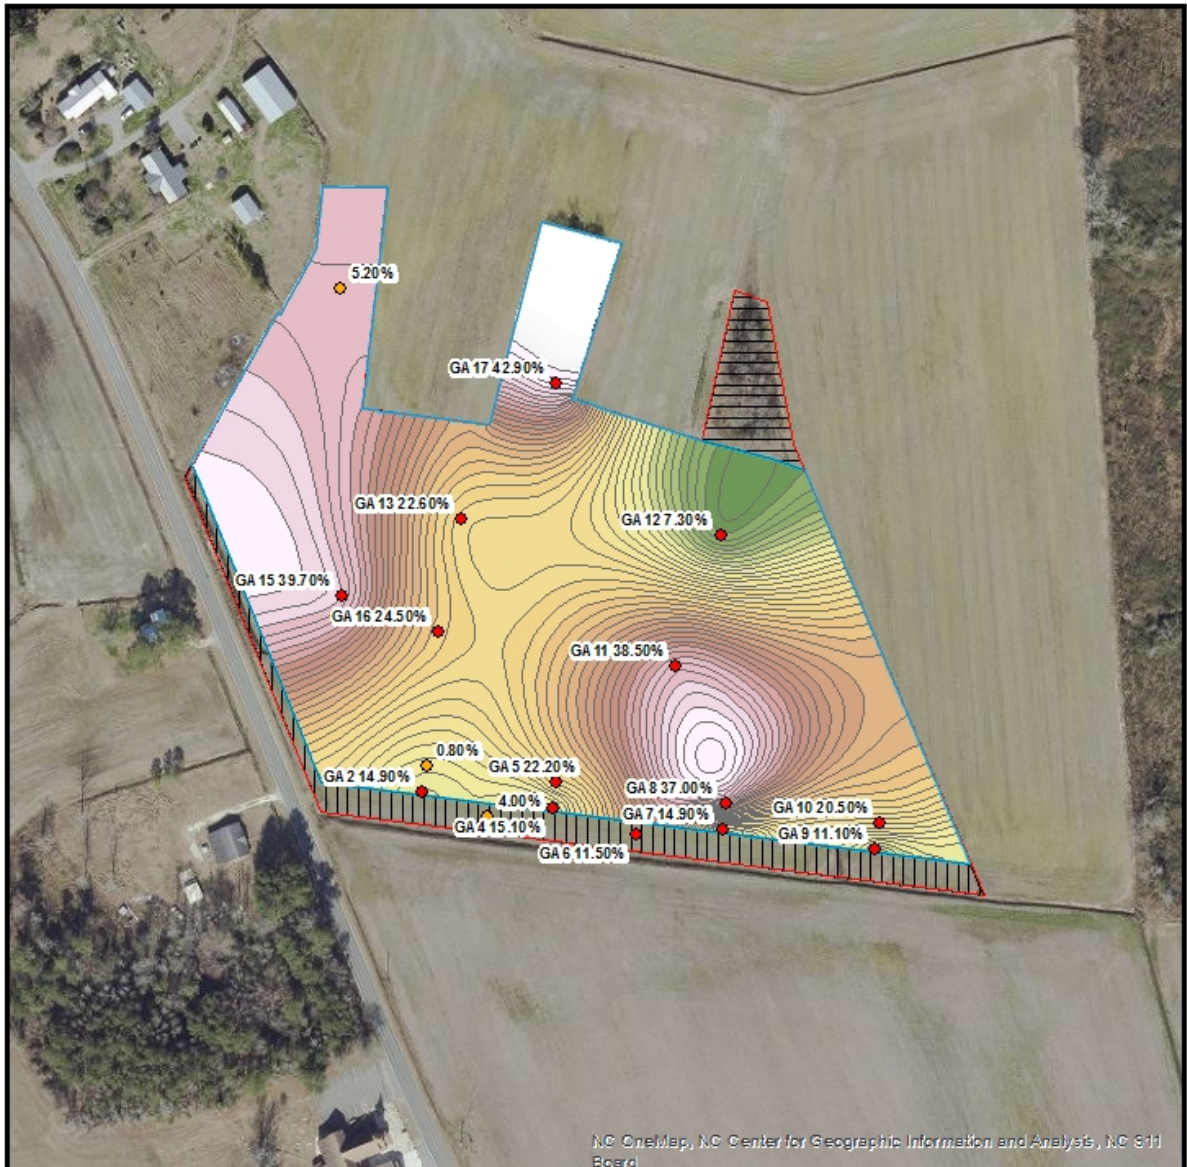
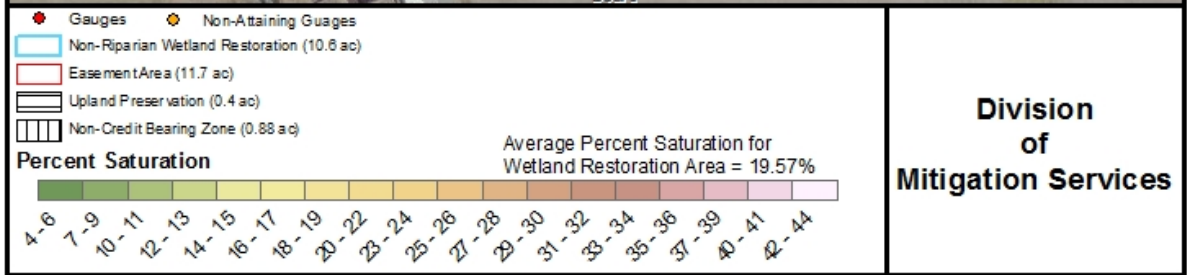
**TWIN BAYS PERCENT SATURATION
TWIN BAYS RESTORATION SITE
DMS PROJECT #95363, DUPLIN COUNTY, NC**

During the site's third growing season, all but four of the seventeen total gauges met the hydrologic success criteria. Of those four, one was in a non-credit bearing area (close to an open ditch). Another of those gauges malfunctioned, but since the gauge adjacent to it, which is closer to the open ditch met the hydrology criteria, it is likely that without the malfunction this gauge also would have met the criteria, like in the previous monitoring years. The other two gauges that did not meet the criteria all achieved hydrology last year, and one of those gauges was only one day from meeting it this year. Three gauges were below 6.5% continuous saturation and so were not used in the analysis to determine the spatial average for the hydrology of the entire site. This analysis is based off percent saturation contours for the restoration area calculated from the gauge data. Following the method described above and as illustrated in the figure in Appendix D, it is determined that based on the spatial average, the site was continuously saturated for 19.6% of the growing season and met the hydrology success criteria of 8% for the third year of monitoring.
