Monitoring Report

Twin Bays Wetland Restoration Site

DMS Project Number 95363

Monitoring Year 04

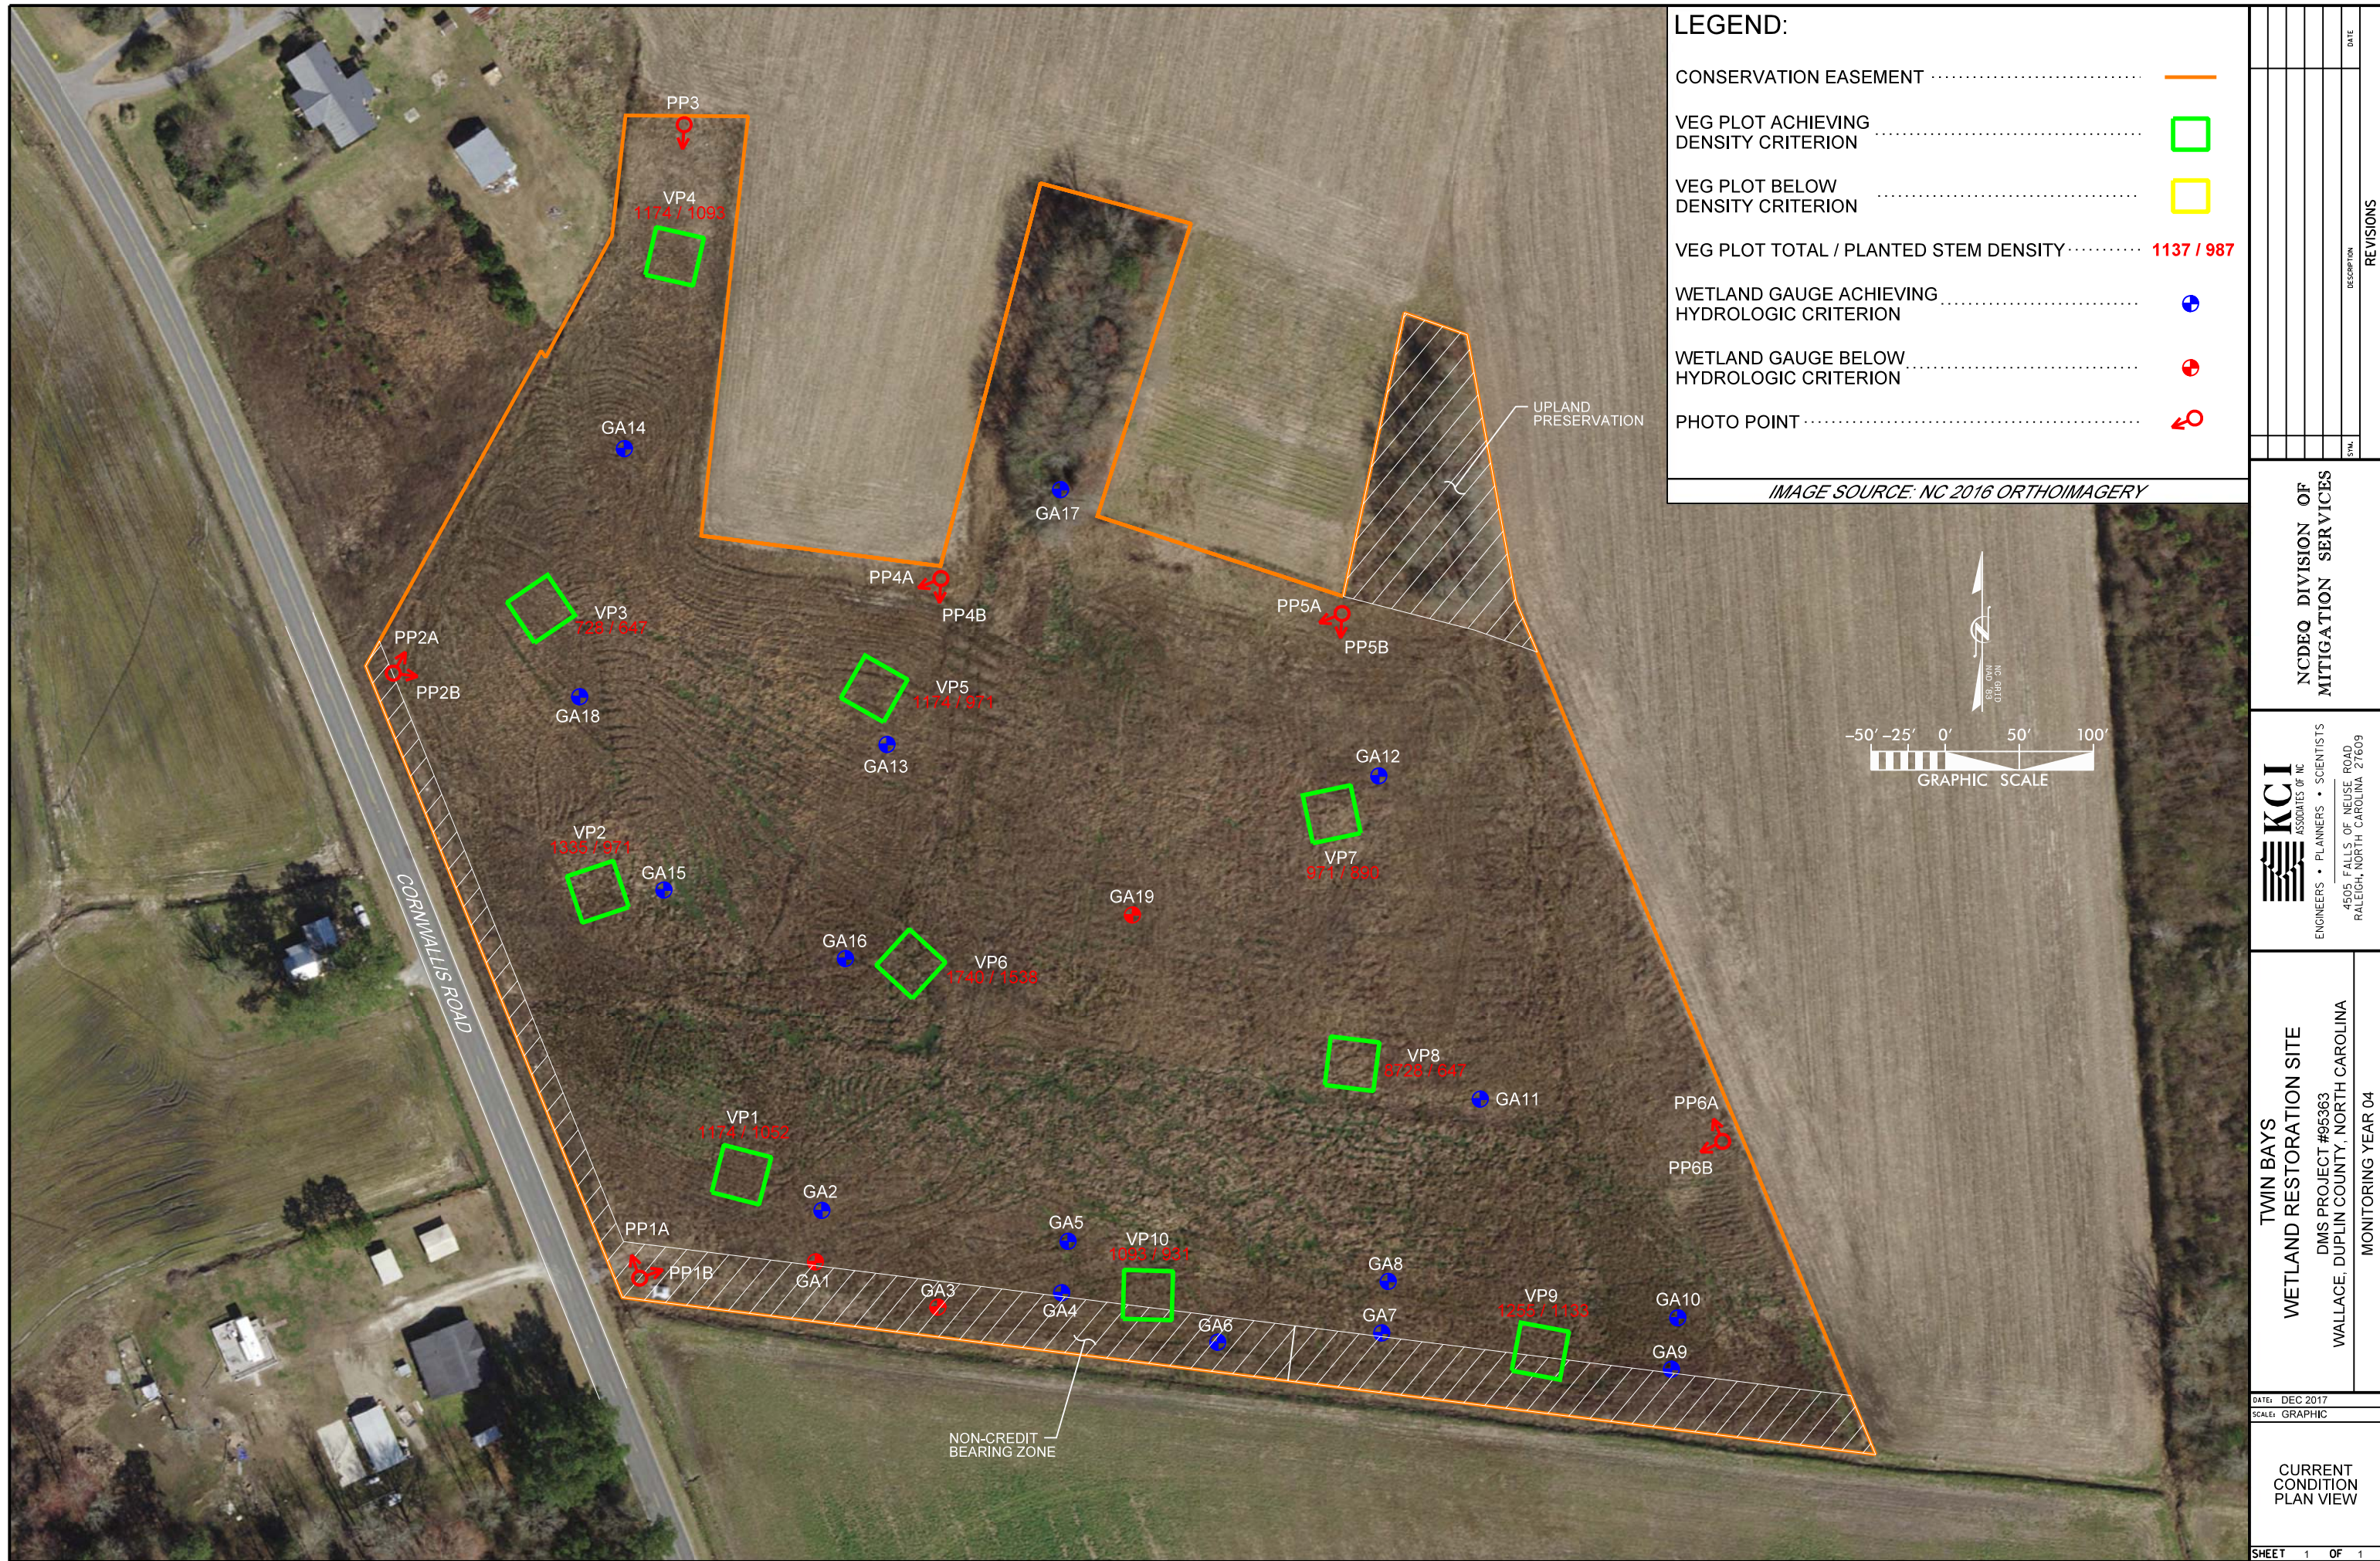
DATE: DEC 2017
 SCALE: GRAPHIC
 CURRENT CONDITION PLAN VIEW
 SHEET 1 OF 1

- CONSERVATION EASEMENT ————
- VEG PLOT ACHIEVING DENSITY CRITERION □
- VEG PLOT BELOW DENSITY CRITERION □
- VEG PLOT TOTAL / PLANTED STEM DENSITY 1137 / 987
- WETLAND GAUGE ACHIEVING HYDROLOGIC CRITERION ⊕
- WETLAND GAUGE BELOW HYDROLOGIC CRITERION ⊖
- PHOTO POINT ↻
