**UNDERWOOD MITIGATION SITE**  
*Chatham County, NC*  
DENR Contract No. 003268

**Mitigation Plan**  
September 2011

# UNDERWOOD MITIGATION SITE

## Mitigation Plan

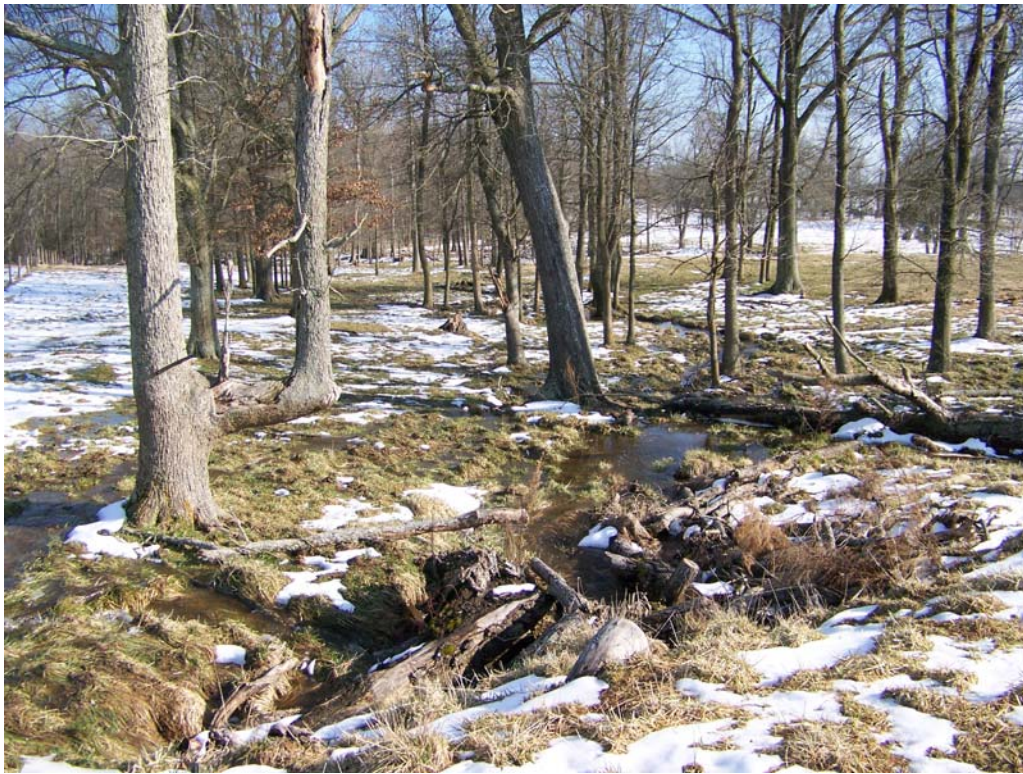
Existing Conditions Reach SF 1

South Fork (SF) is broken into 4 reaches based primarily on geographic separation. SF1 is 682 LF and located within the upstream area of the project, on the property south of Clyde Underwood Road. This reach drains 0.21 square miles. The reach has been channelized and is essentially straight, except for some areas where lateral erosion has created some minor variation in pattern. The channel is in a fairly tight valley and the floodplain side slopes are relatively steep. The channel has a width to depth ratio of 6.15, an entrenchment ratio of 6.97, and a slope of 0.011 ft/ft. The  $d_{50}$  of the bed material is 4.7 mm. The channel classifies as a straightened E4. The bank height ratio is 1.12 indicating that the reach is somewhat incised, however, the most significant problems with this channel are lateral erosion and lack of floodplain vegetation.

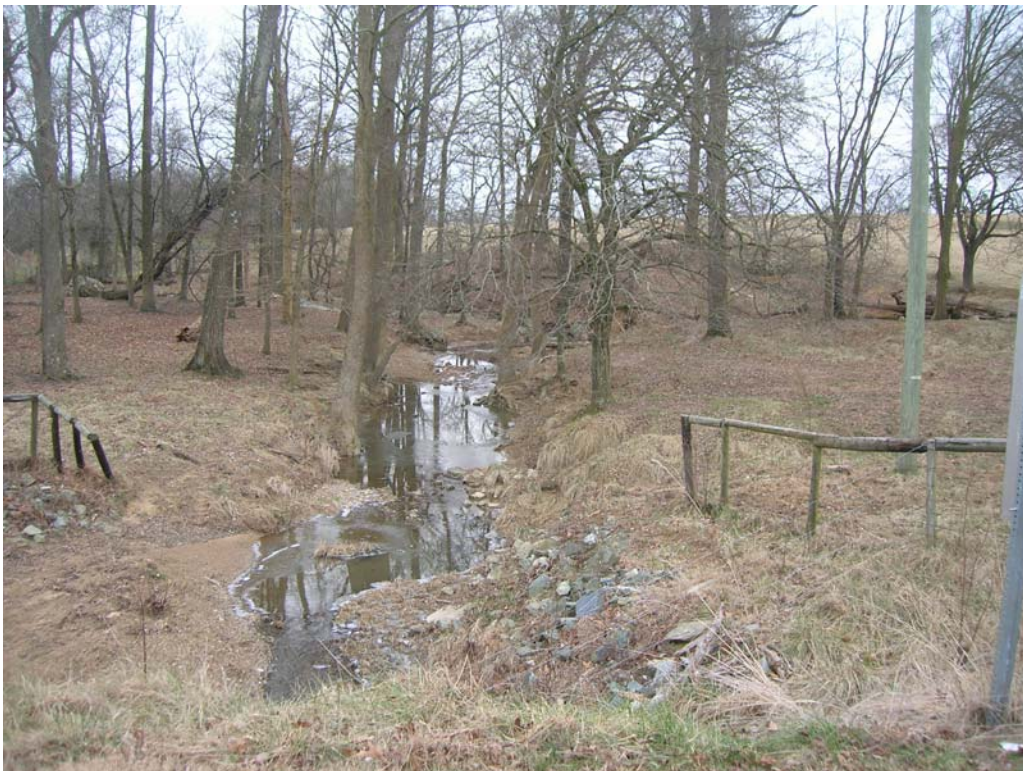
Existing Conditions Reach SF 2

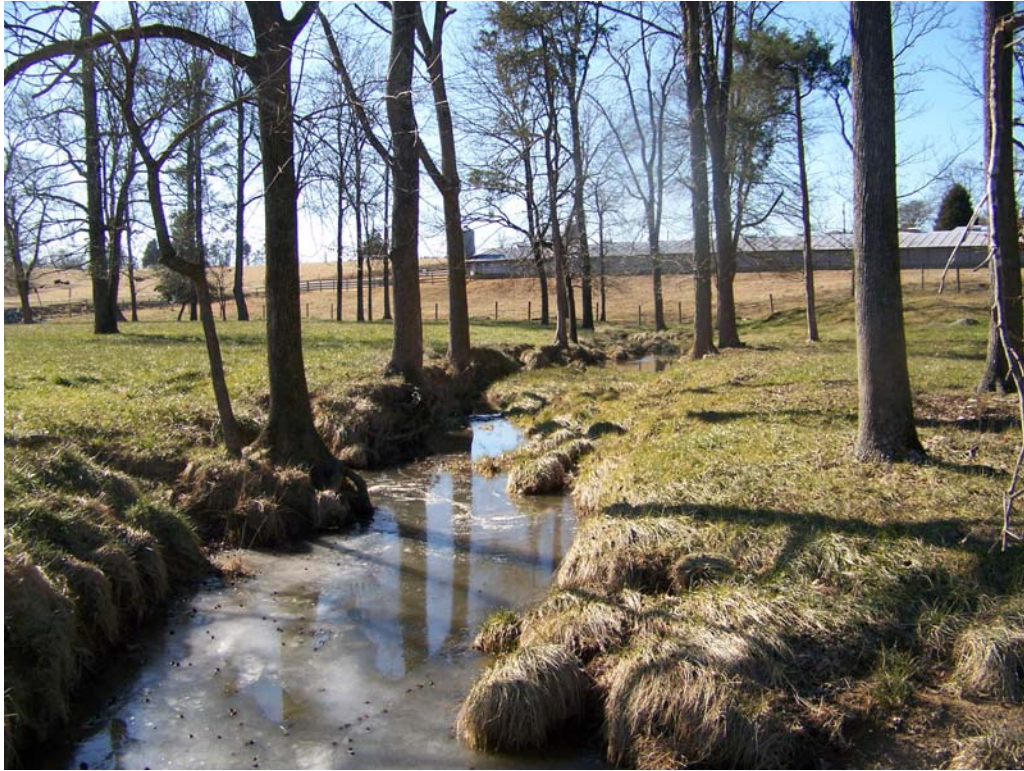
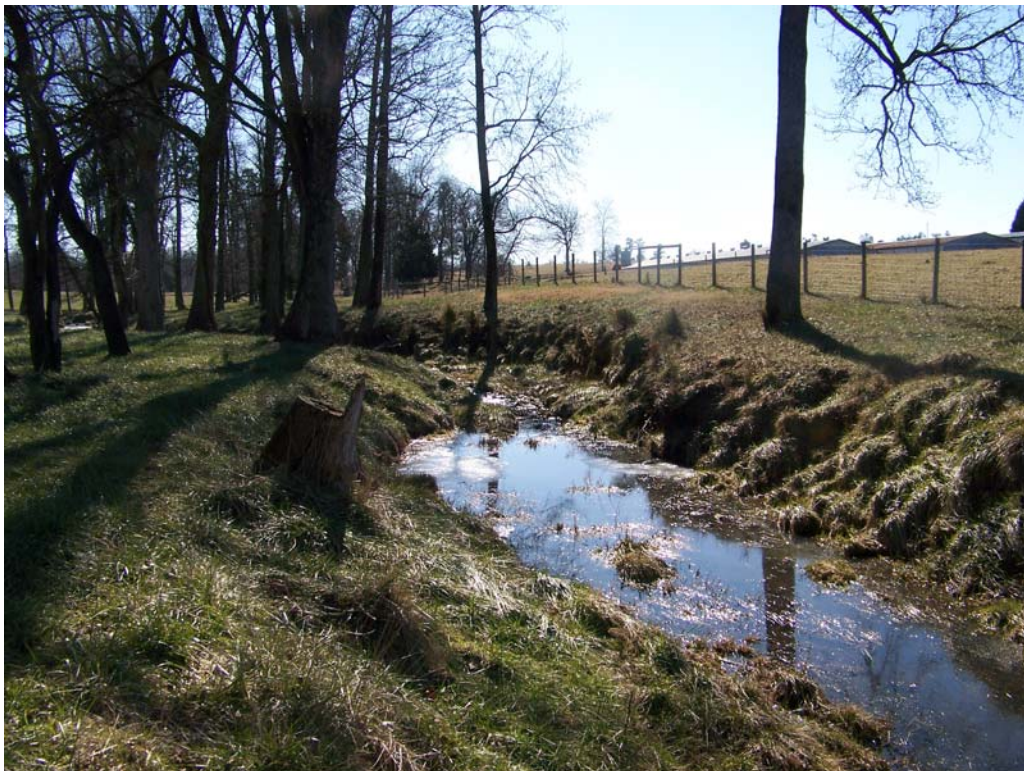
Existing Conditions Reach SF 3

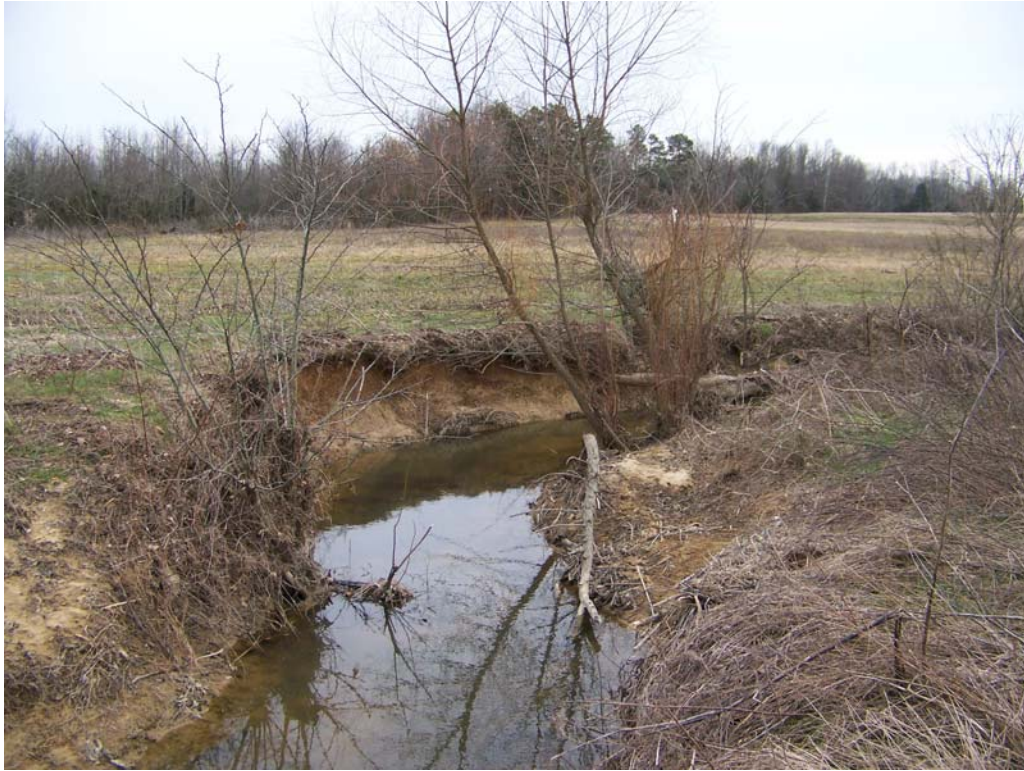
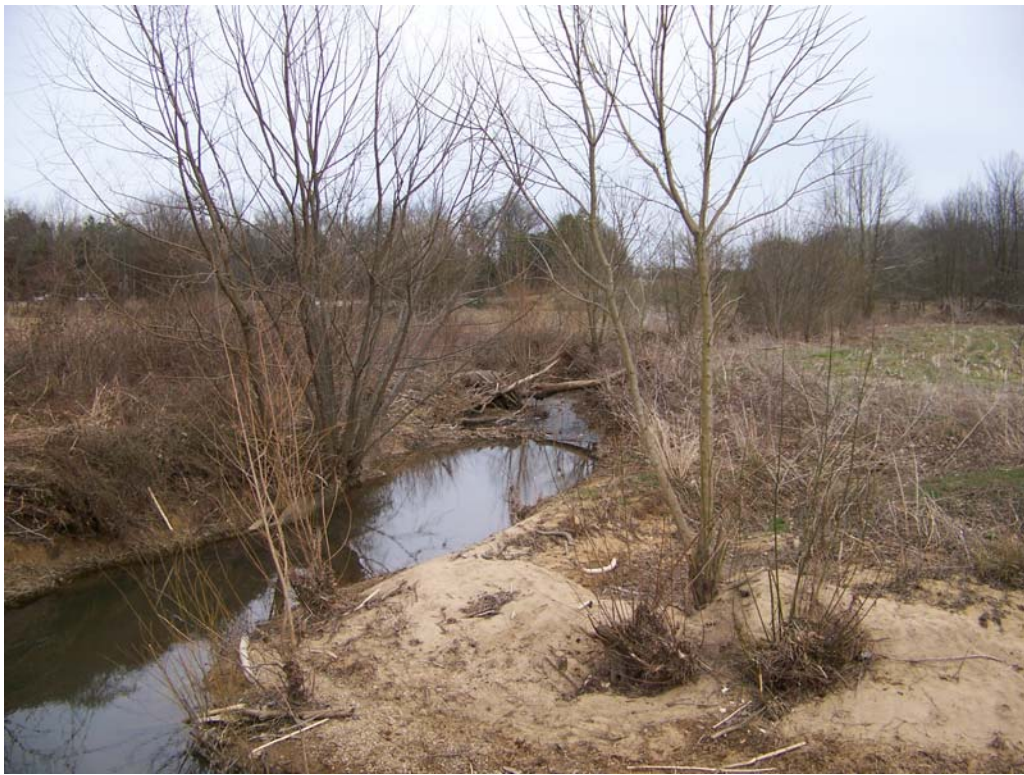
Existing Conditions Reach SF 4

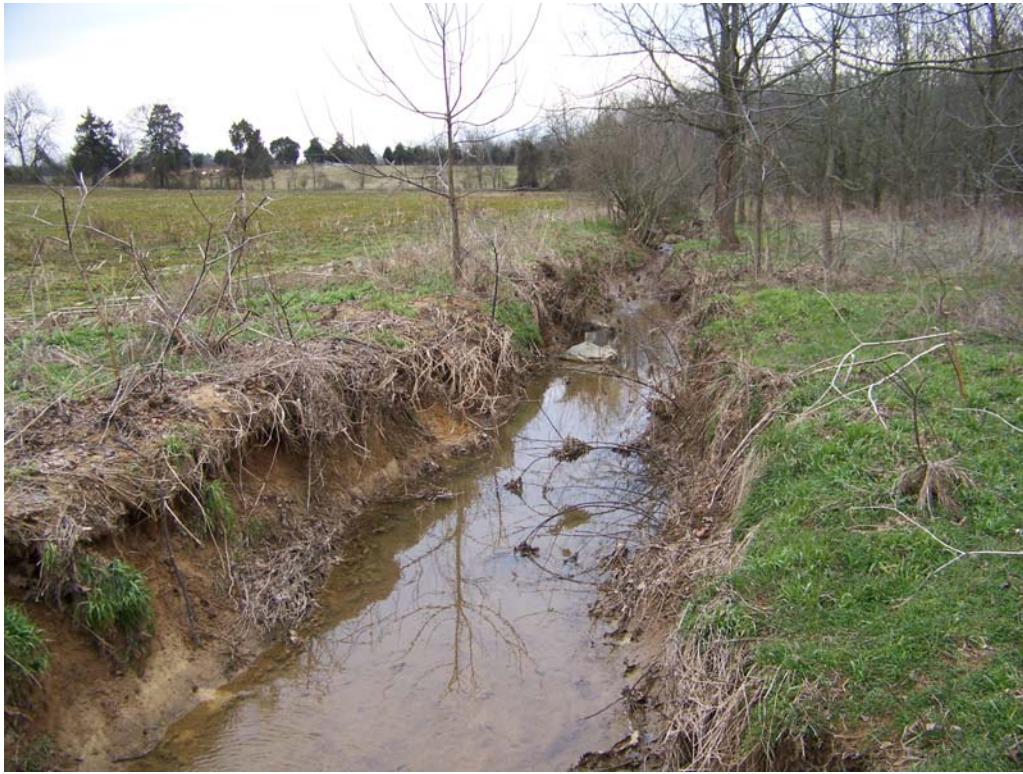
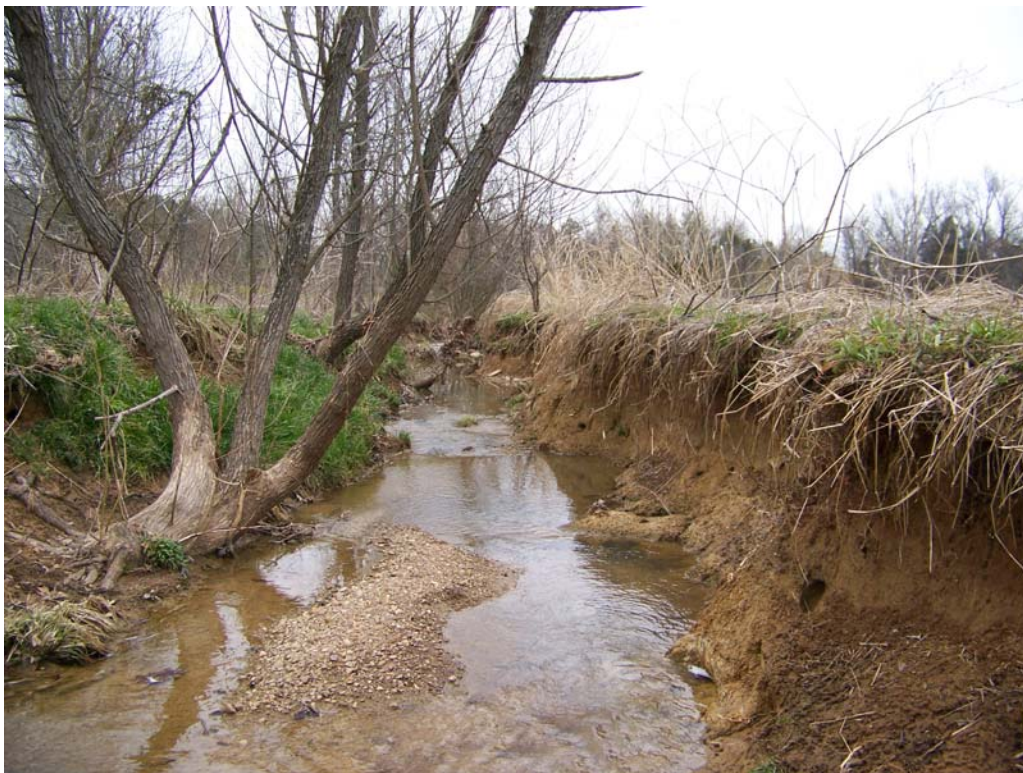
Existing Conditions Reach SF 4A

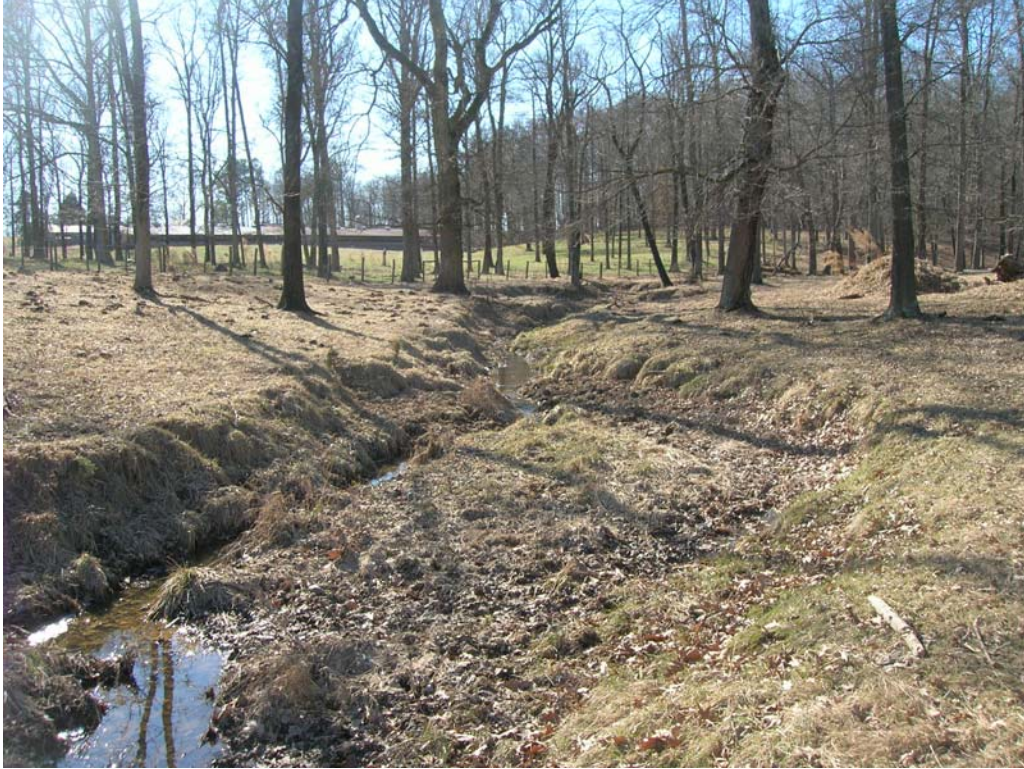
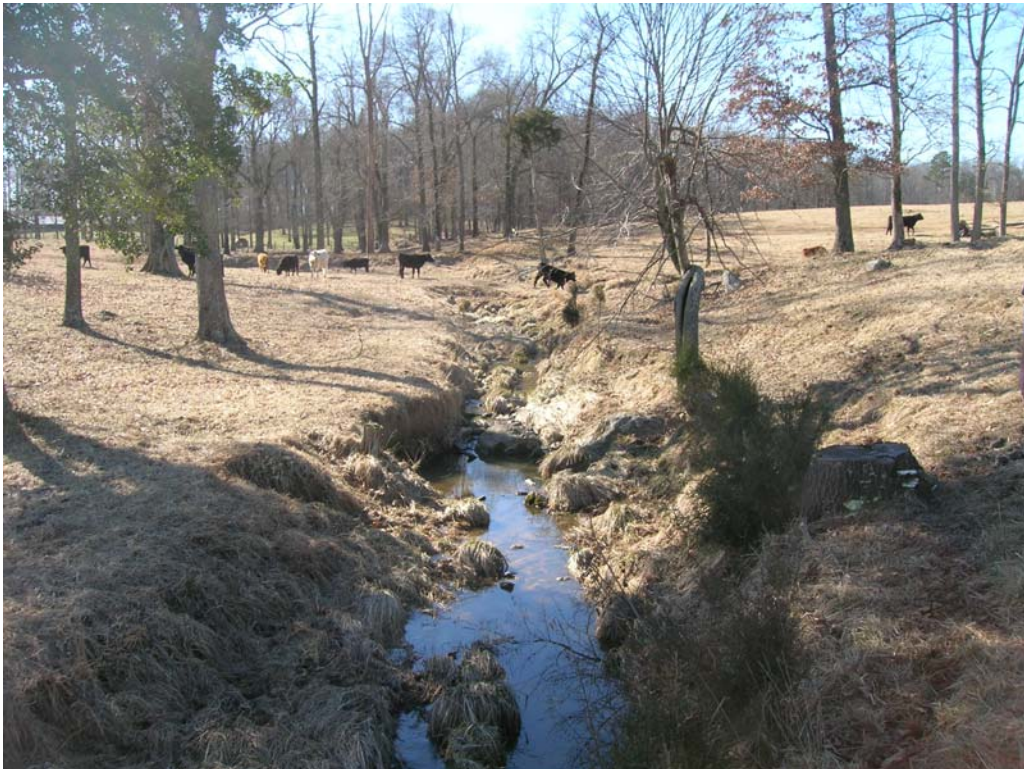
Existing Conditions Reach UT 1

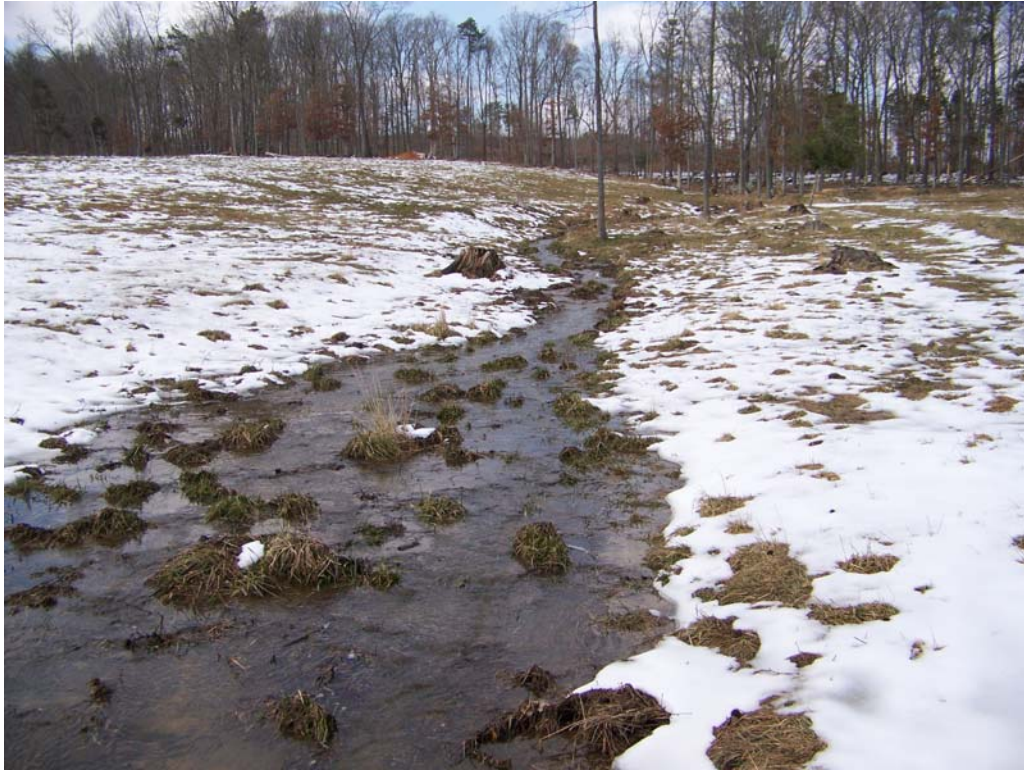
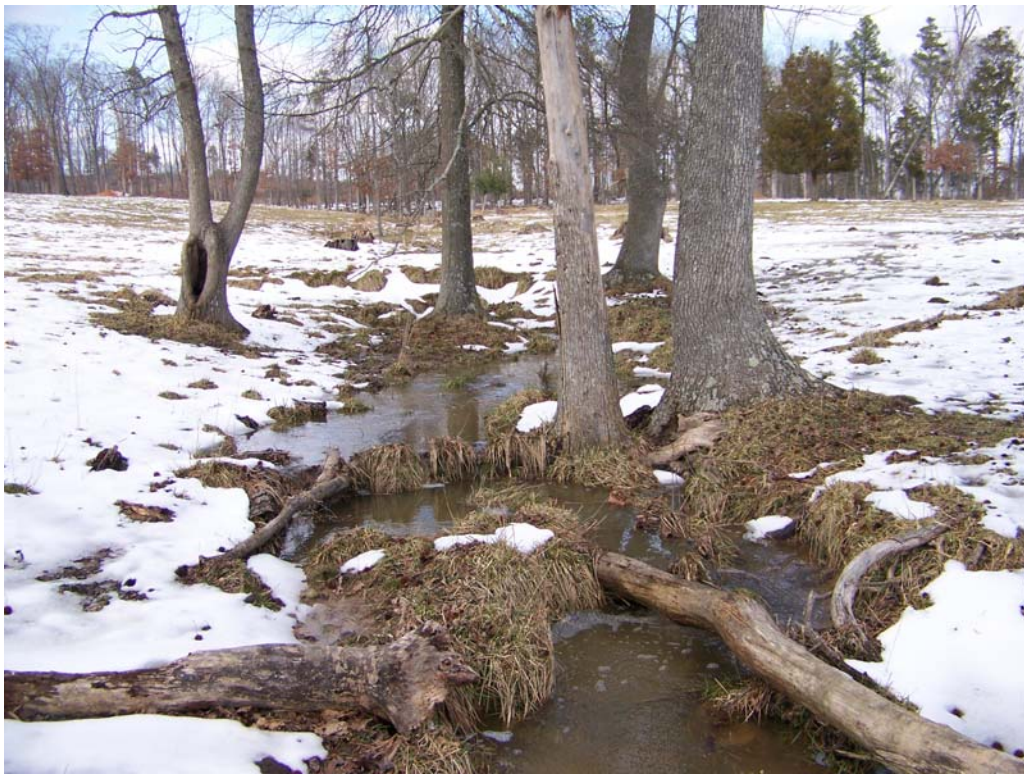
Existing Conditions Reach UT 1A

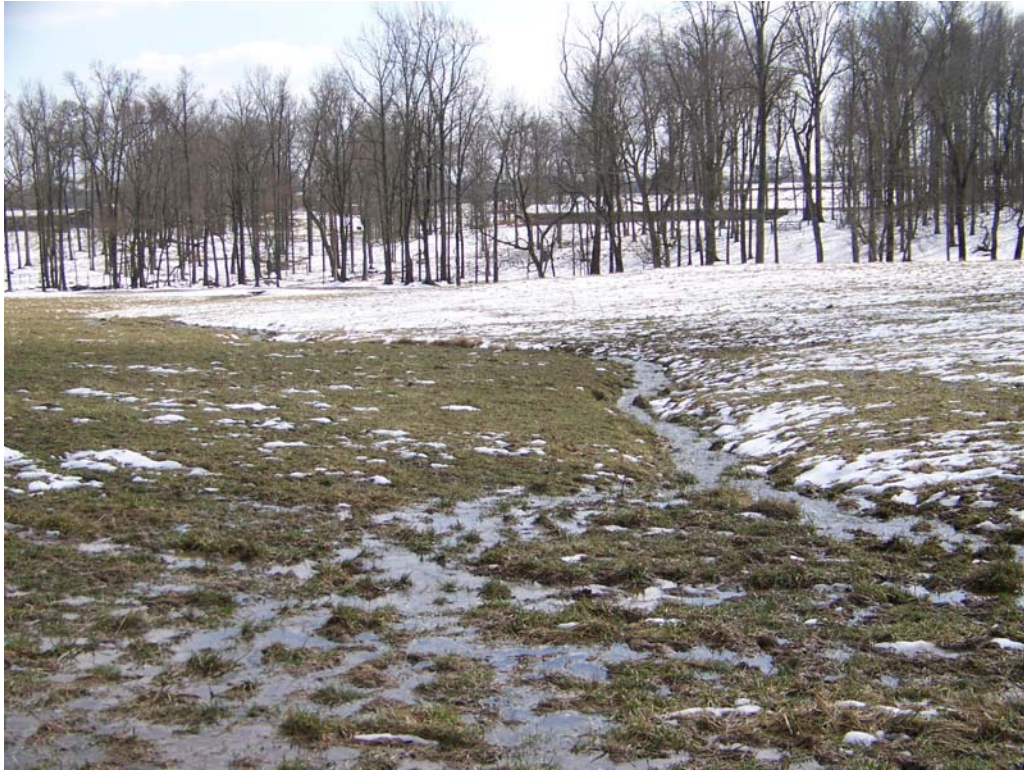
Existing Conditions UT 1B

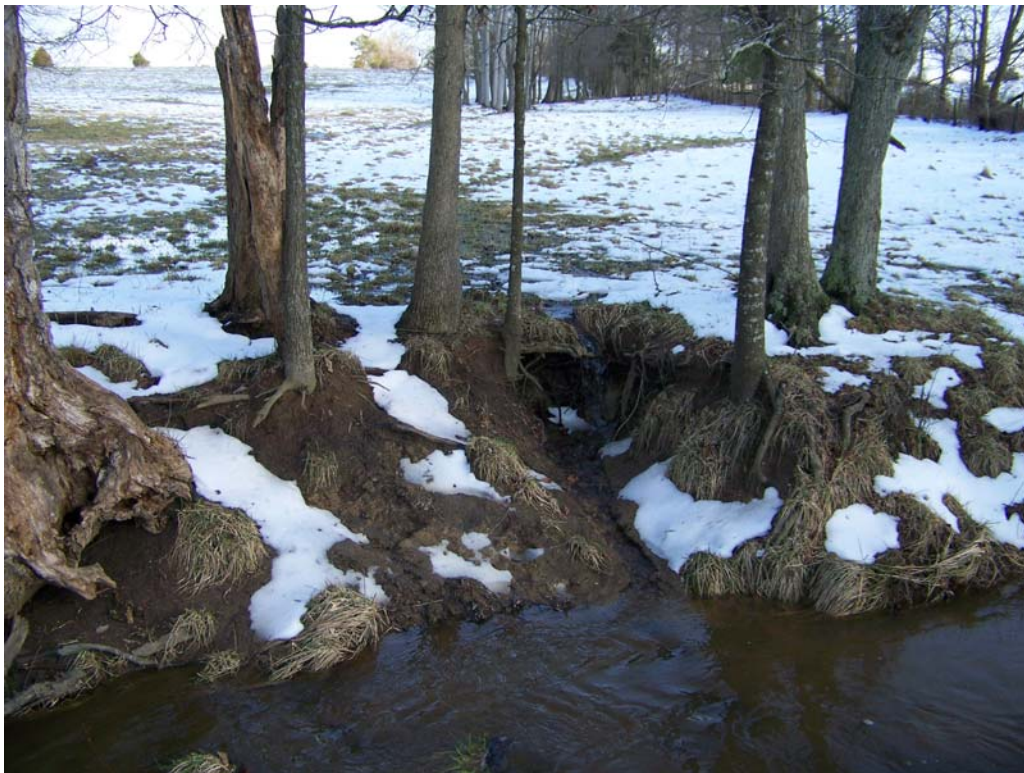
Existing Conditions UT 2

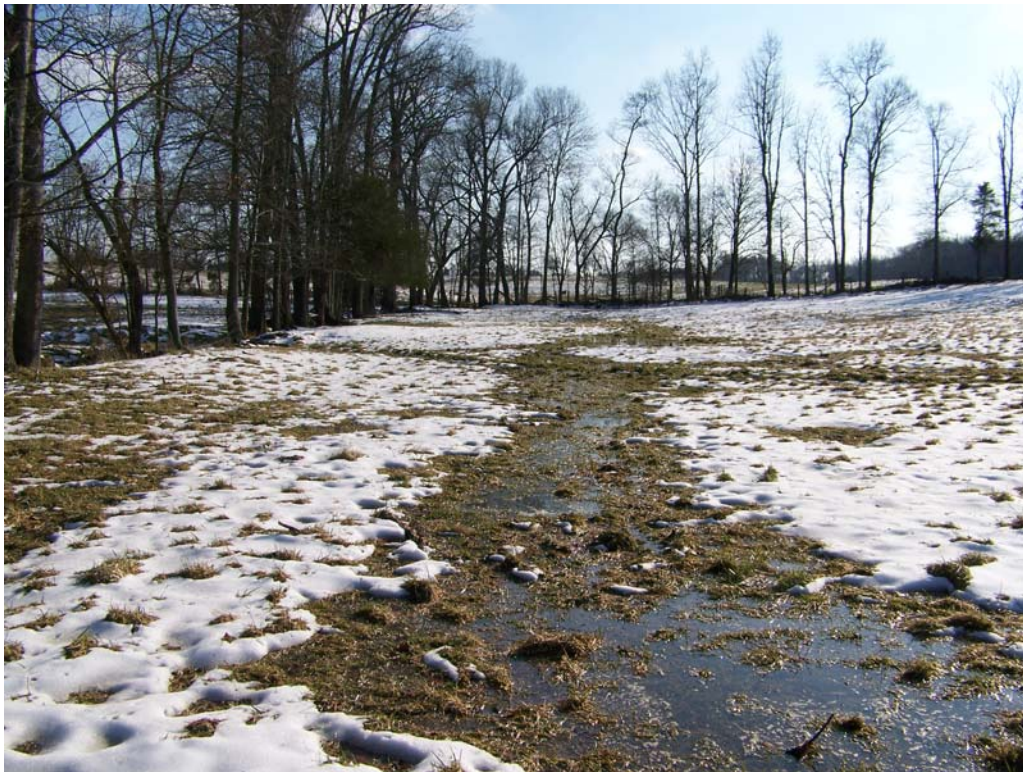
Existing Conditions RW1

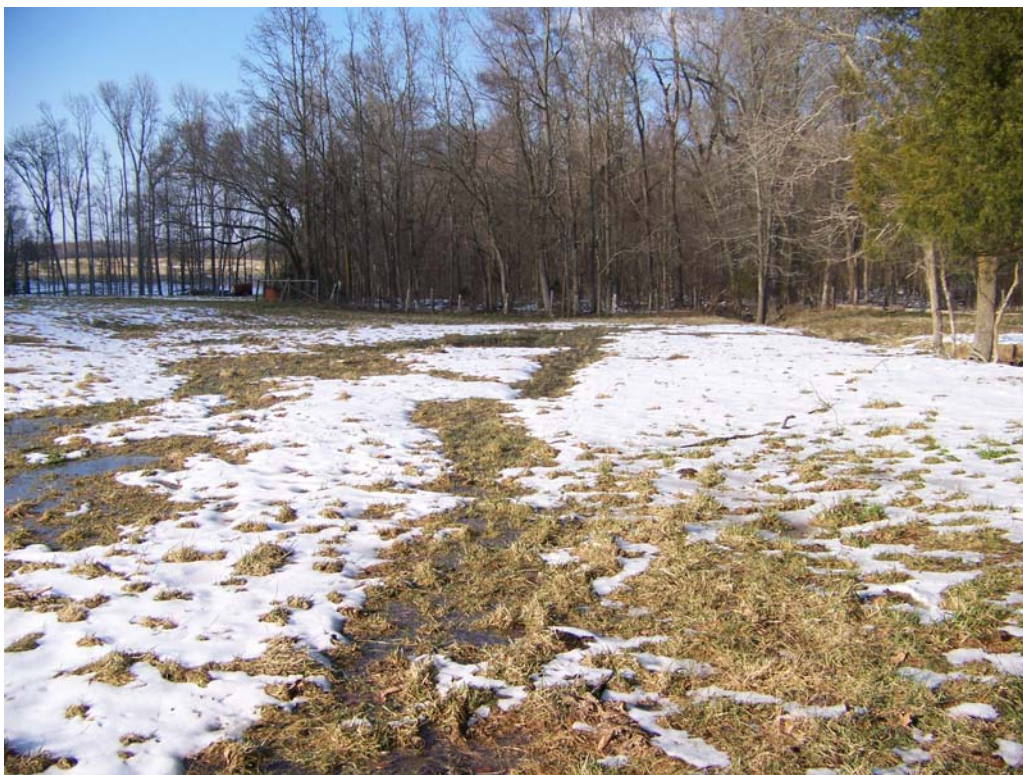
Existing Conditions RW2

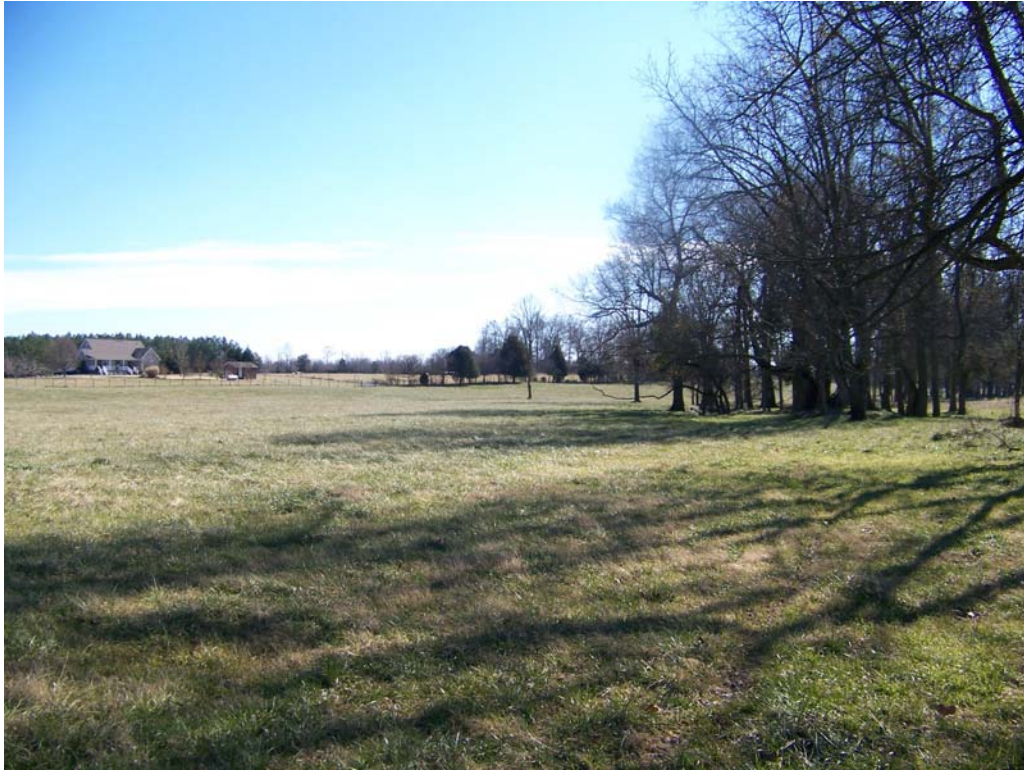
Existing Conditions RW 3

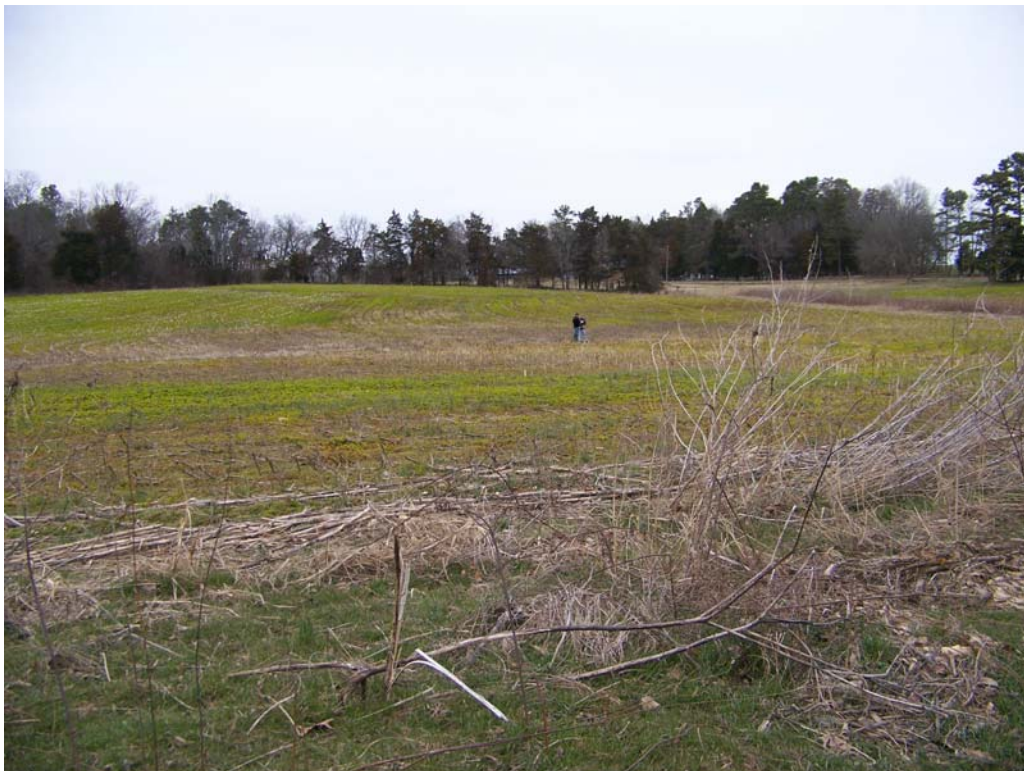
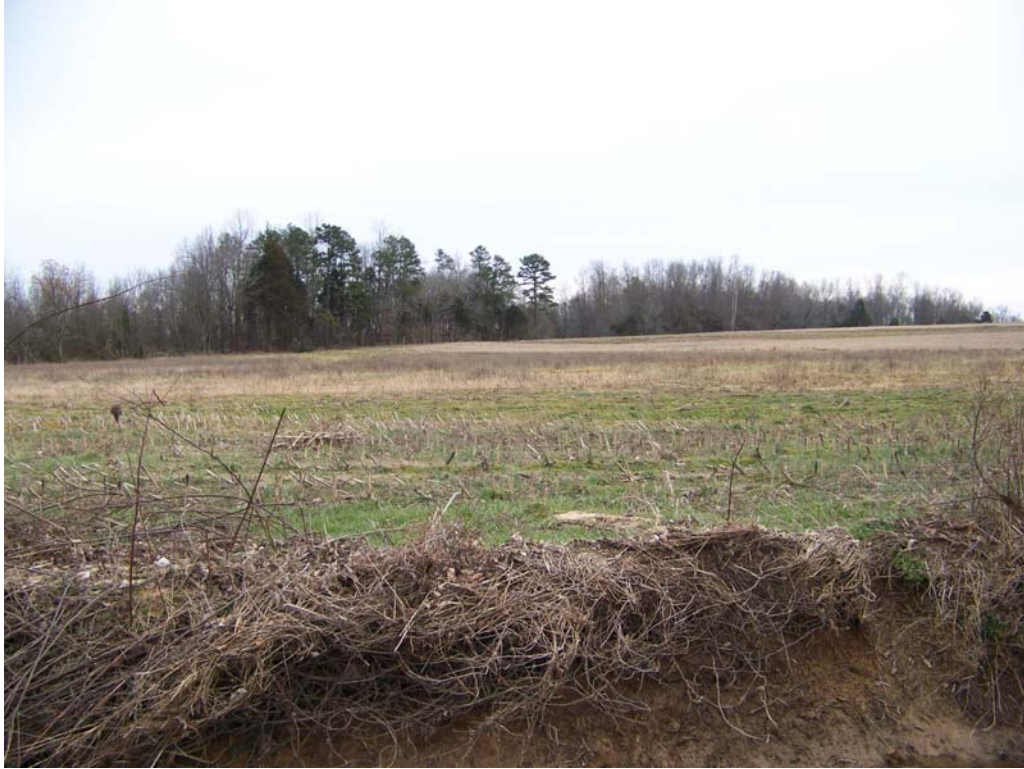
Existing Conditions RW 4

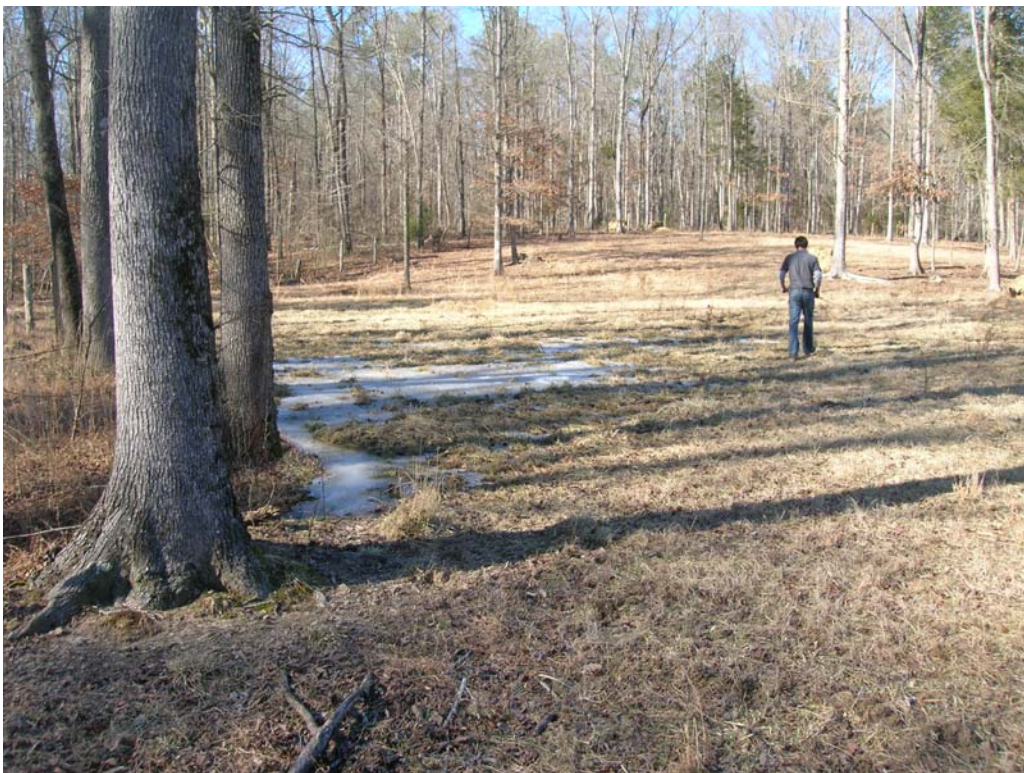
Existing Conditions NRW2

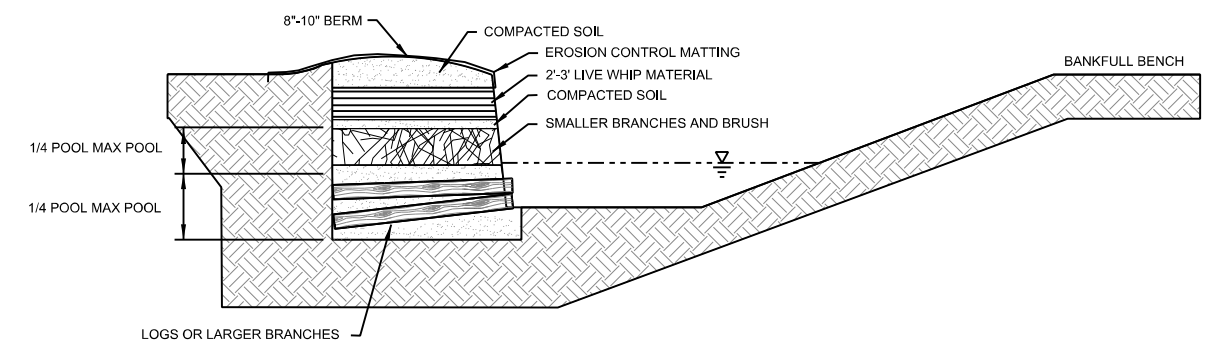
**3**  
6.3  
Brush Toe  
Not to Scale

- OVER-EXCAVATE THE OUTSIDE BEND OF THE CHANNEL, LAY LARGER LOGS AND BRANCHES IN A CRISS-CROSS FASHION, LOCK IN PLACE WITH FILL COVERING 1'-2" OF THE LARGER LOGS.
- LAY SMALLER BRANCHES AND BRUSH OVER LARGER LOGS, PRESS TIGHTLY TOGETHER. BACKFILL TO LOCK IN PLACE.
- LAY LIVE WHIP MATERIAL OVER SOIL COVERING SMALLER BRANCH MATERIAL AND COVER WITH SOIL.
- LAY EROSION CONTROL MATTING OVER SOIL COVERING LIVE WHIP MATERIAL WITH 1/2 OF LENGTH OF MATTING EXTENDING INTO CHANNEL. PLACE SOIL OVER MATTING TO A HEIGHT OF 6" - 10" ABOVE TOP OF BANK ELEVATION. WRAP EROSION CONTROL MATTING OVER SOIL LAYER AND STAKE IN PLACE ACCORDING TO EROSION CONTROL MATTING DETAIL.

Section A-A'

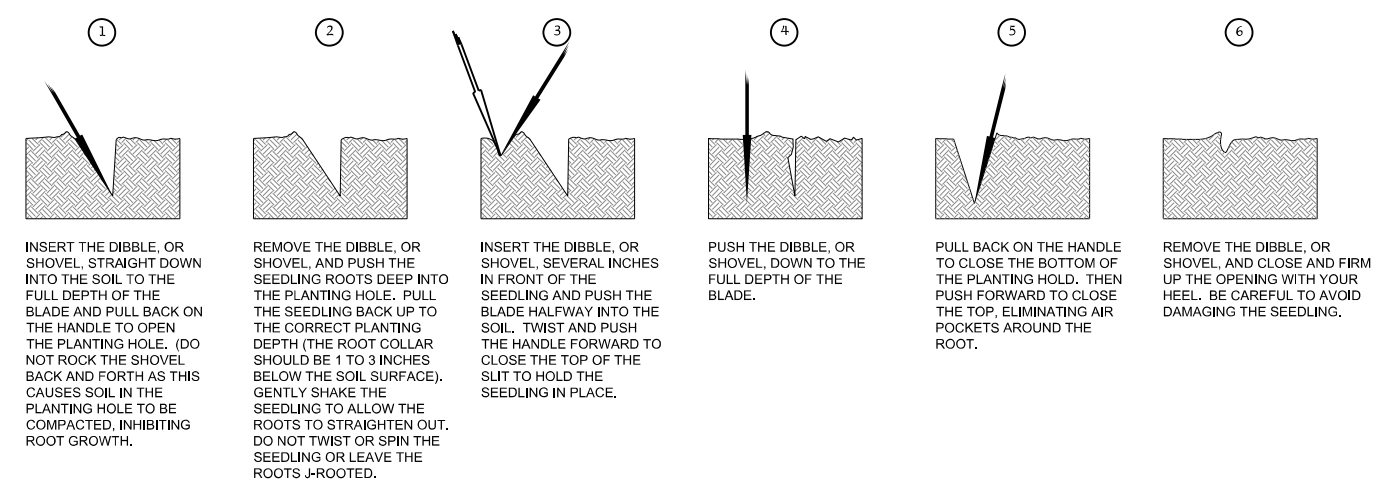
**ROOTING PRUNING**  
ALL ROOTS SHALL BE PRUNED TO AN APPROPRIATE LENGTH TO PREVENT J-ROOTING.

1. INSERT THE DIBBLE, OR SHOVEL, STRAIGHT DOWN INTO THE SOIL TO THE FULL DEPTH OF THE BLADE AND PULL BACK ON THE HANDLE TO OPEN THE PLANTING HOLE. (DO NOT ROCK THE SHOVEL BACK AND FORTH AS THIS CAUSES SOIL IN THE PLANTING HOLE TO BE COMPACTED, INHIBITING ROOT GROWTH.)

2. REMOVE THE DIBBLE, OR SHOVEL, AND PUSH THE SEEDLING ROOTS DEEP INTO THE PLANTING HOLE. PULL THE SEEDLING BACK UP TO THE CORRECT PLANTING DEPTH (THE ROOT COLLAR SHOULD BE 1 TO 3 INCHES BELOW THE SOIL SURFACE). GENTLY SHAKE THE SEEDLING TO ALLOW THE ROOTS TO STRAIGHTEN OUT. DO NOT TWIST OR SPIN THE SEEDLING OR LEAVE THE ROOTS J-ROOTED.

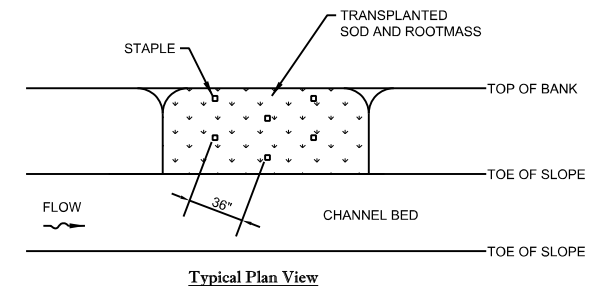
- NOTES:**
1. PREPARE THE BANK WHERE THE SOD MAT WILL BE TRANSPLANTED BY RAKING AS DIRECTED BY ENGINEER.
  2. EXCAVATE TRANSPLANT SOD MATS WITH A WIDE BUCKET AND AS MUCH ADDITIONAL SOIL MATERIAL AS POSSIBLE.
  3. PLACE TRANSPLANT ON THE BANK TO BE STABILIZED.
  4. SECURE WITH SOD STAPLES.
  5. FILL IN ANY HOLES AROUND THE TRANSPLANT AND COMPACT.
  6. ANY LOOSE SOIL LEFT IN THE STREAM SHOULD BE REMOVED.
  7. PLACE MULTIPLE TRANSPLANTS CLOSE TOGETHER SUCH THAT THEY TOUCH.
