# **UT to Rush Fork Stream Mitigation Project Mitigation Plan – Final**

Haywood County, North Carolina

DMS Project ID No. 100068, DEQ Contract No. 7535, DMS RFP #16-007335

**April 2021**

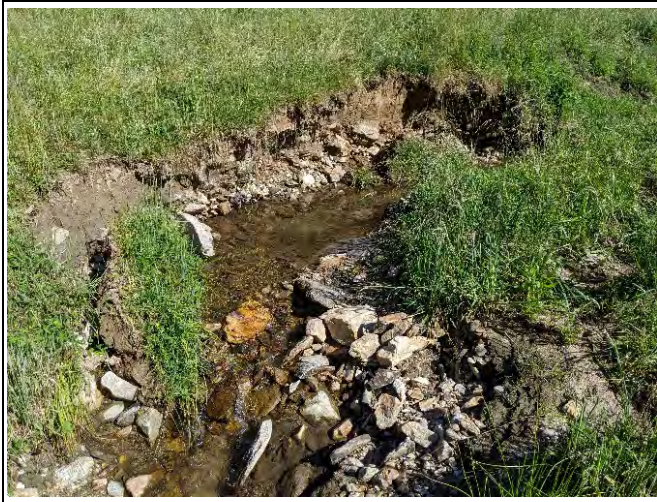
UT1-R4, Left Bank (June 2020)

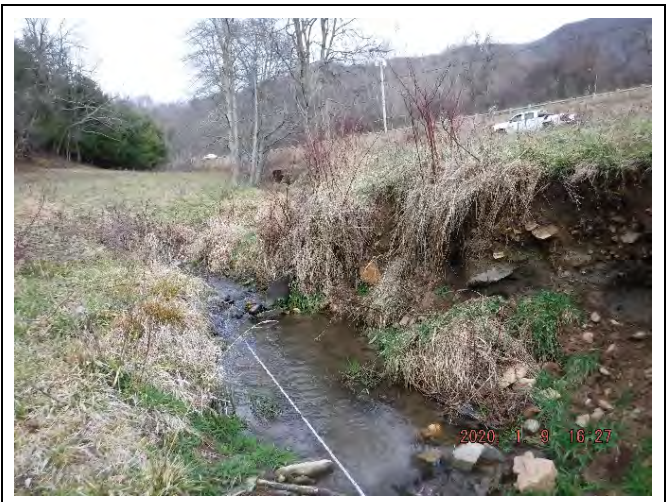
UT1 R4, left bank upstream (Jan. 2020)

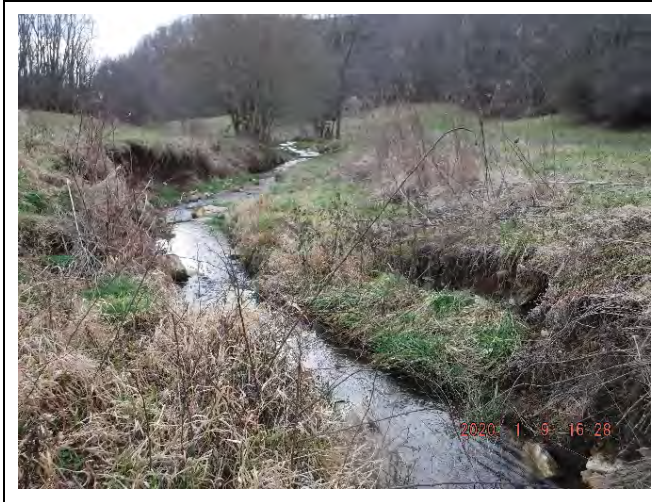
UT1-R4, downstream (Jan. 2020)

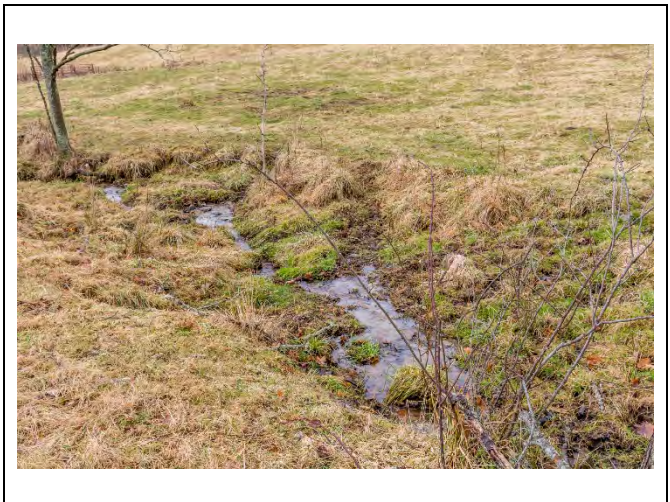
UT1-R3, cattle crossing (Jan. 2020)

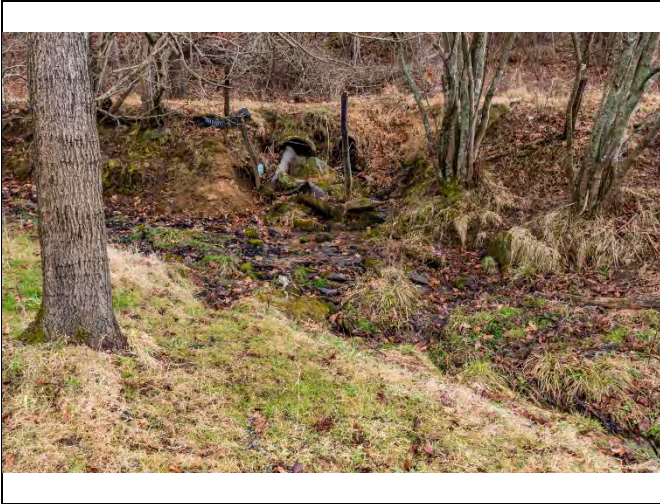
UT1-R3, old culvert (Jan. 2020)

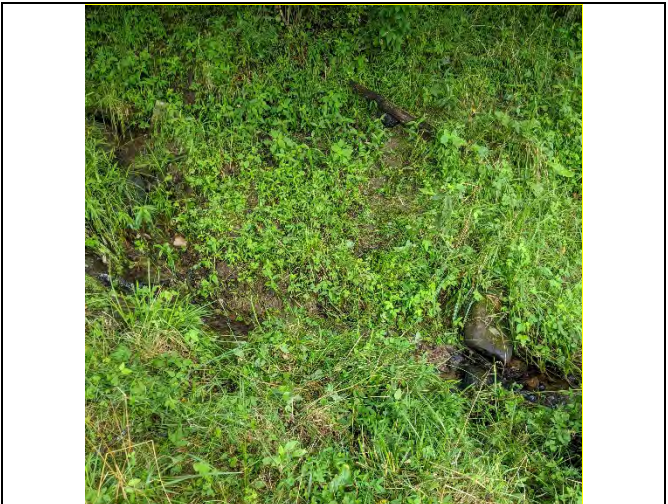
UT2, mid-reach (Aug. 2020)

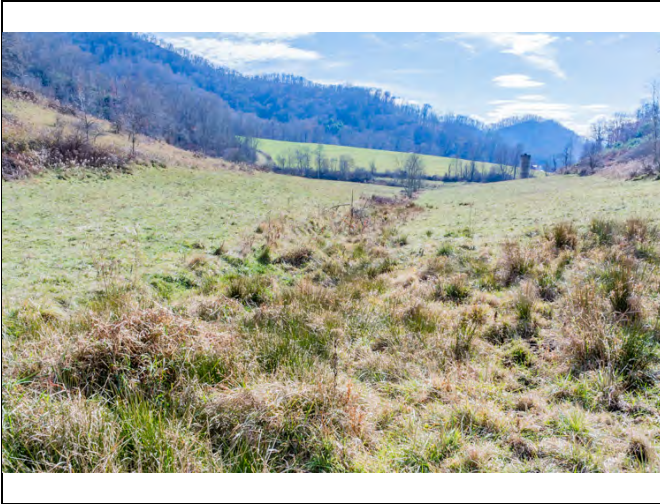
Upper UT3, downstream (Nov. 2017)

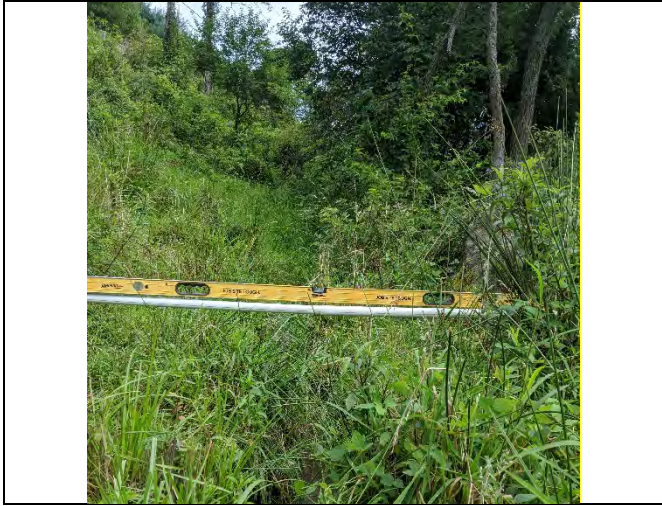
UT4, upstream (Aug. 2020)

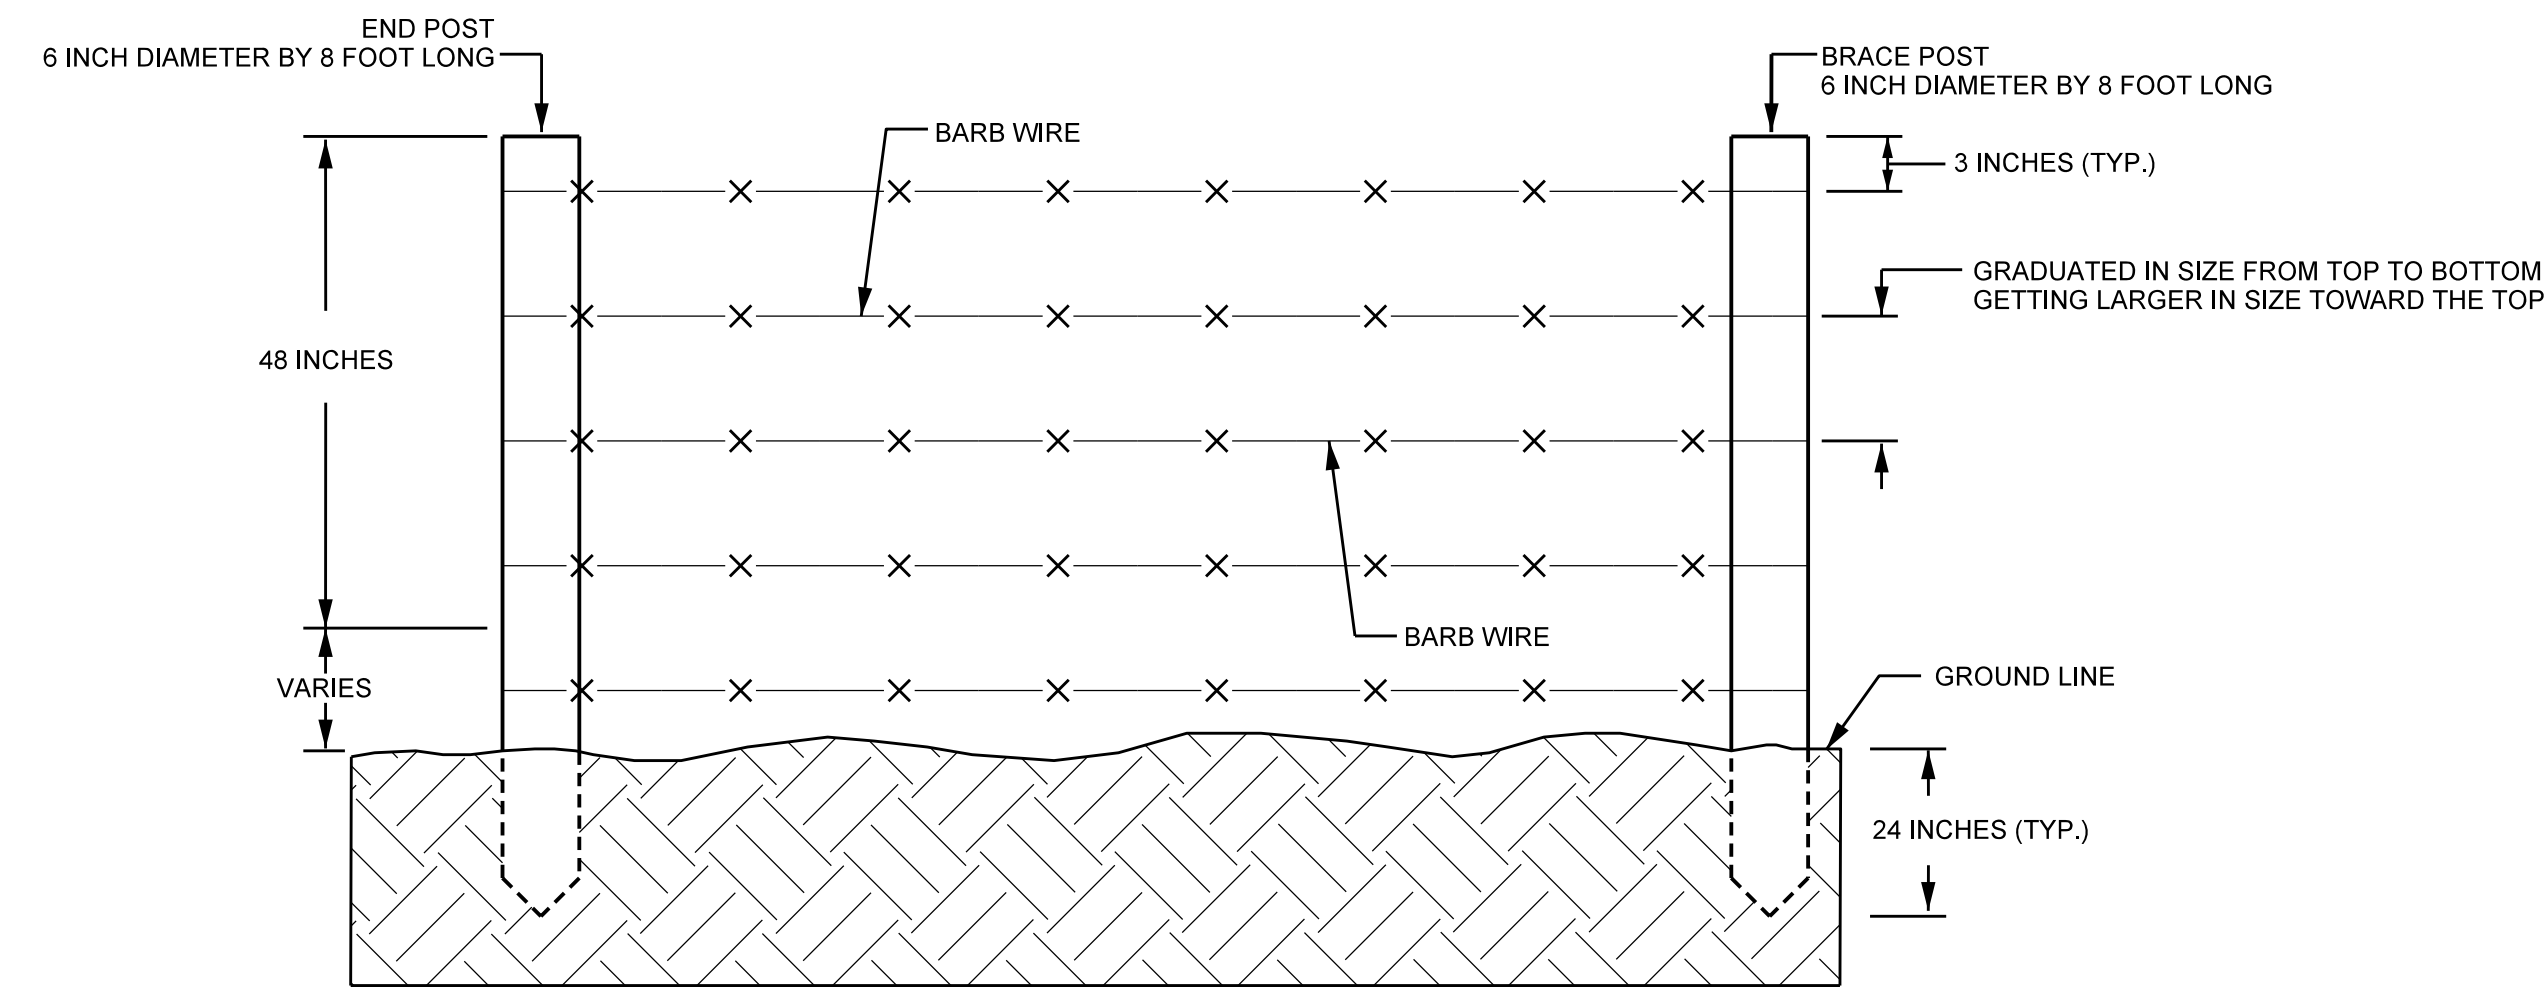
### BARB WIRE FIELD FENCE

1. END POSTS SHALL BE INSTALLED AT A SPACING OF 10-15 FEET.
2. ALL FENCING AND FENCE POSTS SHOULD BE SET 1-2 FEET OUTSIDE OF THE CONSERVATION EASEMENT FOR FENCE LINE MAINTENANCE ( LIKE HERBICIDE SPRAYING ).
