UT ALTAMAHAW SITE

EEP Project No. 92837

MONITORING YEAR 2 (2013) FINAL SUBMITTAL

Alamance County, NC

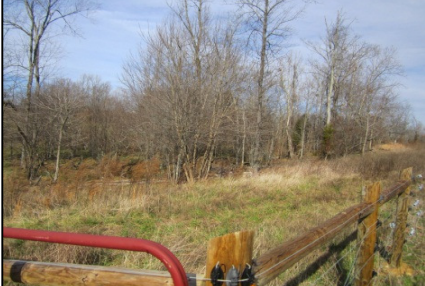
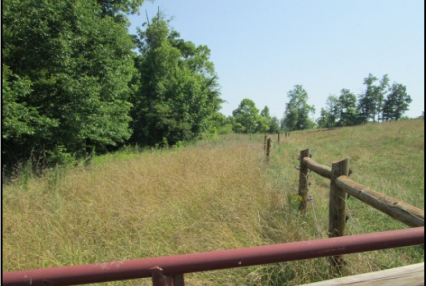
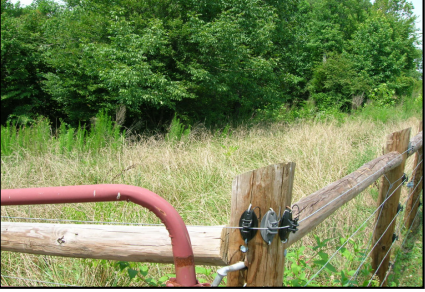
Photostation 5. Facing north from east corner of existing crossing.

Surface erosion at the cattle crossing is a result from repeated livestock trampling and compaction. This has ultimately resulted in surface waters bypassing the existing modified level spreader and erosion around the pipe along the downstream side of the crossing. Photographs in Appendix B depict this area of concern.

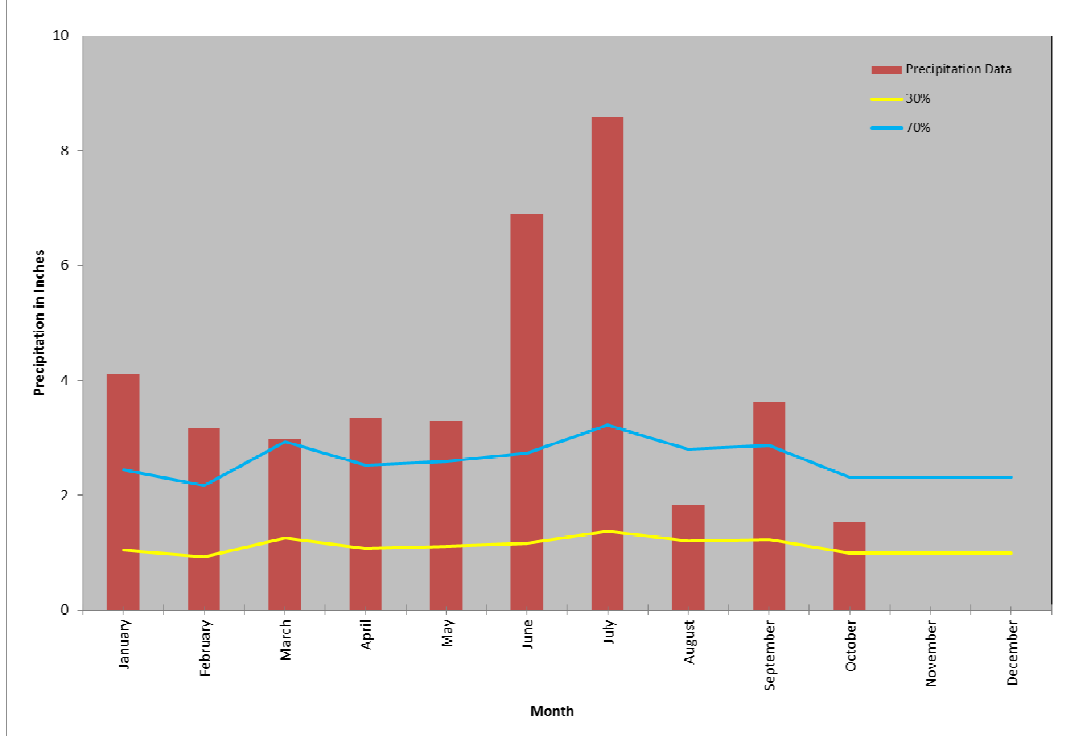
UT Altamahaw Site 30-70 Percentile Graph for Rainfall - Monitoring Year 2 (2013), Alamance County, NC

During June and July 2013, at least one bankfull event occurred. Evidence of this event was wrack material above the bankfull indicators along the channel and cork shavings within the crest gage present at approximately 40 inches. No other bankfull events were indicated during 2013. Annual photograph comparisons of the stream channels are depicted in Appendix B and hydrologic data associated with this year's monitoring assessment is provided in Appendix D.

Month	Amount (in.)	30%	70%
January	4.1038	1.05	2.45
February	3.1642	0.93	2.17
March	2.9724	1.26	2.94
April	3.3429	1.08	2.52
May	3.2845	1.11	2.59
June	6.8952	1.17	2.73
July	8.58	1.38	3.22
August	1.83	1.2	2.8
September	3.62	1.23	2.87
October	1.54	0.99	2.31
November	0	0.99	2.31
December	0	0.99	2.31
