Unnamed Tributaries to Bald Creek Stream Restoration Project

Yancey County, North Carolina
EEP Project Number: 92596
SCO Project Number: 070714901

Final Restoration Plan

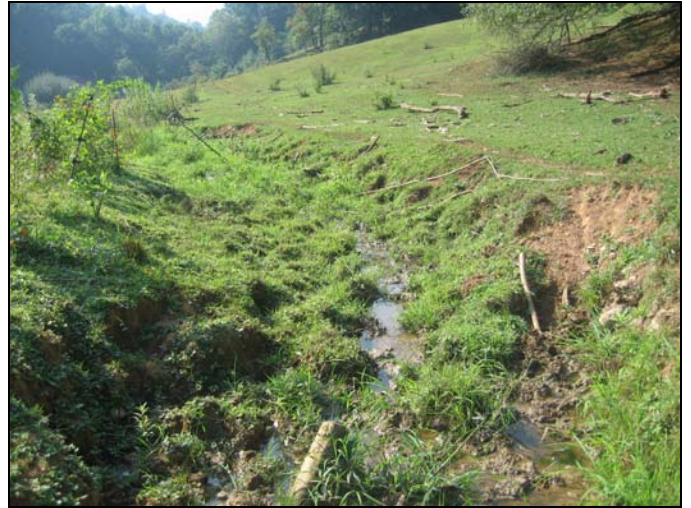
Impaired portion of the Mainstem.

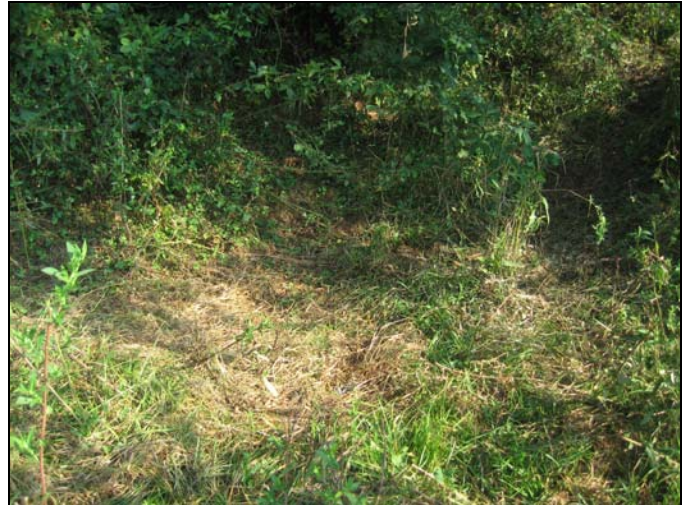
Base of the dam below Sweet Hollow Road, showing the absence of a stream channel.

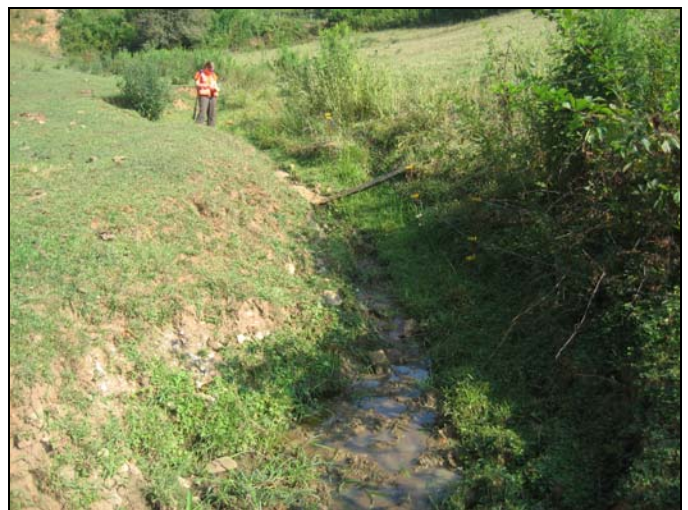
The Mainstem regains stream characteristics below a headcut.

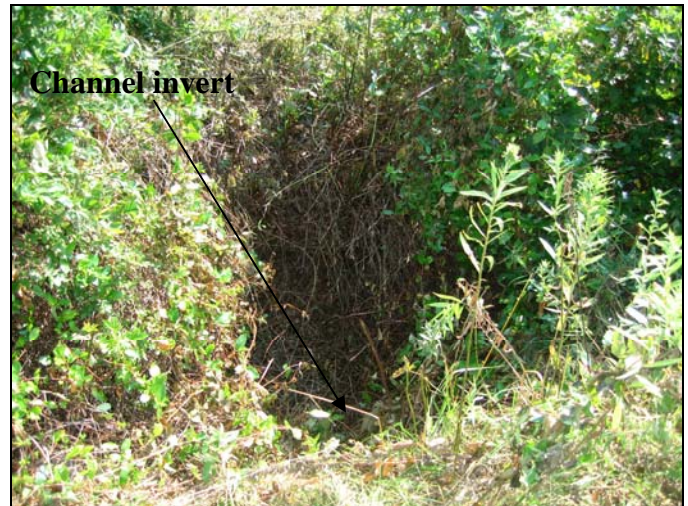
The incised channel at a swath cut through the dense invasive vegetation.

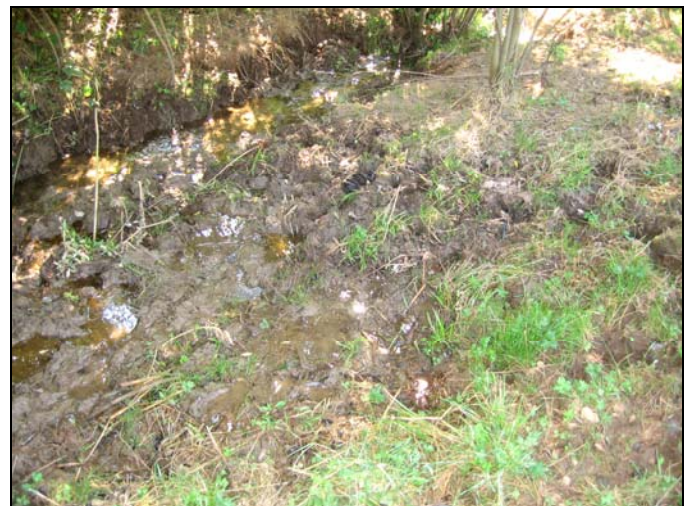
A groundwater seep flows into the channel just above the last proposed crossing near the barn.

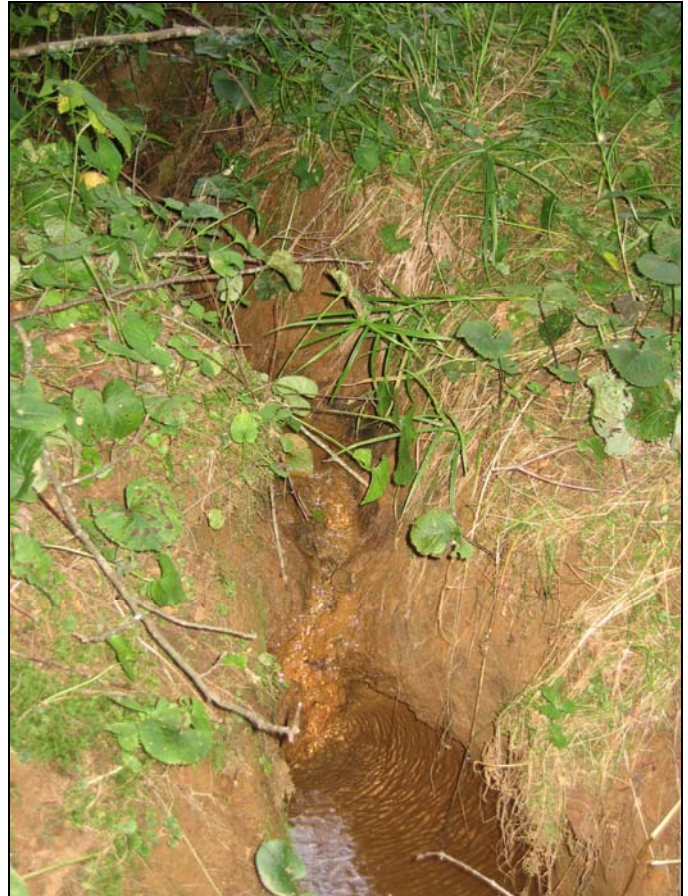
Headcut below perennial origin of Tributary 1.

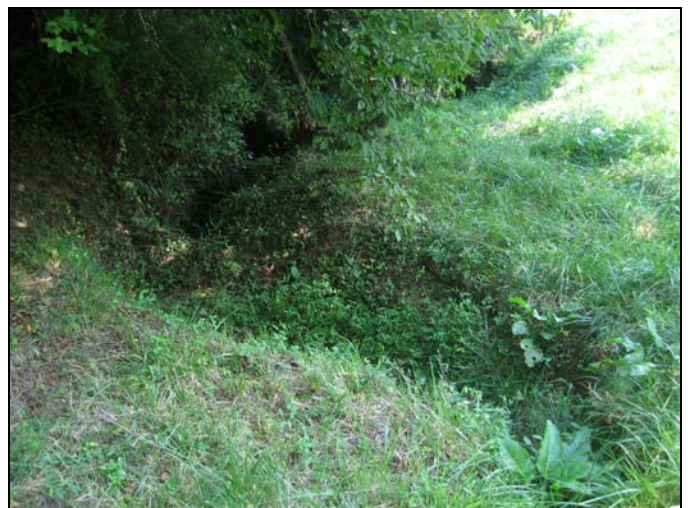
Tributary 2 becomes more incised as it approaches Sweet Hollow Road.

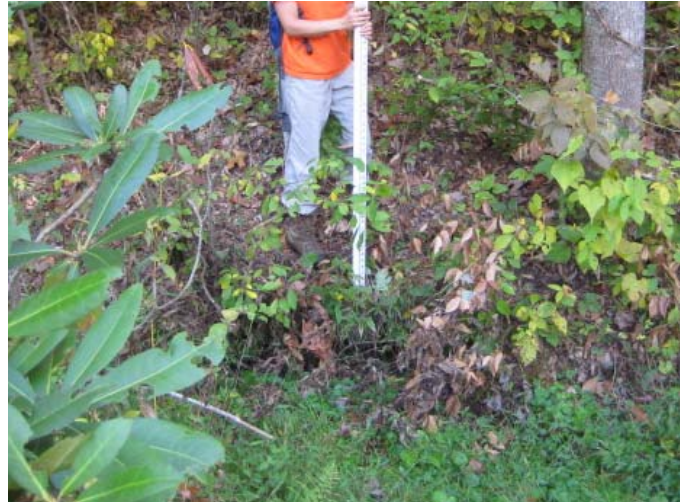
Mainstem Reach B – steep and eroding left bank.

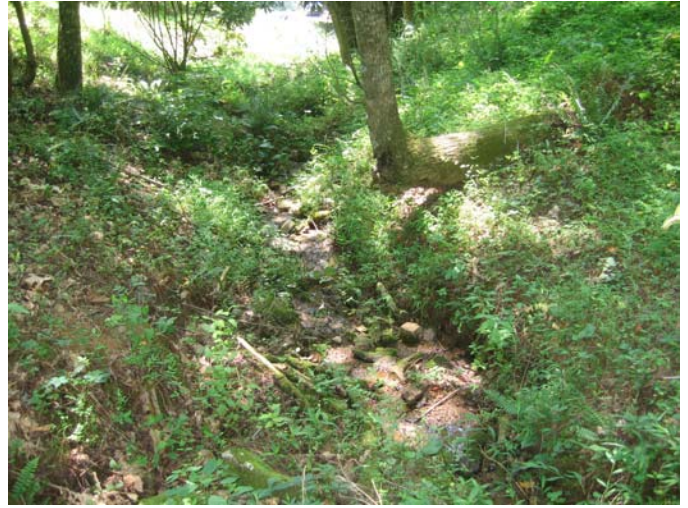
Tributary 2 Reach 2A reference section facing downstream.

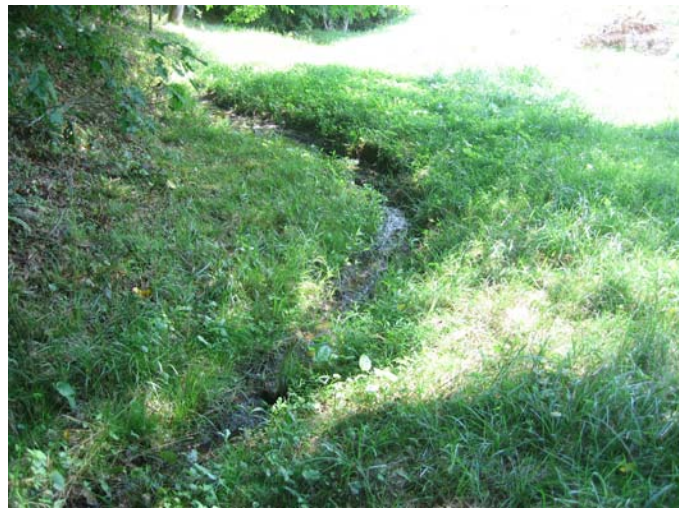
Tributary 2 Reach 2A reference section facing downstream.
