**UT Bear Creek (Phillips)
Stream Restoration Monitoring Report
EEP Project # 92719
Monitoring Year – 01
2009**

December 2009

1.0	EXECUTIVE SUMMARY / PROJECT ABSTRACT	1
2.0	METHODOLOGY	2
3.0	REFERENCES	2

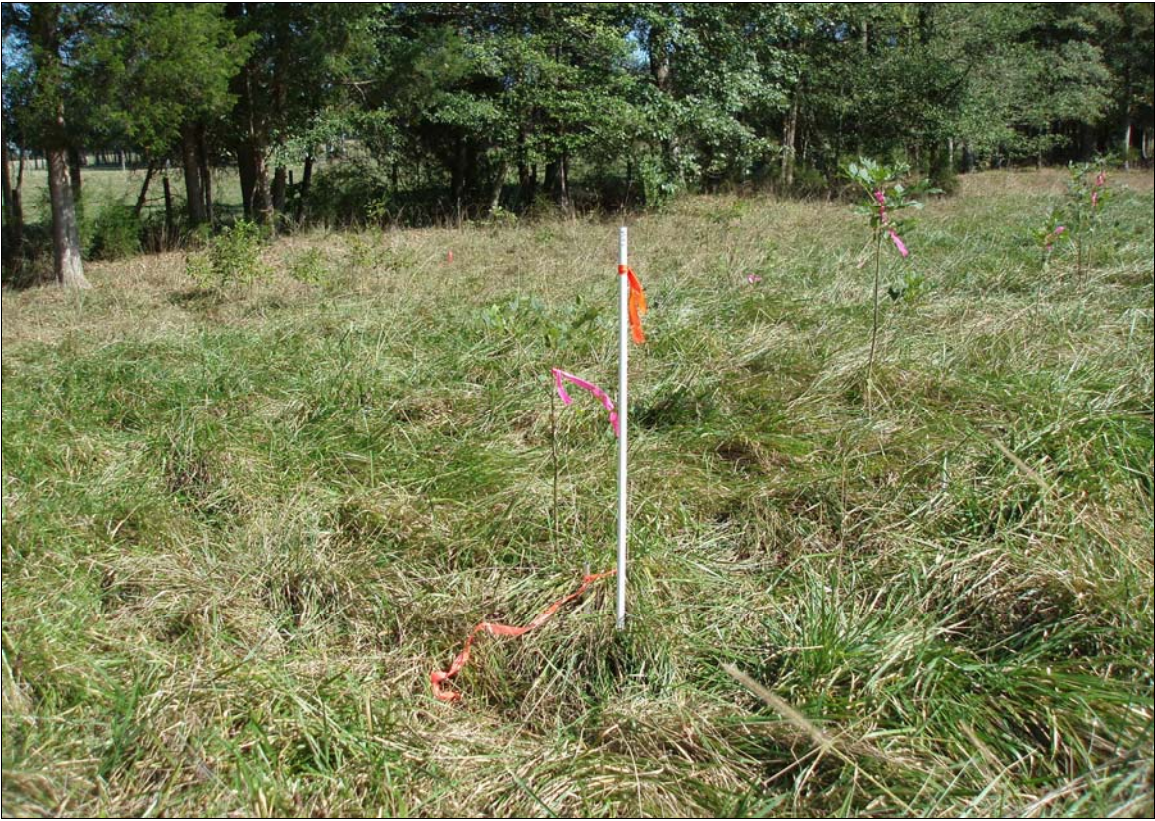
Vegetation Plot 7: 9/30/09 – MY-01

Table 5. Vegetation Plot Mitigation Success Summary Table		
Project Number and Name: 92719 - UT Bear Creek (Phillips)		
Vegetation Plot ID	Monitoring Year 01 Planted Stem Density (stems/acre)	Vegetation Survival Threshold Met?
1	364	Yes
2	405	Yes
3	324	Yes
4	445	Yes
5	526	Yes
6	607	Yes
7	202	No
