**UT Bear Creek (Phillips)  
Stream Restoration Monitoring Report  
EEP Project # 92719  
Monitoring Year 03**

**Data Collection: 2011  
Construction Completed: 2006  
Submitted: December 2011**

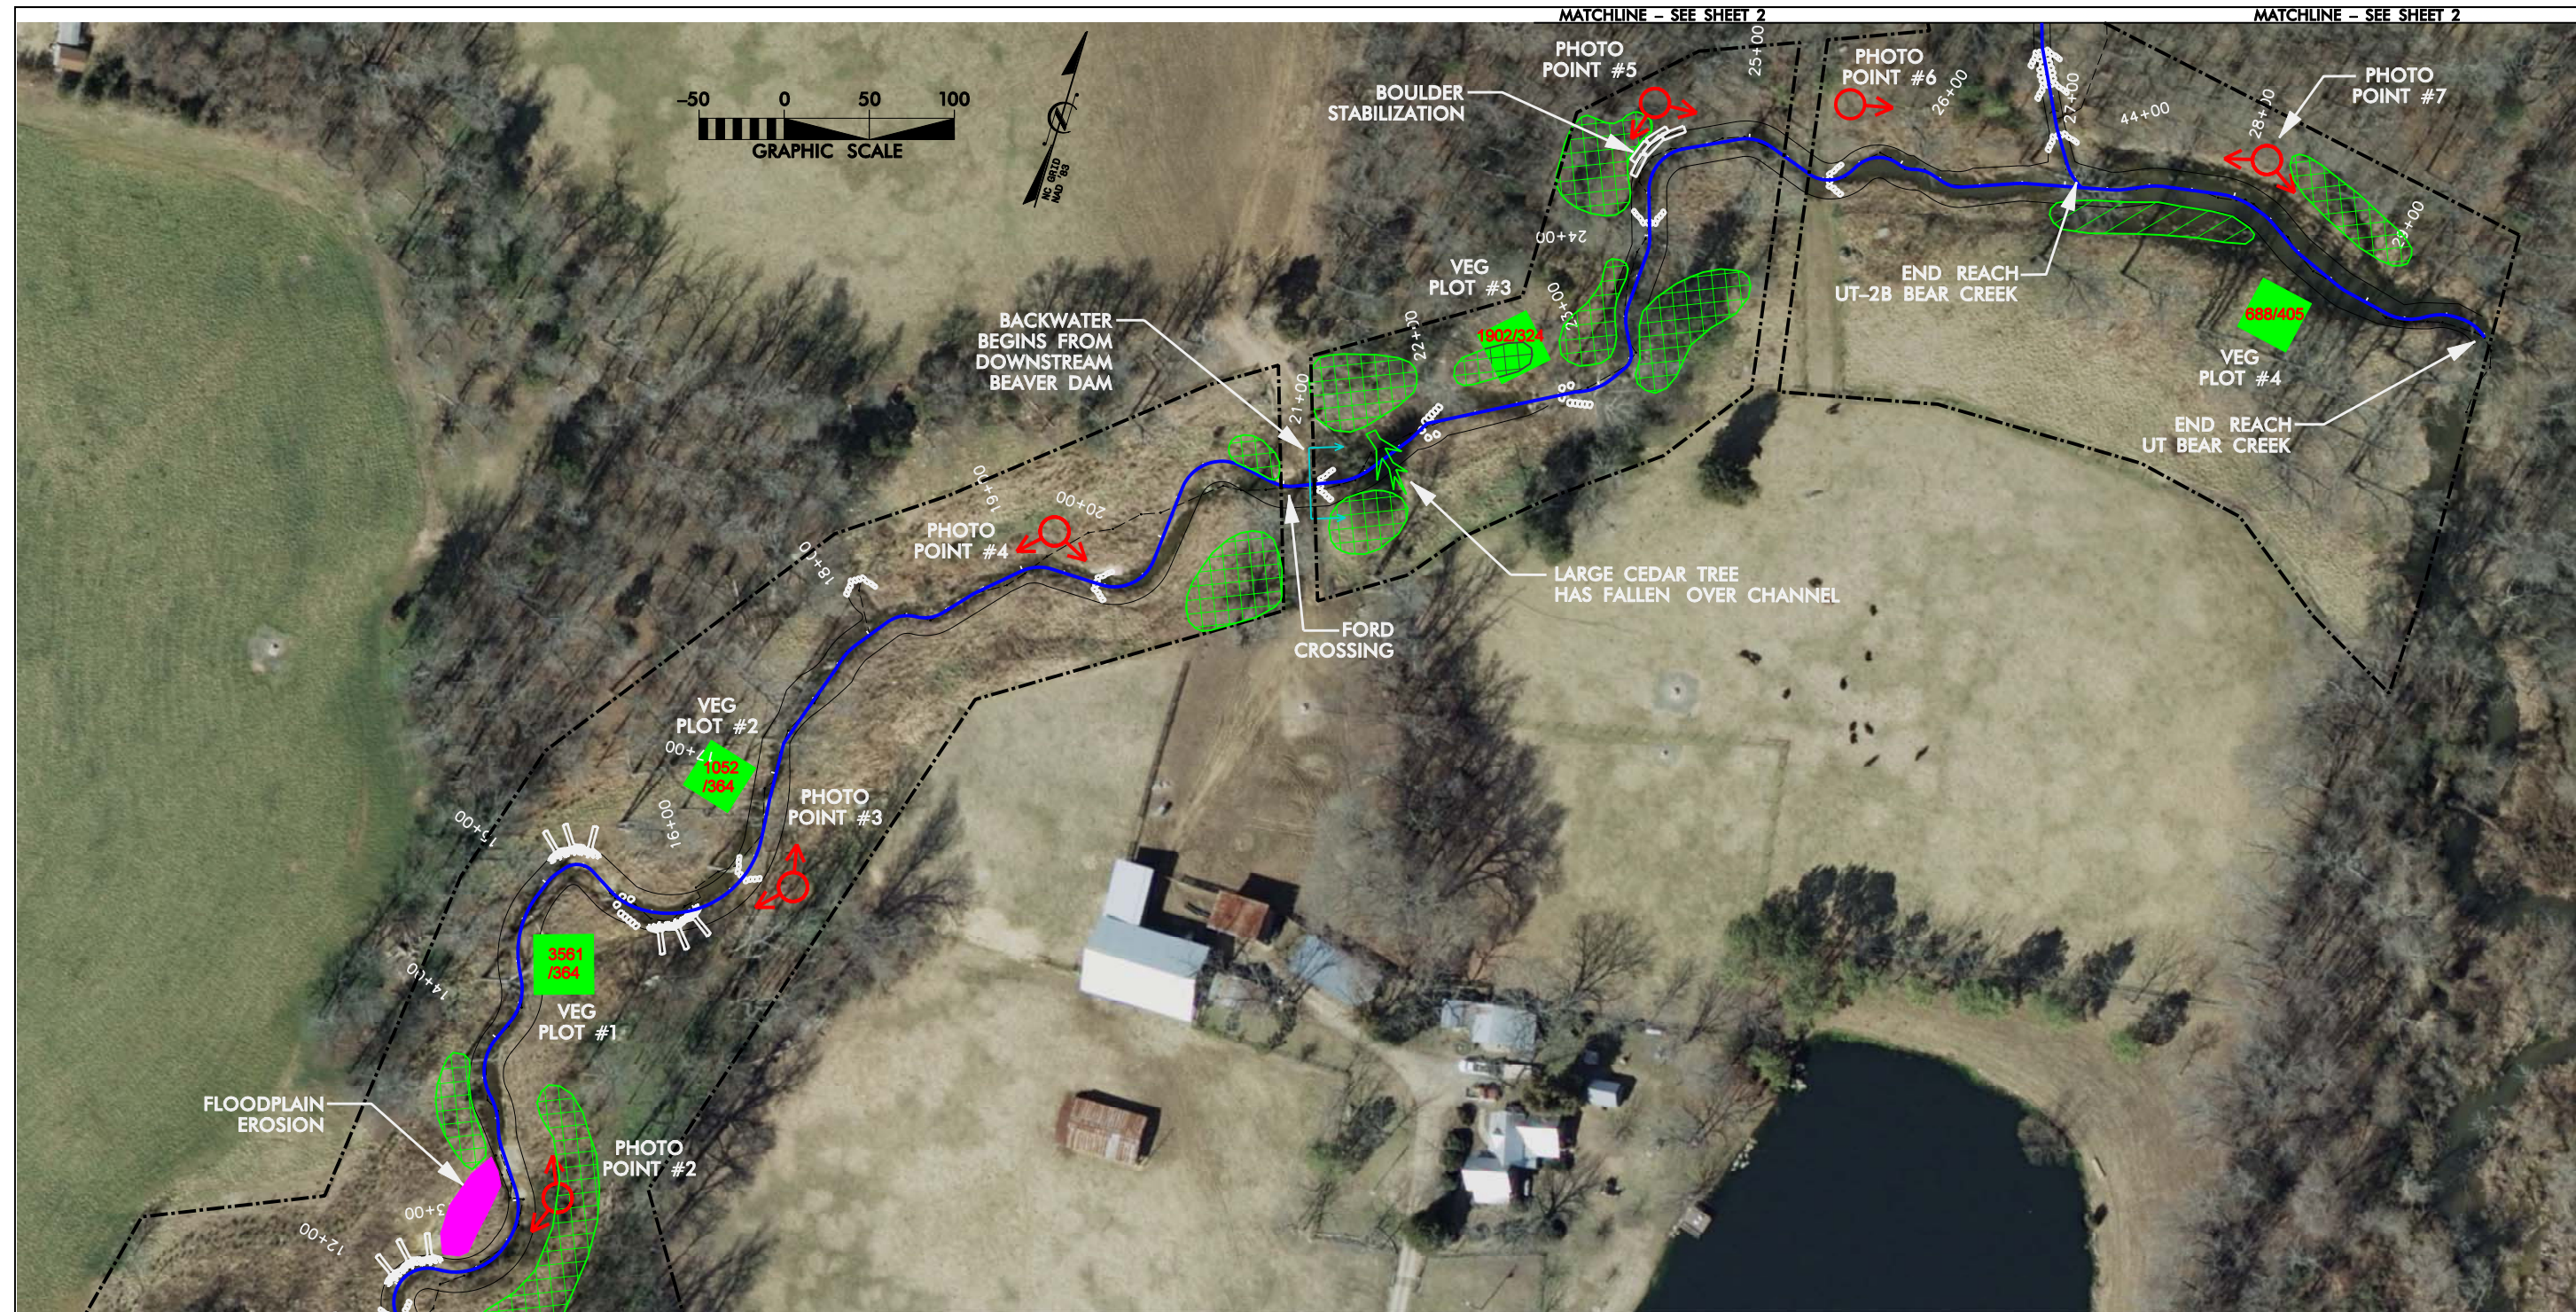
DATE: NOV 2011  
SCALE: 1" = 100'  
CURRENT  
CONDITION  
PLAN VIEW  
SHEET 1 OF 2

UT BEAR CREEK (PHILLIPS)  
CHATHAM COUNTY, NORTH CAROLINA  
EEP PROJECT NUMBER 92719 - MY03  
REACH: UT BEAR CREEK

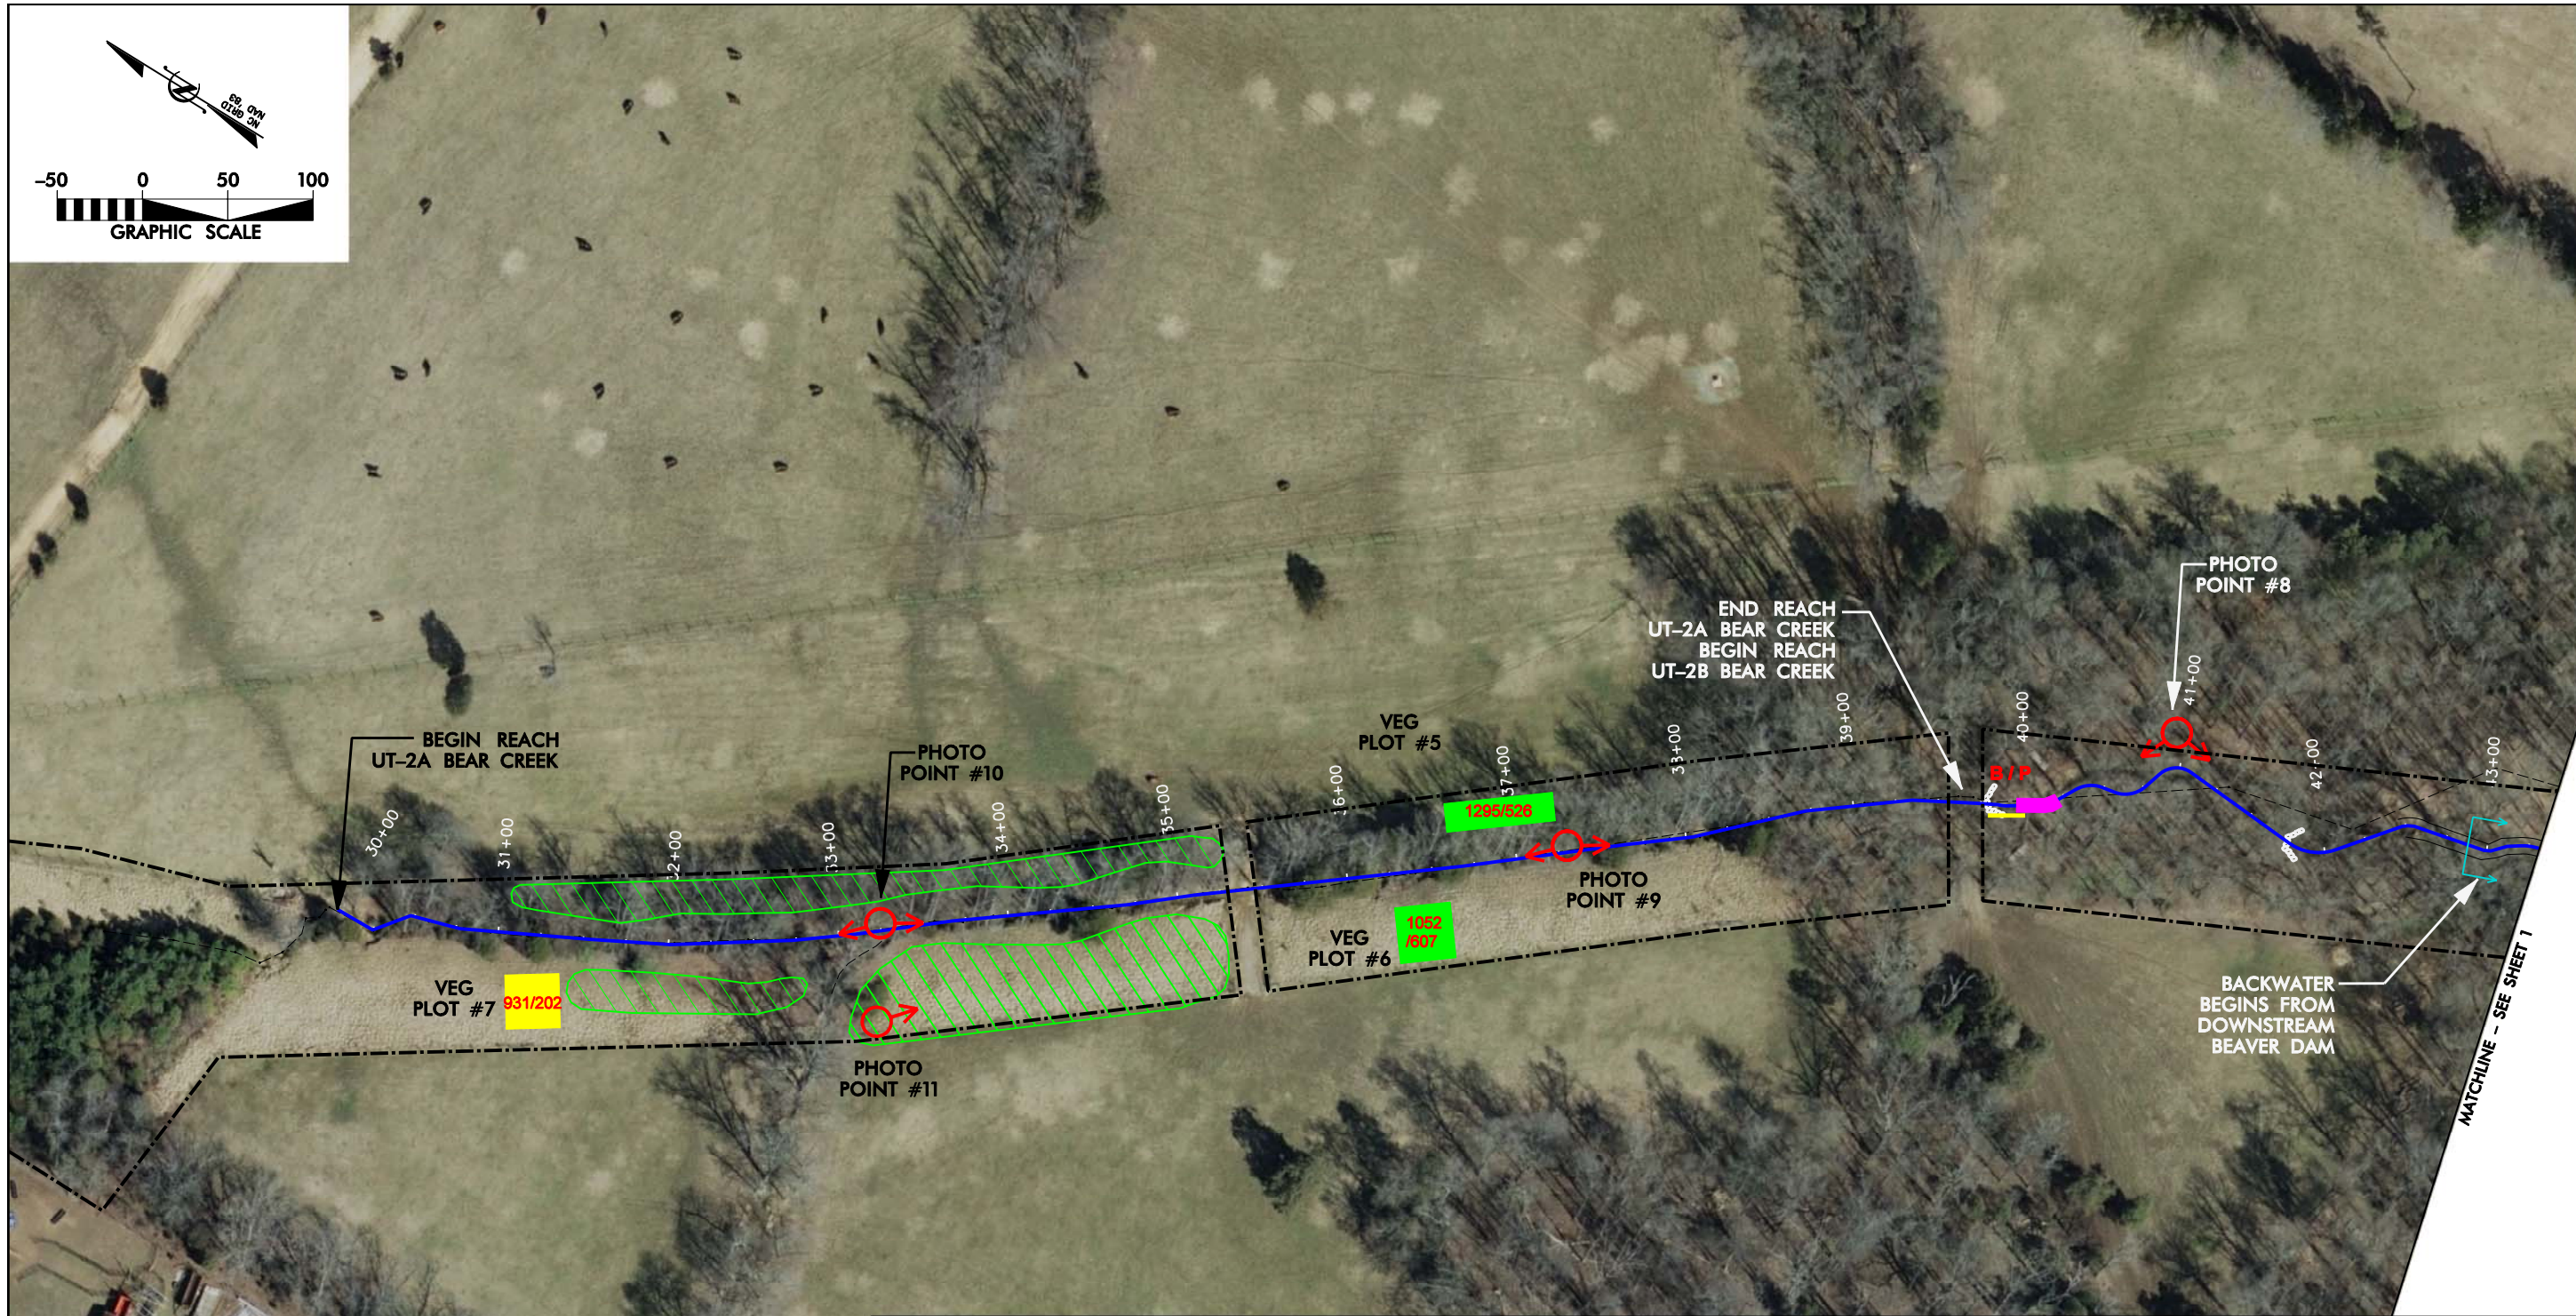
DATE: NOV 2011  
 SCALE: 1" = 100'  
 CURRENT CONDITION PLAN VIEW  
 SHEET 2 OF 2

UT BEAR CREEK (PHILLIPS)  
 CHATHAM COUNTY, NORTH CAROLINA  
 EEP PROJECT NUMBER 92719 - MY03  
 REACHES: UT-2A AND UT-2B BEAR CREEK

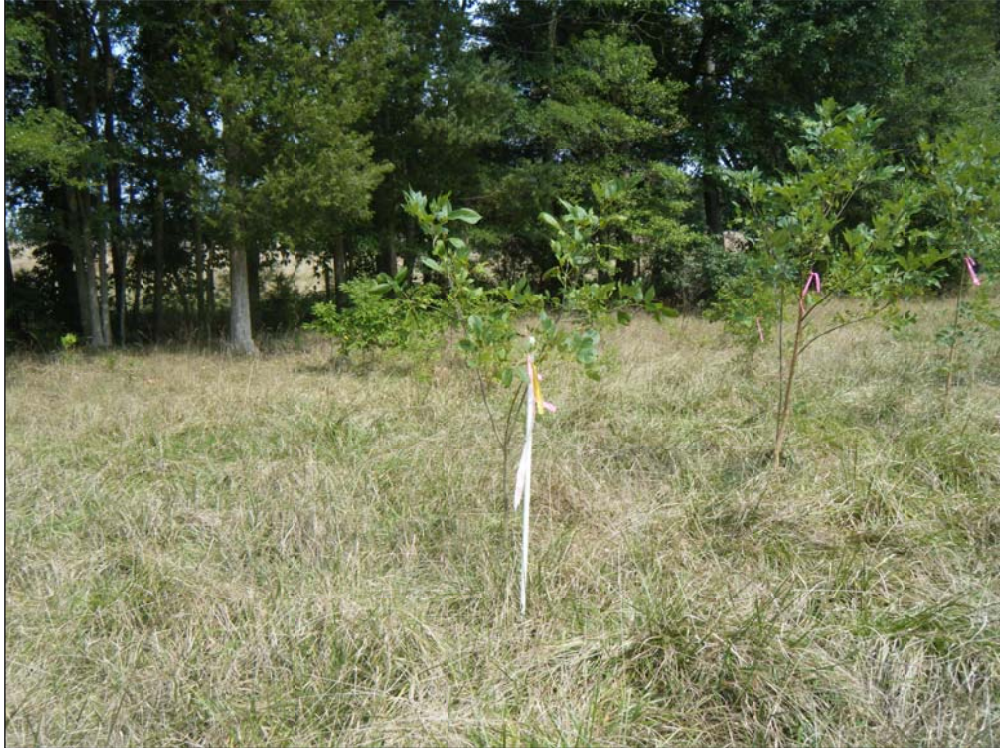
Vegetation Plot 7: 8/16/11 – MY-03

<b>Vegetation Plot ID</b>	<b>Monitoring Year 03 Planted Stem Density (stems/acre)</b>	<b>Vegetation Survival Threshold Met?</b>
1	364	Yes
2	364	Yes
3	324	Yes
4	405	Yes
5	526	Yes
6	607	Yes
7	202	No
