RESTORATION PLAN

UT TO BEAR CREEK STREAM RESTORATION PROJECT

Chatham County, North Carolina

Project ID No. 060684901

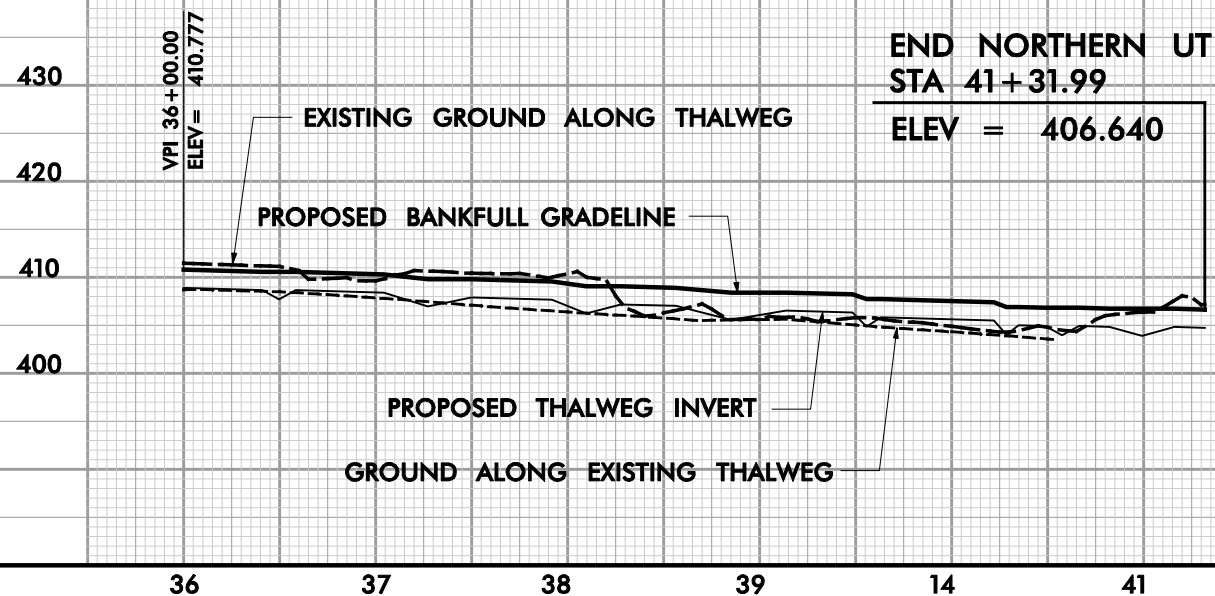
PROJECT REFERENCE NO.	SHEET NO.
BEAR CREEK	Sheet 3
PROJECT ENGINEER

LONGITUDINAL PROFILE

NORTHERN UT

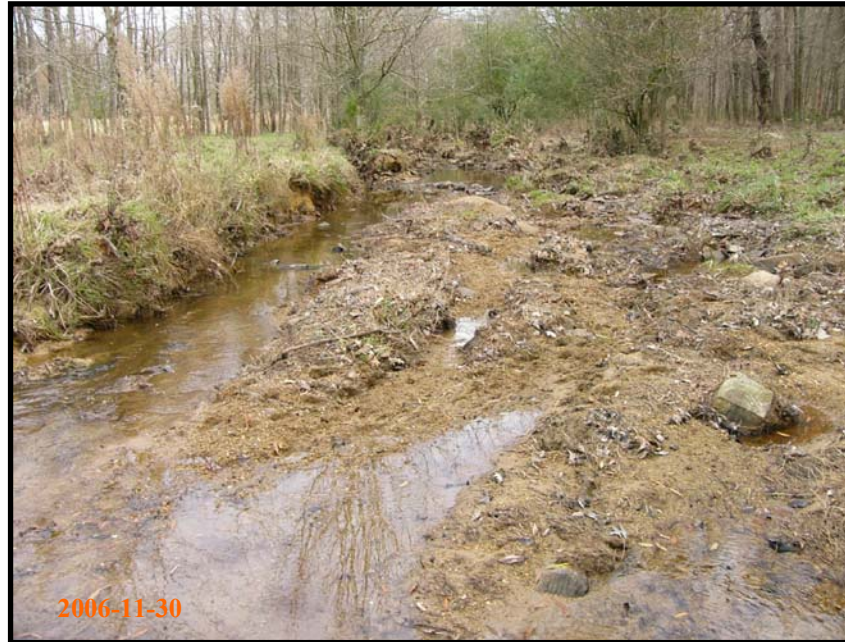
Northern UT looking downstream at cattle access point, and channel over widening. Notice aggradation where channel has over widened.

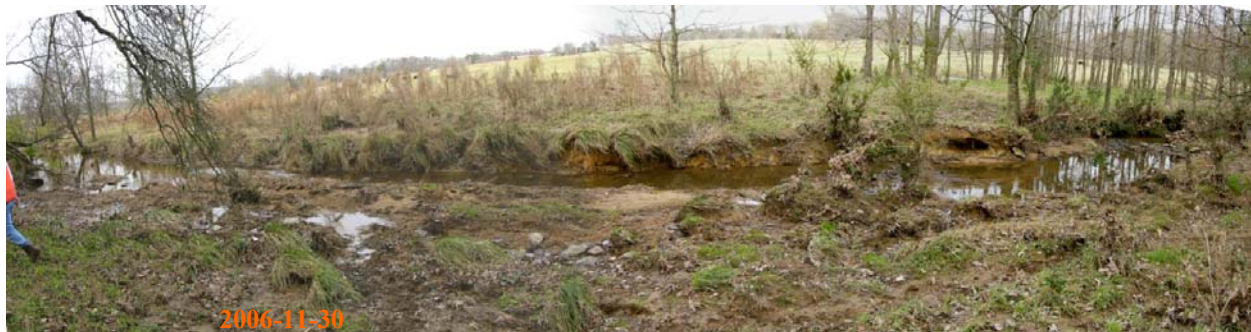
Northern UT where channel is incising and mass wasting of the banks are occurring.

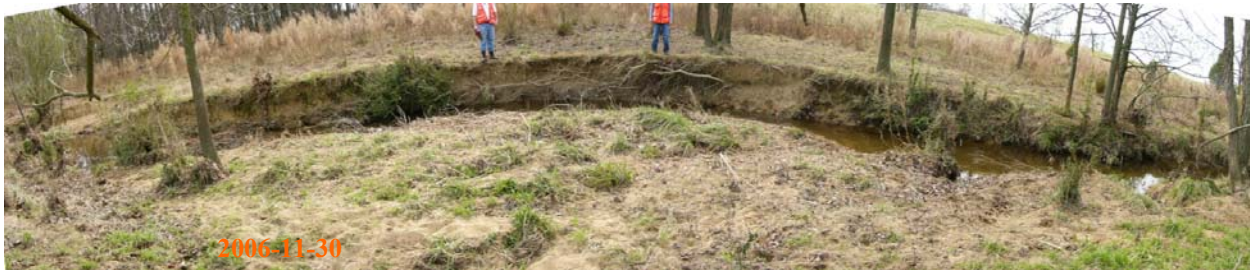
Northern UT where mass wasting of the banks is occurring because of the loss of vegetation and incision of the channel.

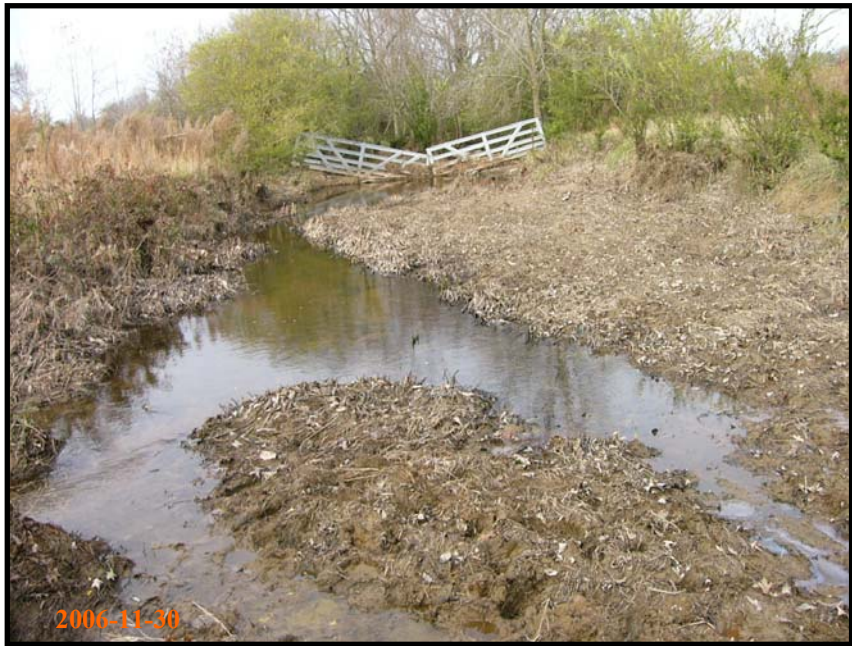
Northern UT Cattle access point where the cattle are using the channel for a watering hole and cooling area.

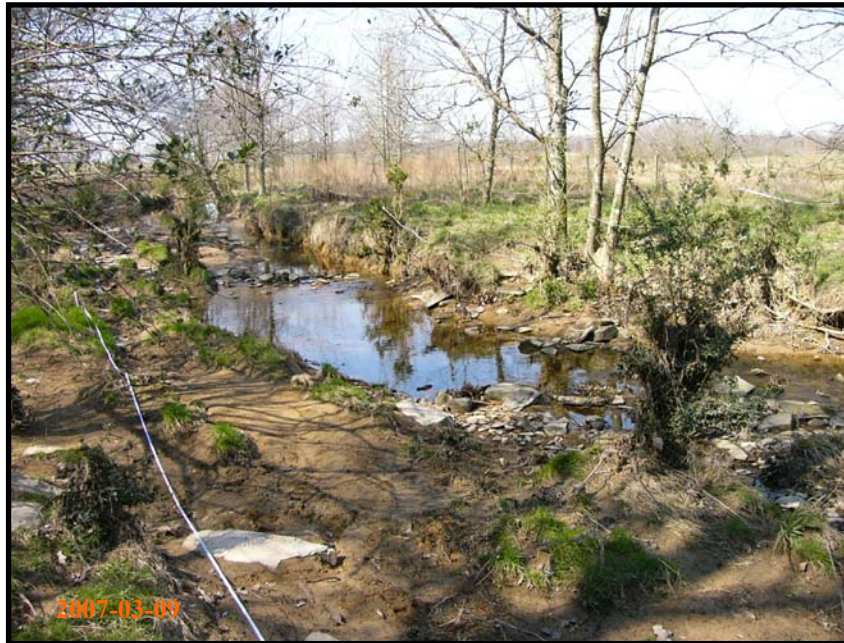
Northern UT where the channel has incised to bedrock and high shear stress is being placed on banks.

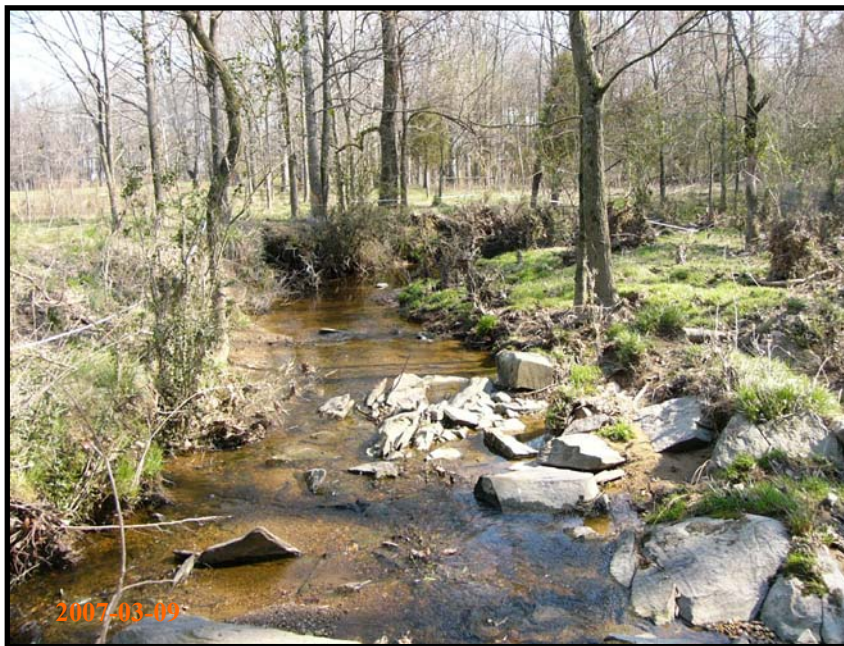
Northern UT where channel has incised to bedrock and is undercutting the trees that are left on the channel banks.

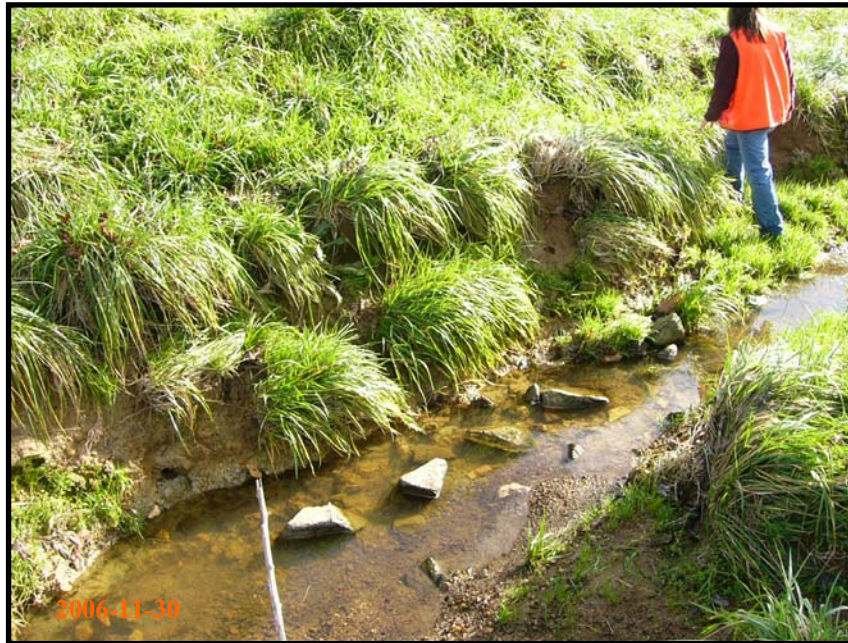
Southern UT: notice slumpage of channel and the deep incision of bankfull (bankfull depth should be just over one foot from channel)

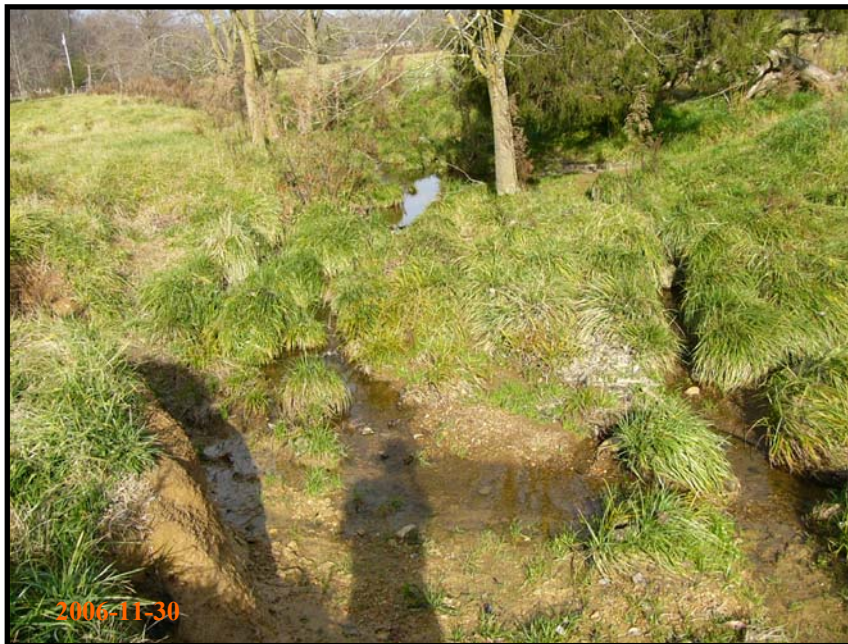
Southern UT where channel has braided because of cattle access.

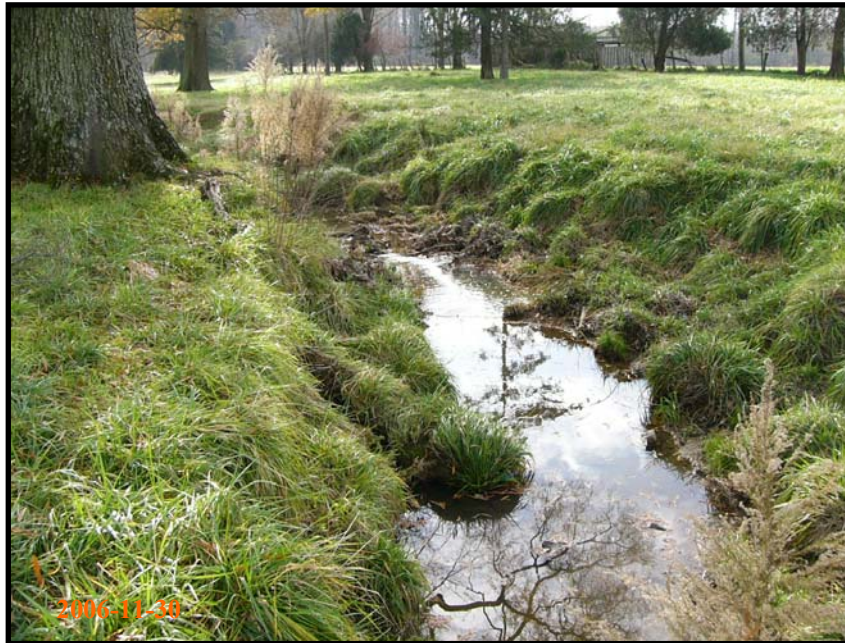
Southern UT has incised to the point that it is undercutting existing vegetation on the banks.

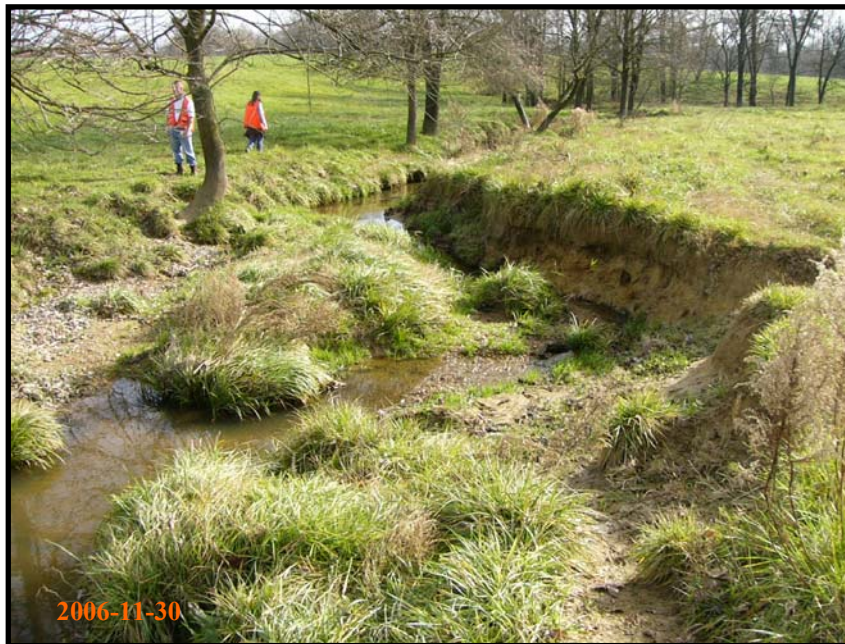
Southern UT: banks are experiencing mass wasting because channel is trying to increase belt width and because of the loss of vegetation.

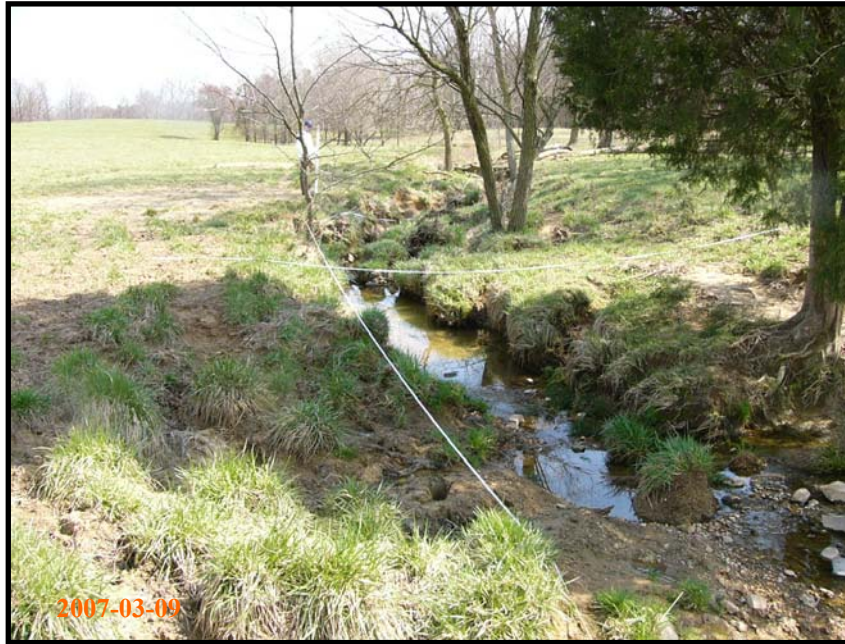
Southern UT has incised and ruts in banks due to cattle access are causing bank slumpage into the middle of channel.

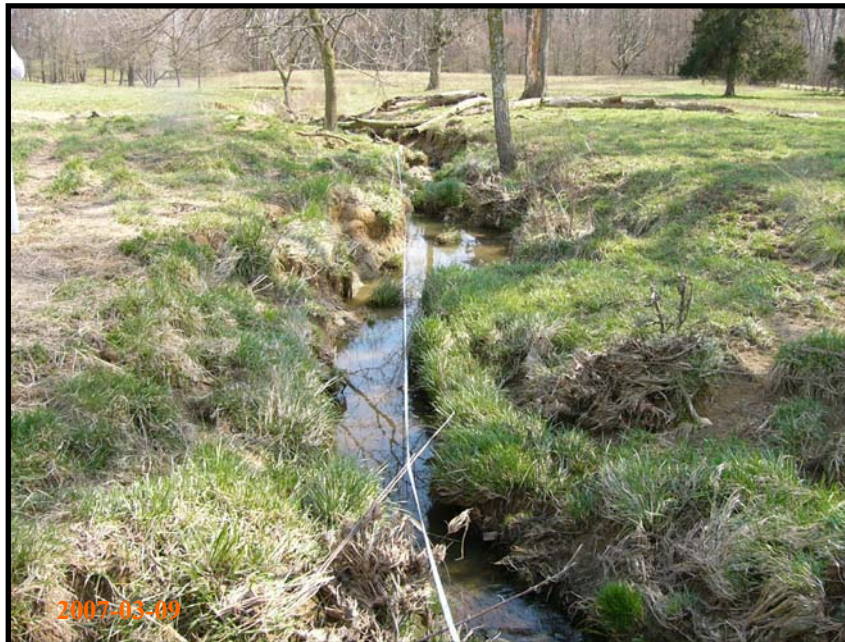
Southern UT: the loss of bank vegetation and cattle access has increased shear stress on banks causing mass wasting and slumpage.

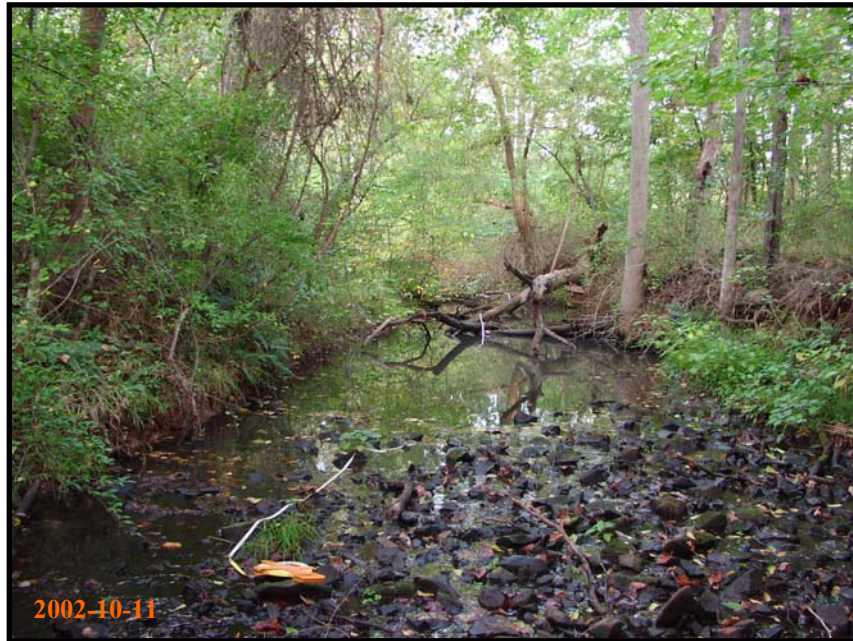
Landrum Creek looking downstream from start of profile.

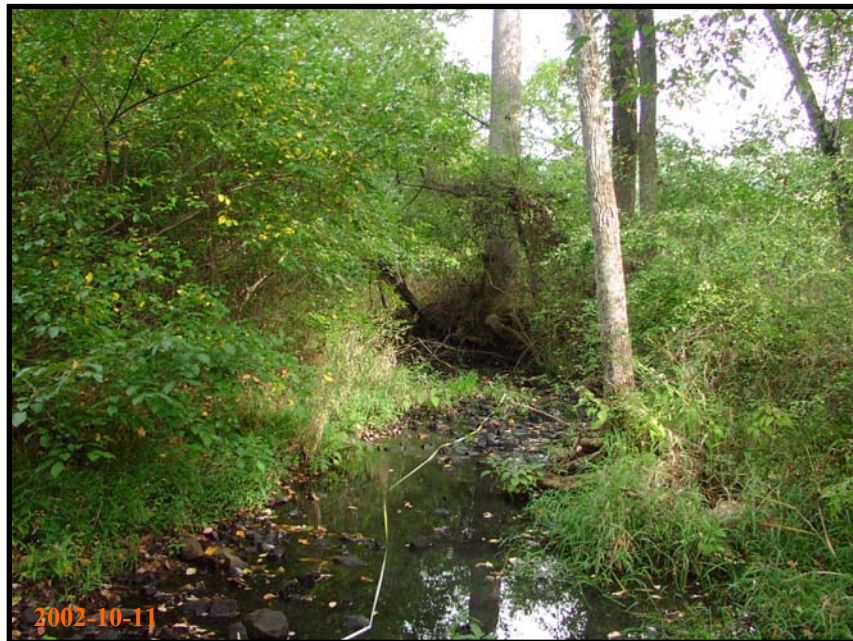
Landrum Creek looking upstream.
