**UT BEAR CREEK (Weaver/McLeod) EEP #92347 -- Chatham County
2013 Stream Restoration Monitoring Report -- Year 4 of 5**

**North Carolina Department of Environment and Natural Resources
Ecosystem Enhancement Program (NCDENR-EEP)**

MY-4 Monitoring Data Collected 2013 --- Project Constructed in 2009

**Robert J. Goldstein & Associates, Inc.
RJG&A Environmental Consultants
1221 Corporation Parkway, suite 100
Raleigh NC 27610 --- 919-872-1174**
**Gerald Pottern, project manager
gpottern@RJGAcarolina.com**

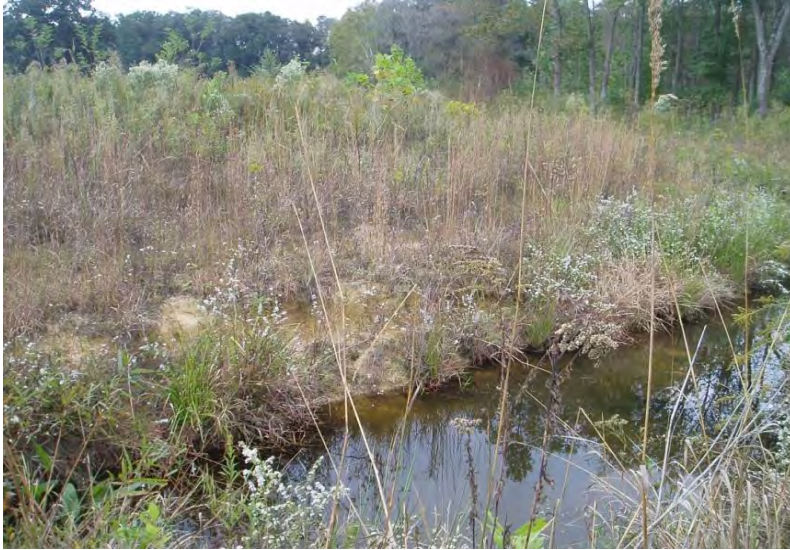
Problem	North UT Station	Suspected Cause	Photo #
Bank erosion & gully at swale outlet, LB	3435-3490 LB	Coir and live stakes washed out in 2010-11; poor root density on bank.	1, 2
Bank erosion, LB	3680-3705 LB	Coir and live stakes washed out in 2010-11; poor root density on bank.	3, 4

1. N-sta-3450.LB Erosion.Oct 2013. Thin veg cover, no woody.

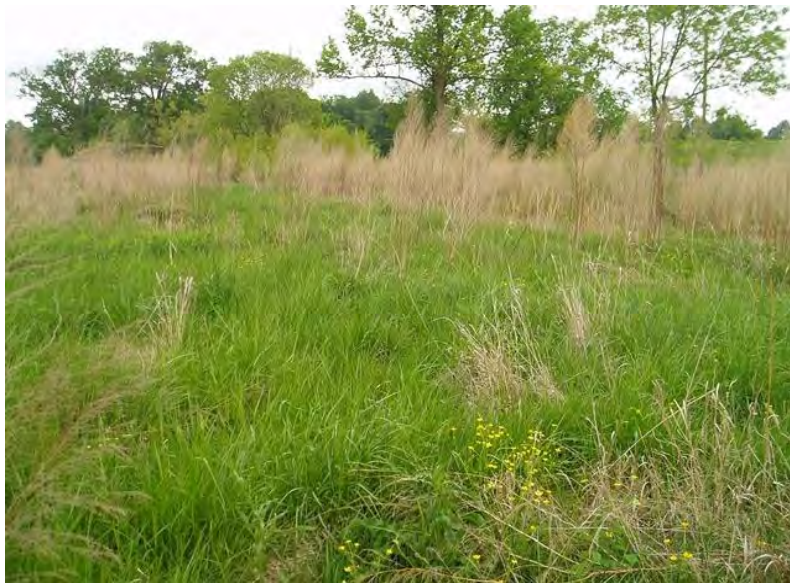
7. N-sta-1900.LB. Face Upstr. Apr.2013. Fescue + Low woody

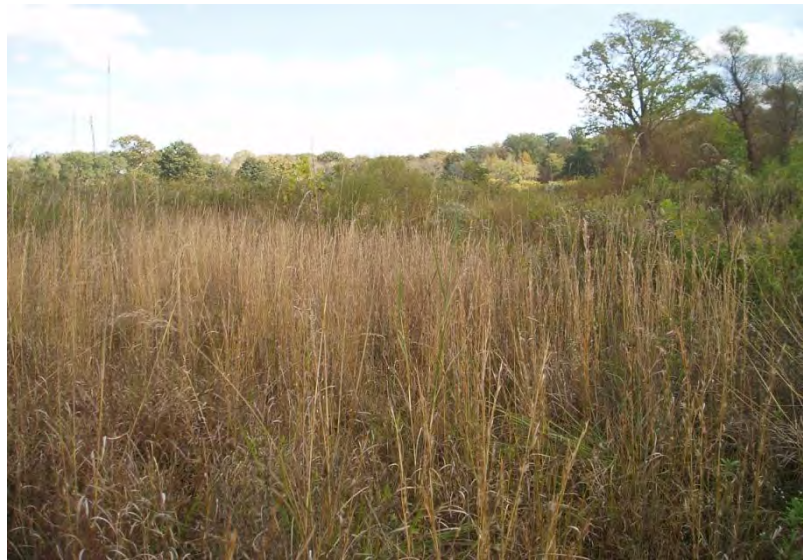
8. N-sta-1980.LB. Face Dnstr. Oct.2013. Low woody density

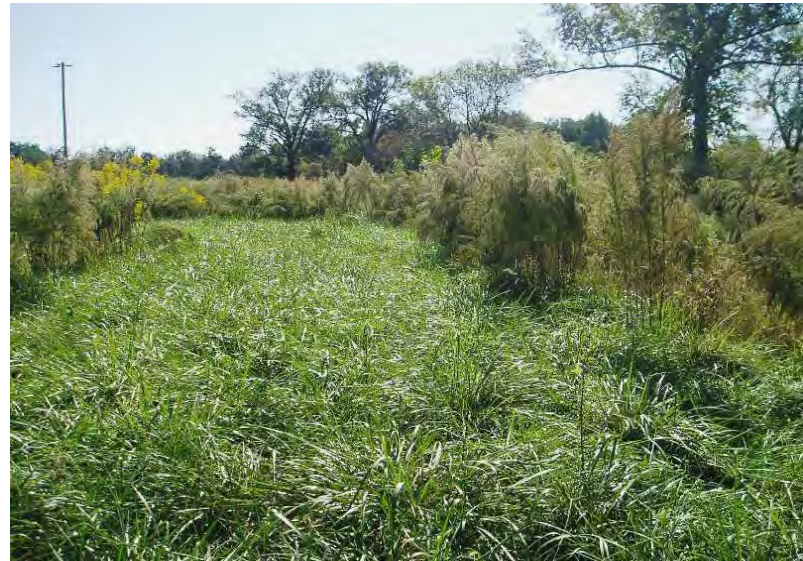
10. S-sta-1280.LB. Face Upstr. Oct.2013. Fescue + Low woody

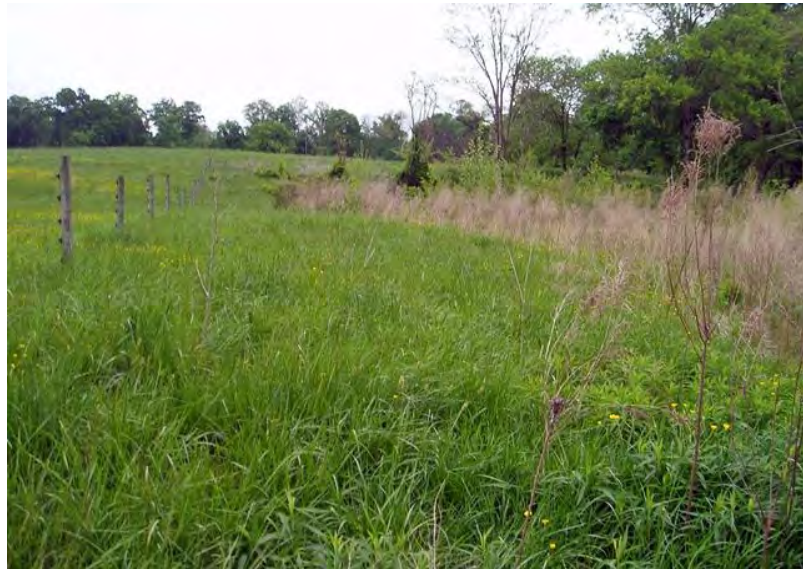
Problem	South UT Station	Suspected Cause	Photo #
<i>Ligustrum sinense</i> invading upper reach along NC-902 (RB+LB)	1000-1050 RB-LB	<i>Ligustrum</i> abundant in roadside scrub along NC-902	
Low woody stem density and poor vigor (LB)	1160-1340 LB	Soil dense/clayey, Fescue dominant	10
Broken fence wires (RB + LB)	1750 LB, 1900 RB	Trees fallen on fence	11
Low woody stem density, poor vigor (LB)	2300-2550 LB	Soil dense/clayey, Fescue dominant	12

12. S-sta-2400.LB. Face Dnstr. Apr.2013. Fescue + Low woody

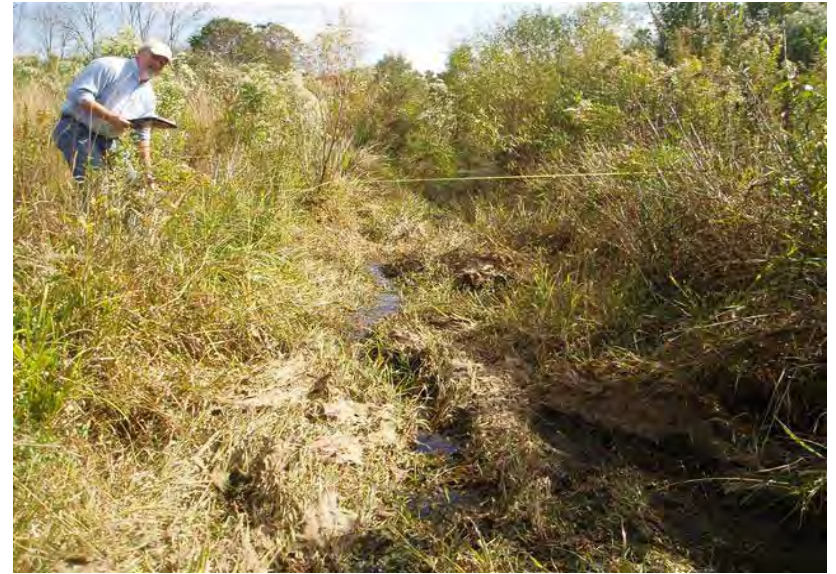
Bankfull Width (ft)	21.2
Floodprone Width (ft)	100.0
Bankfull Mean Depth (ft)	1.2
Bankfull Max Depth (ft)	2.1
Bankfull Area (ft ²)	23.4
Width/Depth Ratio	17.3
Entrenchment Ratio	5.0
Bank Height Ratio	1.0
Cross Sectional Area	72.8

View of cross-section XS-1 looking downstream

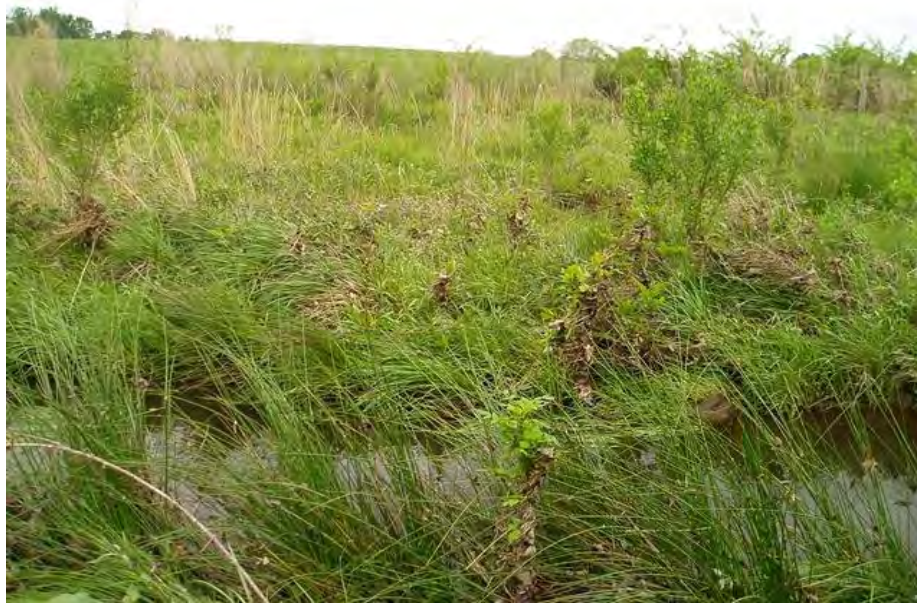
North Trib - Matted vegetation and wrack lines on floodplain, 30 Apr 2013

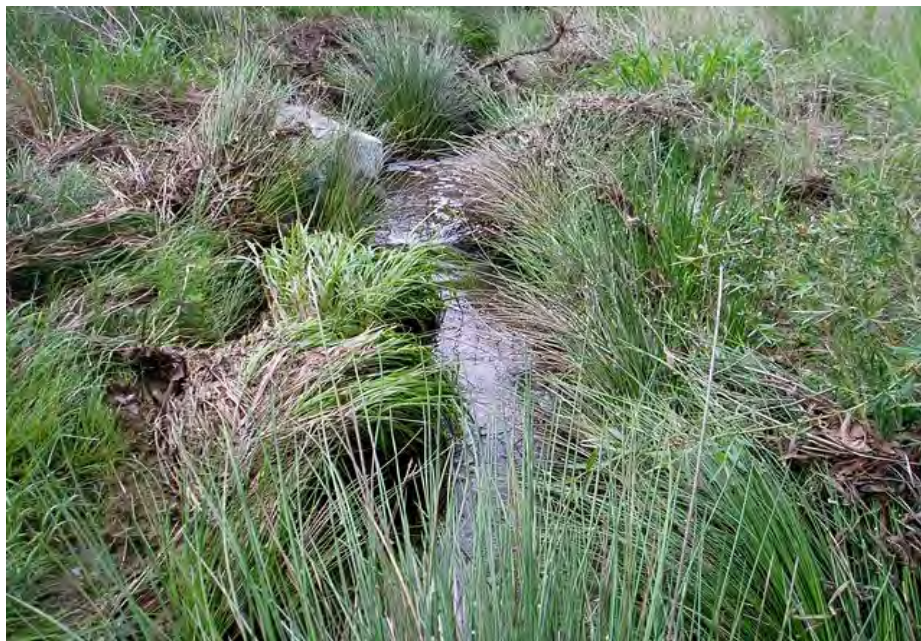
South Trib - Matted vegetation and wrack lines on floodplain, 30 Apr 2013
