FINAL MITIGATION PLAN
and AS-BUILT BASELINE REPORT
UT to CANE CREEK RESTORATION SITE
ALAMANCE COUNTY, NORTH CAROLINA
(EEP Project No. 395)

November 2009

Prepared by:
Axiom Environmental, Inc.
20 Enterprise Street
Suite 7
Raleigh, North Carolina 27607

Design Firm:
URS Corporation
1600 Perimeter Park Drive, Suite 400
Morrisville, NC 27560

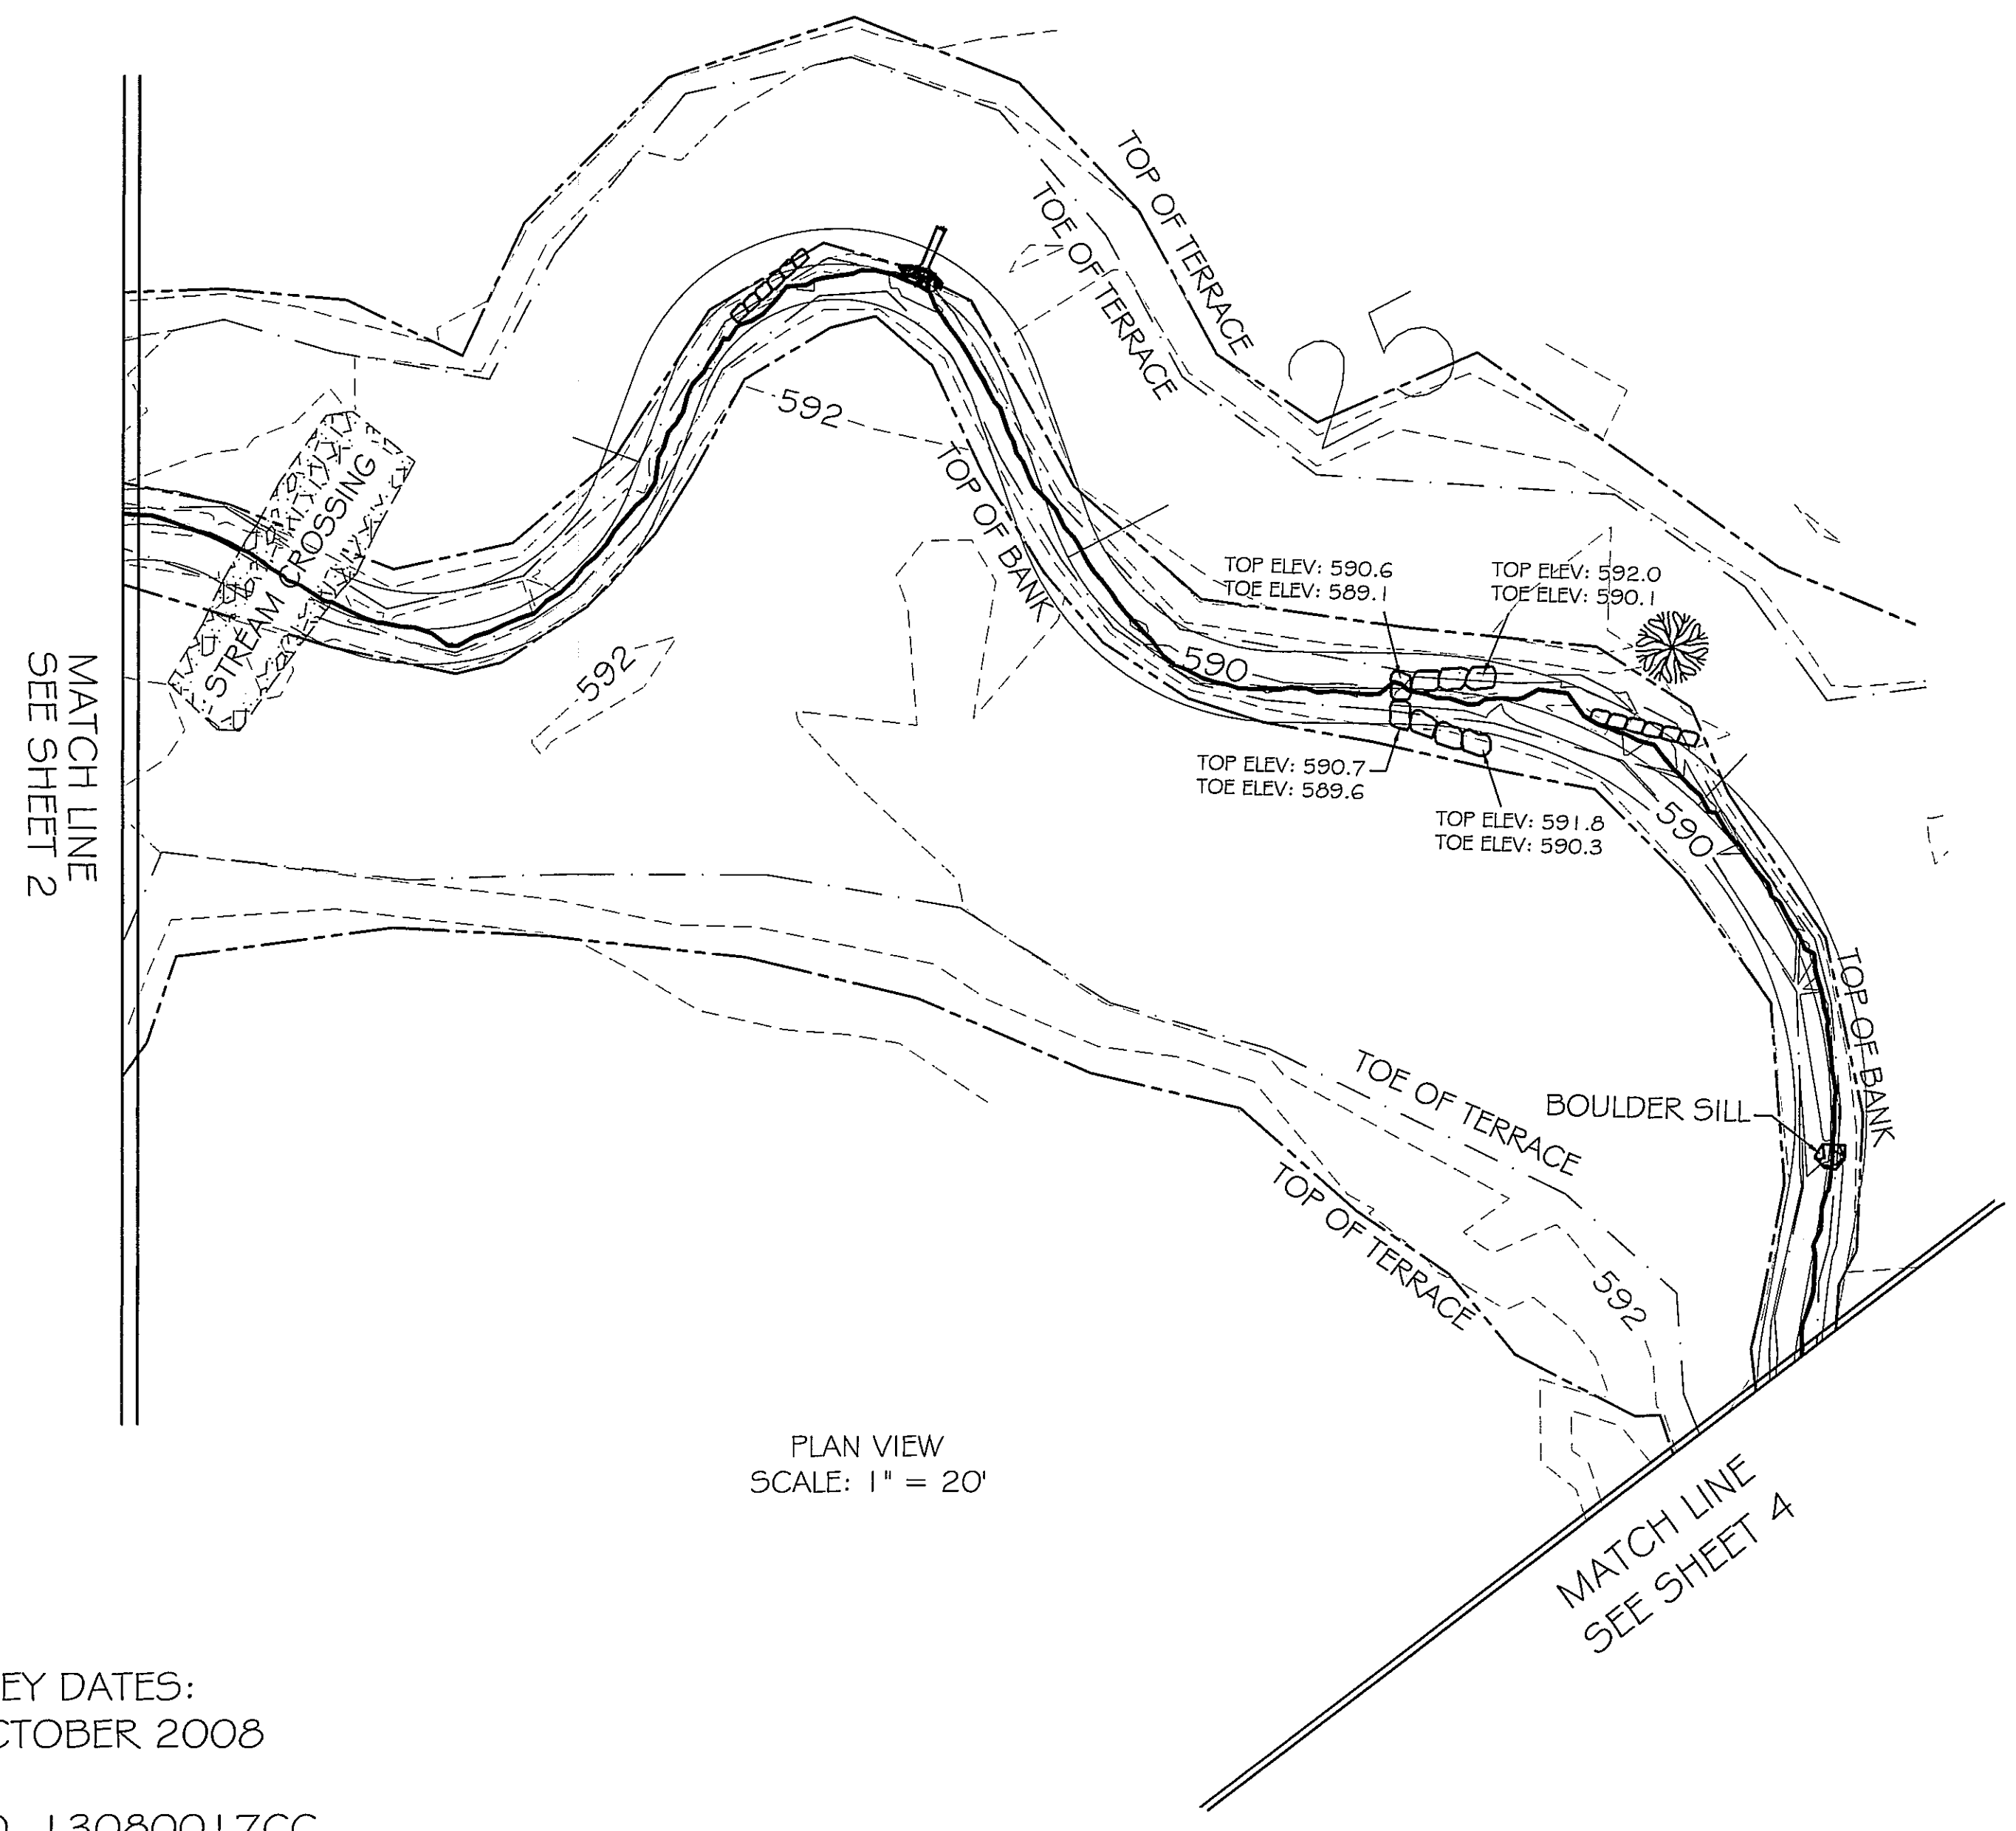
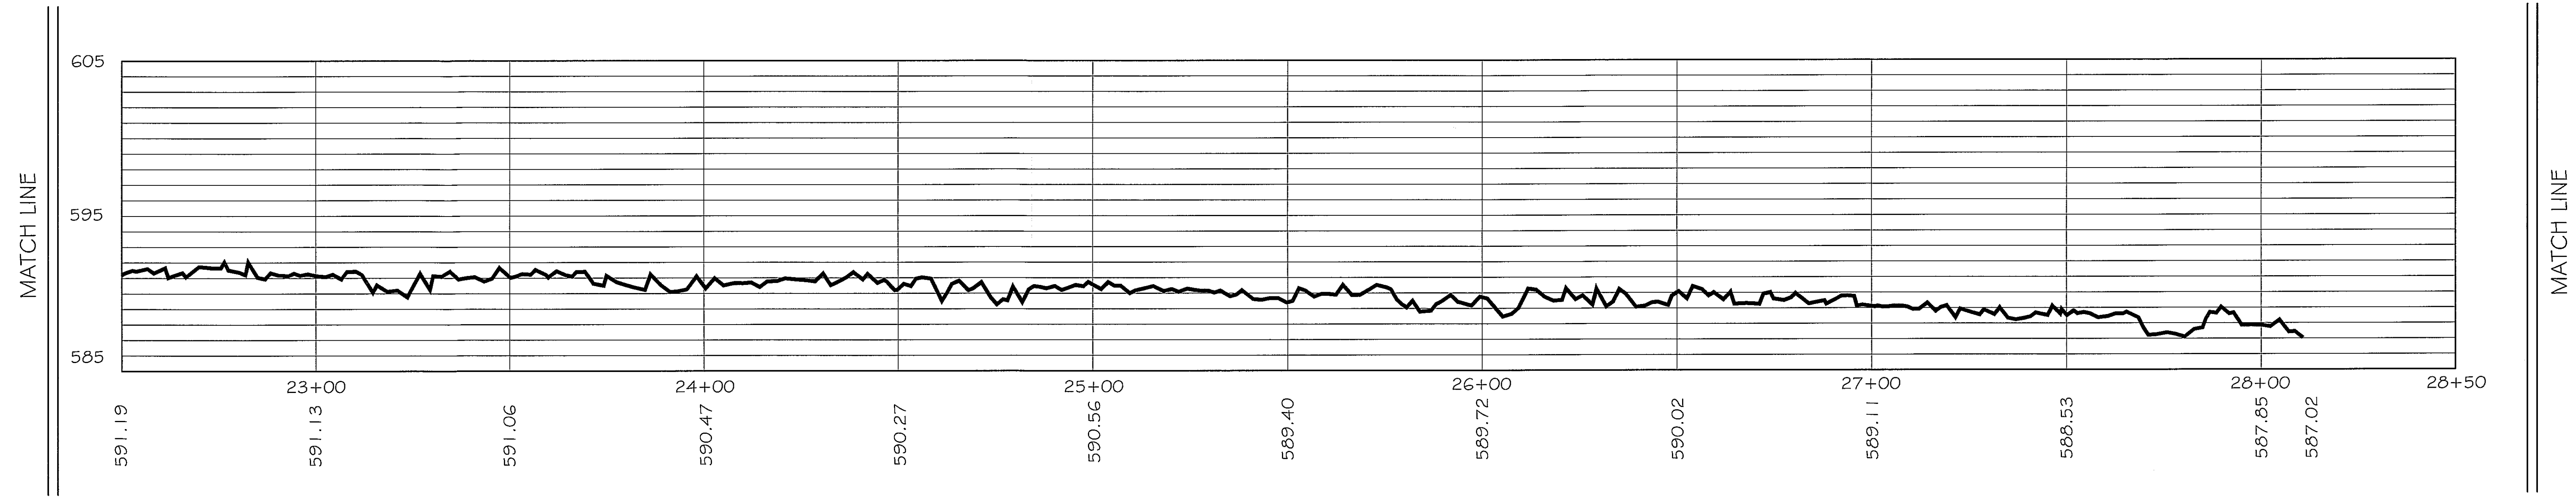
SHEET 2 OF 11
 AS-BUILT SURVEY
 FOR
**CANE CREEK
 RESTORATION**
 REACH A
 ALAMANCE COUNTY
 NORTH CAROLINA

PROFILE
 VERTICAL SCALE: 1" = 5'
 HORIZONTAL SCALE: 1" = 20'

PLAN VIEW
 SCALE: 1" = 20'
