Mitigation Plan

UT Clarke Creek Stream and Wetland Restoration

Mecklenburg County, North Carolina

EEP Job Number: 92500

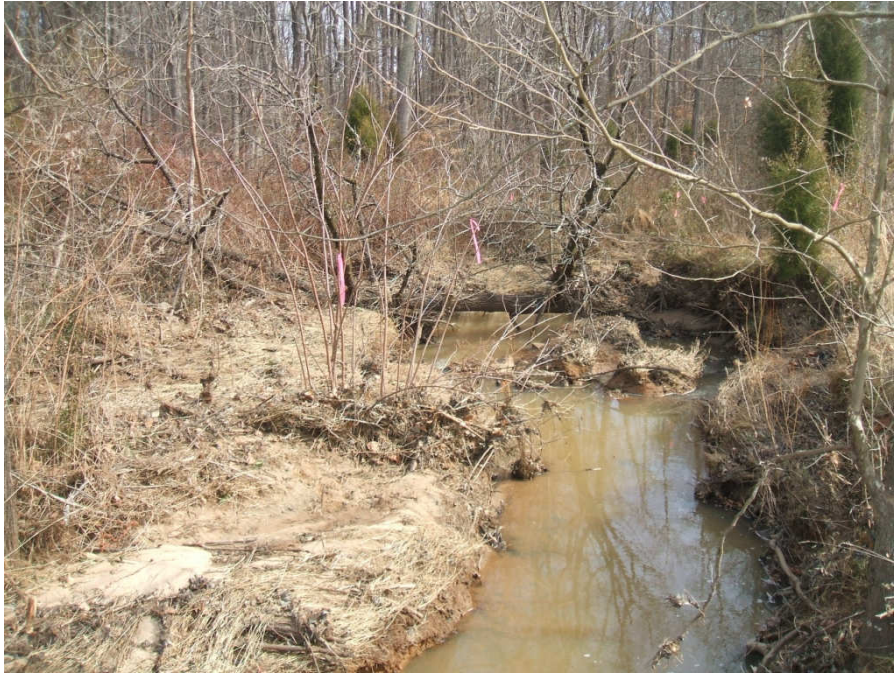
1-1

**UT Clarke Creek facing downstream at the central reach
(taken January 2010)**

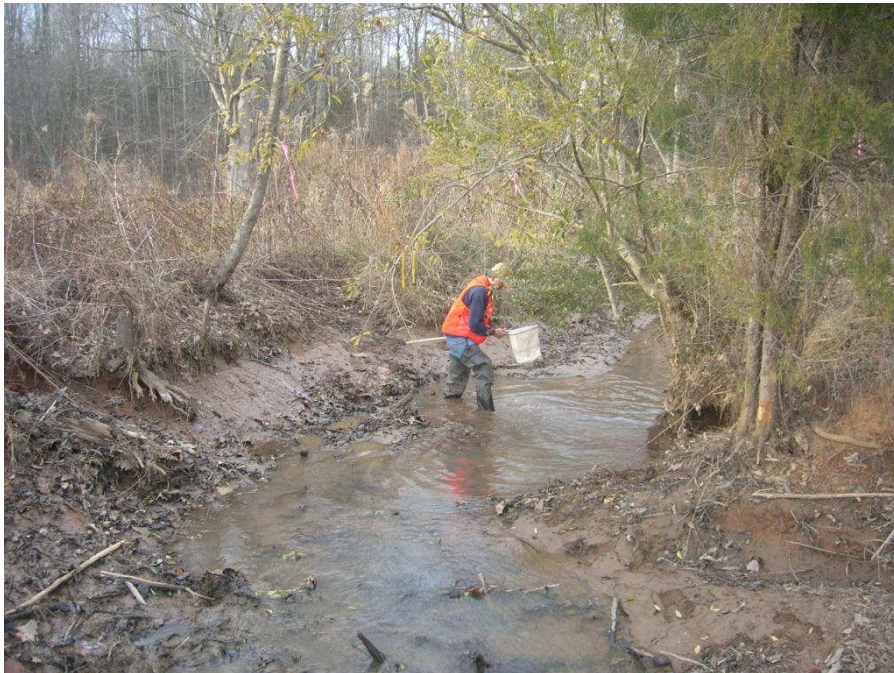
1-2

**UT Clarke Creek facing upstream toward the upstream
reach (taken January 2010)**

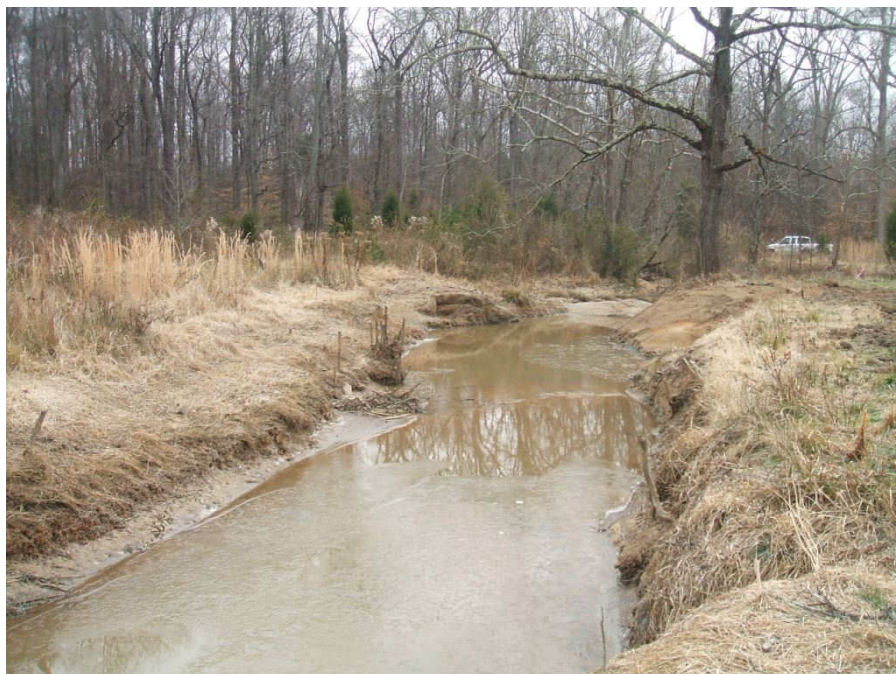
2-1

UT Clarke Creek facing downstream toward the downstream reach (taken January 2010)

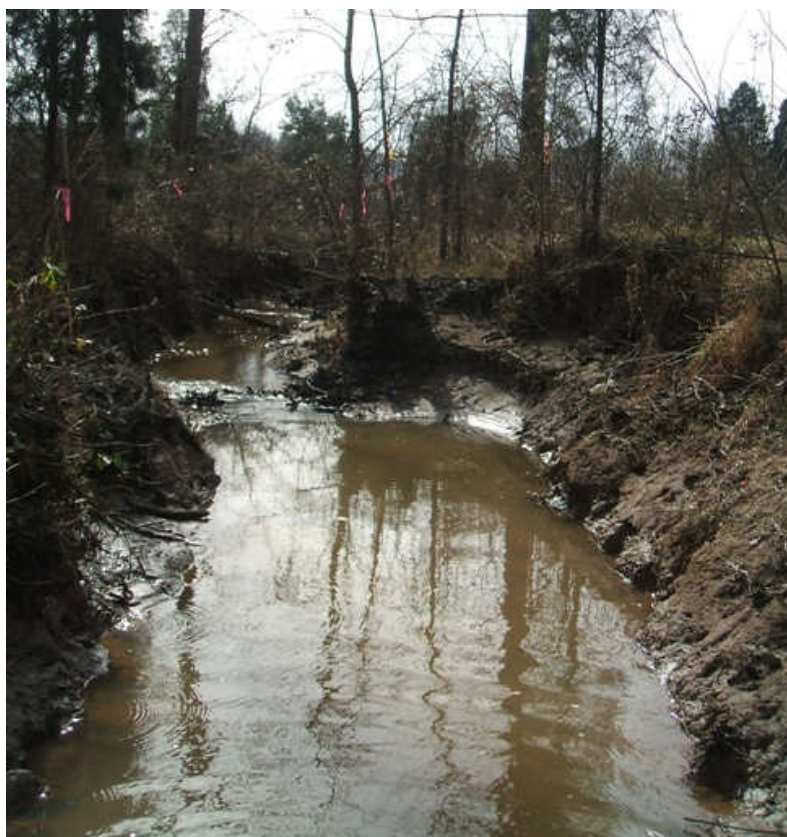
2-2

UT 1 facing downstream from the upstream reach (taken January 2010)

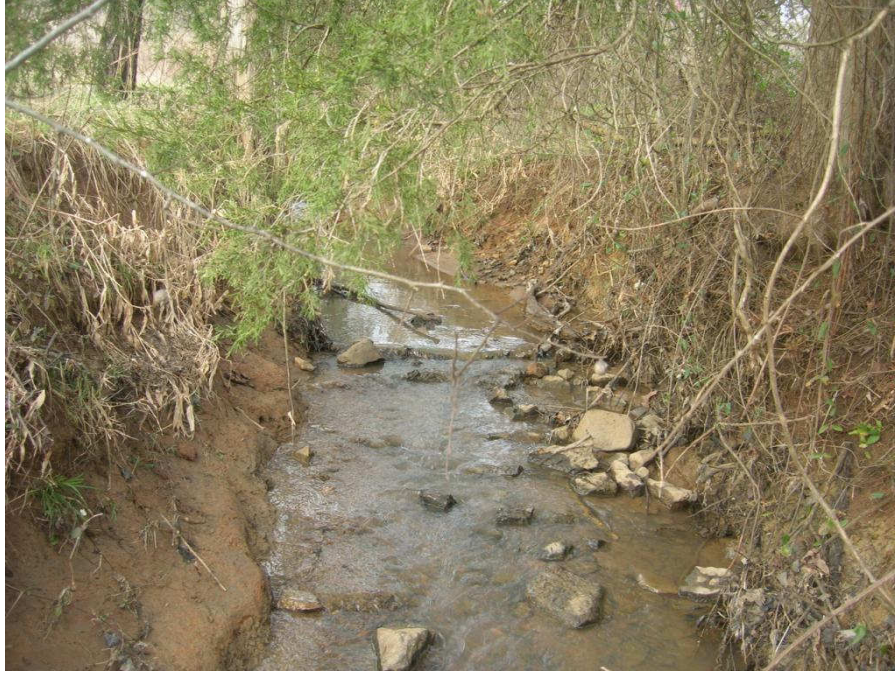
3-1

**UT 1 facing upstream at the central reach
(taken January 2010)**

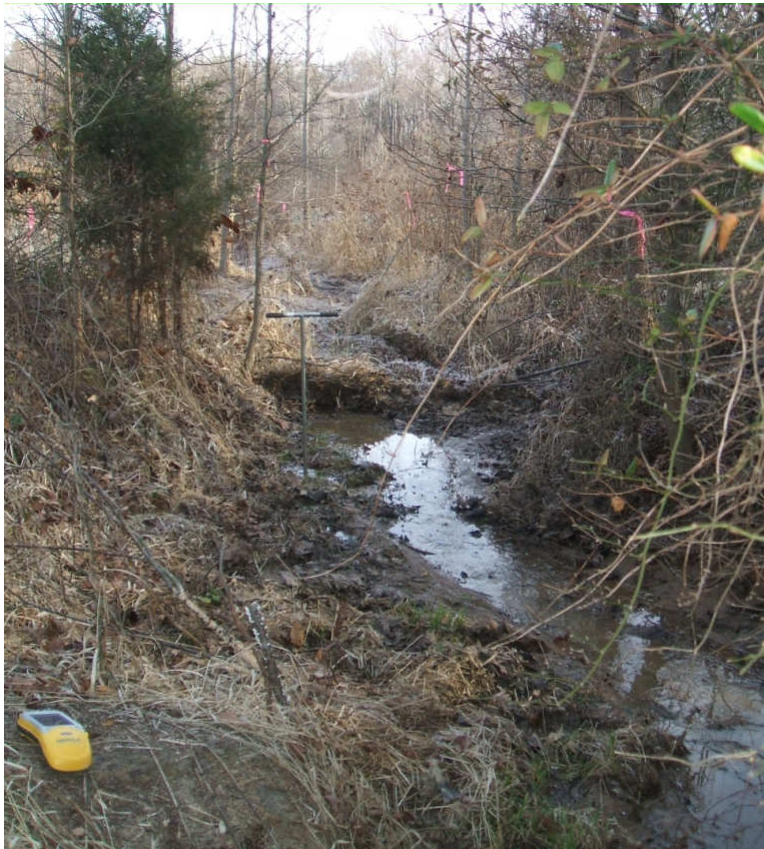
3-2

**UT 2B facing downstream from the upstream reach (taken
January 2010)**

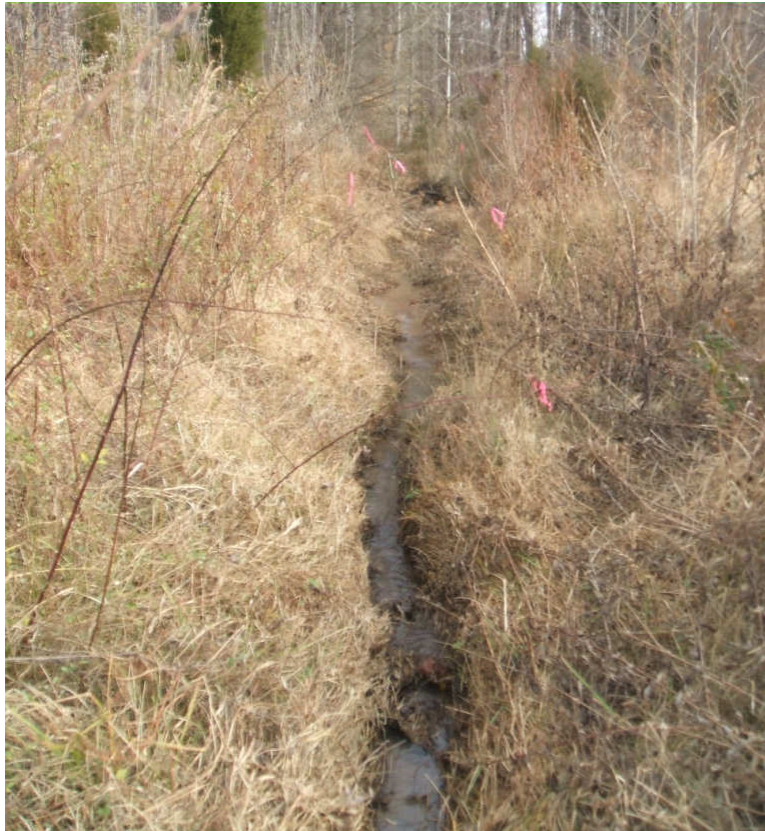
4-1

**UT 2A facing downstream toward the downstream reach
(taken January 2010)**

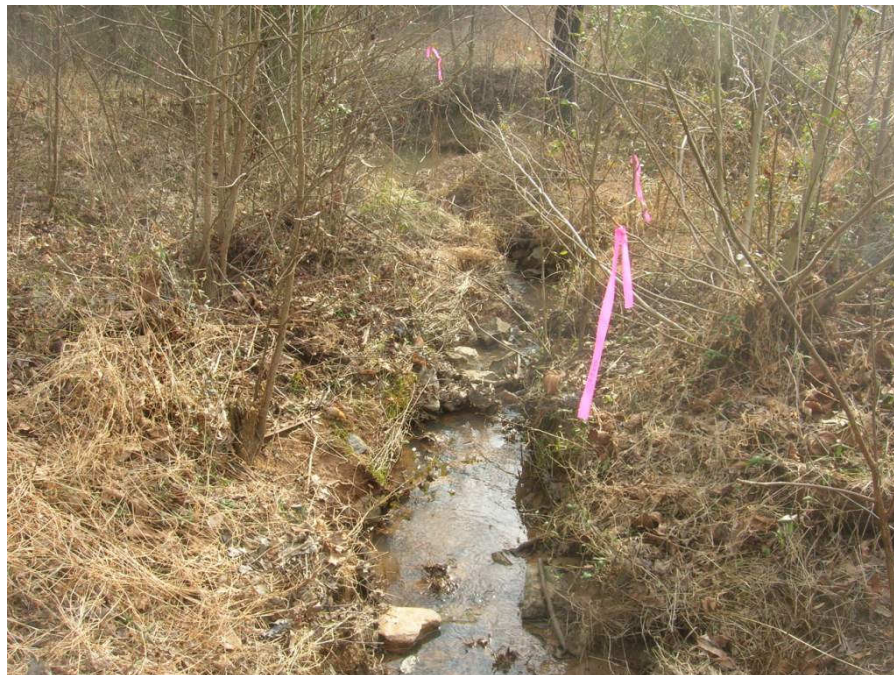
4-2

**UT 3 facing downstream toward the downstream reach
(taken January 2010)**

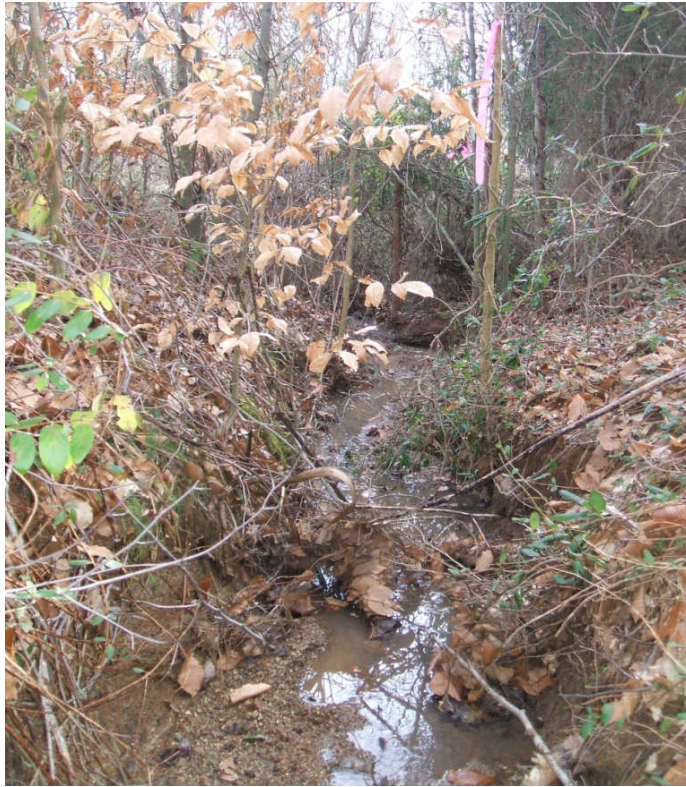
5-1

**UT 4 facing downstream at the central reach
(taken January 2010)**

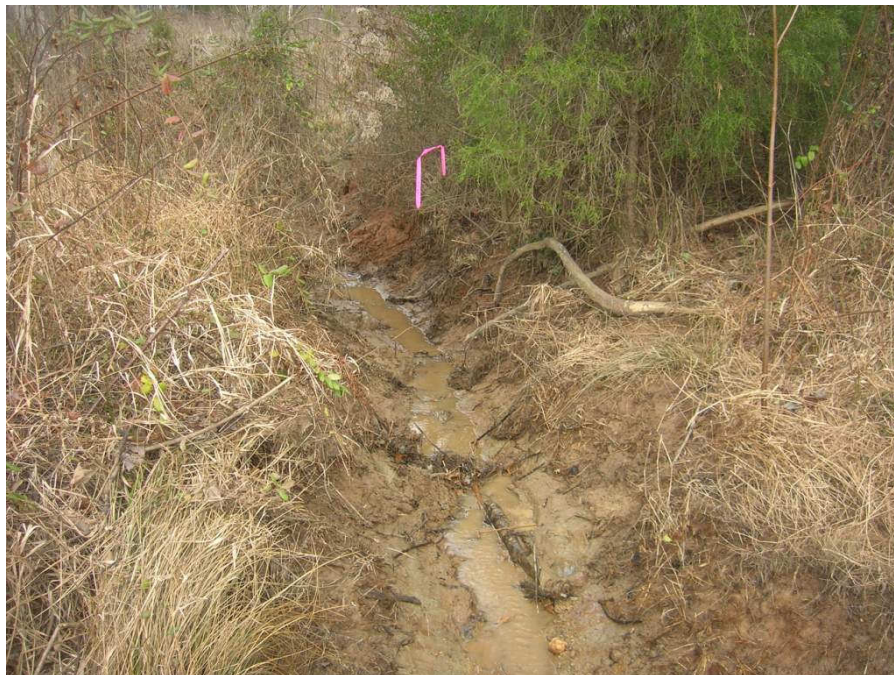
5-2

**UT 5 facing downstream toward the downstream reach
(taken January 2010)**

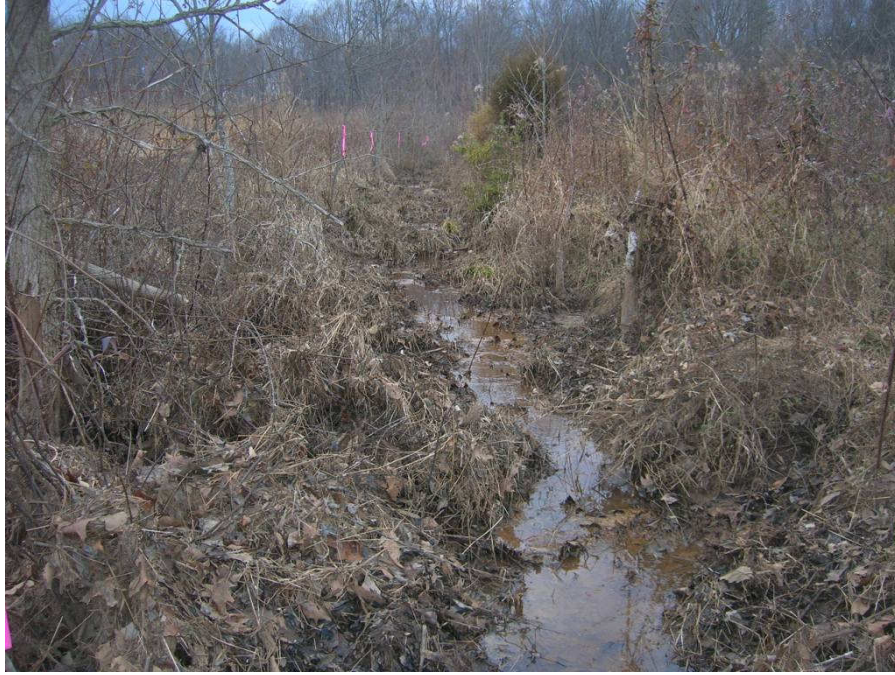
7-1

UT 5 facing upstream toward the upstream reach (taken January 2010)

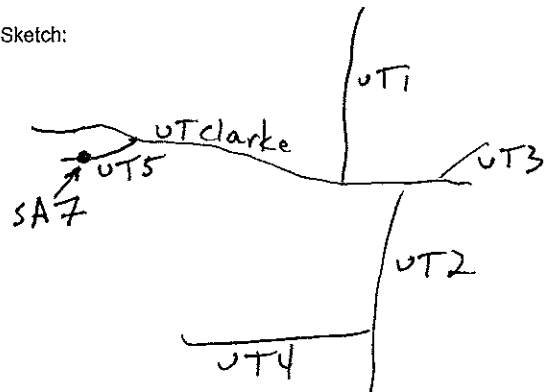
Upstream portion more stable; downstream portion downcut to saprolite
 25. tadpoles
 26. Abundant benthos: damselfly larvae
 dragon fly larva
 midges
 isopods

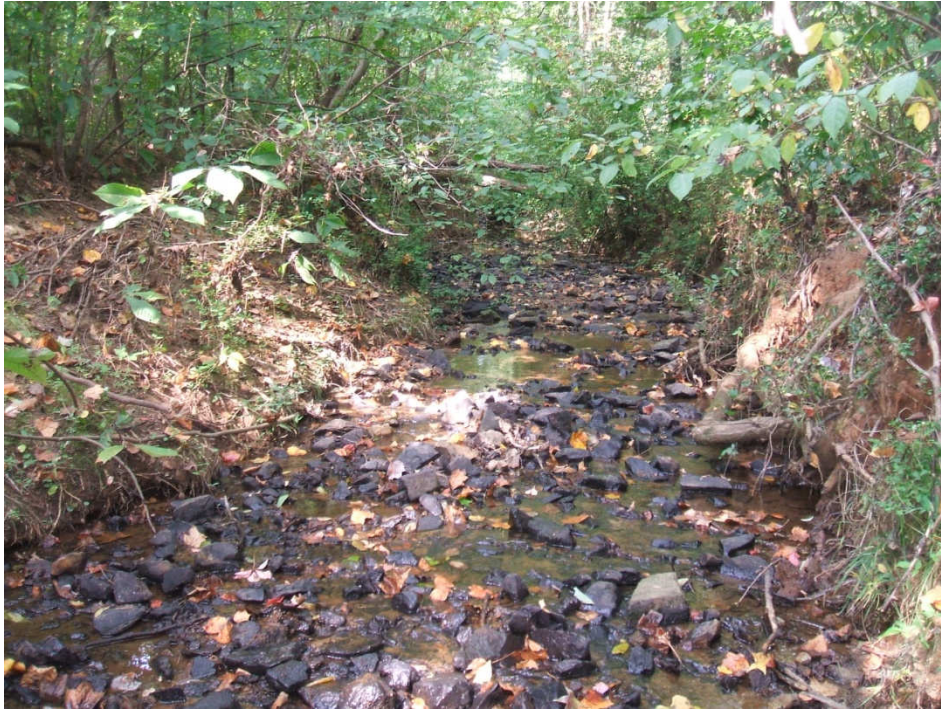
2-1

UT Clarke Creek Reference Reach: Riffle

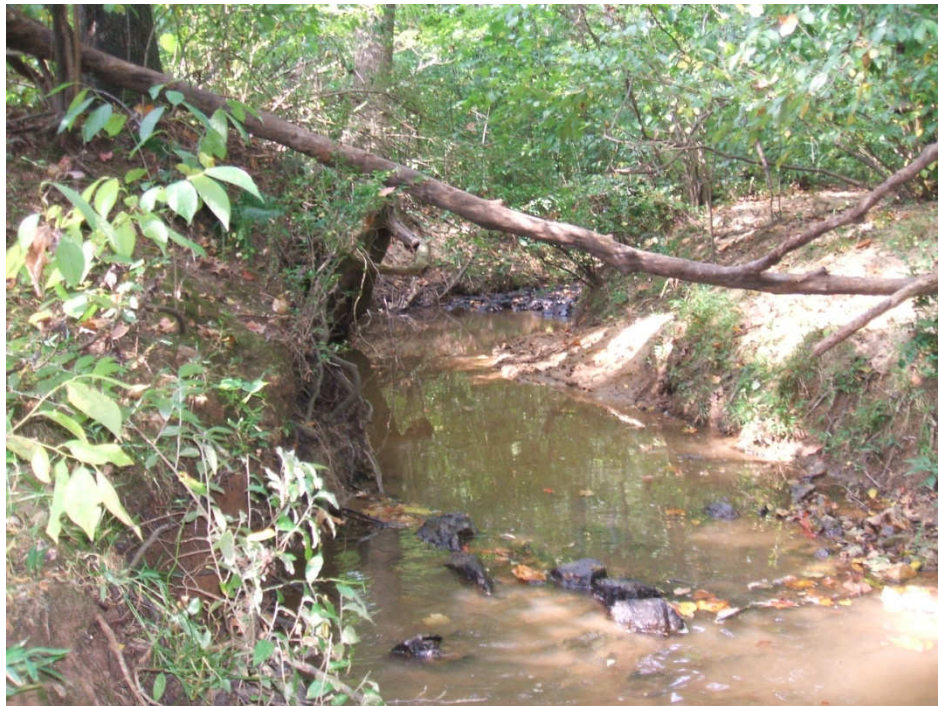
2-2

UT Clarke Creek Reference Reach: Pool

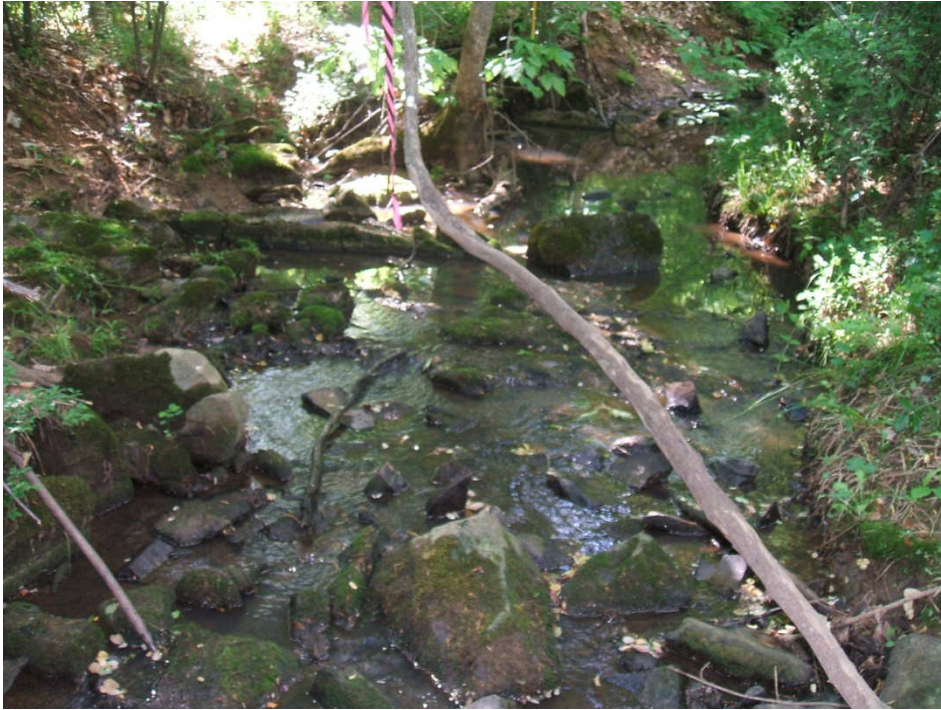
3-1

UT 1 Reference Reach: Riffle

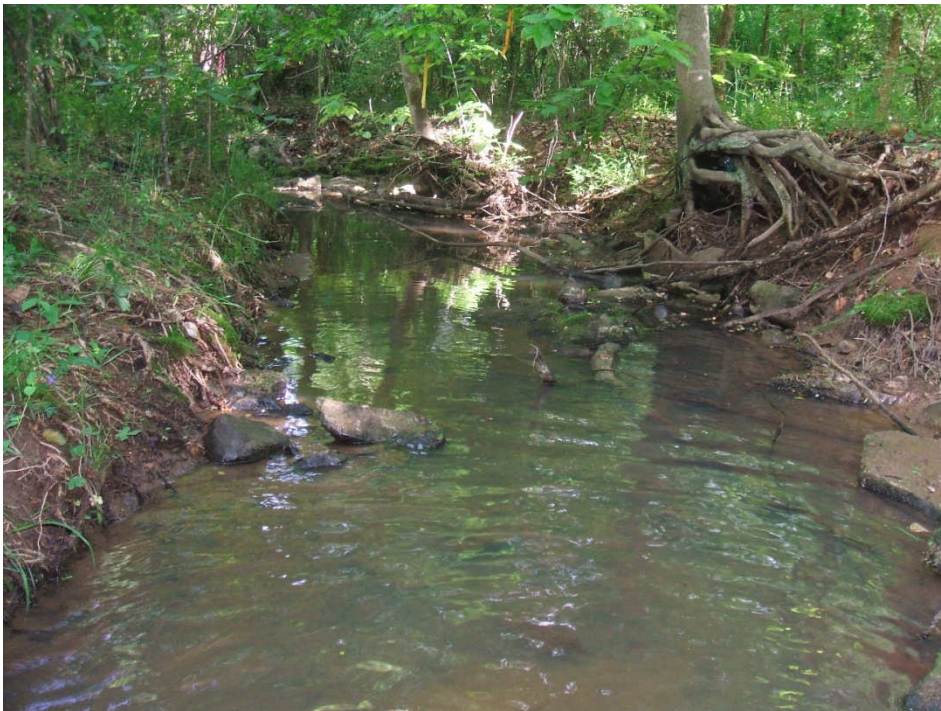
3-2

UT 1 Reference Reach: Pool

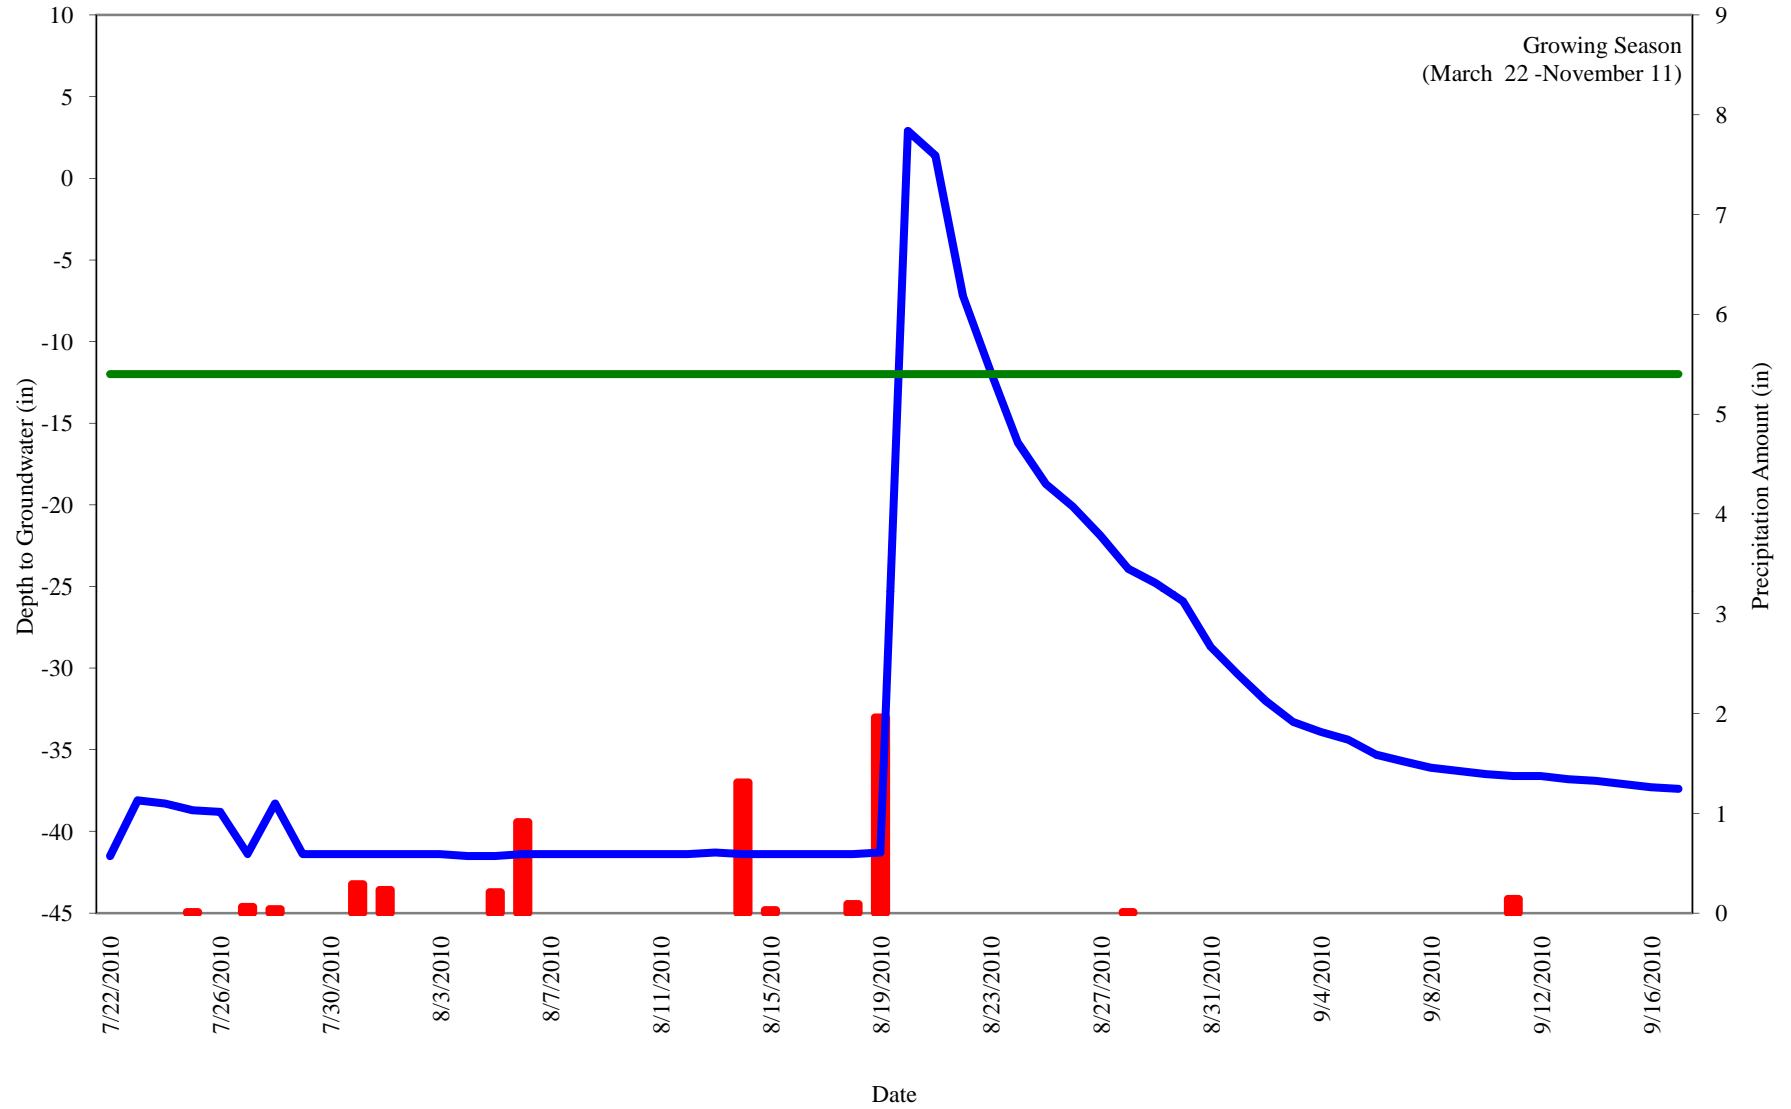
Clarke Creek Hydrology Monitoring Groundwater Gauge 2

Growing Season
(March 22 - November 11)

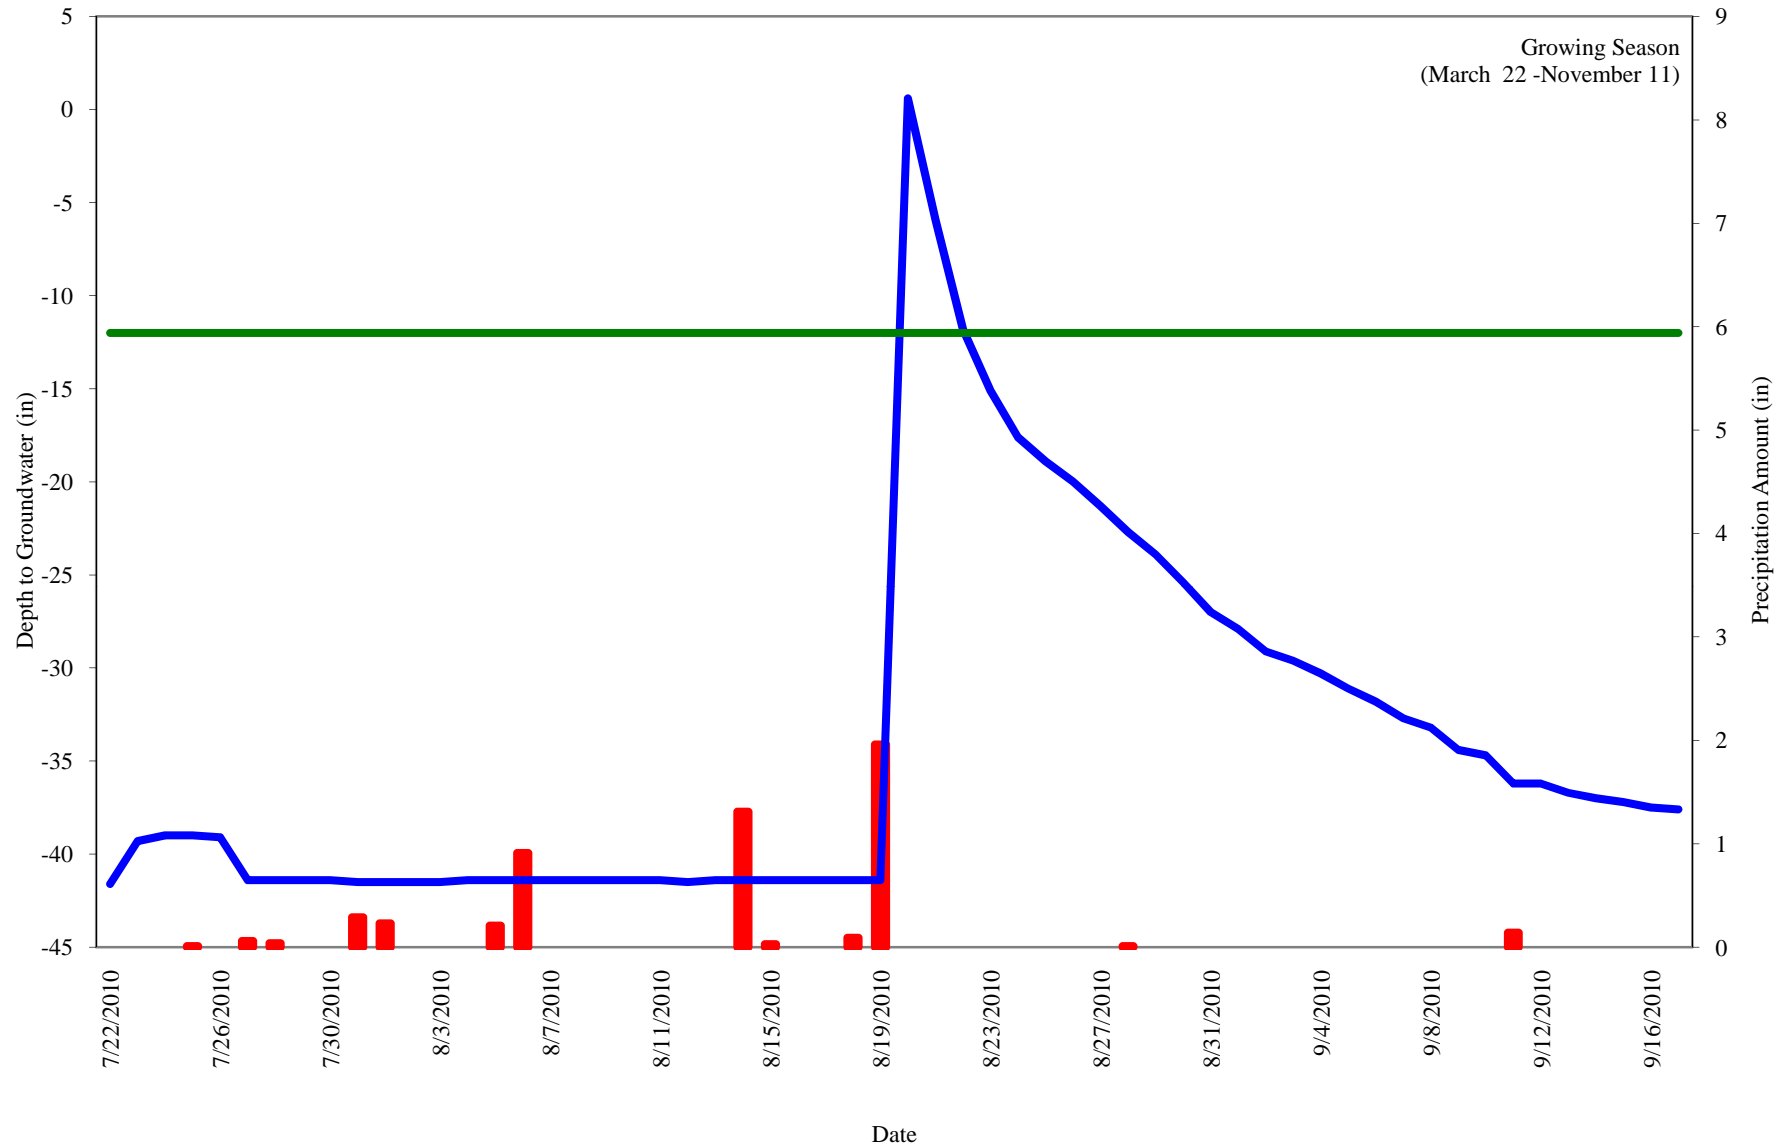
Clarke Creek Hydrology Monitoring Groundwater Gauge 4

Growing Season
(March 22 - November 11)
