# **UT to Clarke Creek Stream and Wetland Restoration Site Annual Final Monitoring Report**

DMS # 92500  
DENR Contract # 005363  
USACE Action ID # SAW-2010-00471  
DWR Project # 11-0409  
SCO # 09-07763-01  
DLR (Land Quality) Project # MECK-2012-034

Monitoring Report Year 3 of 5  
Mecklenburg County, North Carolina

Data Collection: October 2016  
Report Submission: January 2017

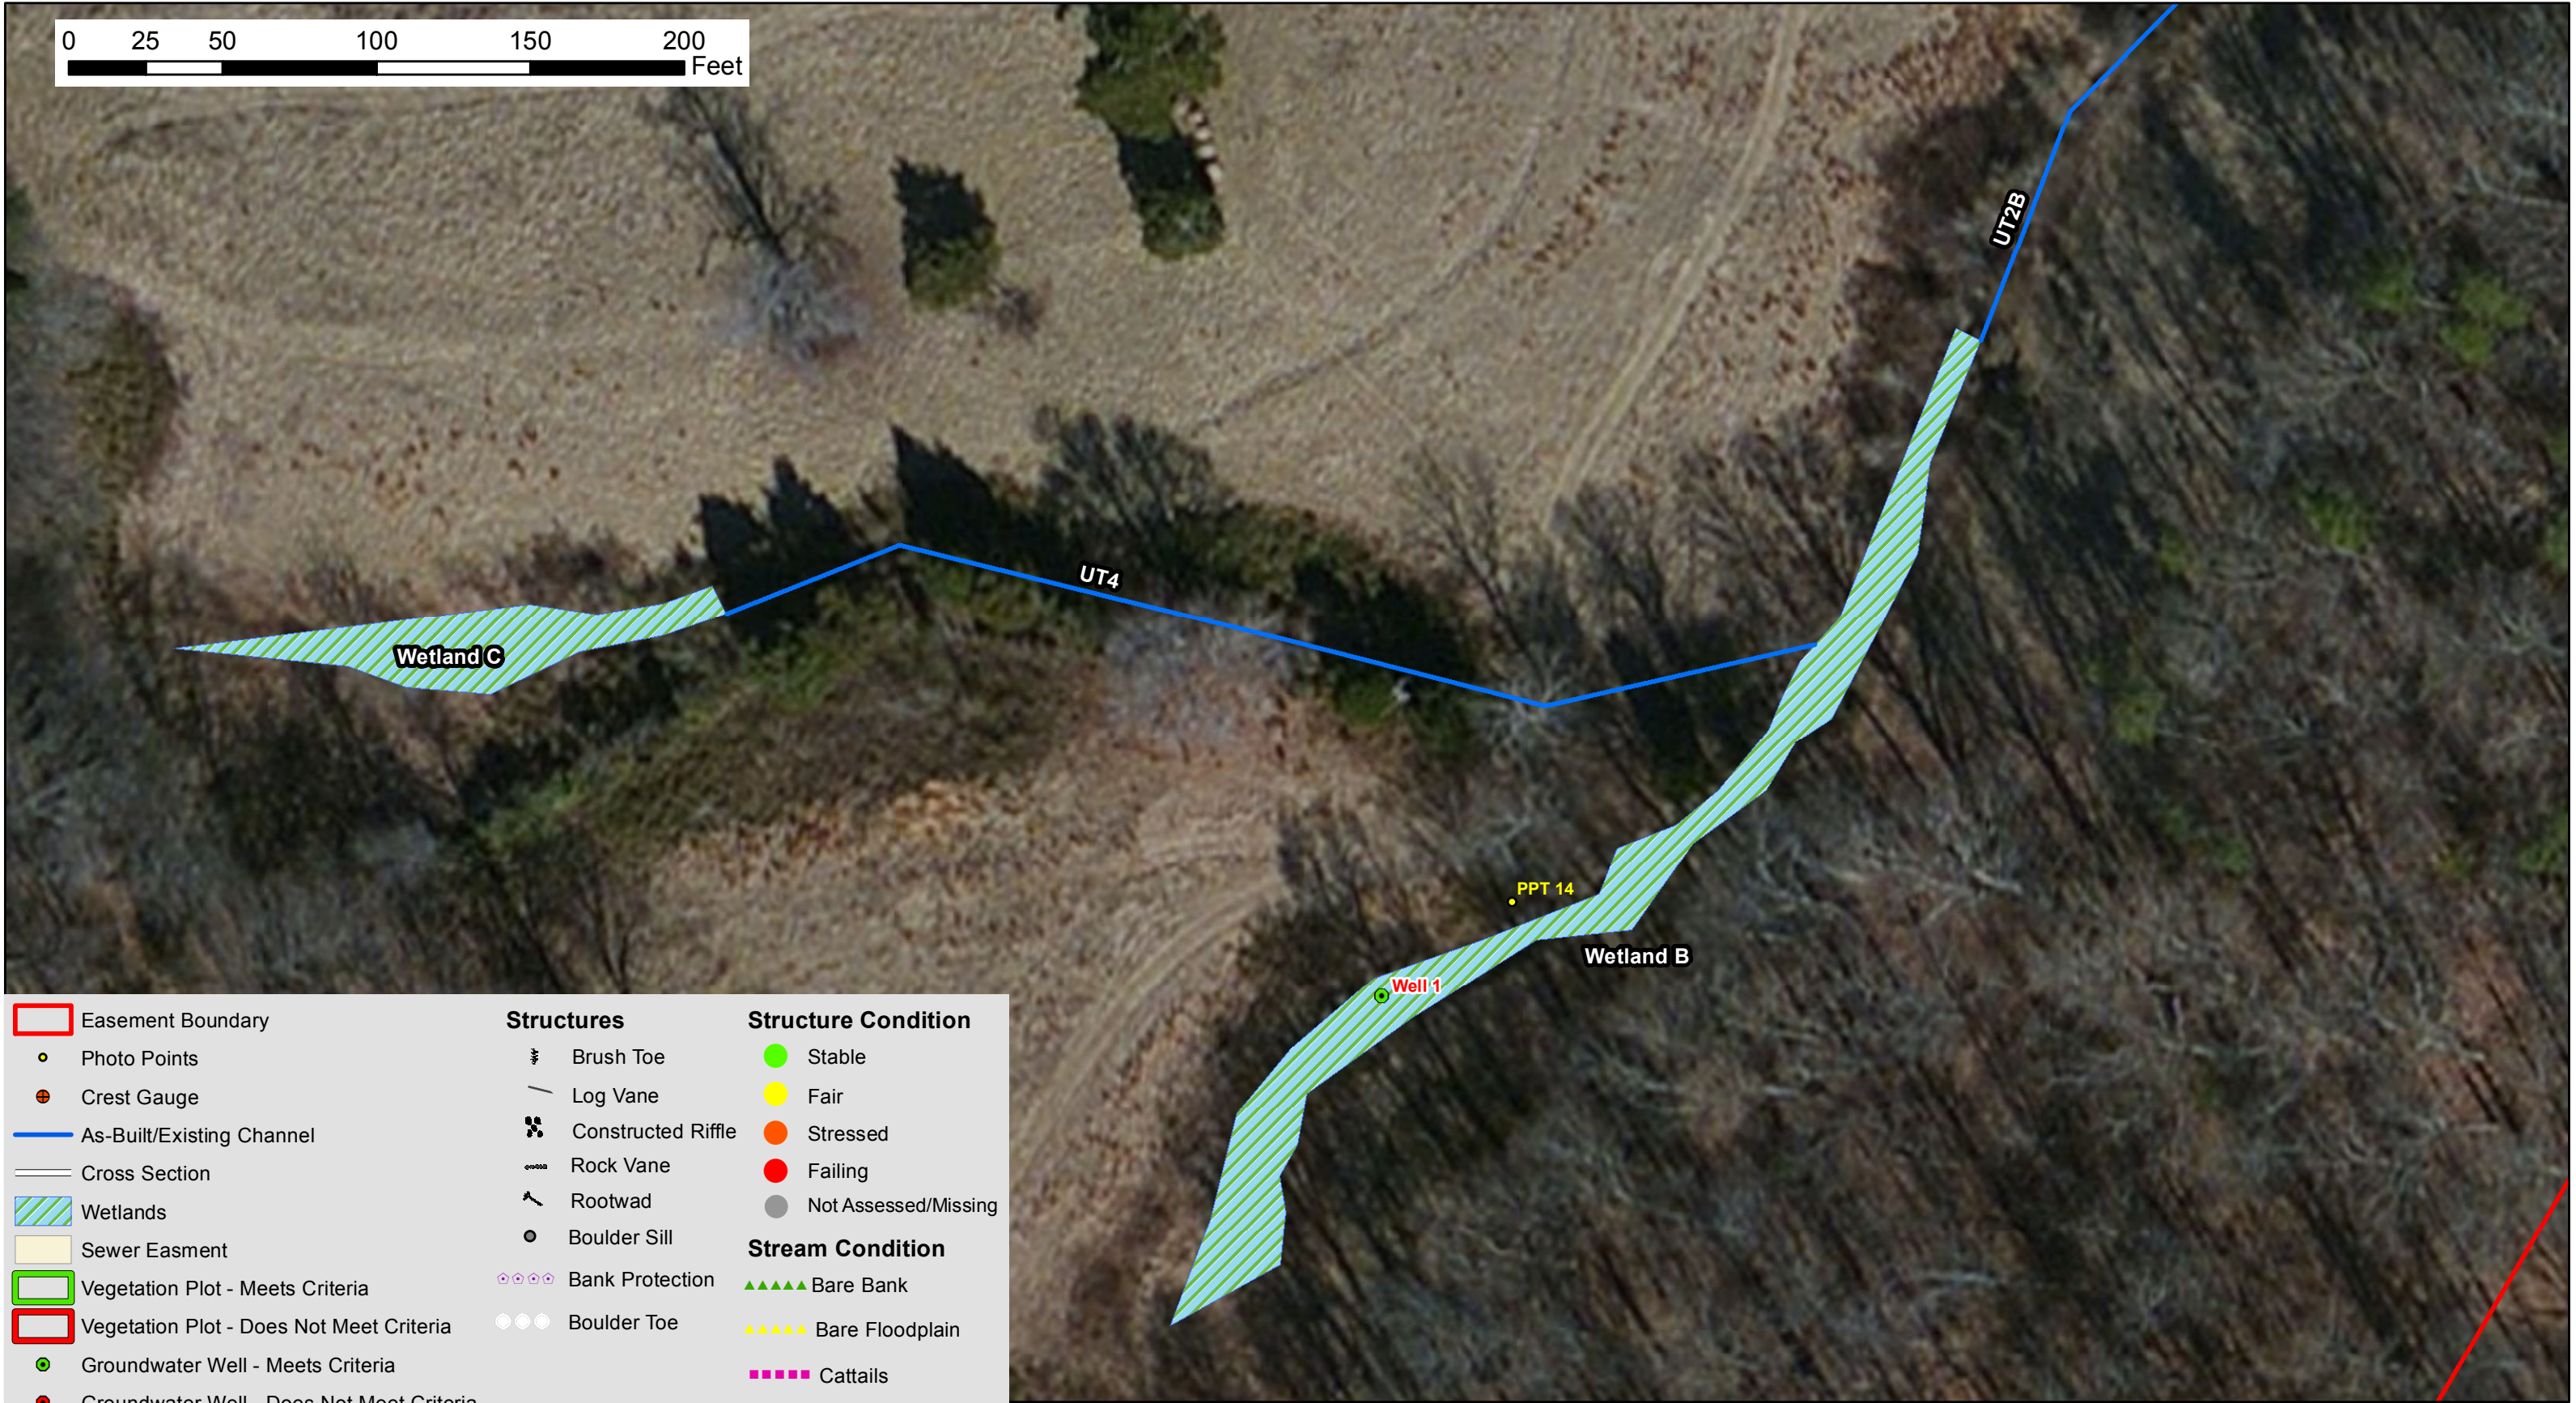
## Current Conditions Plan View - UT 1

Reach UT1 had one area of bare bank between Stations 4+78 to 5+37. This area was lacking significant woody and herbaceous vegetation. Two instances of bare floodplain were observed between Stations 7+65 to 7+87 and 6+97 to 7+37. Cross Section 4 showed an increase in particle size for this monitoring year compared to the previous year but still less than baseline condition.

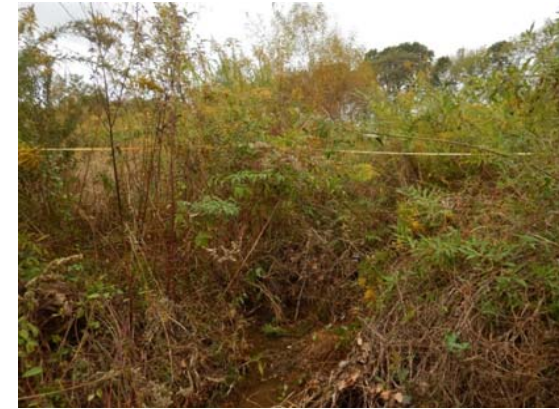
Sta. 4+52 Looking Downstream

<b>Reach</b>	UT to Clarke Creek
<b>River Basin</b>	Yadkin/Pee Dee
<b>Cross Section ID</b>	XSC-1, Riffle, 4+52
<b>Drainage Area (Sq Mi)</b>	1.08
<b>Date</b>	10/21/2016
<b>Observers</b>	P. Beach, E. Webster

SUMMARY DATA	
Baseline Bankfull Datum, ft	744.21
Bankfull Cross Sectional Area, ft <sup>2</sup>	4.35
Bankfull Width, ft	6.89
Max Depth at Bankfull, ft	1.03
Mean Depth at Bankfull, ft	0.63
Width/Depth Ratio	10.90
Flood Prone Width, ft	21.00
Flood Prone Area Elevation	745.24
Entrenchment Ratio	3.05
Bank Height Ratio	1.09

Stream Type | E4

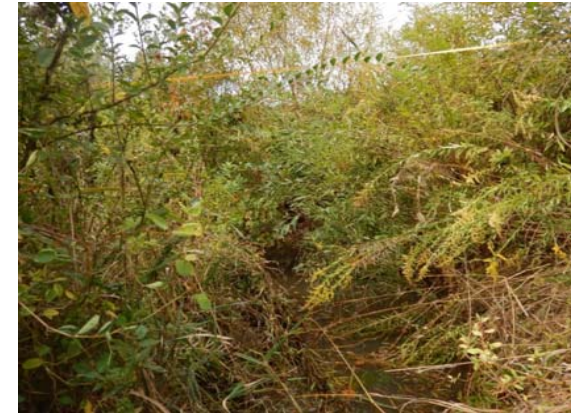
Sta. 5+58 Looking Downstream

On UT to Clarke Creek areas of channel widening which were observed during the May 2016 Site Assessment at Stations 1+00, 3+75, 6+50 are still present. Vegetation observed in the channel between Station 1+78 and 2+41 is now absent. The area of bare bank from Stations 2+85 to 3+00, 4+90 to 5+29, and 11+00 to 11+30 is also still present. One area of bare floodplain was observed between Stations 10+68 and 10+88. Cross Sections 1A and 9 showed an increase in D50 compared to MY02 (but less than baseline) while Station 7+50 showed a decrease in D50 compared to MY02. The increase in particle size at Cross Section 9 may be attributed to the loss of vegetation in the channel and subsequent fine sediment removal at Station 1+78 and 2+41. The particle size increase at Cross Section 1A may be attributed to the channel widening at Station 6+50.

Reach	UT to Clarke Creek
River Basin	Yadkin/Pee Dee
Cross Section ID	XSC-1A, Pool, 5+58
Drainage Area (Sq Mi)	1.08
Date	10/21/2016
Observers	P. Beach, E. Webster

SUMMARY DATA	
Baseline Bankfull Datum, ft	742.39
Bankfull Cross Sectional Area, ft <sup>2</sup>	7.92
Bankfull Width, ft	8.71
Max Depth at Bankfull, ft	1.65
Mean Depth at Bankfull, ft	0.91
Width/Depth Ratio	9.58
Flood Prone Width, ft	29.00
Flood Prone Area Elevation	744.04
Entrenchment Ratio	3.33
Bank Height Ratio	1.47

Stream Type | E4

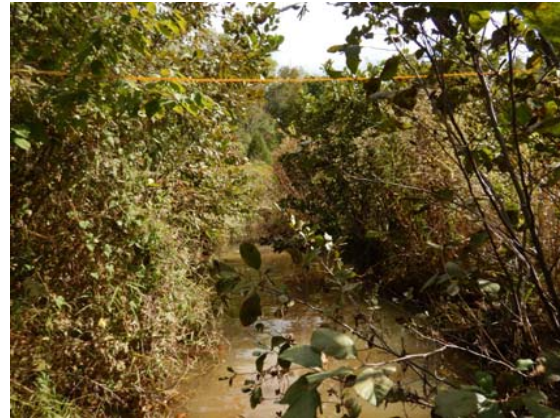
Sta. 9+33 Looking Downstream

Reach	UT to Clarke Creek
River Basin	Yadkin/Pee Dee
Cross Section ID	XSC-2, Riffle, 9+33
Drainage Area (Sq Mi)	1.08
Date	10/21/2016
Observers	P. Beach, E. Webster

SUMMARY DATA	
Baseline Bankfull Datum, ft	739.37
Bankfull Cross Sectional Area, ft <sup>2</sup>	20.16
Bankfull Width, ft	9.77
Max Depth at Bankfull, ft	2.48
Mean Depth at Bankfull, ft	2.06
Width/Depth Ratio	4.73
Flood Prone Width, ft	47.25
Flood Prone Area Elevation	741.85
Entrenchment Ratio	4.84
Bank Height Ratio	1.09

Stream Type E4

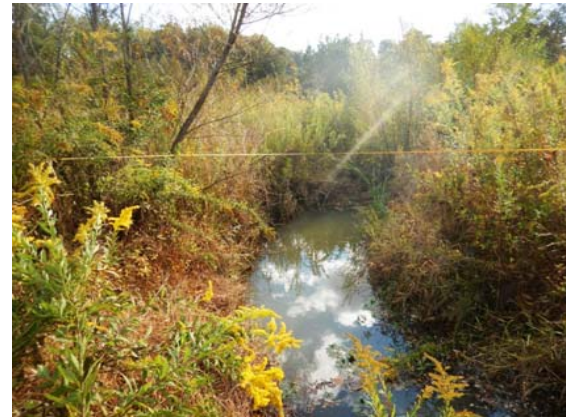
Sta. 7+25 Looking Downstream

Reach	UT1
River Basin	Yadkin/Pee Dee
Cross Section ID	XSC-3, Pool, 7+25
Drainage Area (Sq Mi)	0.46
Date	10/21/2016
Observers	P. Beach, E. Webster

SUMMARY DATA	
Baseline Bankfull Datum, ft	741.07
Bankfull Cross Sectional Area, ft <sup>2</sup>	19.48
Bankfull Width, ft	10.11
Max Depth at Bankfull, ft	2.55
Mean Depth at Bankfull, ft	1.93
Width/Depth Ratio	5.25
Flood Prone Width, ft	62.00
Flood Prone Area Elevation	743.62
Entrenchment Ratio	6.13
Bank Height Ratio	1.17

Stream Type B4c

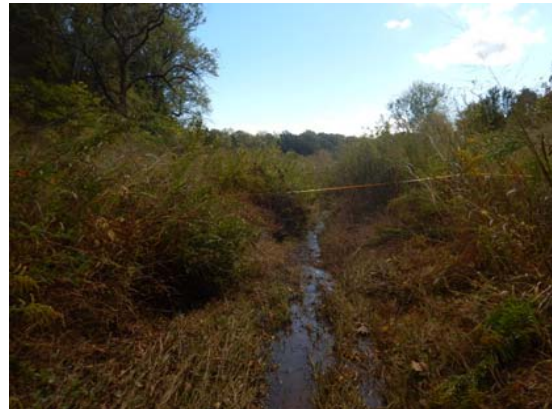
Reach	UT1
River Basin	Yadkin/Pee Dee
Cross Section ID	XSC-4, Riffle, 1+26
Drainage Area (Sq Mi)	0.46
Date	10/21/2016
Observers	P. Beach, E. Webster

SUMMARY DATA	
Baseline Bankfull Datum, ft	745.96
Bankfull Cross Sectional Area, ft <sup>2</sup>	4.24
Bankfull Width, ft	8.41
Max Depth at Bankfull, ft	0.68
Mean Depth at Bankfull, ft	0.50
Width/Depth Ratio	16.67
Flood Prone Width, ft	26
Flood Prone Area Elevation	746.64
Entrenchment Ratio	3.09
Bank Height Ratio	1.99

Stream Type B4c

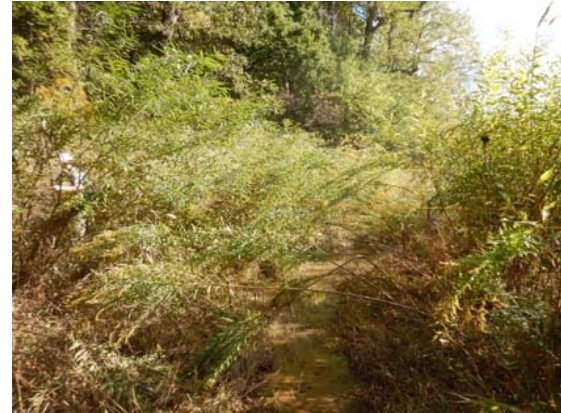
Reach	UT1
River Basin	Yadkin/Pee Dee
Cross Section ID	XSC-5, Pool, 2+66
Drainage Area (Sq Mi)	0.46
Date	10/21/2016
Observers	P. Beach, E. Webster

SUMMARY DATA	
Baseline Bankfull Datum, ft	745.90
Bankfull Cross Sectional Area, ft <sup>2</sup>	6.20
Bankfull Width, ft	7.31
Max Depth at Bankfull, ft	1.33
Mean Depth at Bankfull, ft	0.85
Width/Depth Ratio	8.61
Flood Prone Width, ft	34
Flood Prone Area Elevation	746.33
Entrenchment Ratio	4.65
Bank Height Ratio	1.59

Stream Type B4c

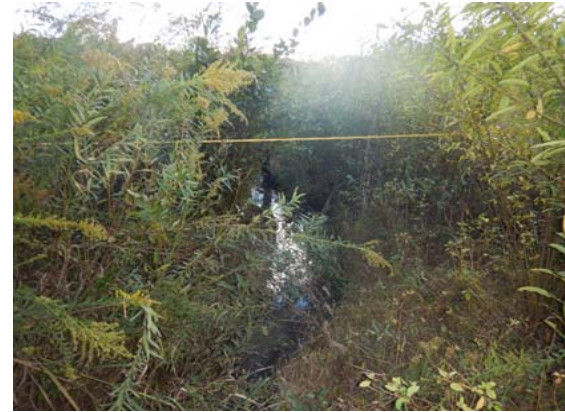
Reach	UT1
River Basin	Yadkin/Pee Dee
Cross Section ID	XSC-6, Riffle, 3+33
Drainage Area (Sq Mi)	0.46
Date	10/21/2016
Observers	P. Beach, E. Webster

SUMMARY DATA	
Baseline Bankfull Datum, ft	744.63
Bankfull Cross Sectional Area, ft <sup>2</sup>	4.23
Bankfull Width, ft	6
Max Depth at Bankfull, ft	0.96
Mean Depth at Bankfull, ft	0.71
Width/Depth Ratio	8.51
Flood Prone Width, ft	16
Flood Prone Area Elevation	745.59
Entrenchment Ratio	2.67
Bank Height Ratio	1.61

Stream Type | B4c

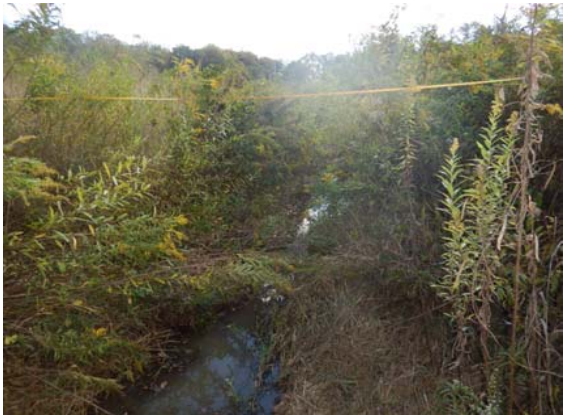
Reach	UT1
River Basin	Yadkin/Pee Dee
Cross Section ID	XSC-8, Riffle, 4+14
Drainage Area (Sq Mi)	0.46
Date	10/21/2016
Observers	P. Beach, E. Webster

SUMMARY DATA	
Baseline Bankfull Datum, ft	744.70
Bankfull Cross Sectional Area, ft <sup>2</sup>	5.68
Bankfull Width, ft	5.69
Max Depth at Bankfull, ft	1.19
Mean Depth at Bankfull, ft	1.00
Width/Depth Ratio	5.70
Flood Prone Width, ft	24
Flood Prone Area Elevation	745.89
Entrenchment Ratio	4.22
Bank Height Ratio	1.24

Stream Type B4c

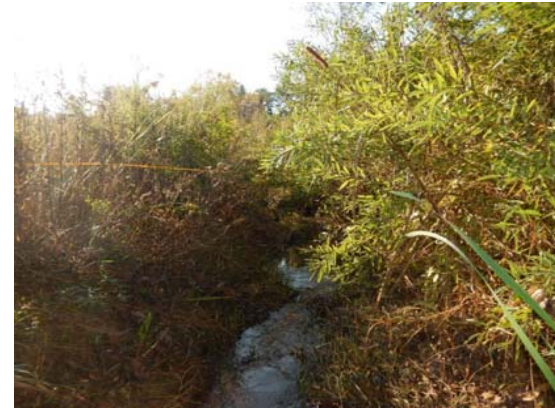
Reach	UT to Clarke Creek
River Basin	Yadkin/Pee Dee
Cross Section ID	XSC-9, Riffle, 2+02
Drainage Area (Sq Mi)	1.08
Date	10/21/2016
Observers	P. Beach, E. Webster

SUMMARY DATA	
Baseline Bankfull Datum, ft	746.79
Bankfull Cross Sectional Area, ft <sup>2</sup>	4.41
Bankfull Width, ft	6.1
Max Depth at Bankfull, ft	1.24
Mean Depth at Bankfull, ft	0.72
Width/Depth Ratio	8.44
Flood Prone Width, ft	38
Flood Prone Area Elevation	748.03
Entrenchment Ratio	6.23
Bank Height Ratio	1.29

Stream Type | E4

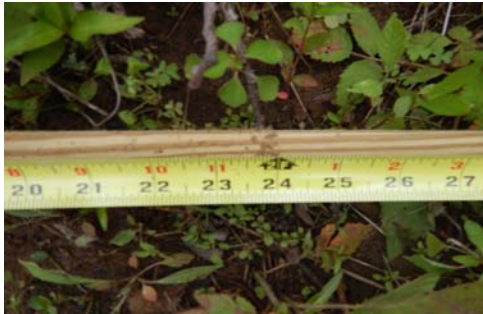
5/18/2016	Between 10/22/2015 and 5/18/2016	Crest Gauge Reading* 12.5" above bankfull (UT1) and 24" above bankfull (UT Clarke Creek); visual observation of wrack lines	No wrack line photos captured during this monitoring period. See below for crest gauge photo.
10/21/2016	Between 5/18/2016 and 10/21/2016	Crest Gauge Reading* 13" above bankfull (UT1) and 11" above bankfull (UT Clarke Creek)	No wrack line photos captured during this monitoring period. See below for crest gauge photo.

Photo 1: 05/18/16 - Crest gauge indication of bankfull event.

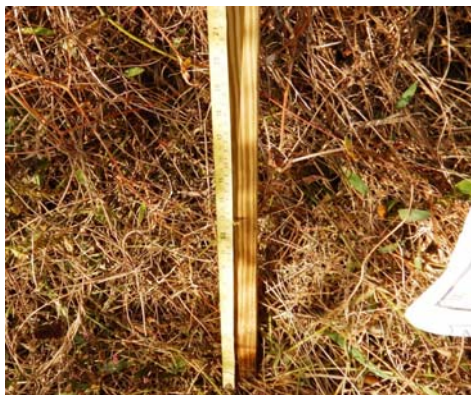
Photo 2: 10/21/16 - Crest gauge indication of bankfull event.
