# **Unnamed Tributary to Crab Creek Stream and Wetland Restoration**

**NCEEP Project Number: 857**

**Monitoring Year 2**

**2011 Final Report**

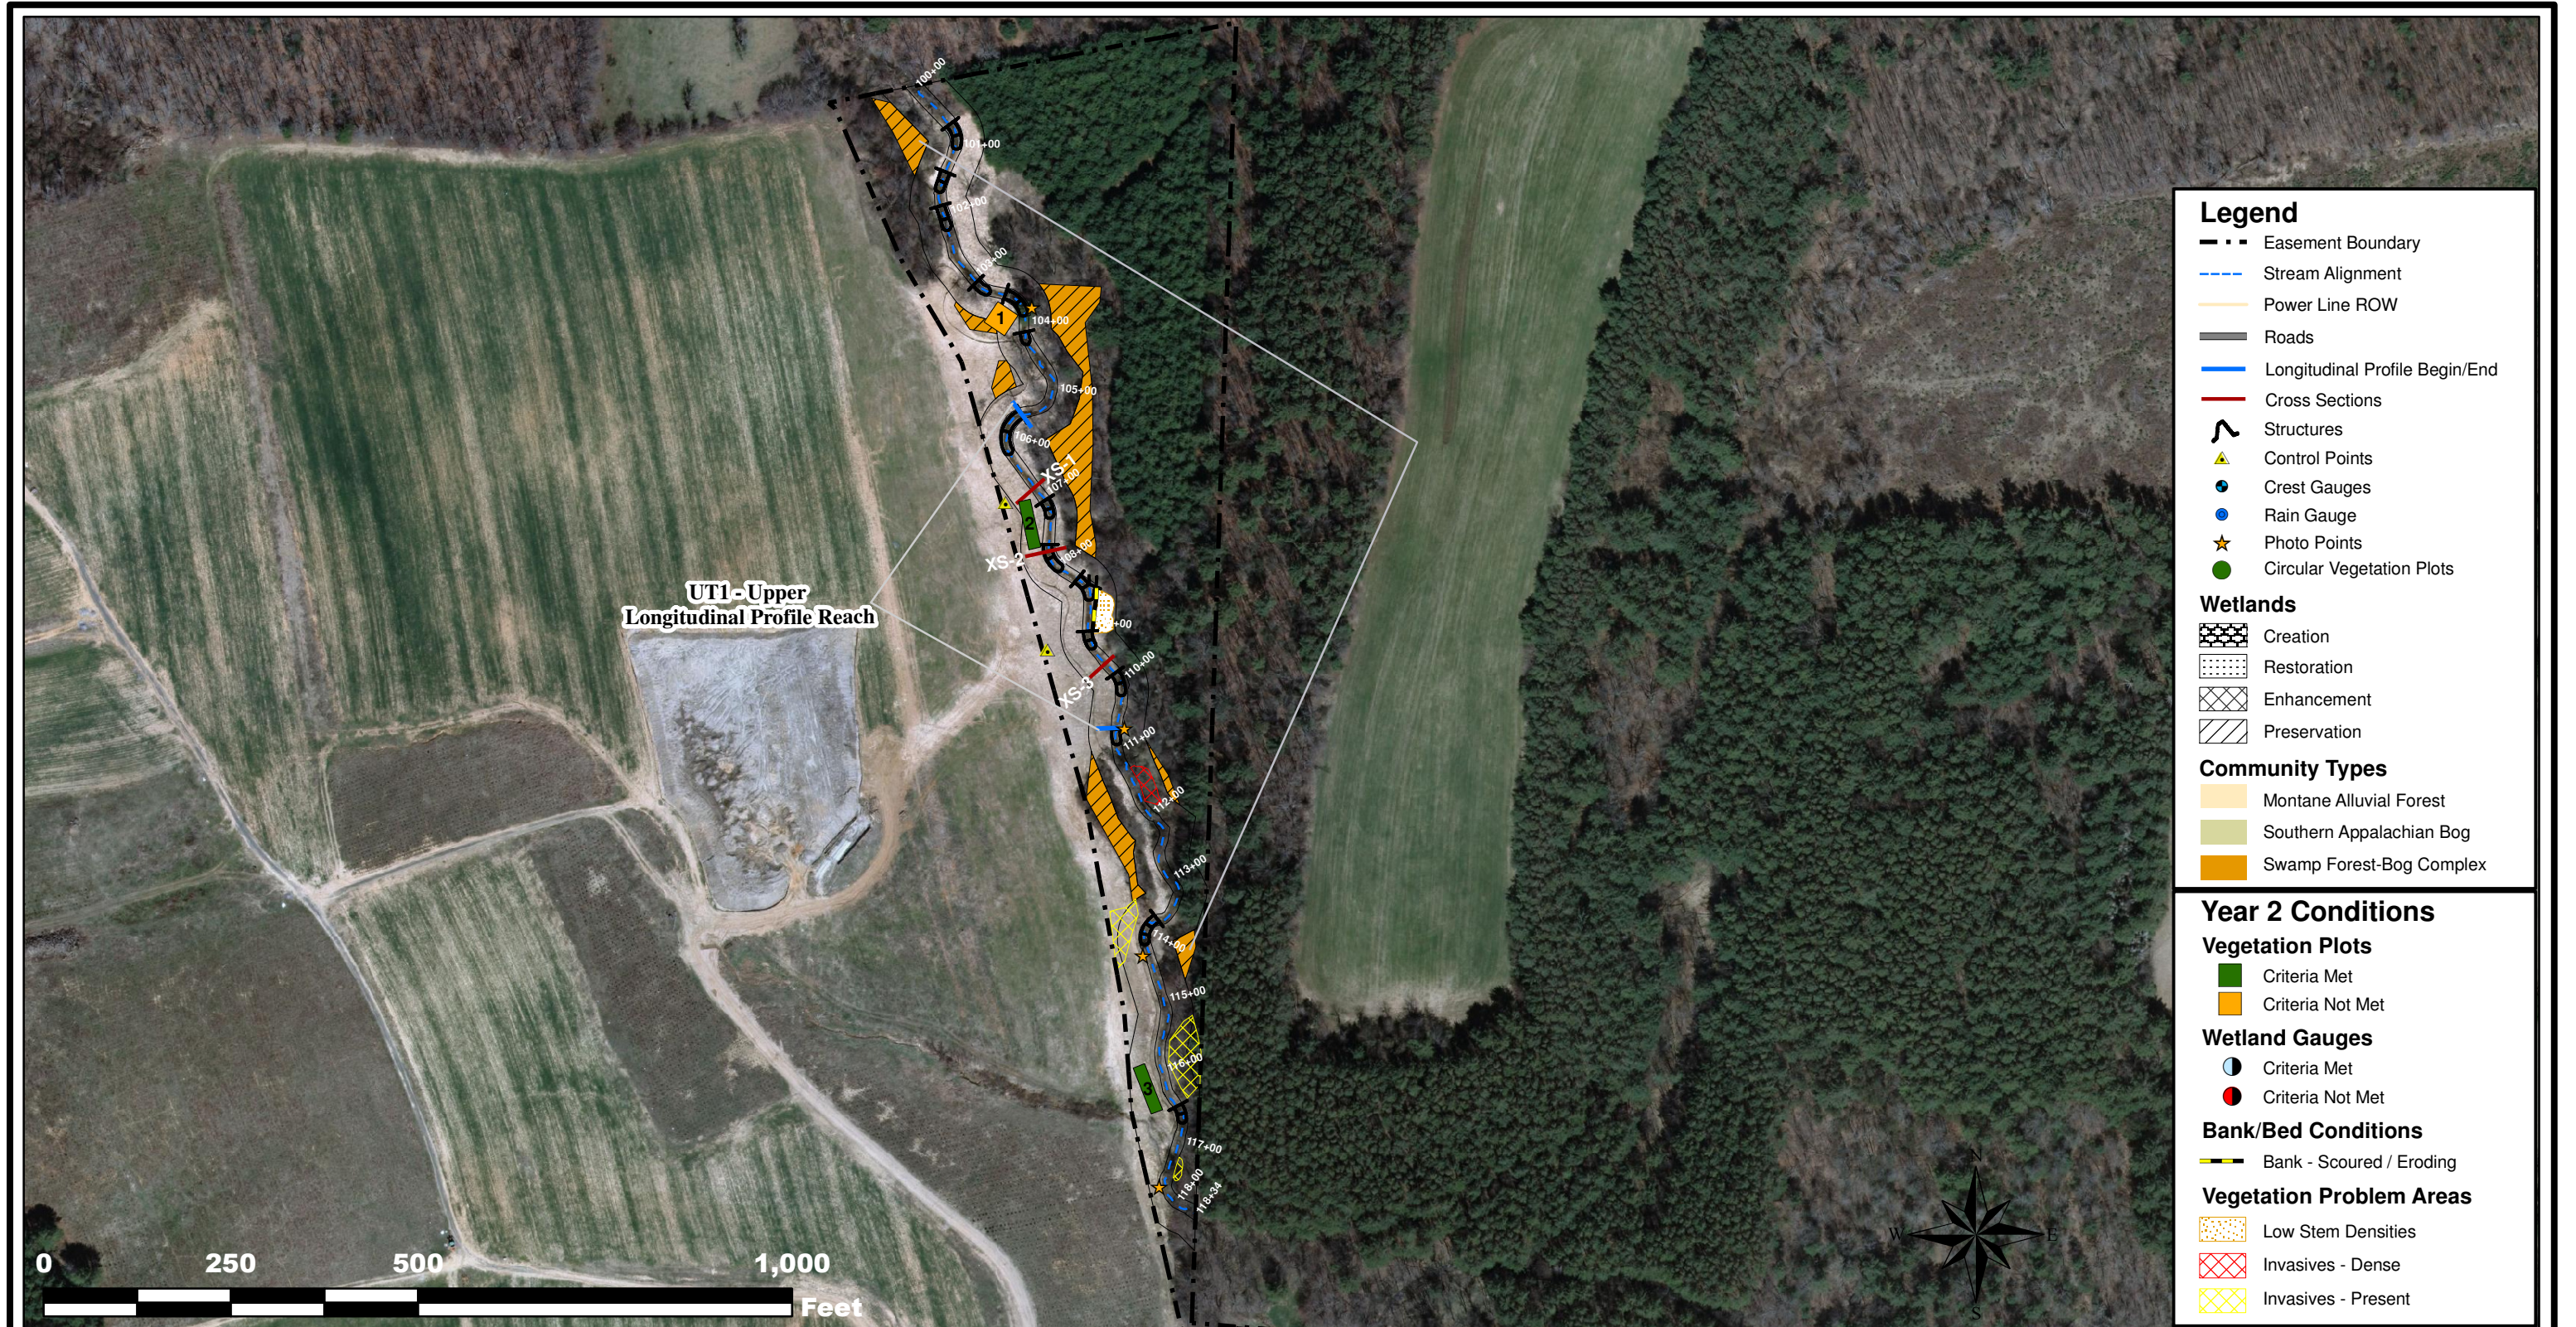
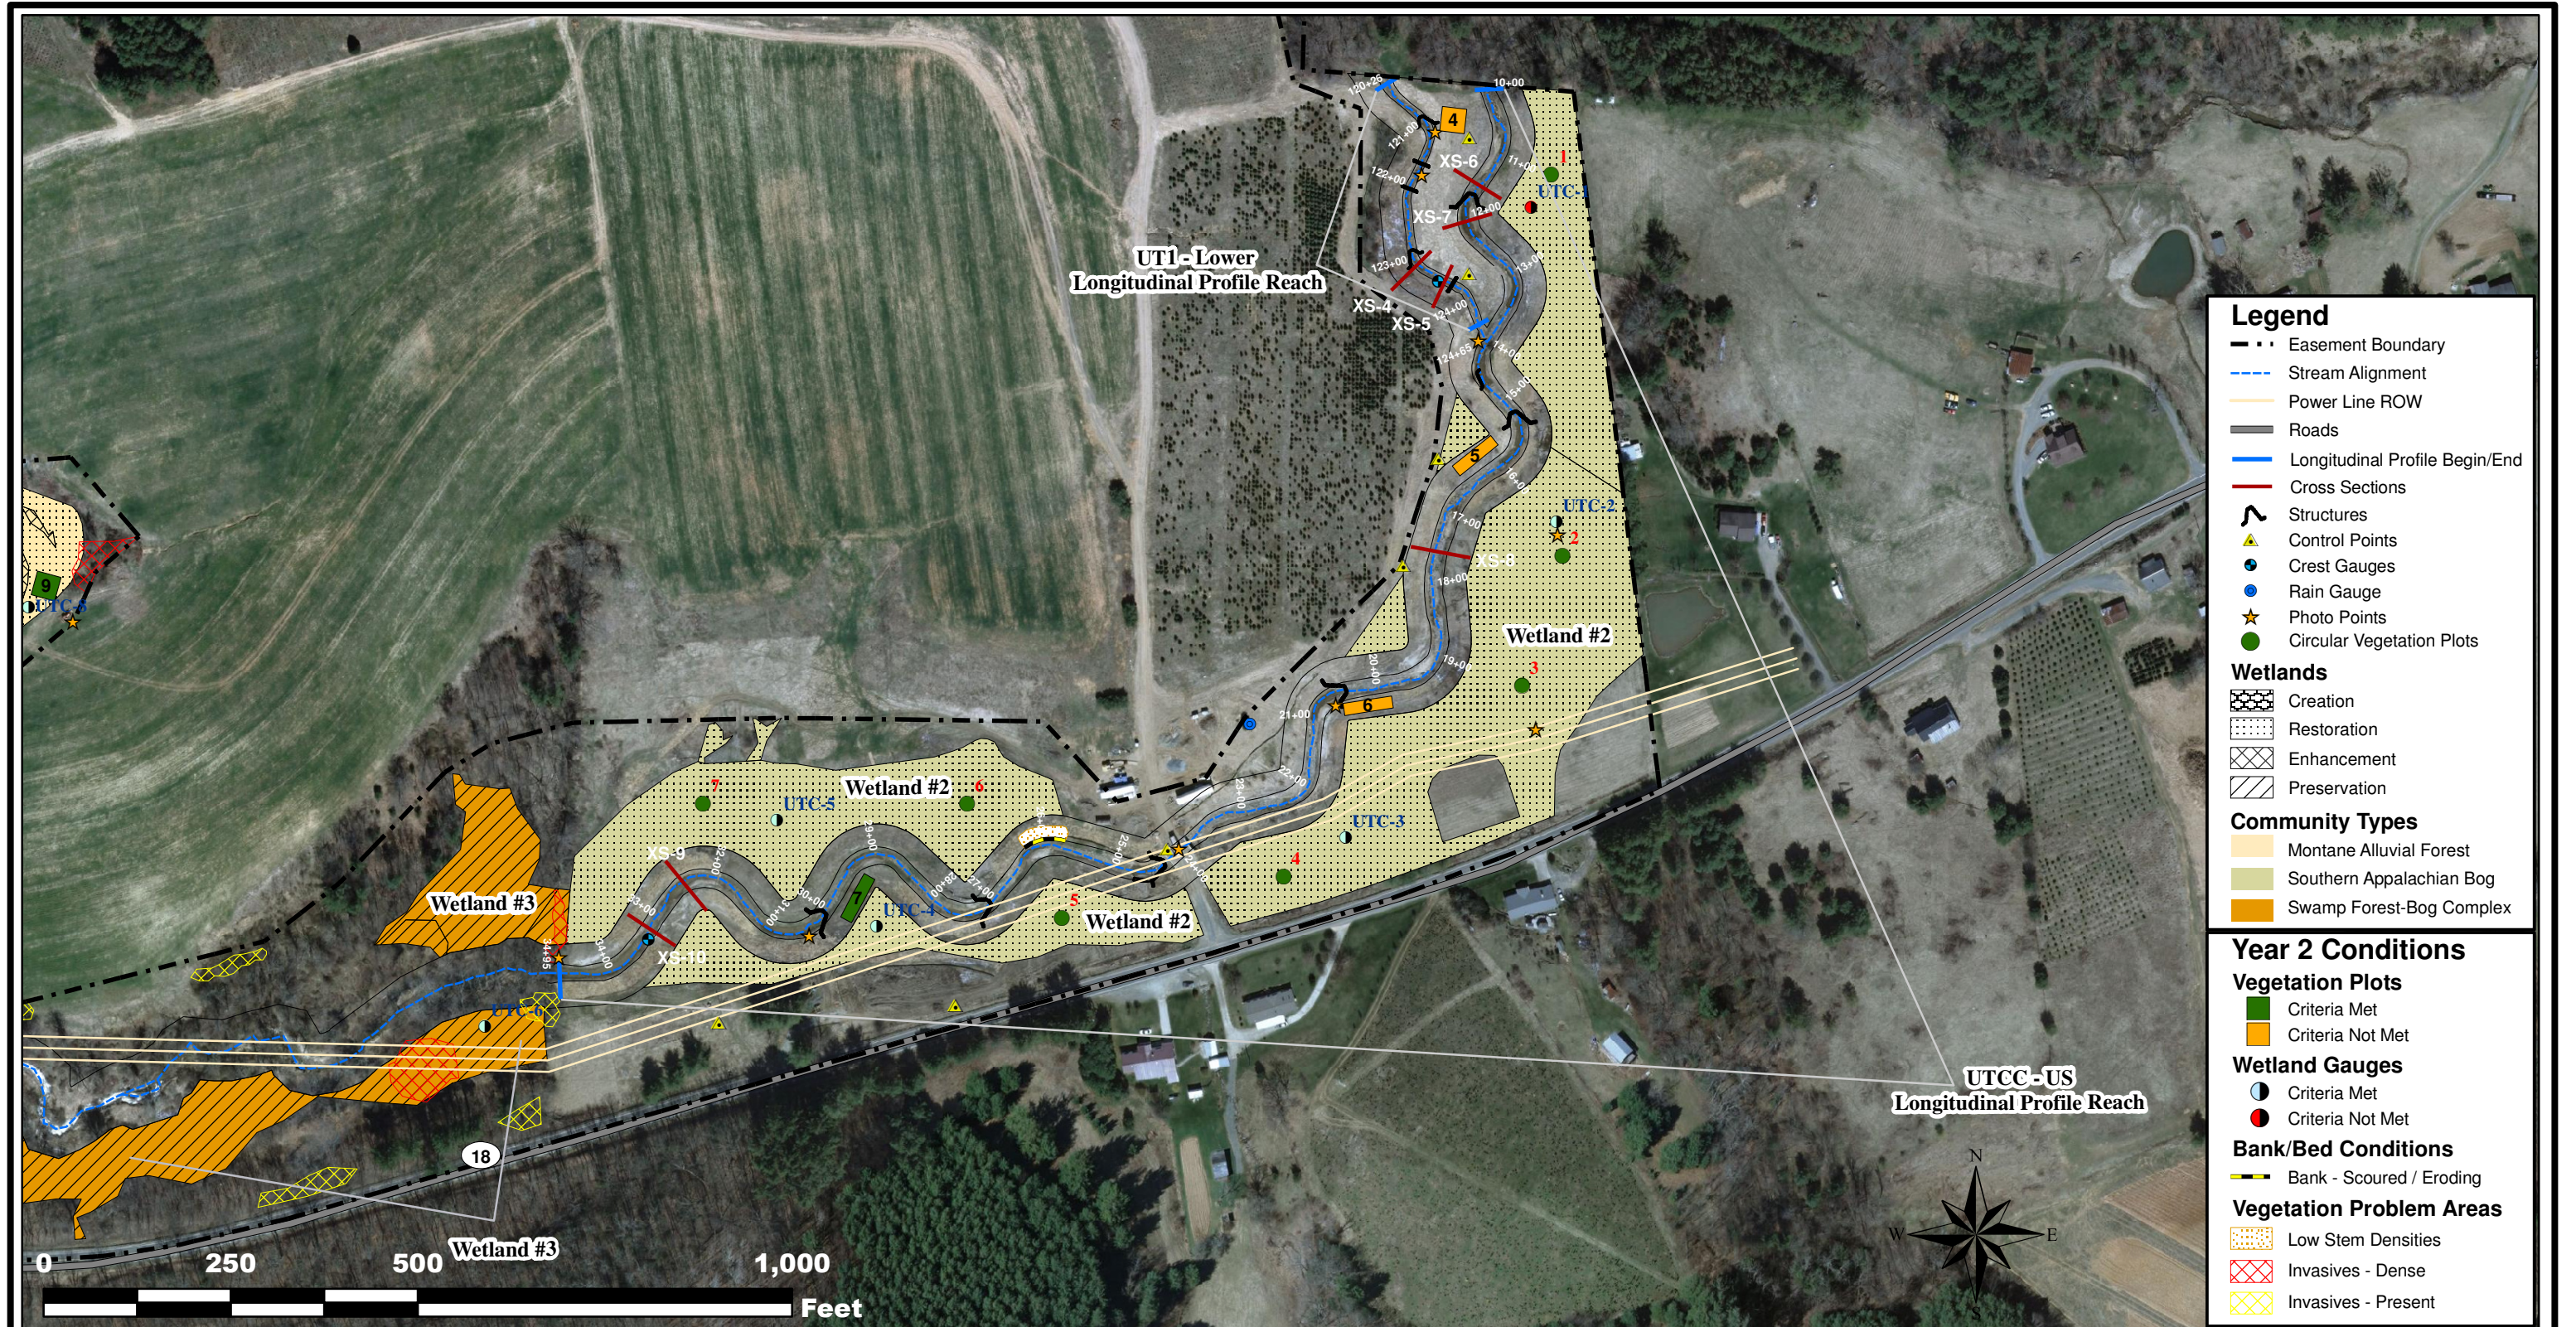
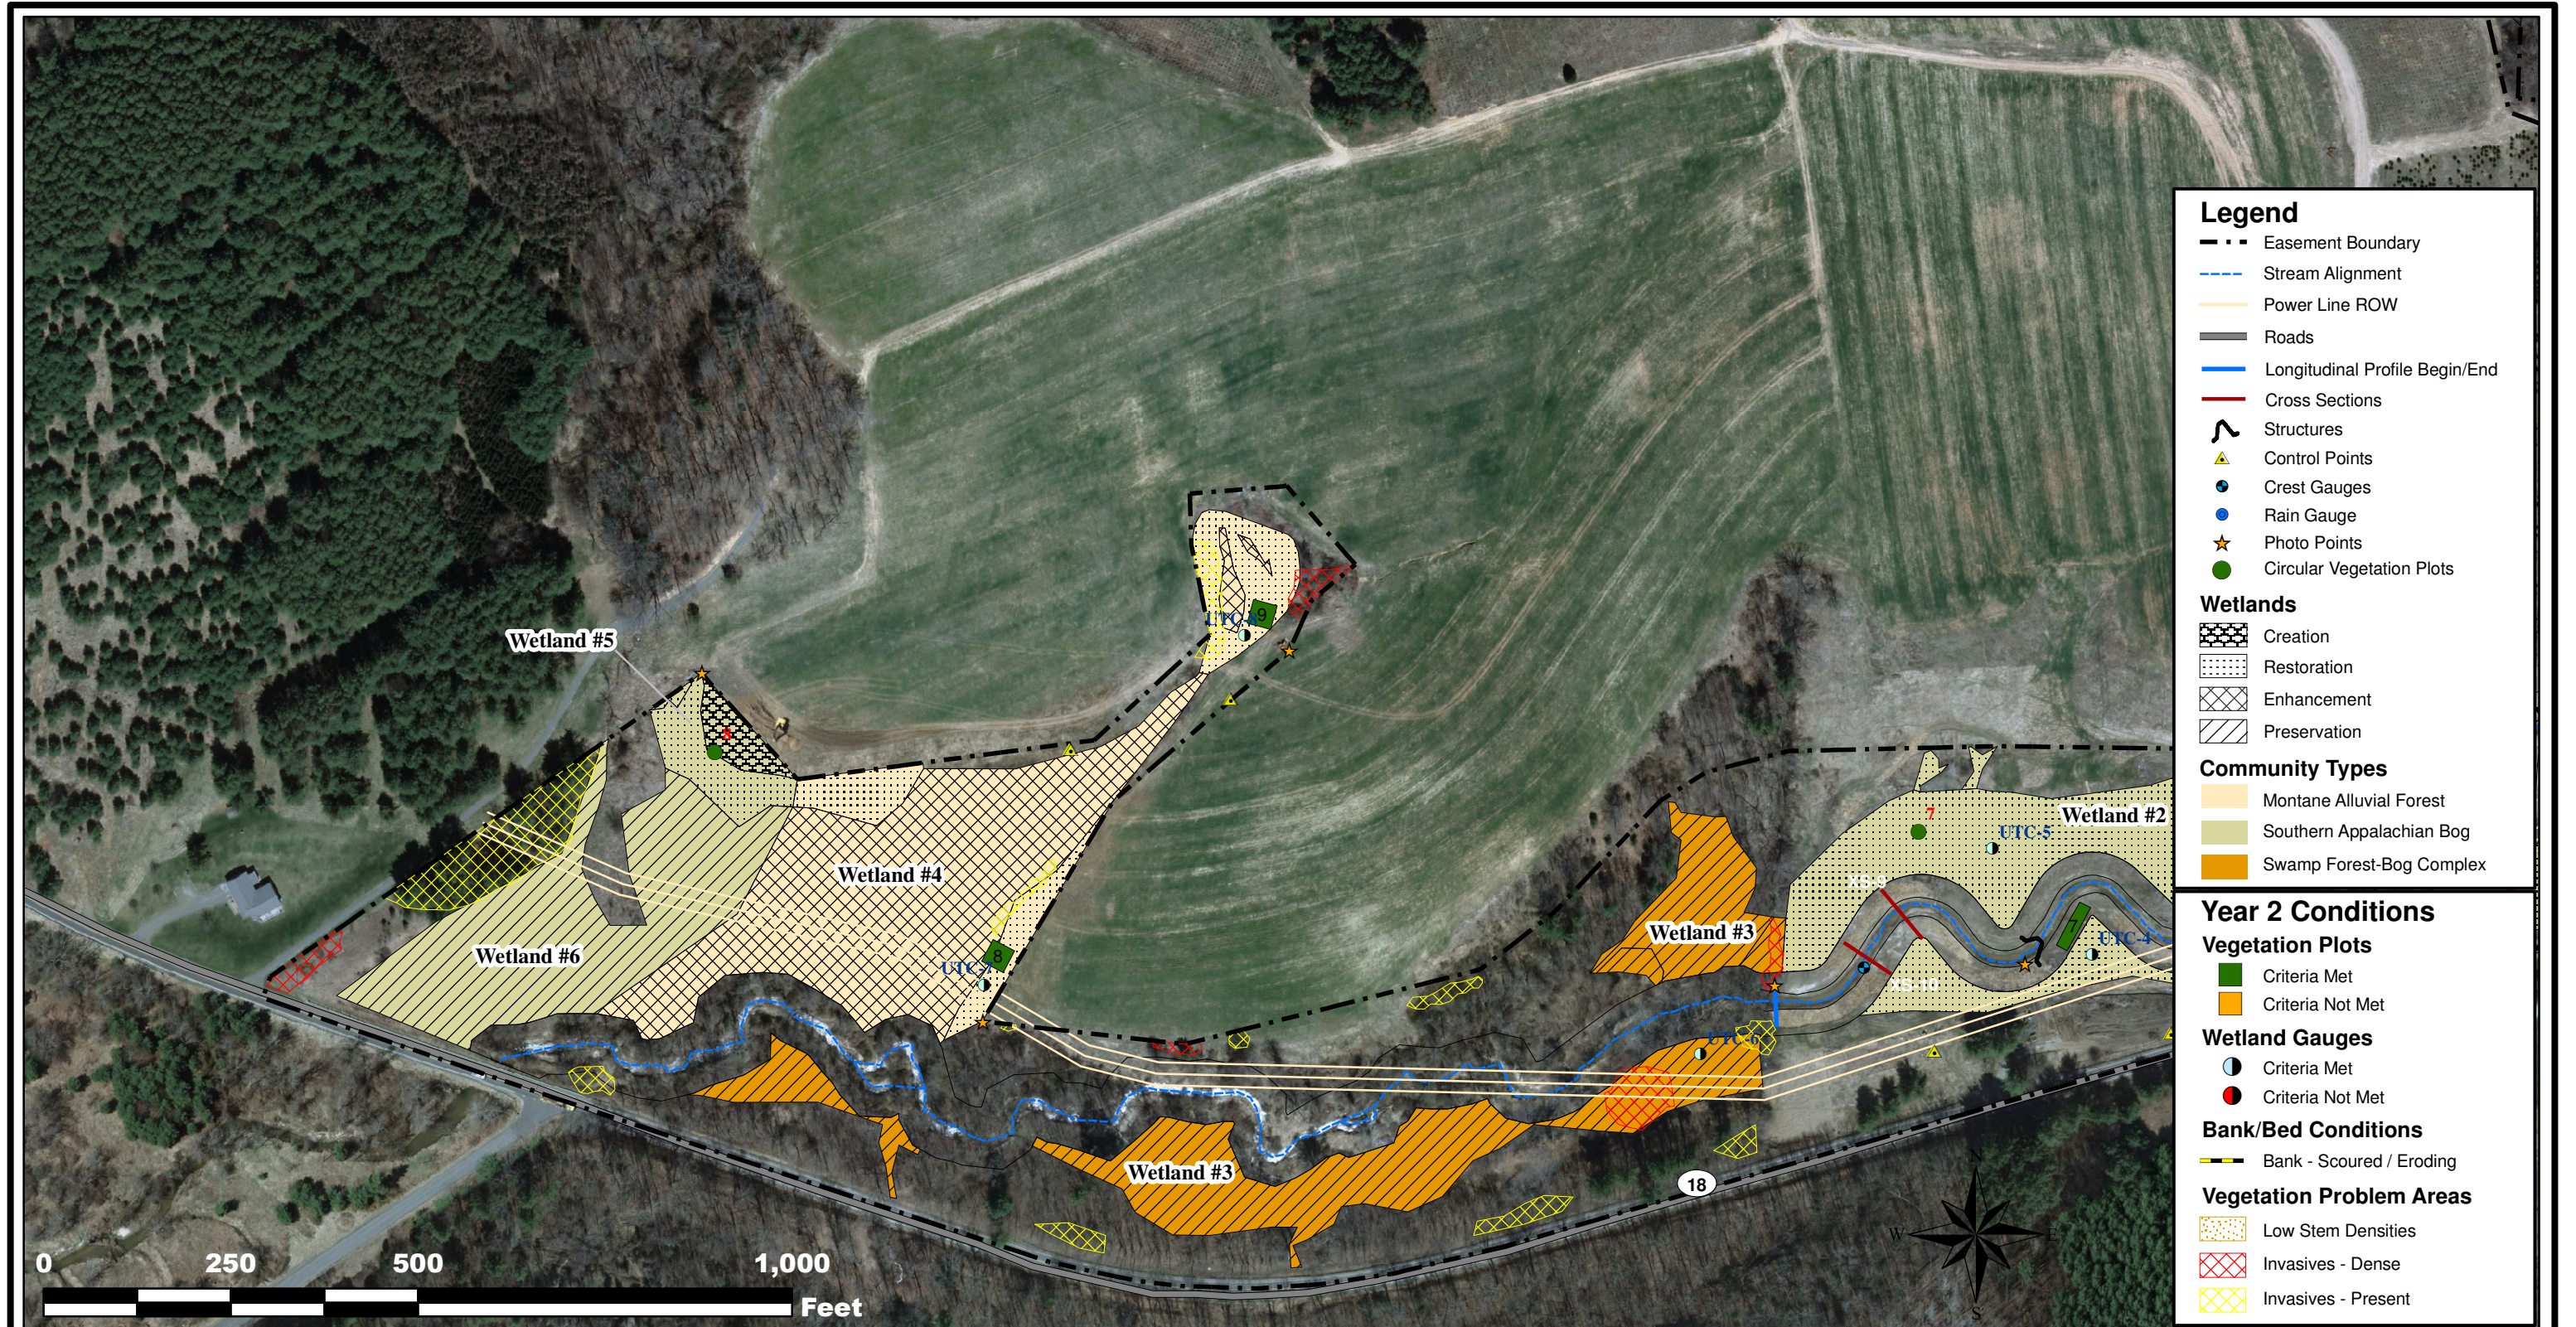
Figure 2. Integrated Current Condition Plan View

Problems with vegetation consist of approximately 20 currently isolated patches of high threat invasive plant species that span the project extent. The dominant species noted for the site is multiflora rose *Rosa multiflora* with additional species comprised of oriental bittersweet *Celastrus orbiculatus*, privet *Ligustrum sp.*, and Japanese honeysuckle *Lonicera japonica*. Additionally, there are 2 areas noted as having low stem densities associated with the bank erosion areas noted below.

Stream longitudinal profiles have remained stable among monitoring years. Stream issues observed during MY2 were minimal and consisted of two bank erosion areas. No bankfull events were documented during MY2.

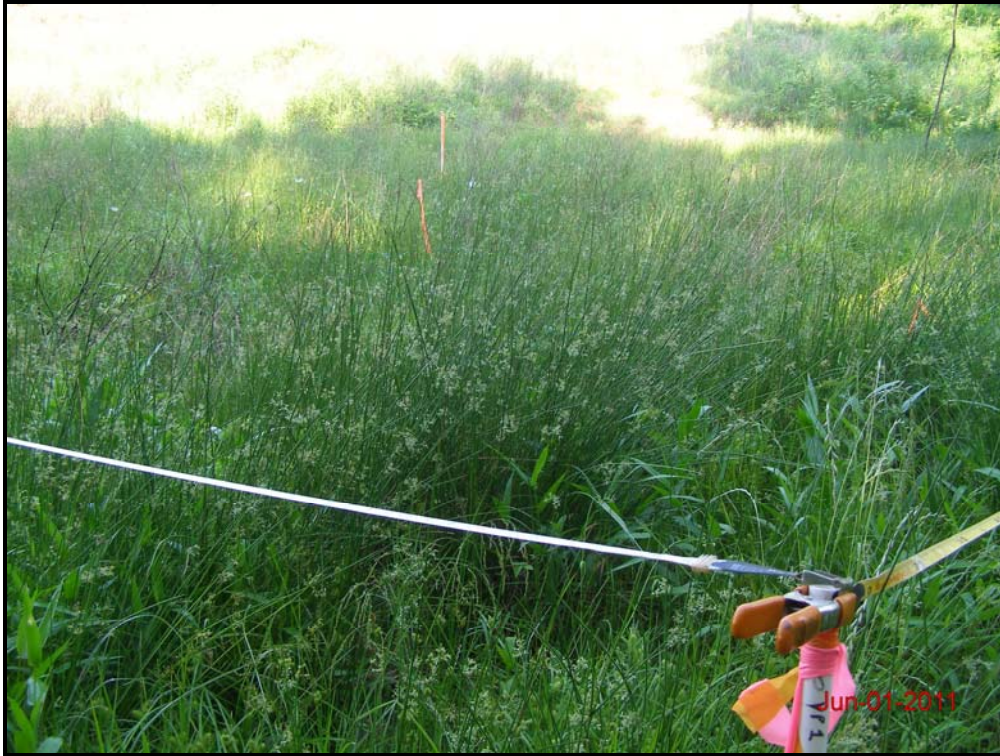
Vegetation Monitoring Plot 1  
Monitoring Year 2 – June 1, 2011

<b>Table 7. Vegetation Plot Criteria Attainment UT Crab Creek / Project No. 857</b>		
<b>Vegetation Plot ID</b>	<b>Vegetation Survival Threshold Met?</b>	<b>Tract Mean</b>
1	No	56%
2	Yes	
3	Yes	
4	No	
5	No	
6	No	
7	Yes	
8	Yes	
9	Yes

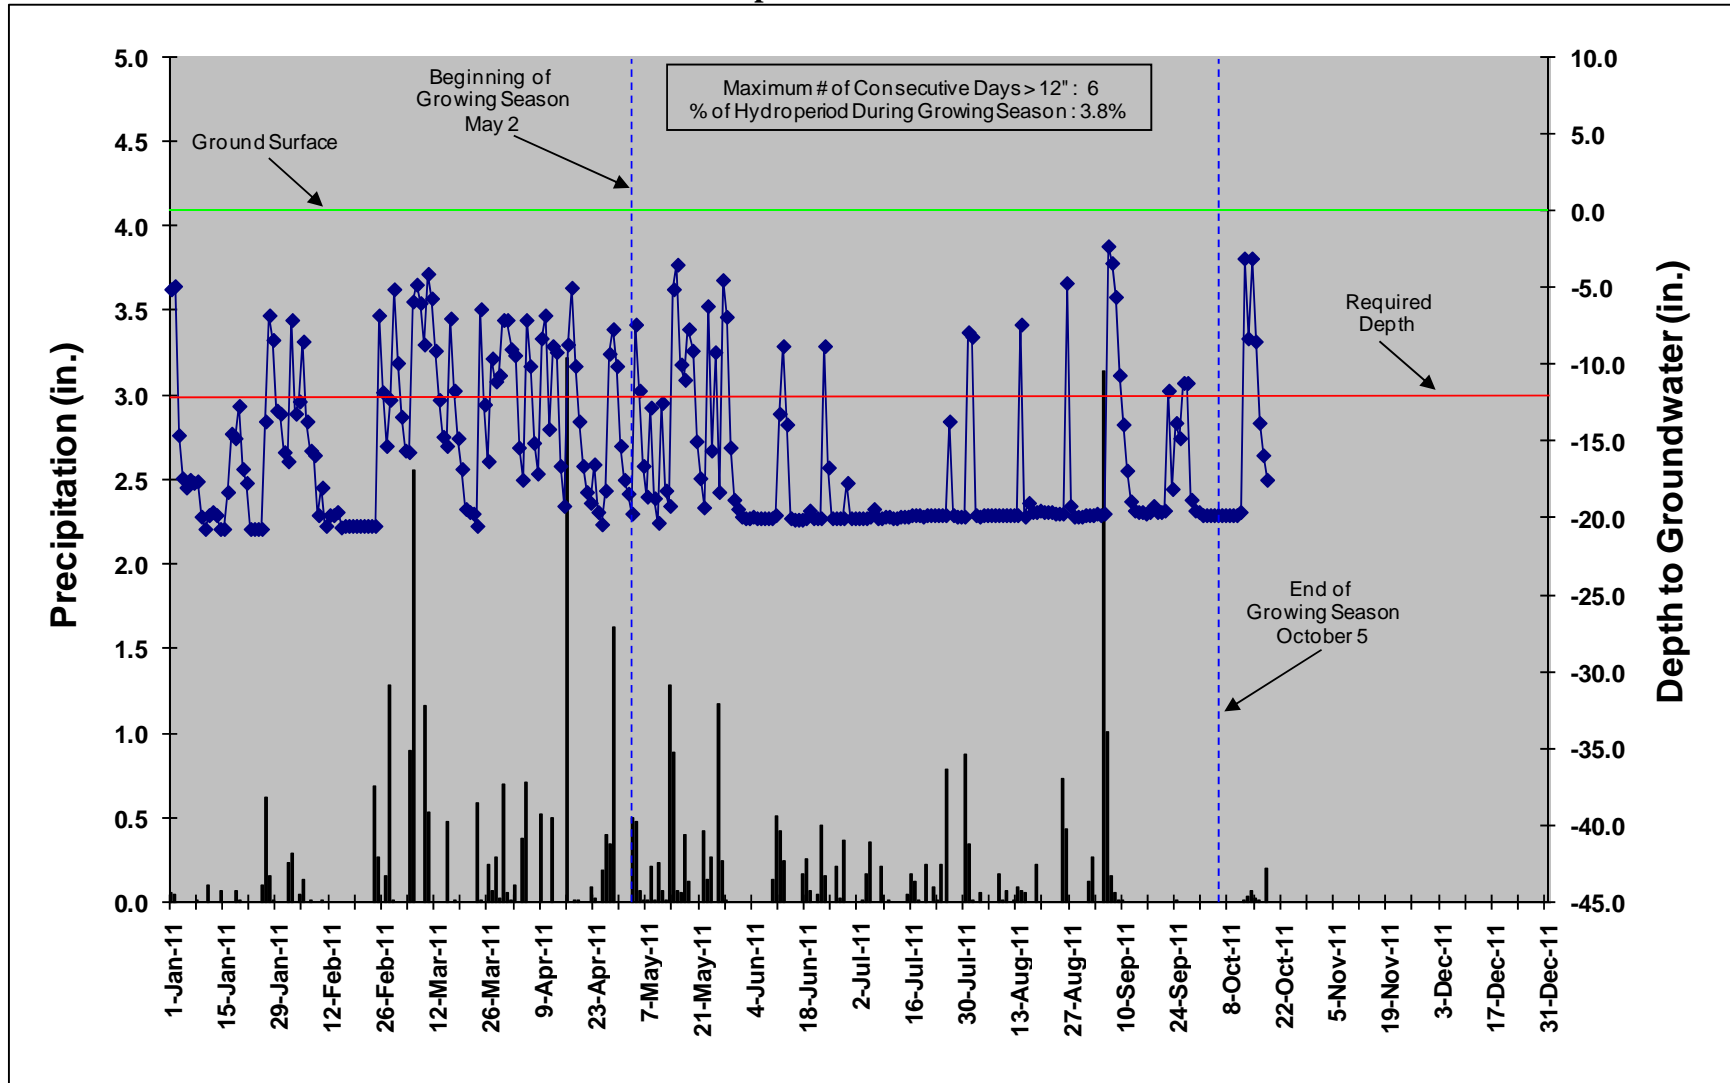
UTC-1 Precipitation and Water Level Plot

Data from the groundwater monitoring stations resulted in all but one station exceeding saturation of the upper soil surfaces for five percent of the growing season. The on-site rain gauge documented below normal precipitation during the majority of the growing season. During normal rainfall years all groundwater gauges are expected to meet criteria.
