Unnamed Tributary to Crab Creek Stream and Wetland Restoration

NCEEP Project Number: 857

Monitoring Year 4

2013 Final Report

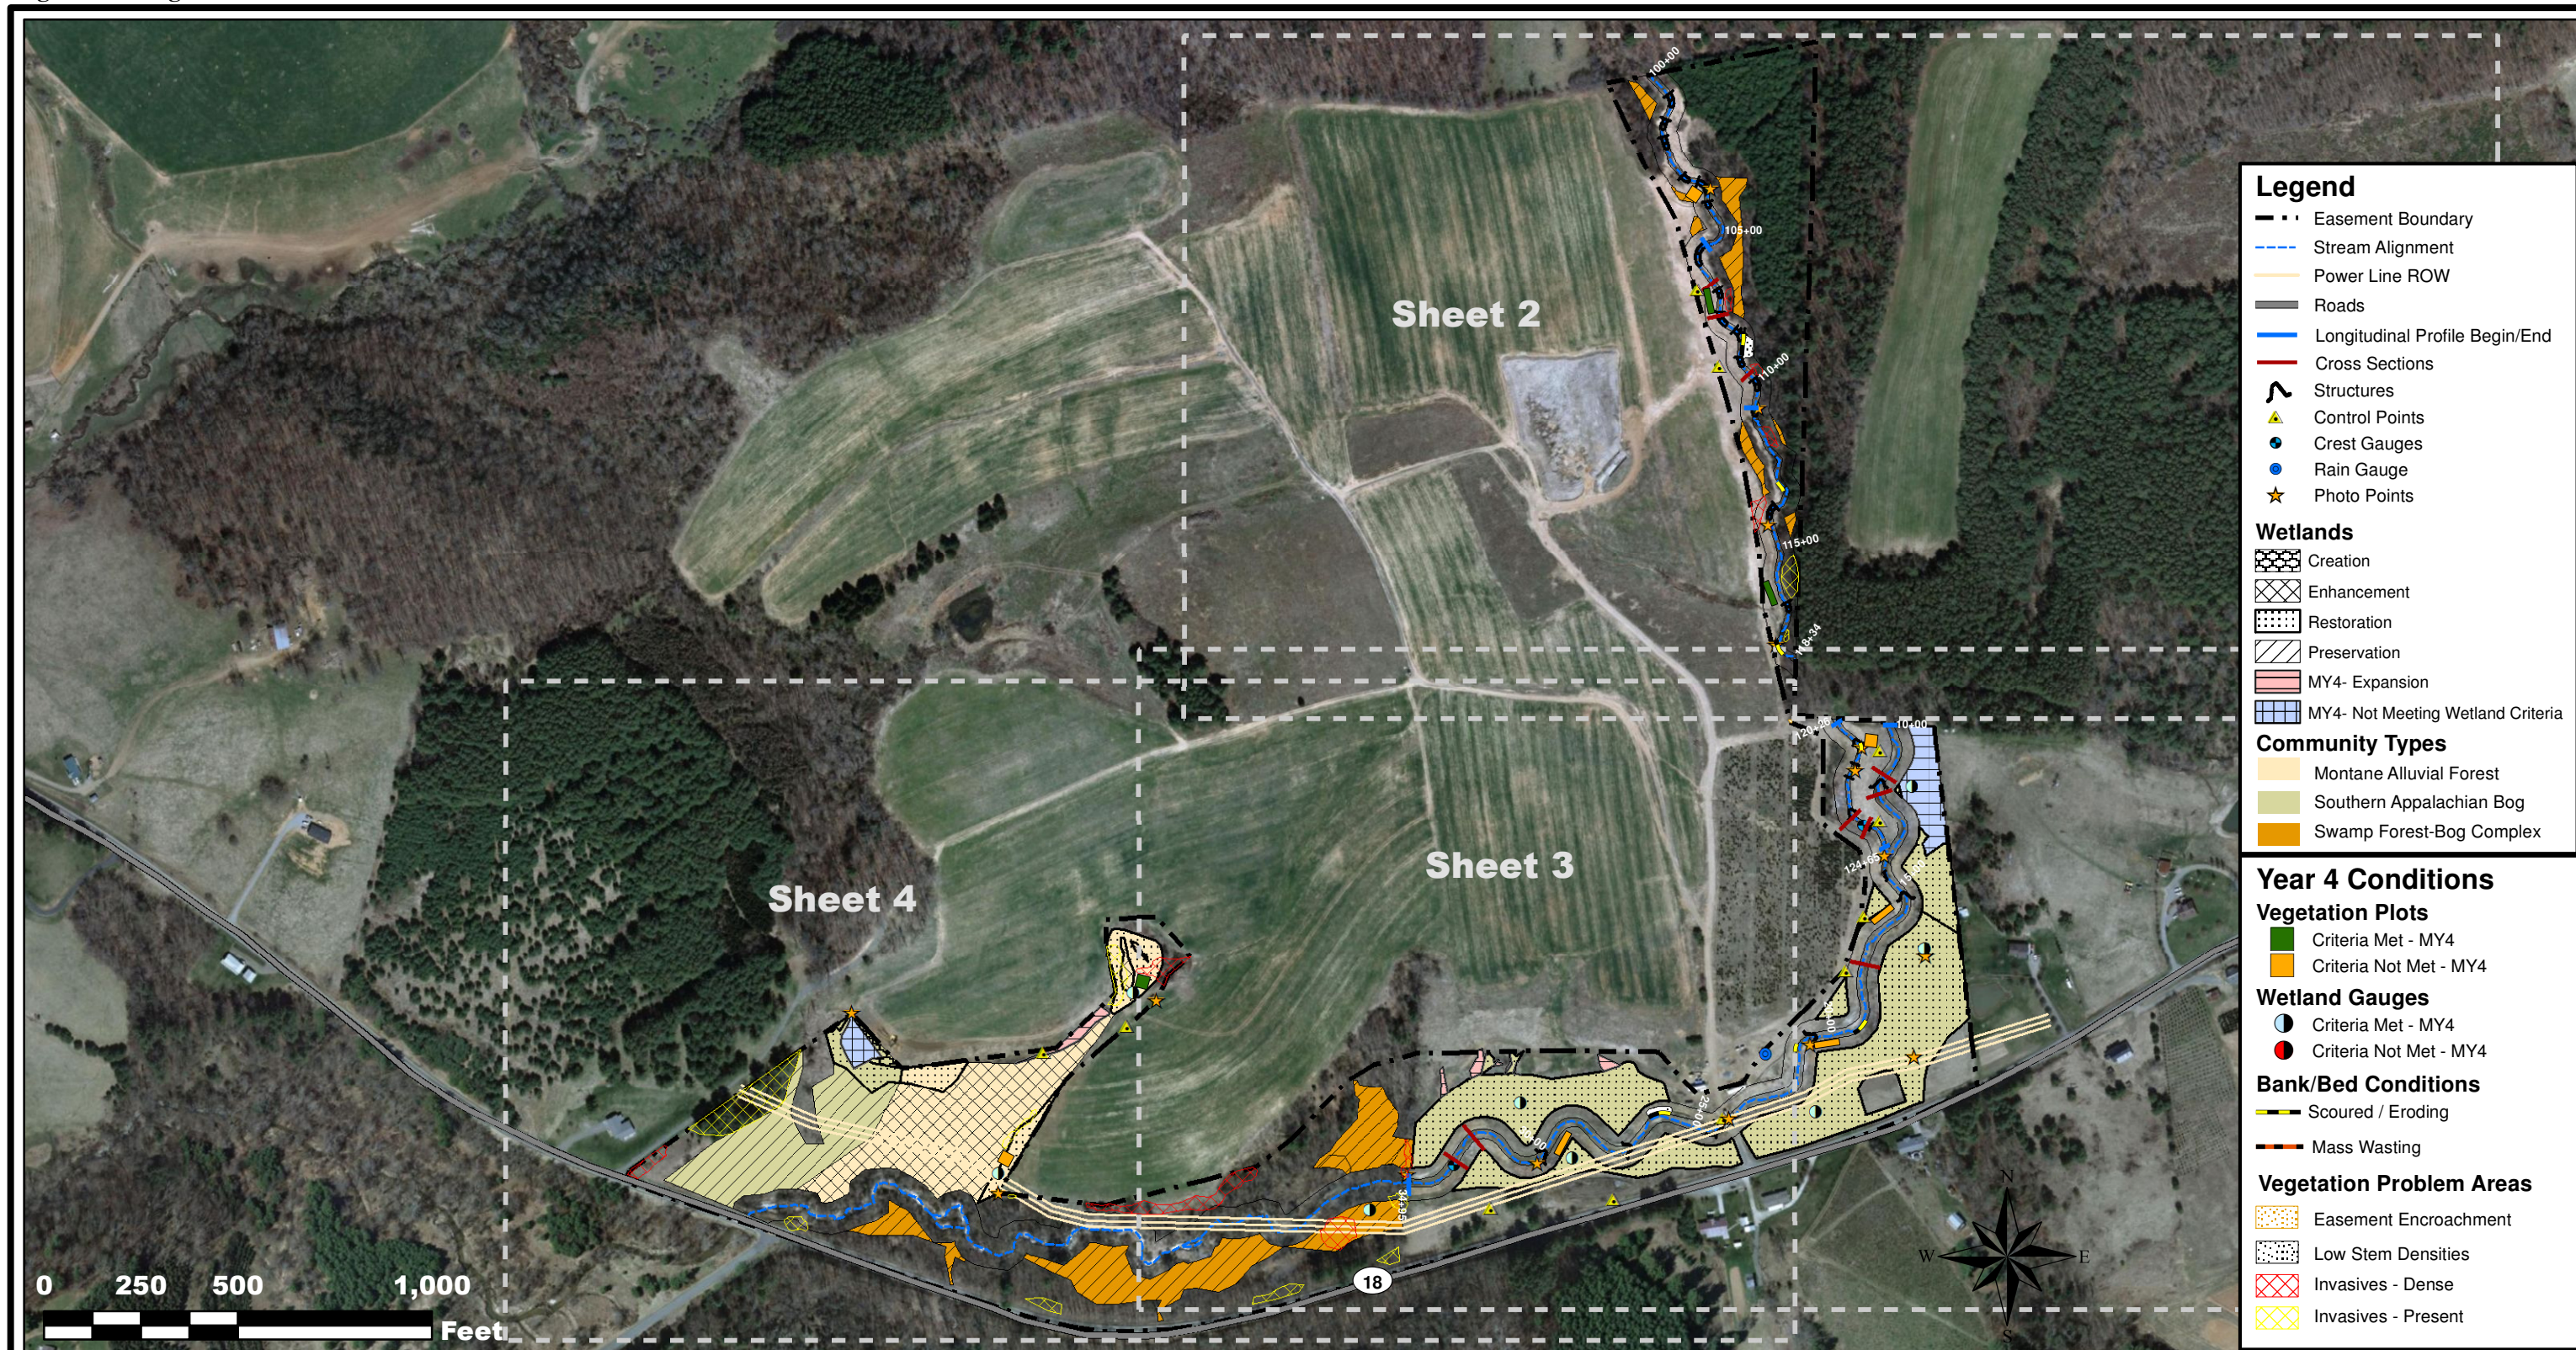
Sheet 1 of 4		
	Date	Project Number	
	November 2013	NCEP # 857

Figure 2. Integrated Current Condition Plan View - Draft

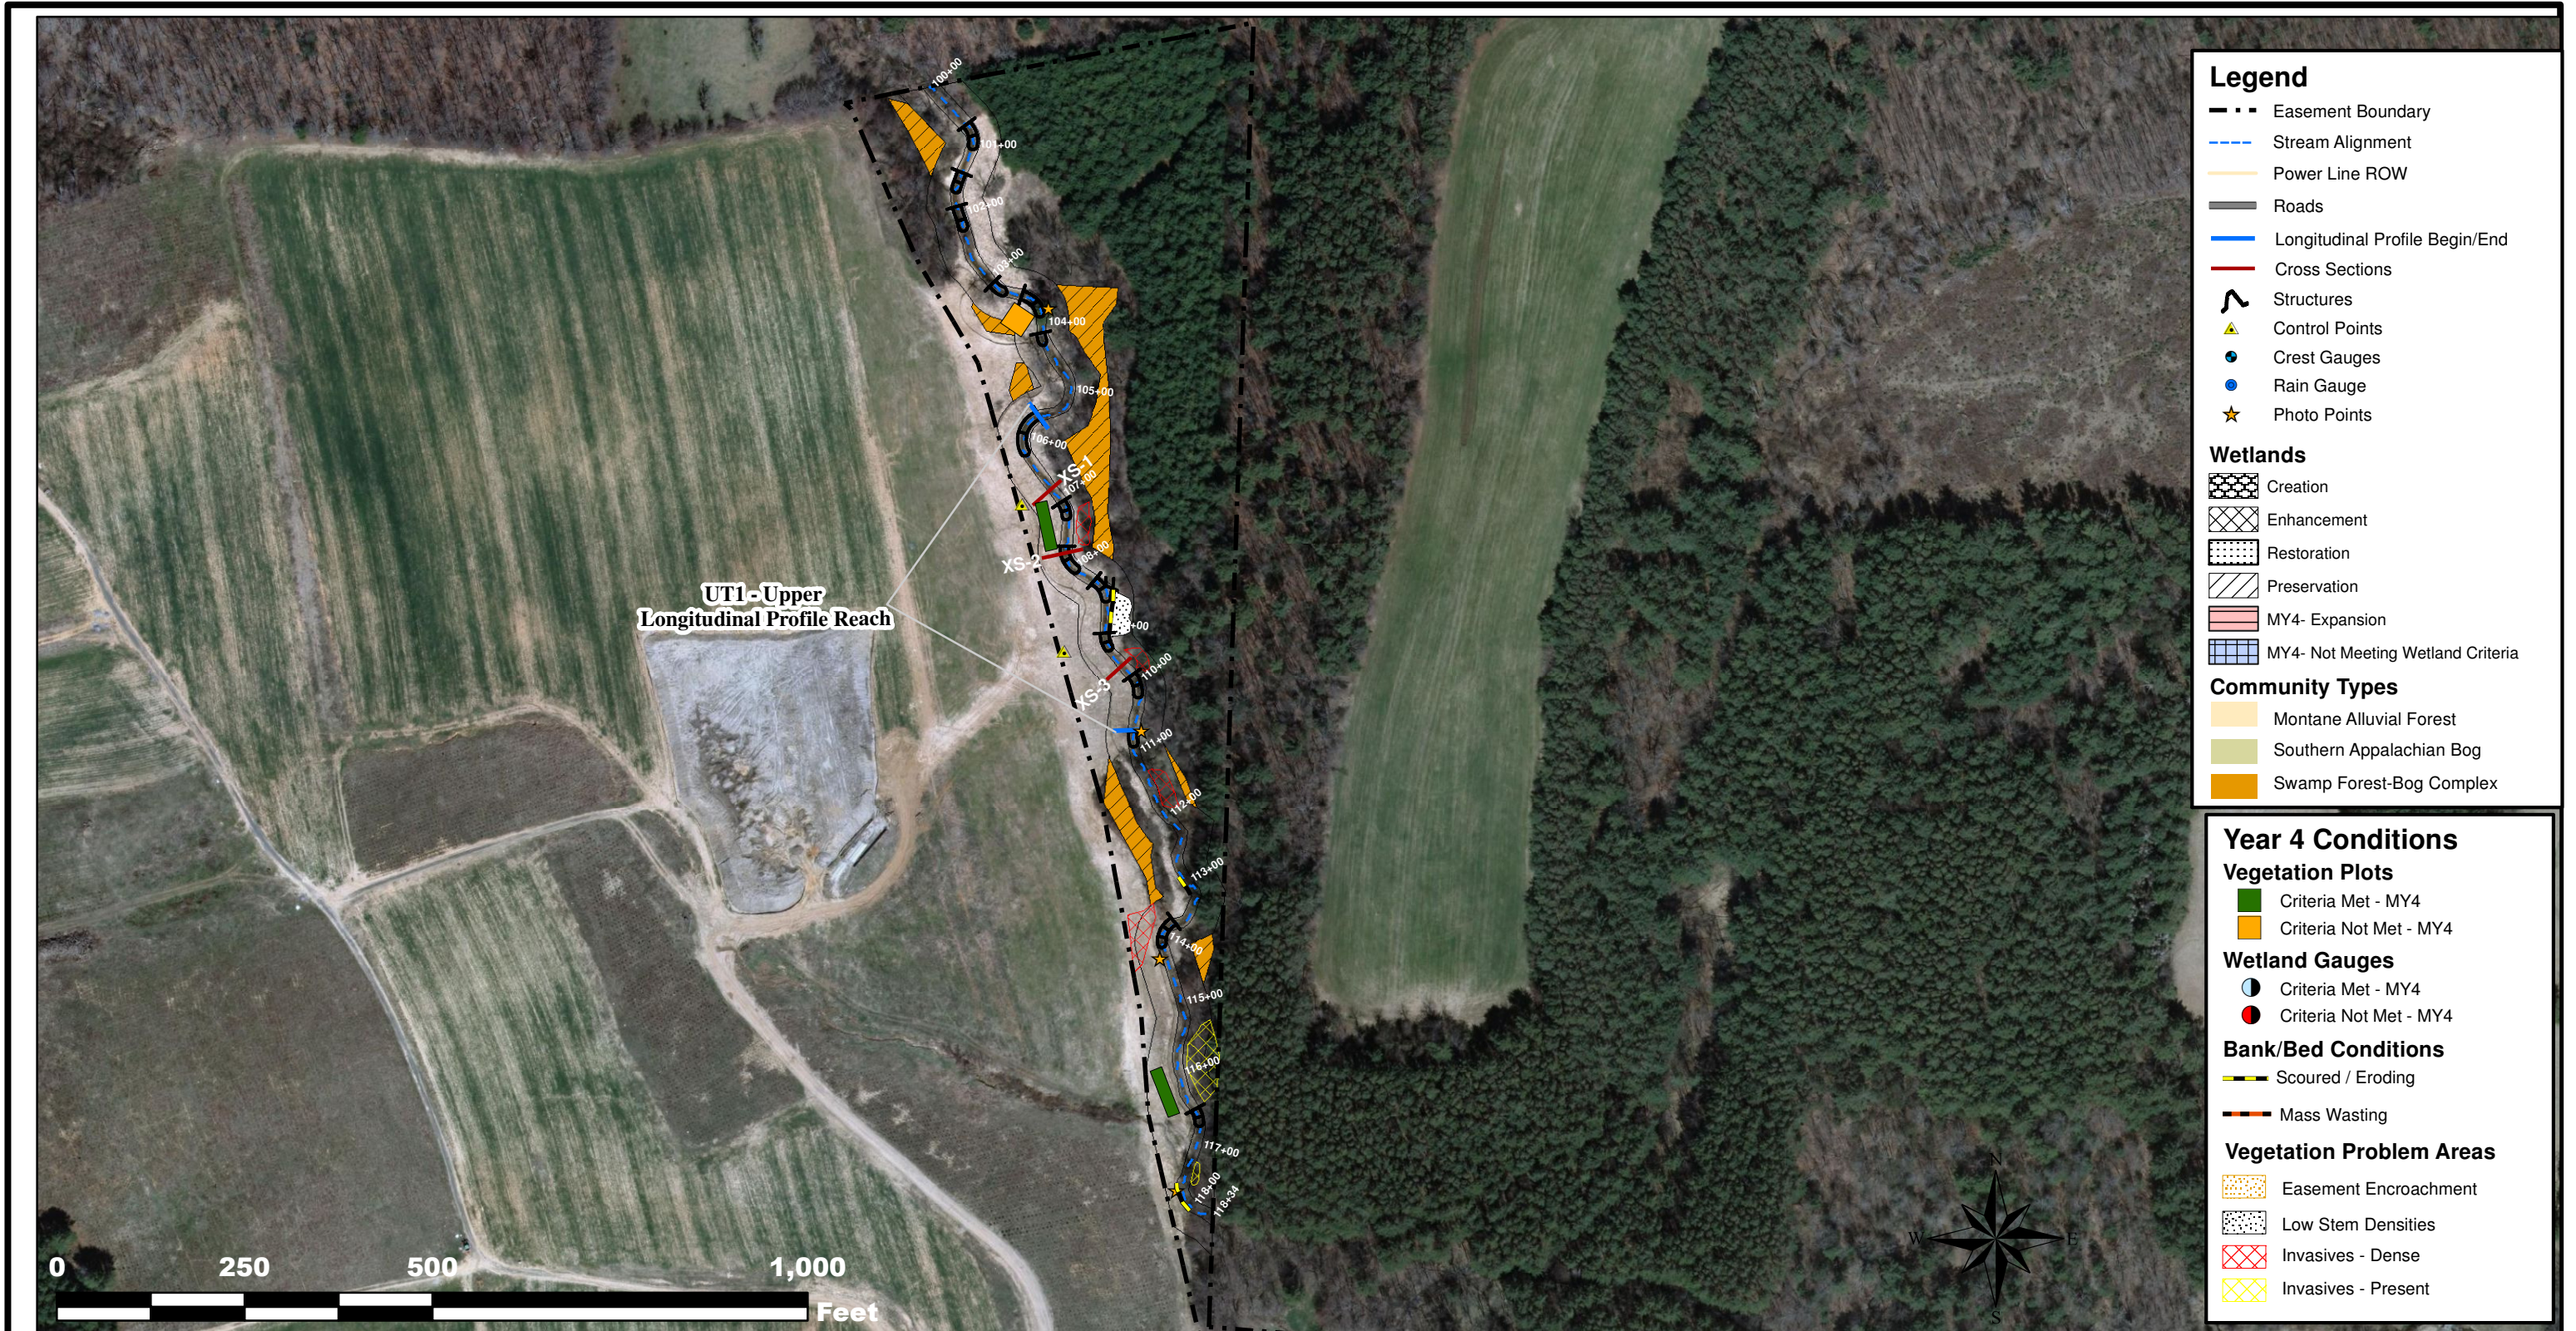
Figure 2. Integrated Current Condition Plan View - Draft

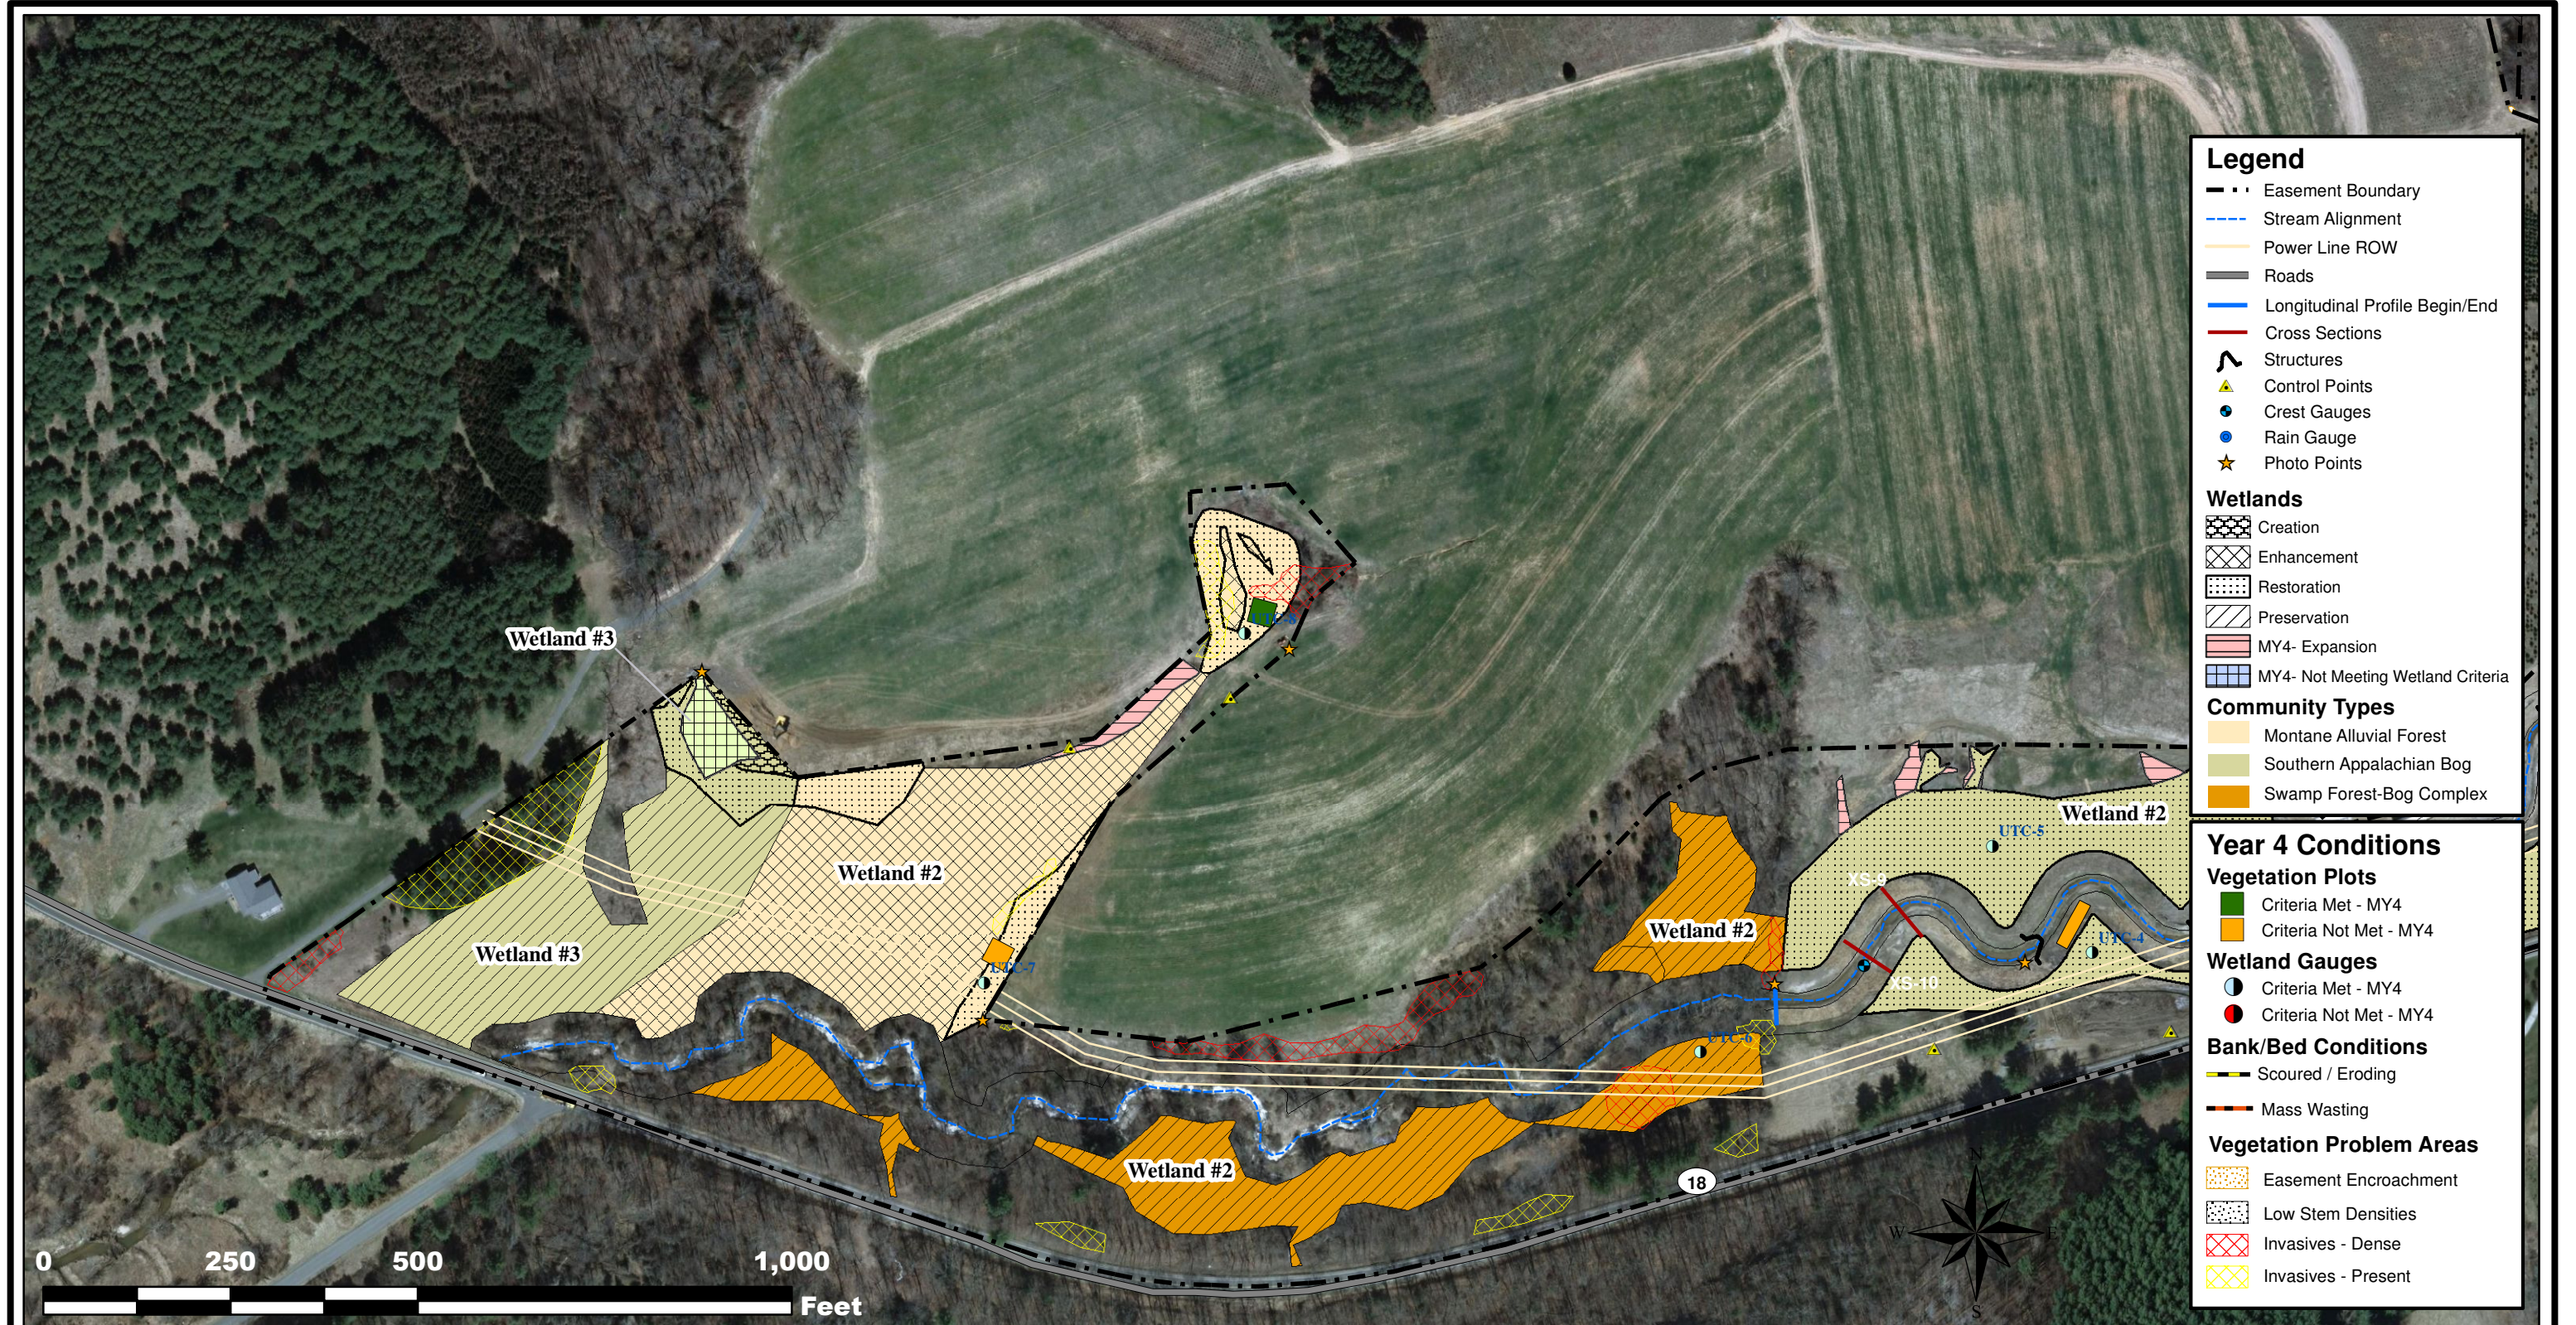
Figure 2. Integrated Current Condition Plan View - Draft

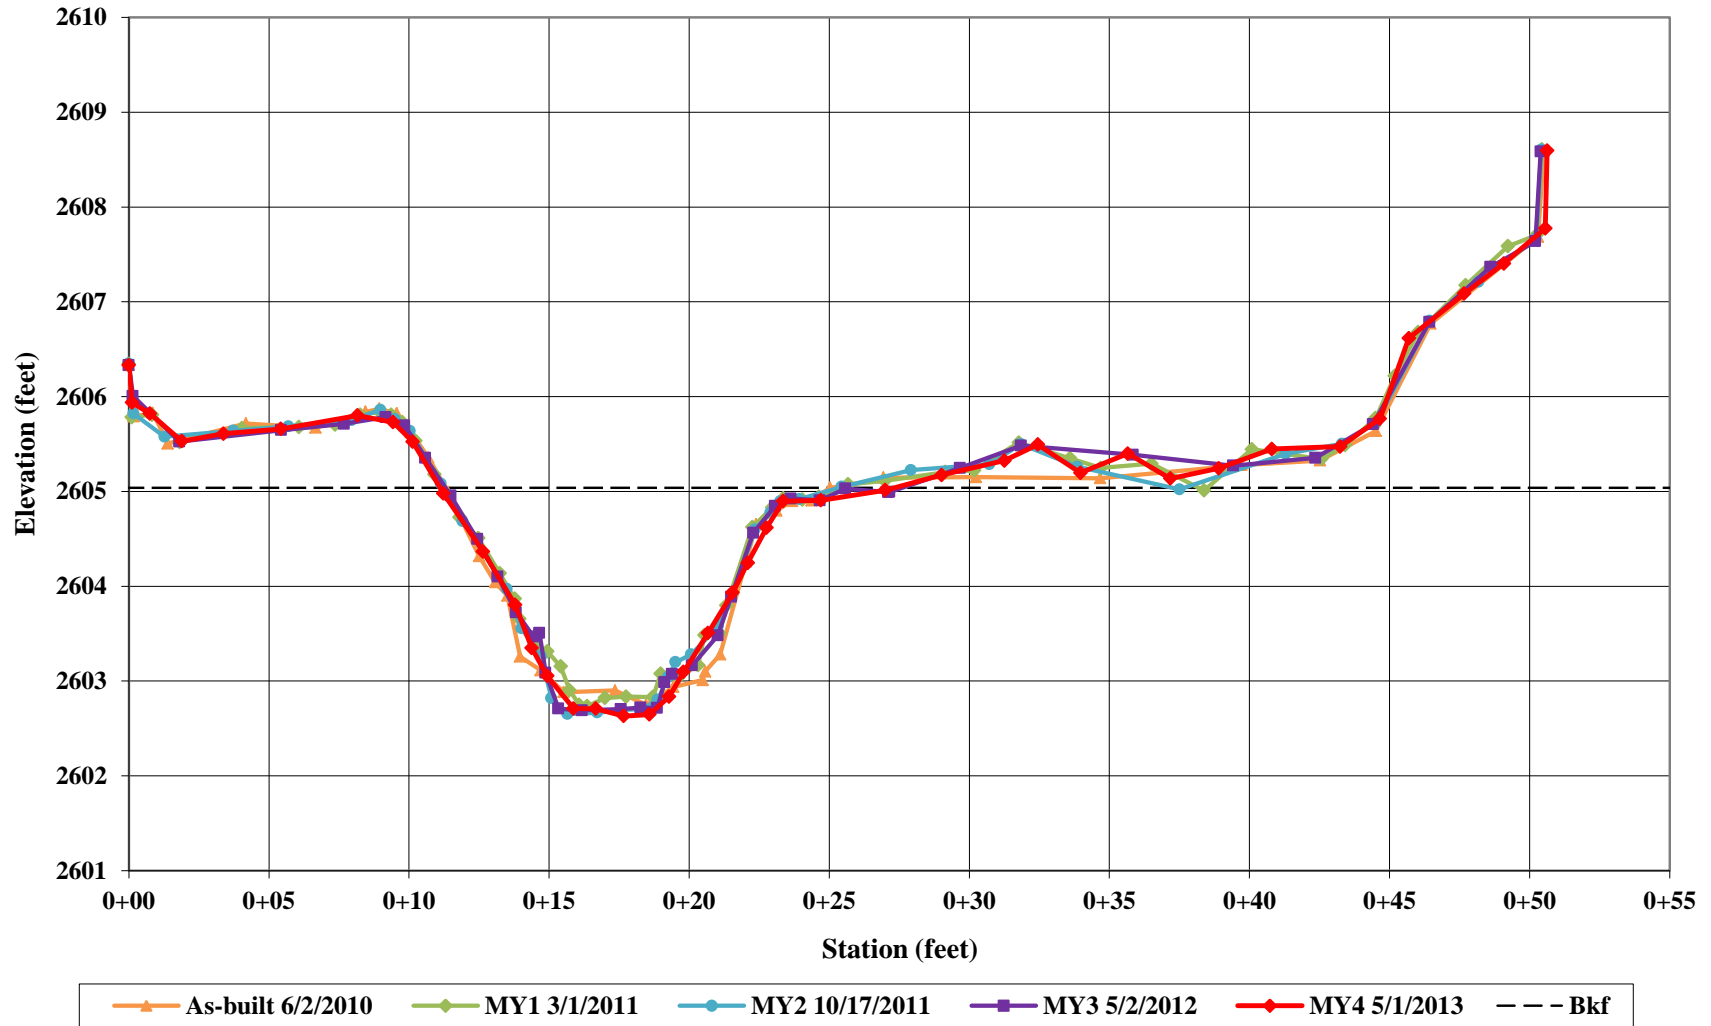
**Unnamed Tributary 1 - Upper
Cross-Section 1 - Riffle
Station 106 + 83.73**

All cross sections have remained stable through MY4. With the exception of cross-sections 3 and 4 on the lower reach of the Unnamed Tributary, all cross sections are well vegetated and

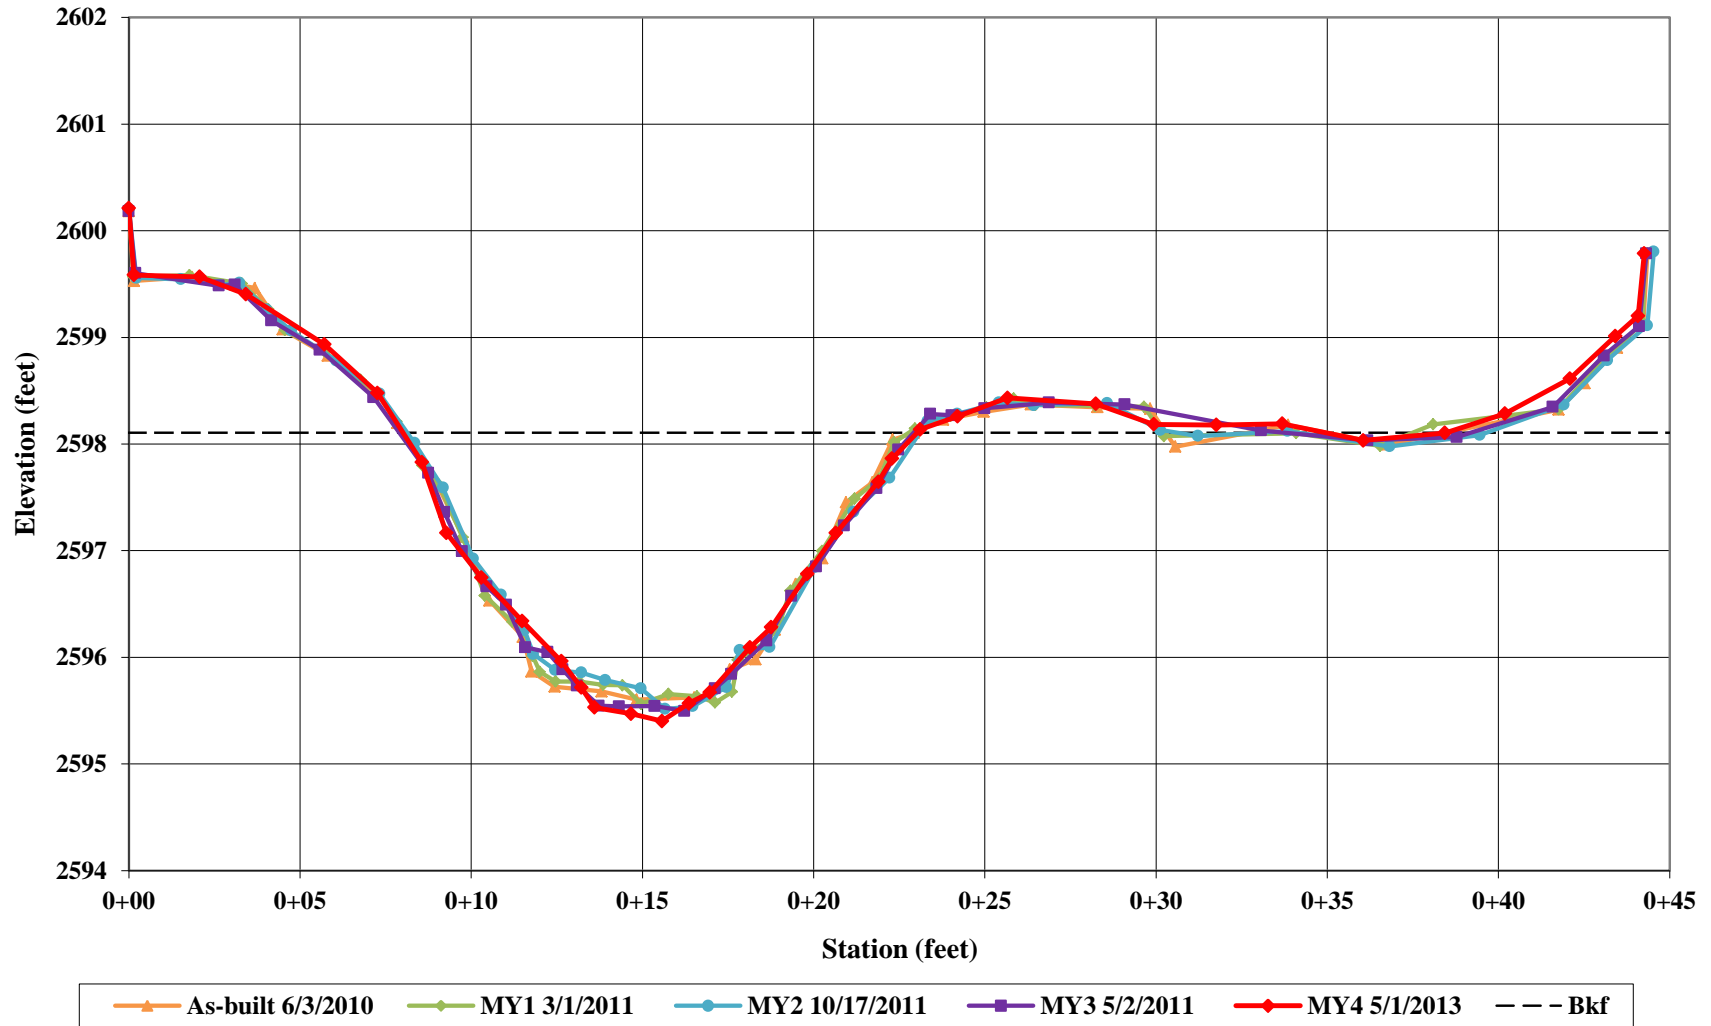
**Unnamed Tributary 1 - Upper
Cross-Section 3 - Riffle
Station 109 + 65.00**

show no signs of erosion or deterioration. Vegetation at cross sections 3 and 4 is limited due to the recent removal of beaver dams in the reach; however, shows no signs of channel instability.

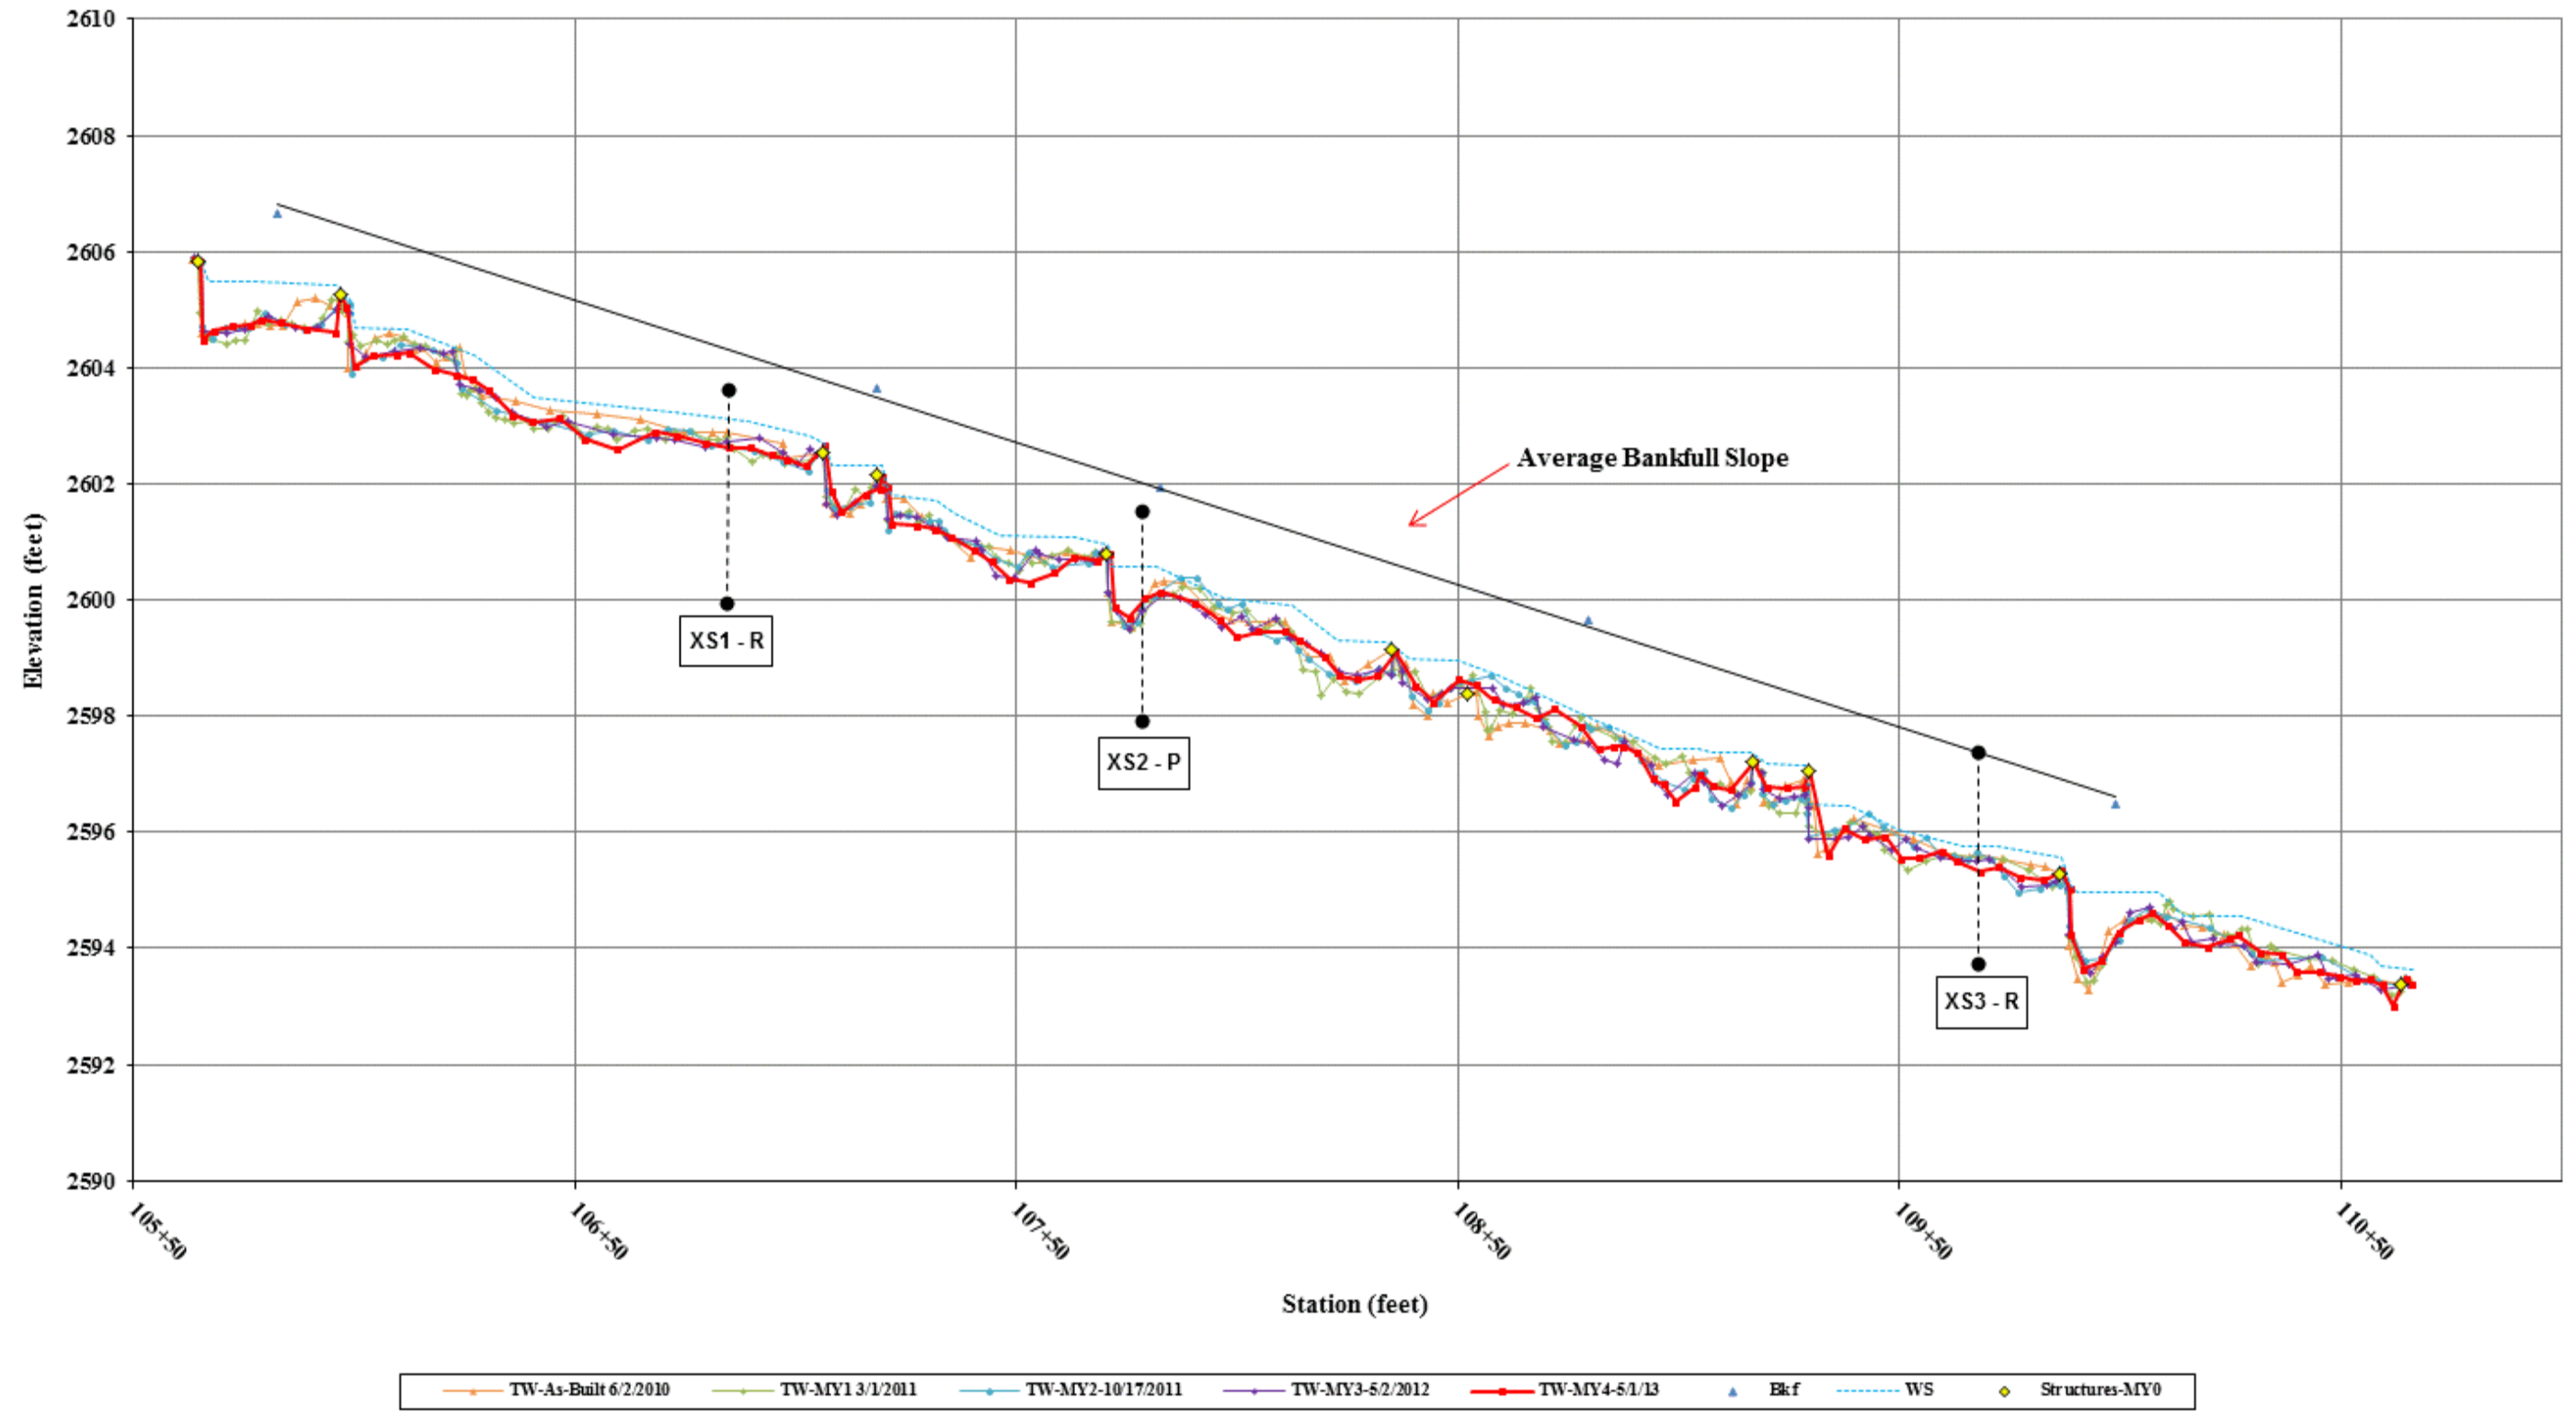
UT to Crab Creek - Upper
Longitudinal Profile
Stationing 105+63 - 110+63

Stream reach geomorphological data indicates the stream channels have remained very stable since construction. Stream longitudinal profiles also have remained stable between monitoring years. Stream channel problems observed during MY4 were minimal and consisted of six areas, totaling 240 feet, throughout all assessed reaches. Two bankfull events were documented on both UT1 and UTCC during MY4.

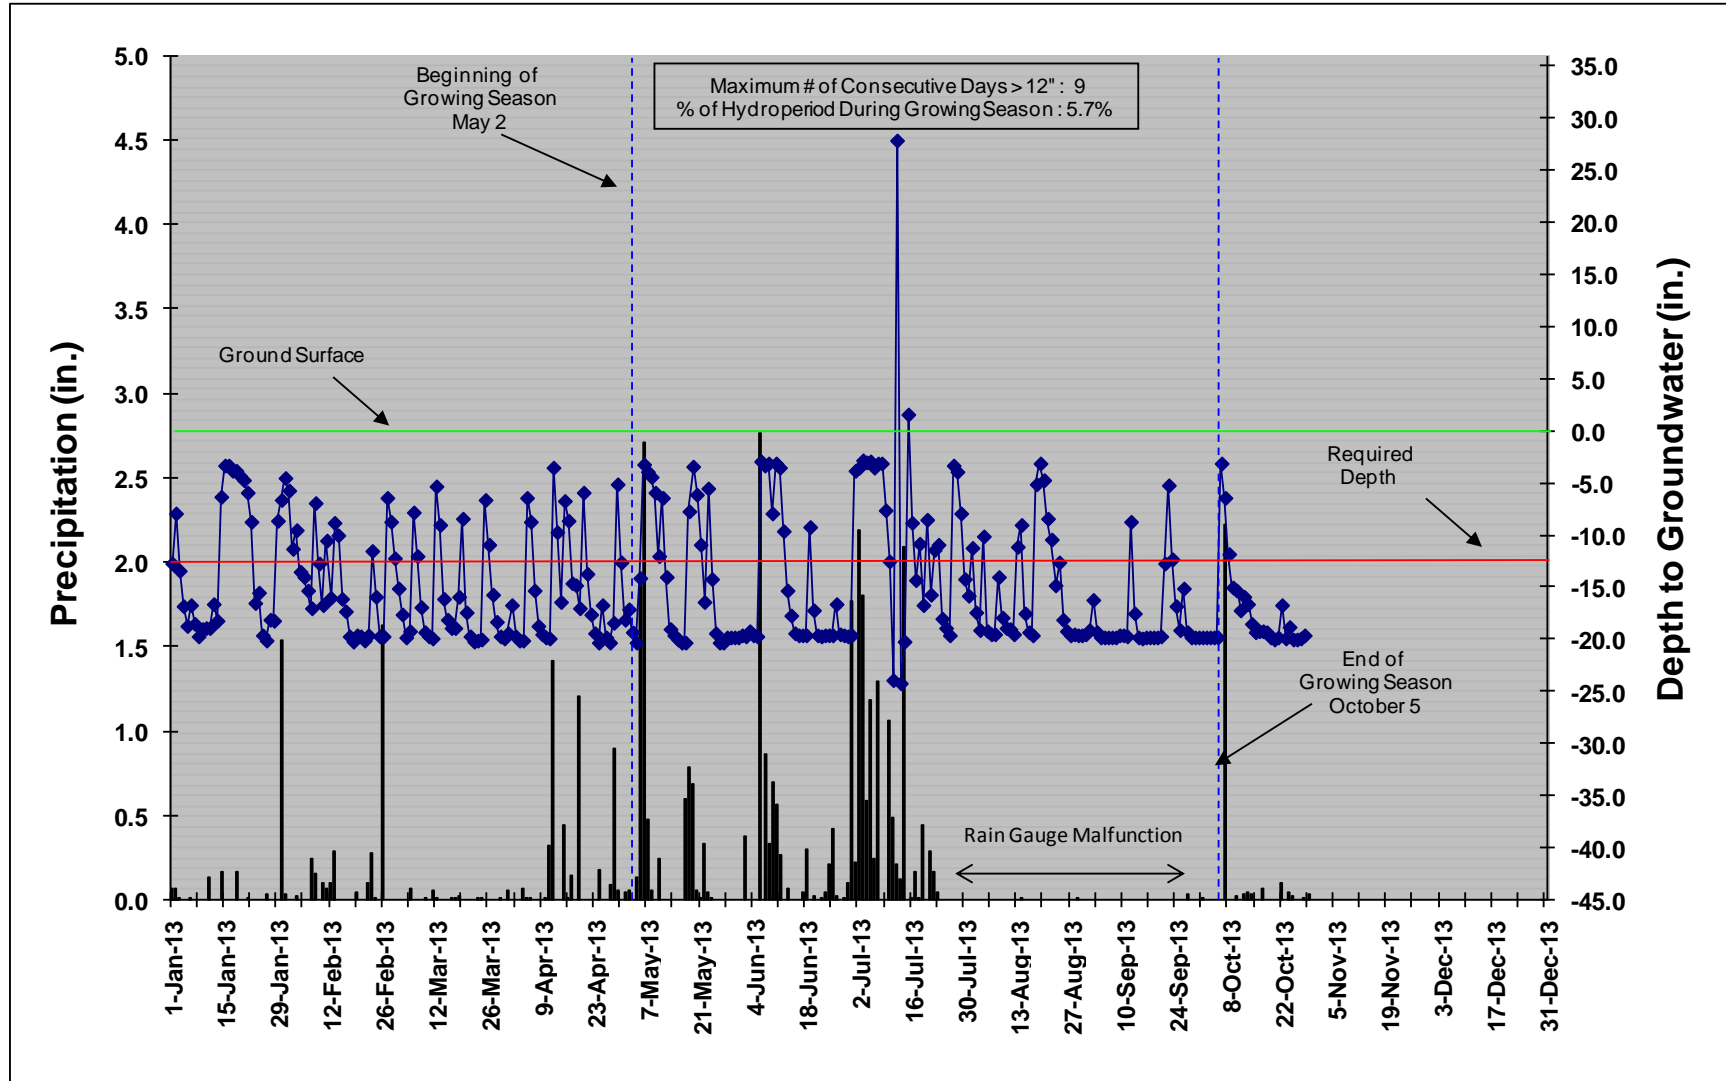
UTC-1 Precipitation and Water Level Plot

Data from the eight groundwater monitoring stations indicated that all stations met the soil saturation criterion of groundwater being within 12 inches of the soil surfaces for at least five percent of the Hydro period during the MY4 growing season. The on-site rain gauge documented above normal precipitation during May-July. During normal rainfall years all groundwater gauges are expected to meet the minimum criteria.

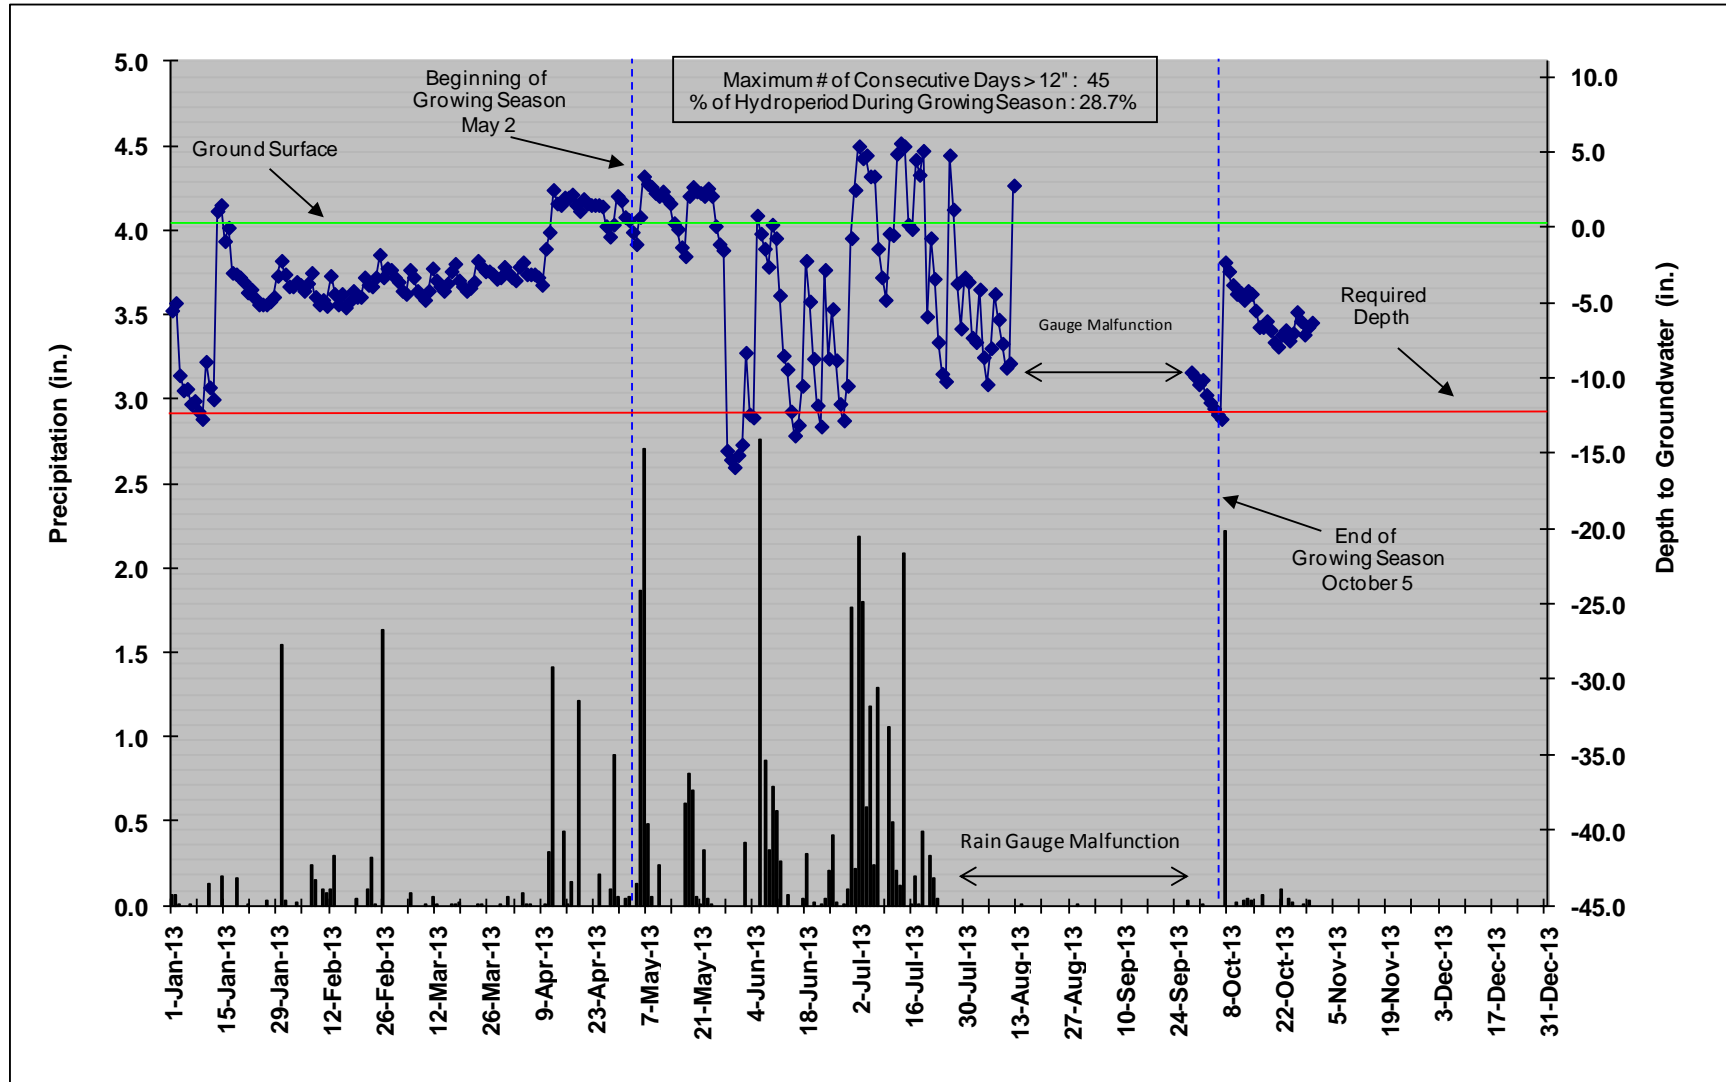
UTC-8 Precipitation and Water Level Plot

UTC-8	Yes/37 23.6 Percent	Yes/58 36.9 Percent	Yes/48 30.6 Percent	Yes/45 28.7 Percent
