# **Unnamed Tributary to Crab Creek Stream and Wetland Restoration**

**NCEEP Project Number: 857**

**Monitoring Year 5**

**2014 Report**

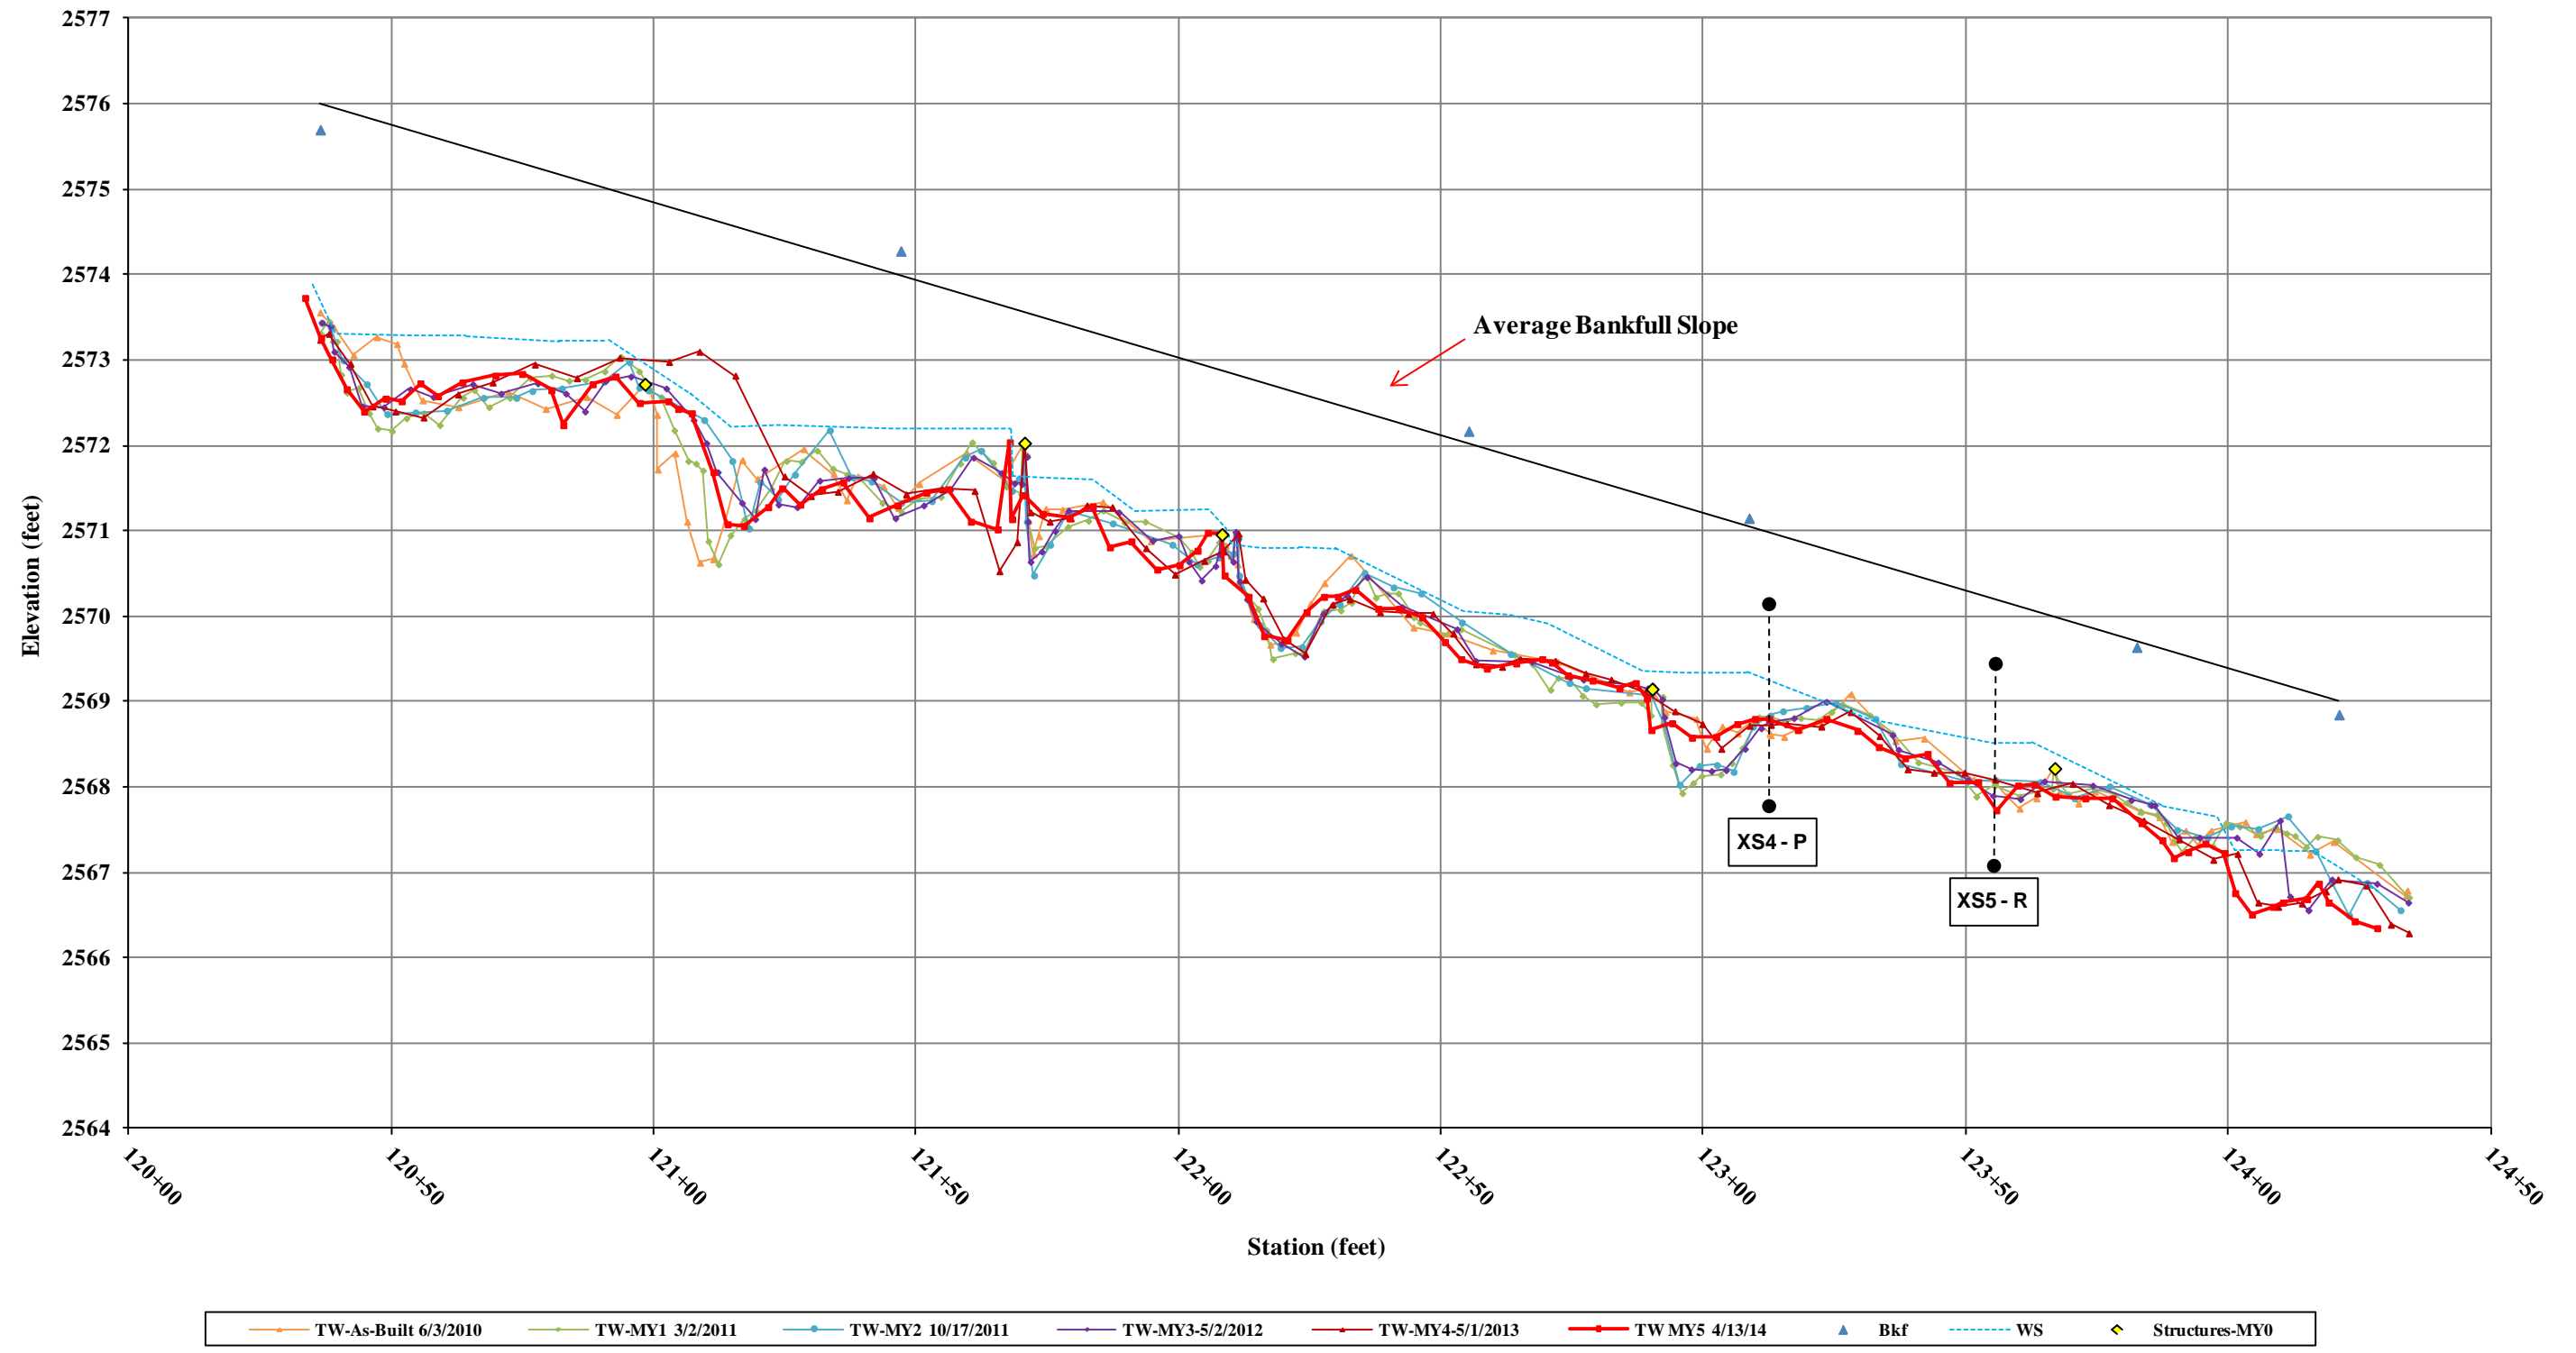
**UT to Crab Creek- Lower  
Longitudinal Profile  
Stationing 120+36 - 124+33**

All cross sections have remained stable through MY5. All cross sections show no signs of erosion or deterioration. Stream reach geomorphological data indicates the stream channels have remained very stable since construction. Stream channel problems observed during MY5 were minimal and consisted of seven small problems areas, 2 areas of aggradation and 5 areas of degradation, throughout all assessed reaches. Particle-size distributions remain stable, with no significant trends towards coarser or finer materials. This indicates that the channel is transporting sediment as designed.

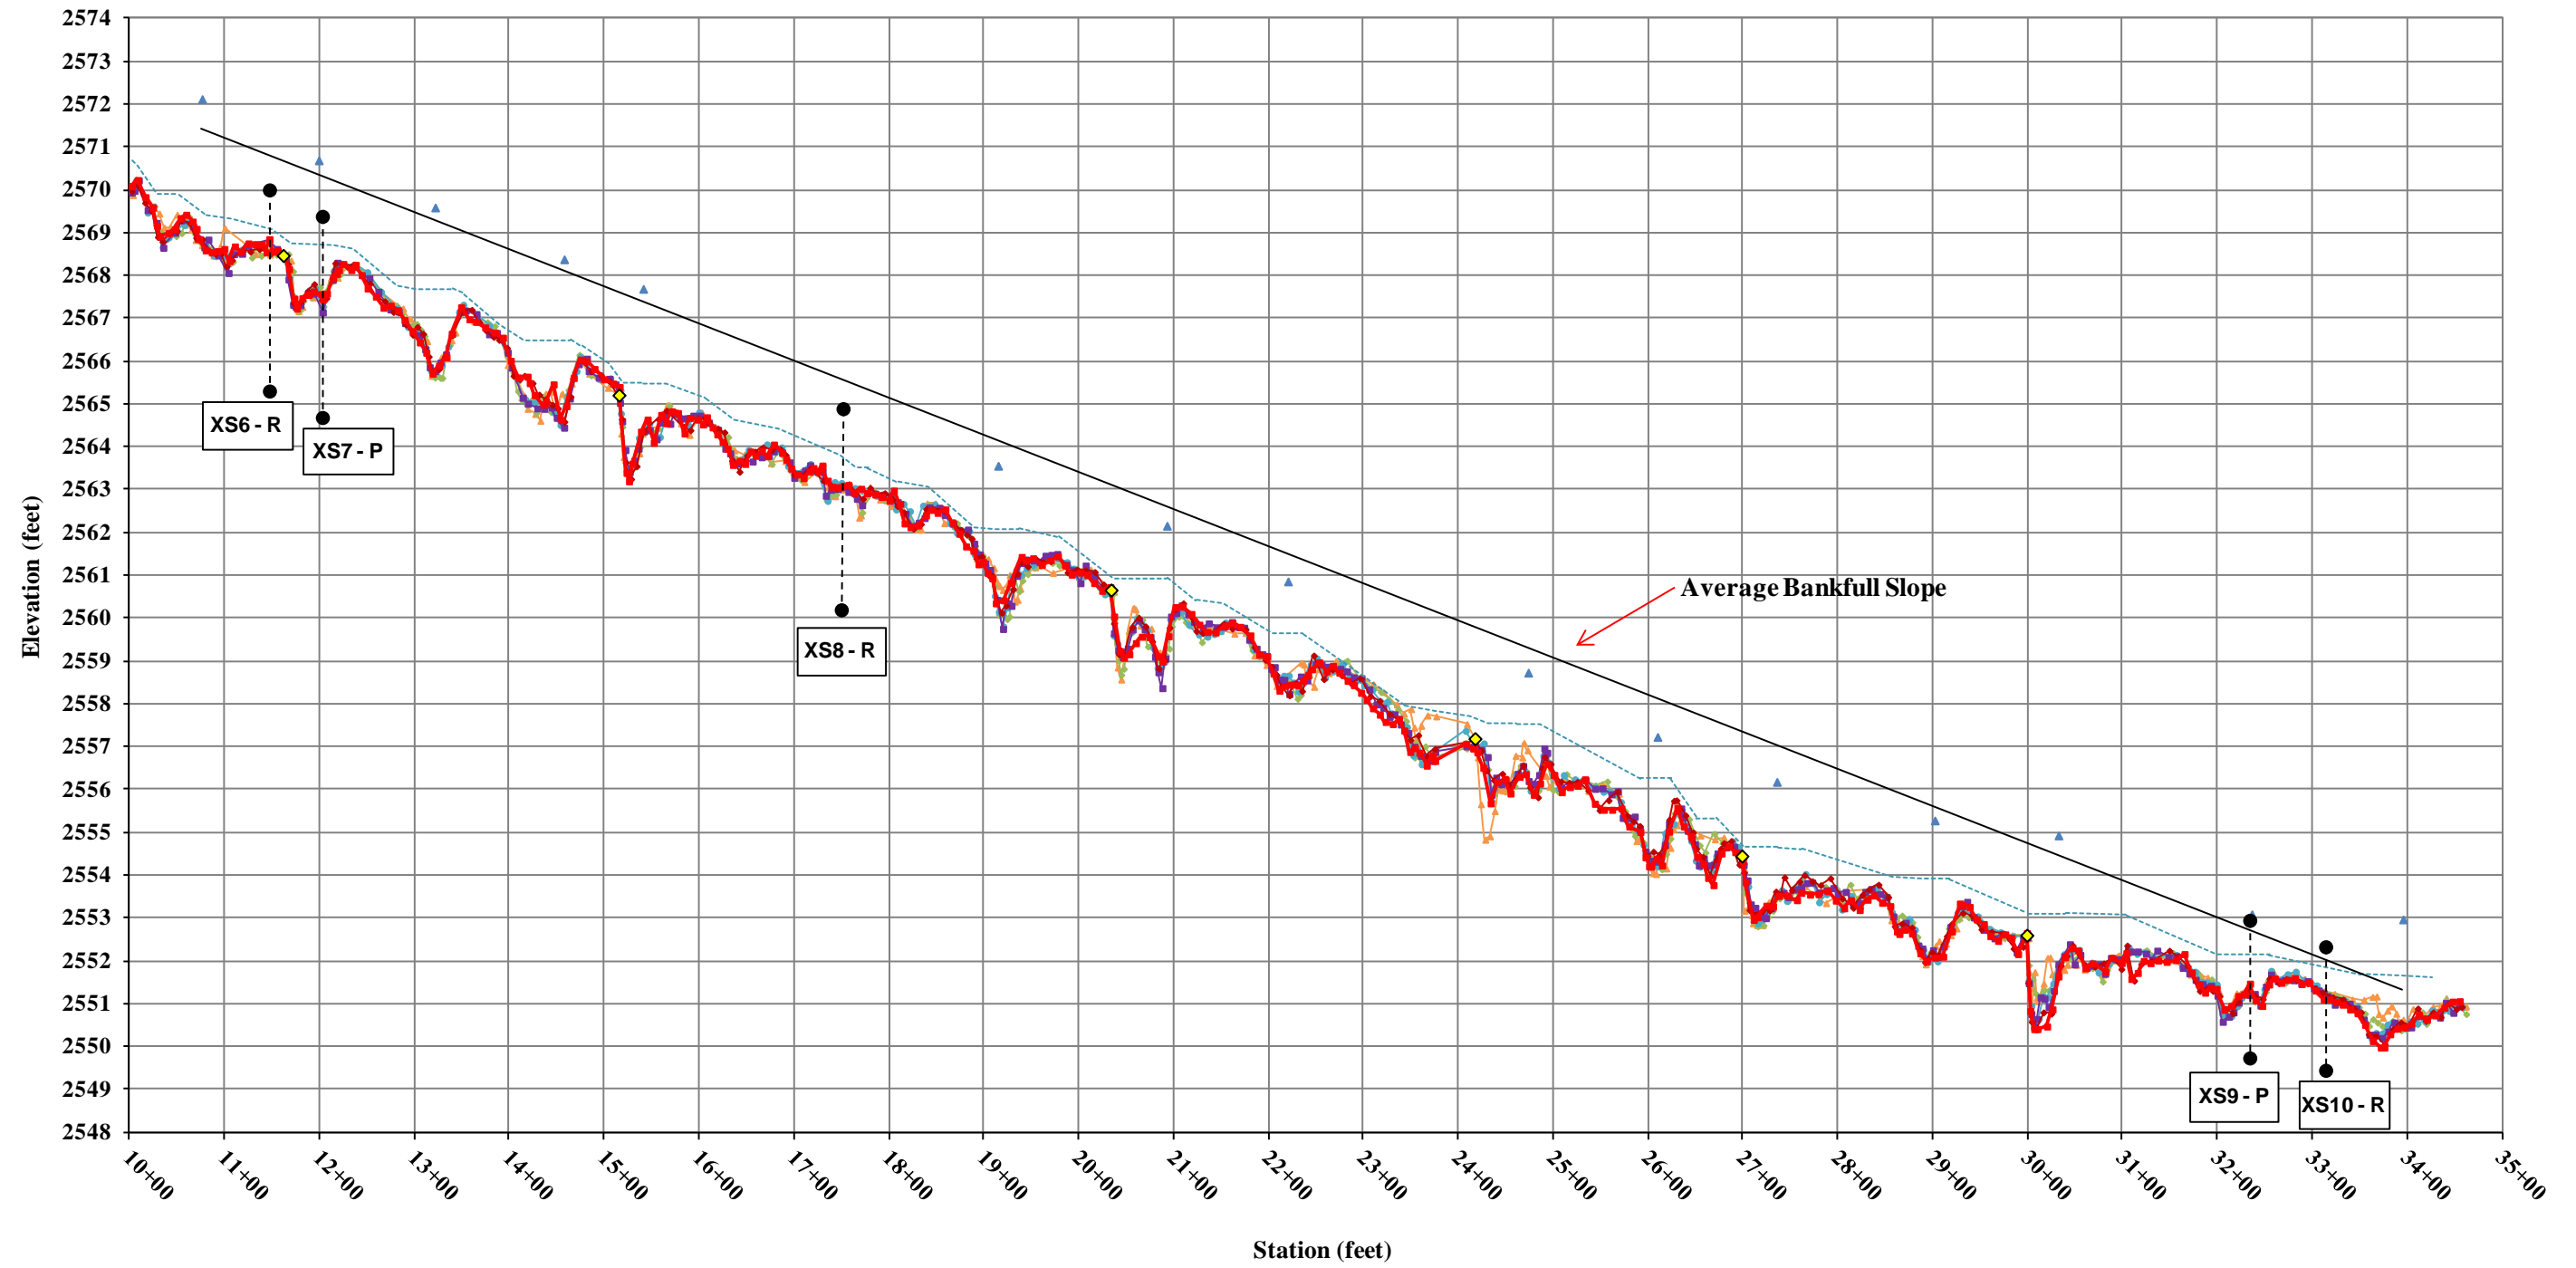
**UT to Crab Creek- Upstream  
Longitudinal Profile  
Stationing 10+02 - 34+57**

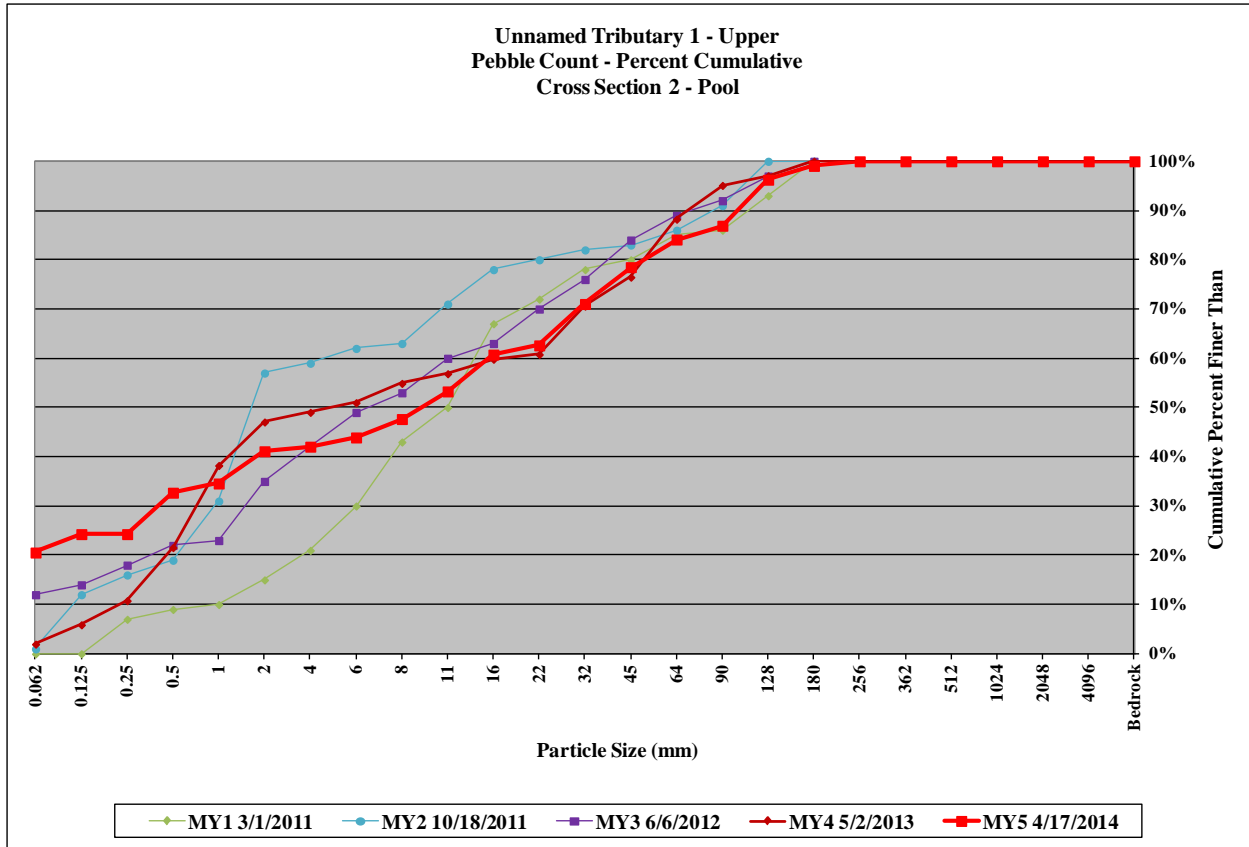
<b>UT Crab Creek Stream &amp; Wetland / Project No. 857</b>					
<b>UT1 - Upper - Cross-Section 2 - Pool</b>					
<b>Pebble Count Summary</b>					
			Monitoring Year 5		
<b>Description</b>	<b>Material</b>	<b>Size (mm)</b>	<b>Total #</b>	<b>Item %</b>	<b>Cum %</b>
<b>Silt/Clay</b>	silt/clay	0.062	22	21%	21%
<b>Sand</b>	very fine sand	0.125	4	4%	24%
	fine sand	0.25	0	0%	24%
	medium sand	0.50	9	8%	33%
	coarse sand	1.00	2	2%	35%
	very coarse sand	2.00	7	7%	41%
<b>Gravel</b>	very fine gravel	4.0	1	1%	42%
	fine gravel	5.7	2	2%	44%
	fine gravel	8.0	4	4%	48%
	medium gravel	11.3	6	6%	53%
	medium gravel	16.0	8	7%	61%
	coarse gravel	22.3	2	2%	63%
	coarse gravel	32	9	8%	71%
	very coarse gravel	45	8	7%	79%
<b>Cobble</b>	very coarse gravel	64	6	6%	84%
	small cobble	90	3	3%	87%
	medium cobble	128	10	9%	96%
	large cobble	180	3	3%	99%
<b>Boulder</b>	very large cobble	256	1	1%	100%
	small boulder	362	0	0%	100%
	small boulder	512	0	0%	100%

<b>Summary Data</b>	
D50	9.1
D84	64
D95	120

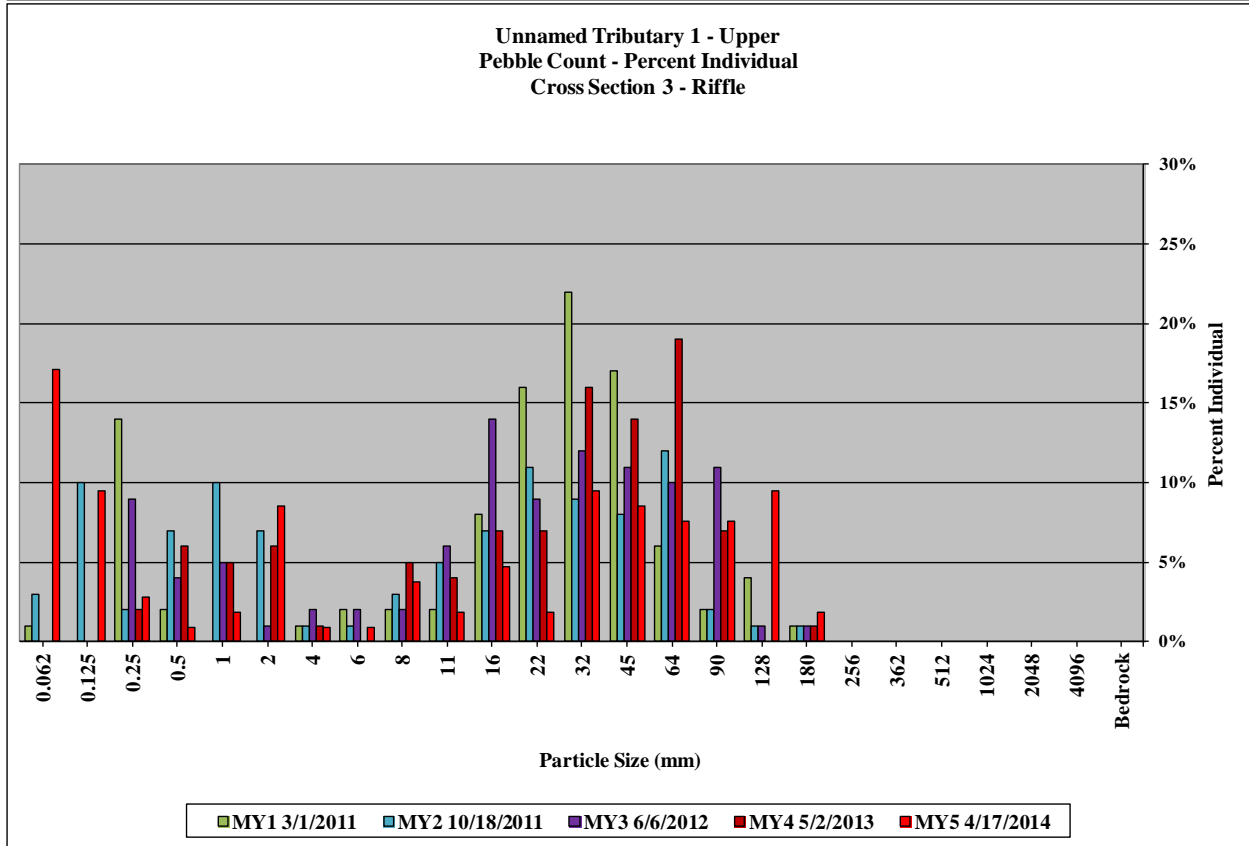
<b>UT Crab Creek Stream &amp; Wetland / Project No. 857</b>					
<b>UT1 - Upper - Cross-Section 3 - Riffle</b>					
<b>Pebble Count Summary</b>					
			Monitoring Year 5		
<b>Description</b>	<b>Material</b>	<b>Size (mm)</b>	<b>Total #</b>	<b>Item %</b>	<b>Cum %</b>
<b>Silt/Clay</b>	silt/clay	0.062	18	17%	17%
<b>Sand</b>	very fine sand	0.125	10	10%	27%
	fine sand	0.25	3	3%	30%
	medium sand	0.50	1	1%	30%
	coarse sand	1.00	2	2%	32%
	very coarse sand	2.00	9	9%	41%
<b>Gravel</b>	very fine gravel	4.0	1	1%	42%
	fine gravel	5.7	1	1%	43%
	fine gravel	8.0	4	4%	47%
	medium gravel	11.3	2	2%	49%
	medium gravel	16.0	5	5%	53%
	coarse gravel	22.3	2	2%	55%
	coarse gravel	32	10	10%	65%
	very coarse gravel	45	9	9%	73%
<b>Cobble</b>	very coarse gravel	64	8	8%	81%
	small cobble	90	8	8%	89%
	medium cobble	128	10	10%	98%
	large cobble	180	2	2%	100%
<b>Boulder</b>	very large cobble	256	0	0%	100%
	small boulder	362	0	0%	100%
	small boulder	512	0	0%	100%

<b>Summary Data</b>	
D50	12
D84	73
D95	110

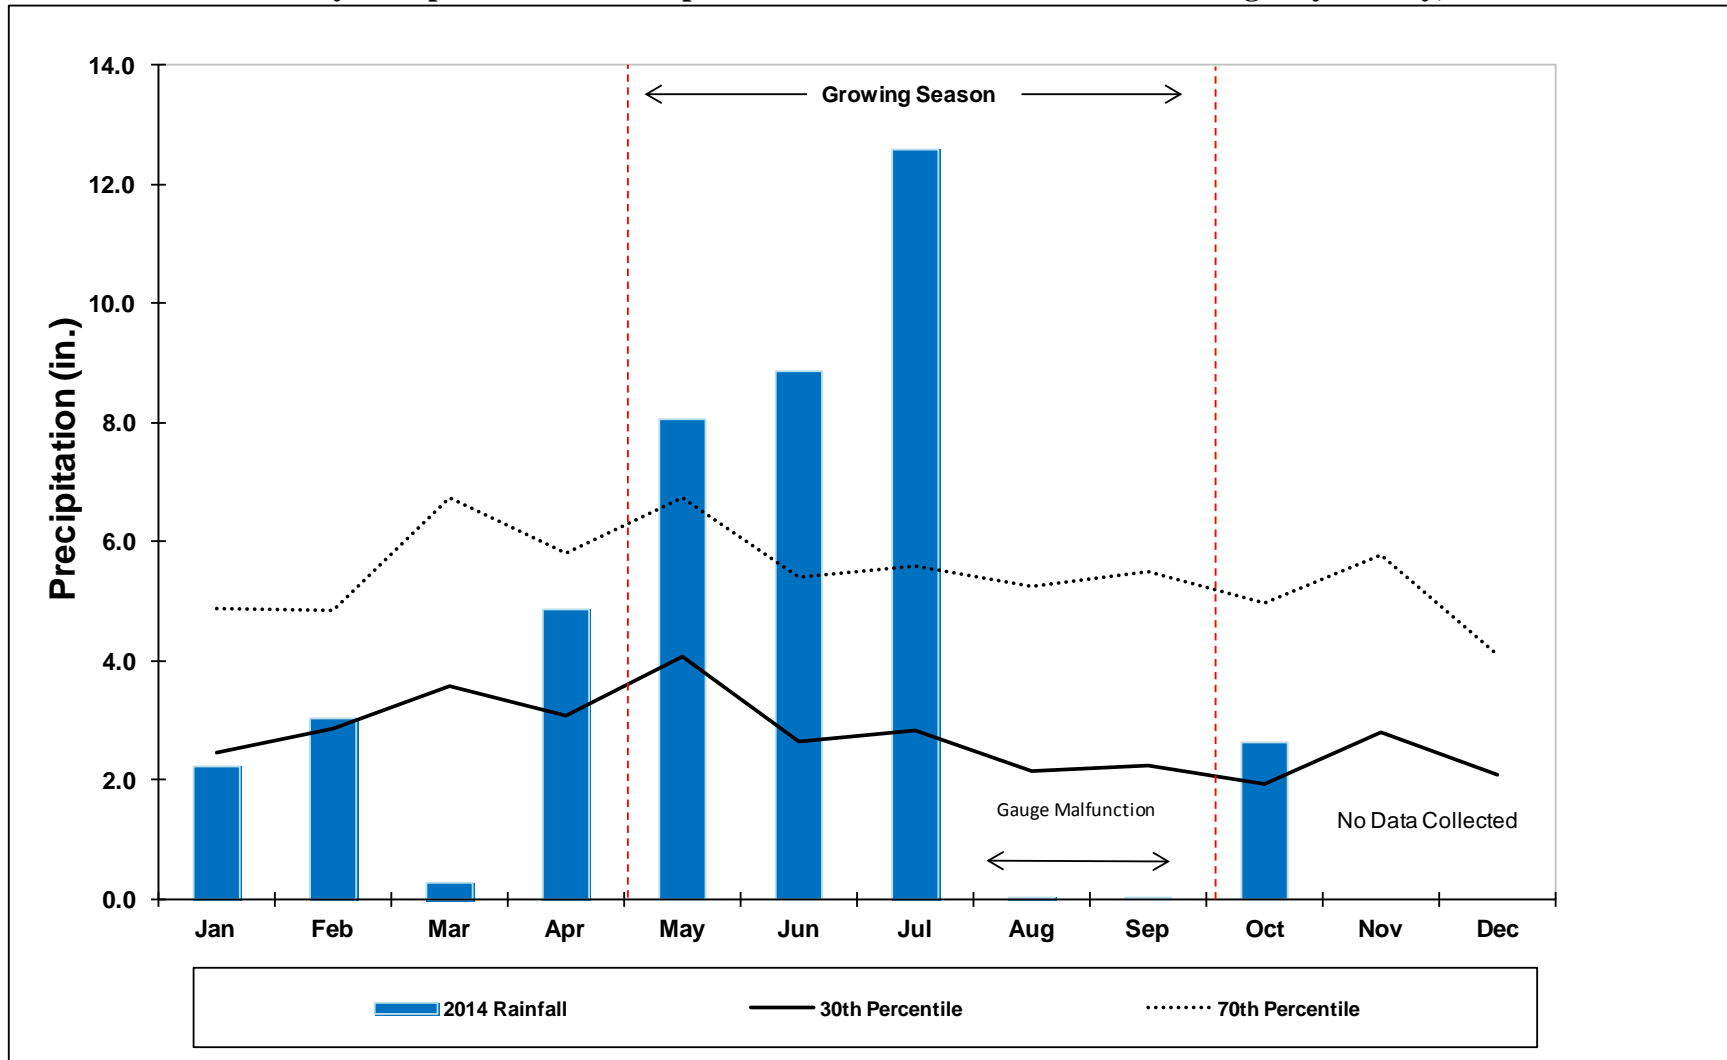
Monthly Precipitation Data Compared to 30<sup>th</sup> and 70<sup>th</sup> Percentiles for Allegheny County, NC
