## *EXECUTIVE SUMMARY OF RESTORATION PLAN*

### **UNNAMED TRIBUTARY TO CROOKED CREEK**

Franklin County, North Carolina

Project ID No. 040614801

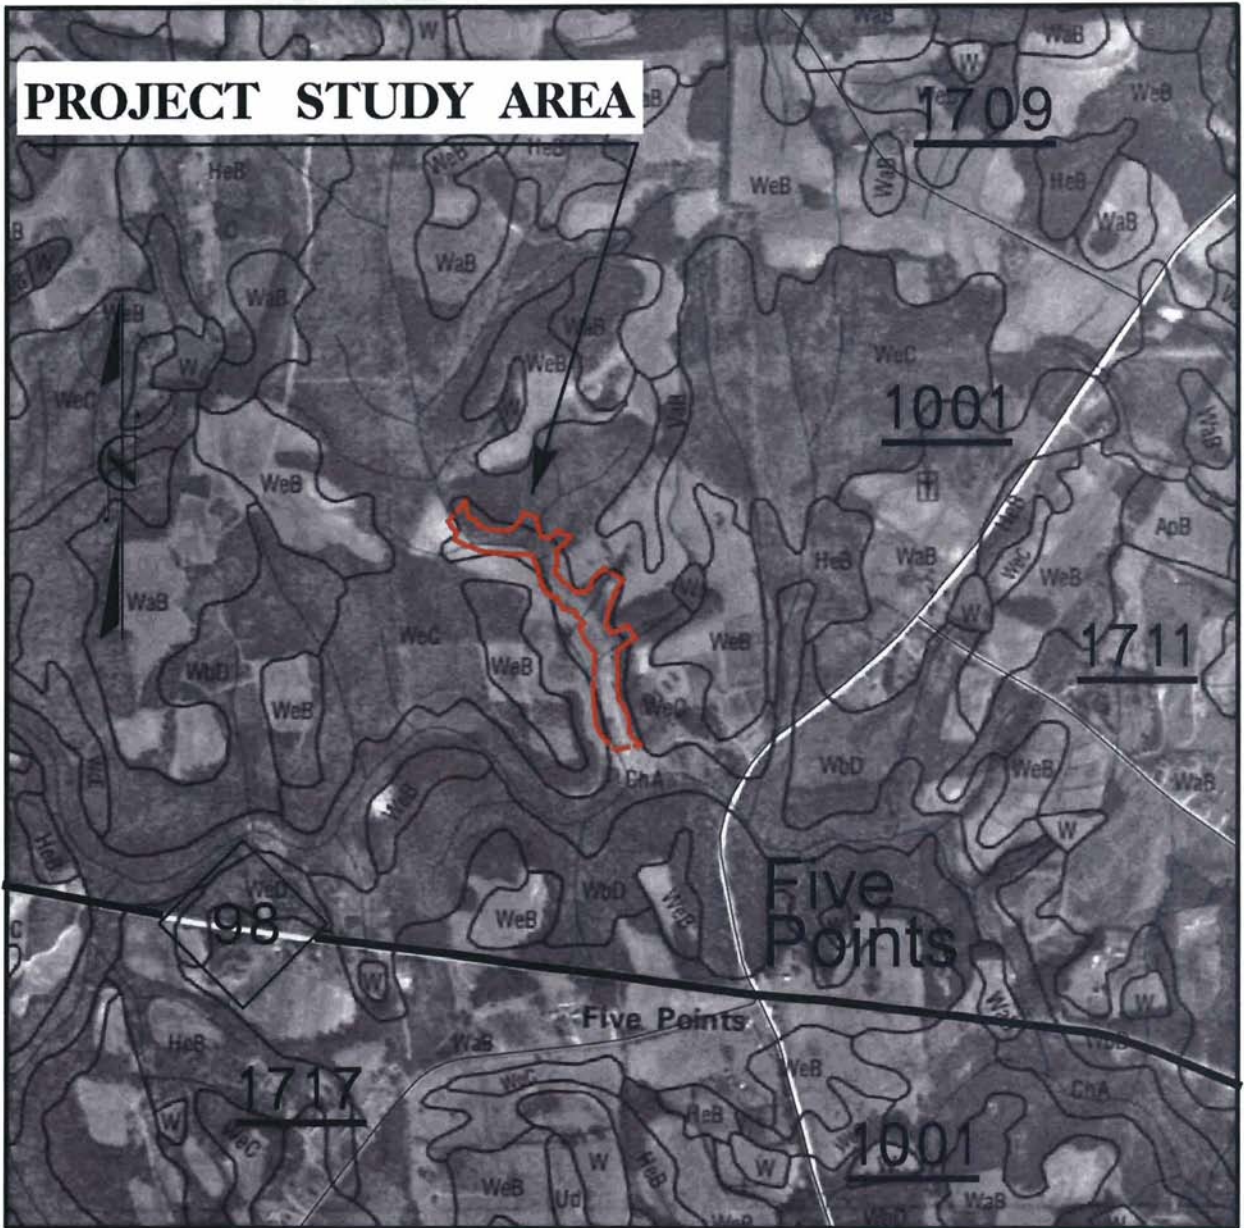
Figure: 1.0.3

<b>LEGEND</b>	
<u>Symbol</u>	<u>Name</u>
ChA	Chewacla and Wehadkee soil (0 to 3 percent slopes, frequently flooded)
WeC	Wedowee sandy loam (6 to 10 percent slopes)

**Soil Survey Map**

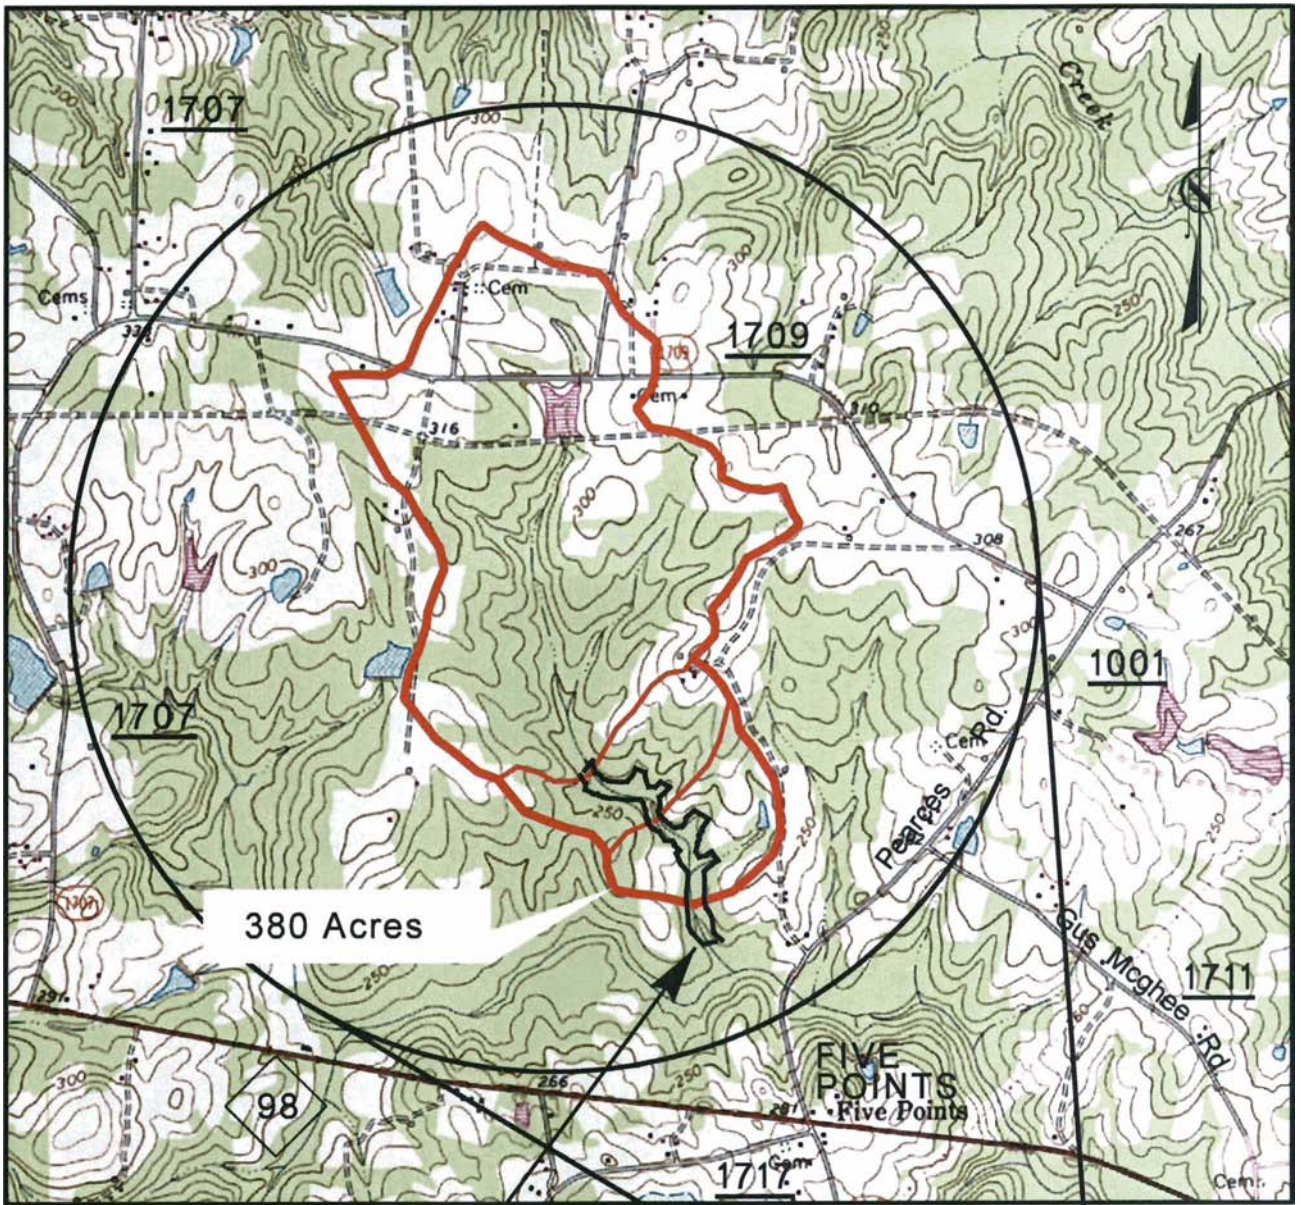
Figure: 2.1.1

## Watershed Topo Map

The watershed above Unnamed Tributary to Crooked Creek is approximately 380 acres in area. Elevations range from a topographic high of approximately 316 feet above mean sea level to a topographic low of 210 feet above mean sea level at the lower portion of the project study area (Figure 2.1.1). Current land use within the watershed is generally rural in nature, containing several small farms and private residences (Figure 2.1.2). Relief within the watershed is gently sloping.

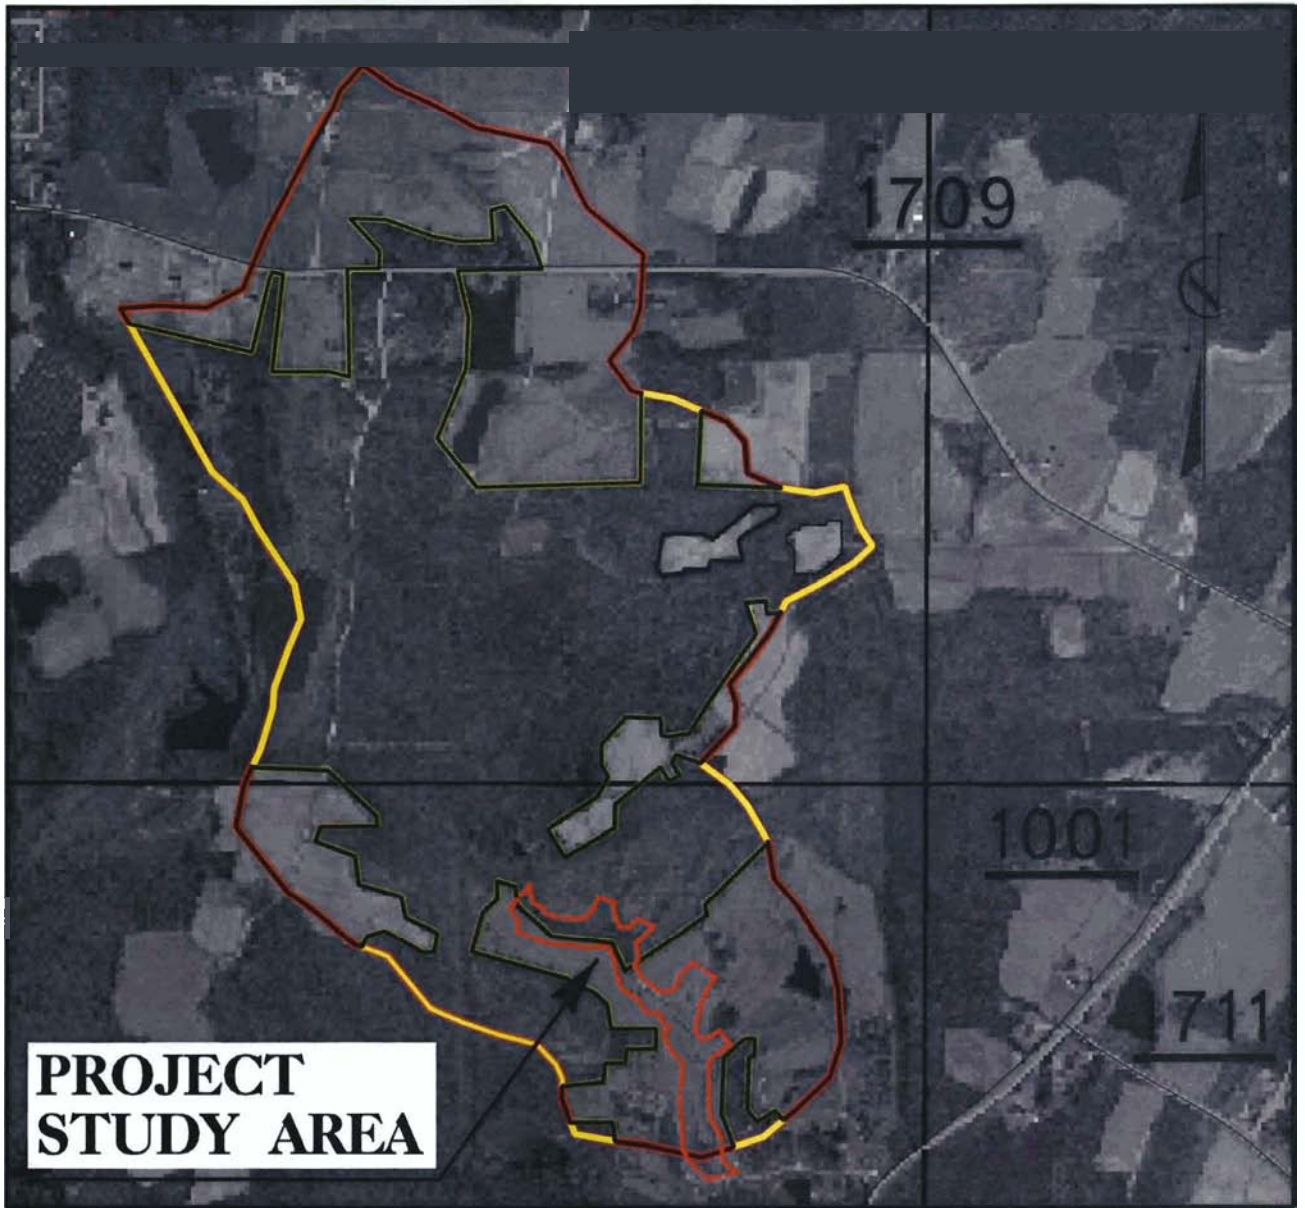
Figure: 2.1.2

- PROJECT WATERSHED LIMITS
- FOREST
- AGRICULTURAL

## Land Use Map

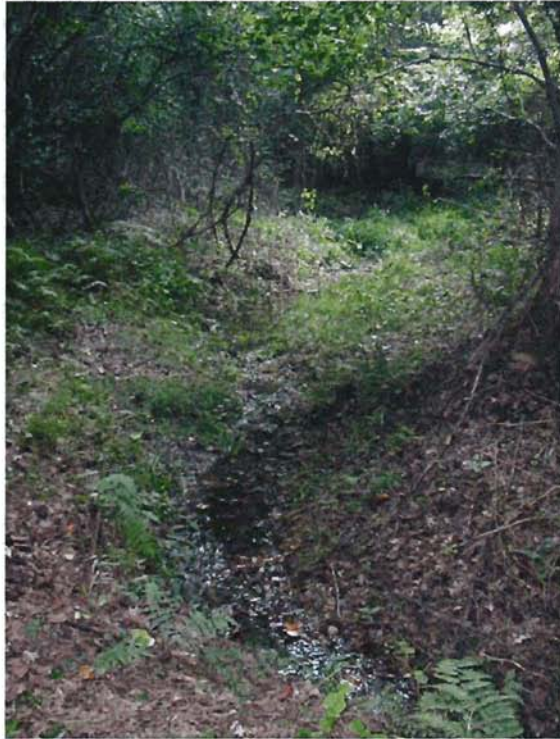
Exhibit 3.1: Marks Creek South

The stream reach used for the survey totaled 106 feet. The survey included a longitudinal profile, cross-sections, bed material evaluation, buffer assessment, and system stability evaluation. The UT to Marks Creek reference reach was classified as a C5 stream type based upon the survey data. The reach is transporting its sediment supply without aggrading or degrading while maintaining its dimension, pattern, and profile. Bankfull width of the stream is approximately 11.1 and bankfull depth is approximately 0.7 feet. The reference reach has a sinuosity of 1.23 and a radius of curvature of 7-16 feet. The width-to-depth ratio of 15 is moderate and the entrenchment ratio of 5.3 is slightly entrenched as expected for a C type stream. The streambed material for Marks Creek South and Unnamed Tributary to Crooked Creek are dominated by sand. Photographs of Marks Creek South are presented in Exhibit 3.1. DWQ representatives inspected the site February 2002. The DWQ inspectors approved of the use of Marks Creek South as a reference reach.

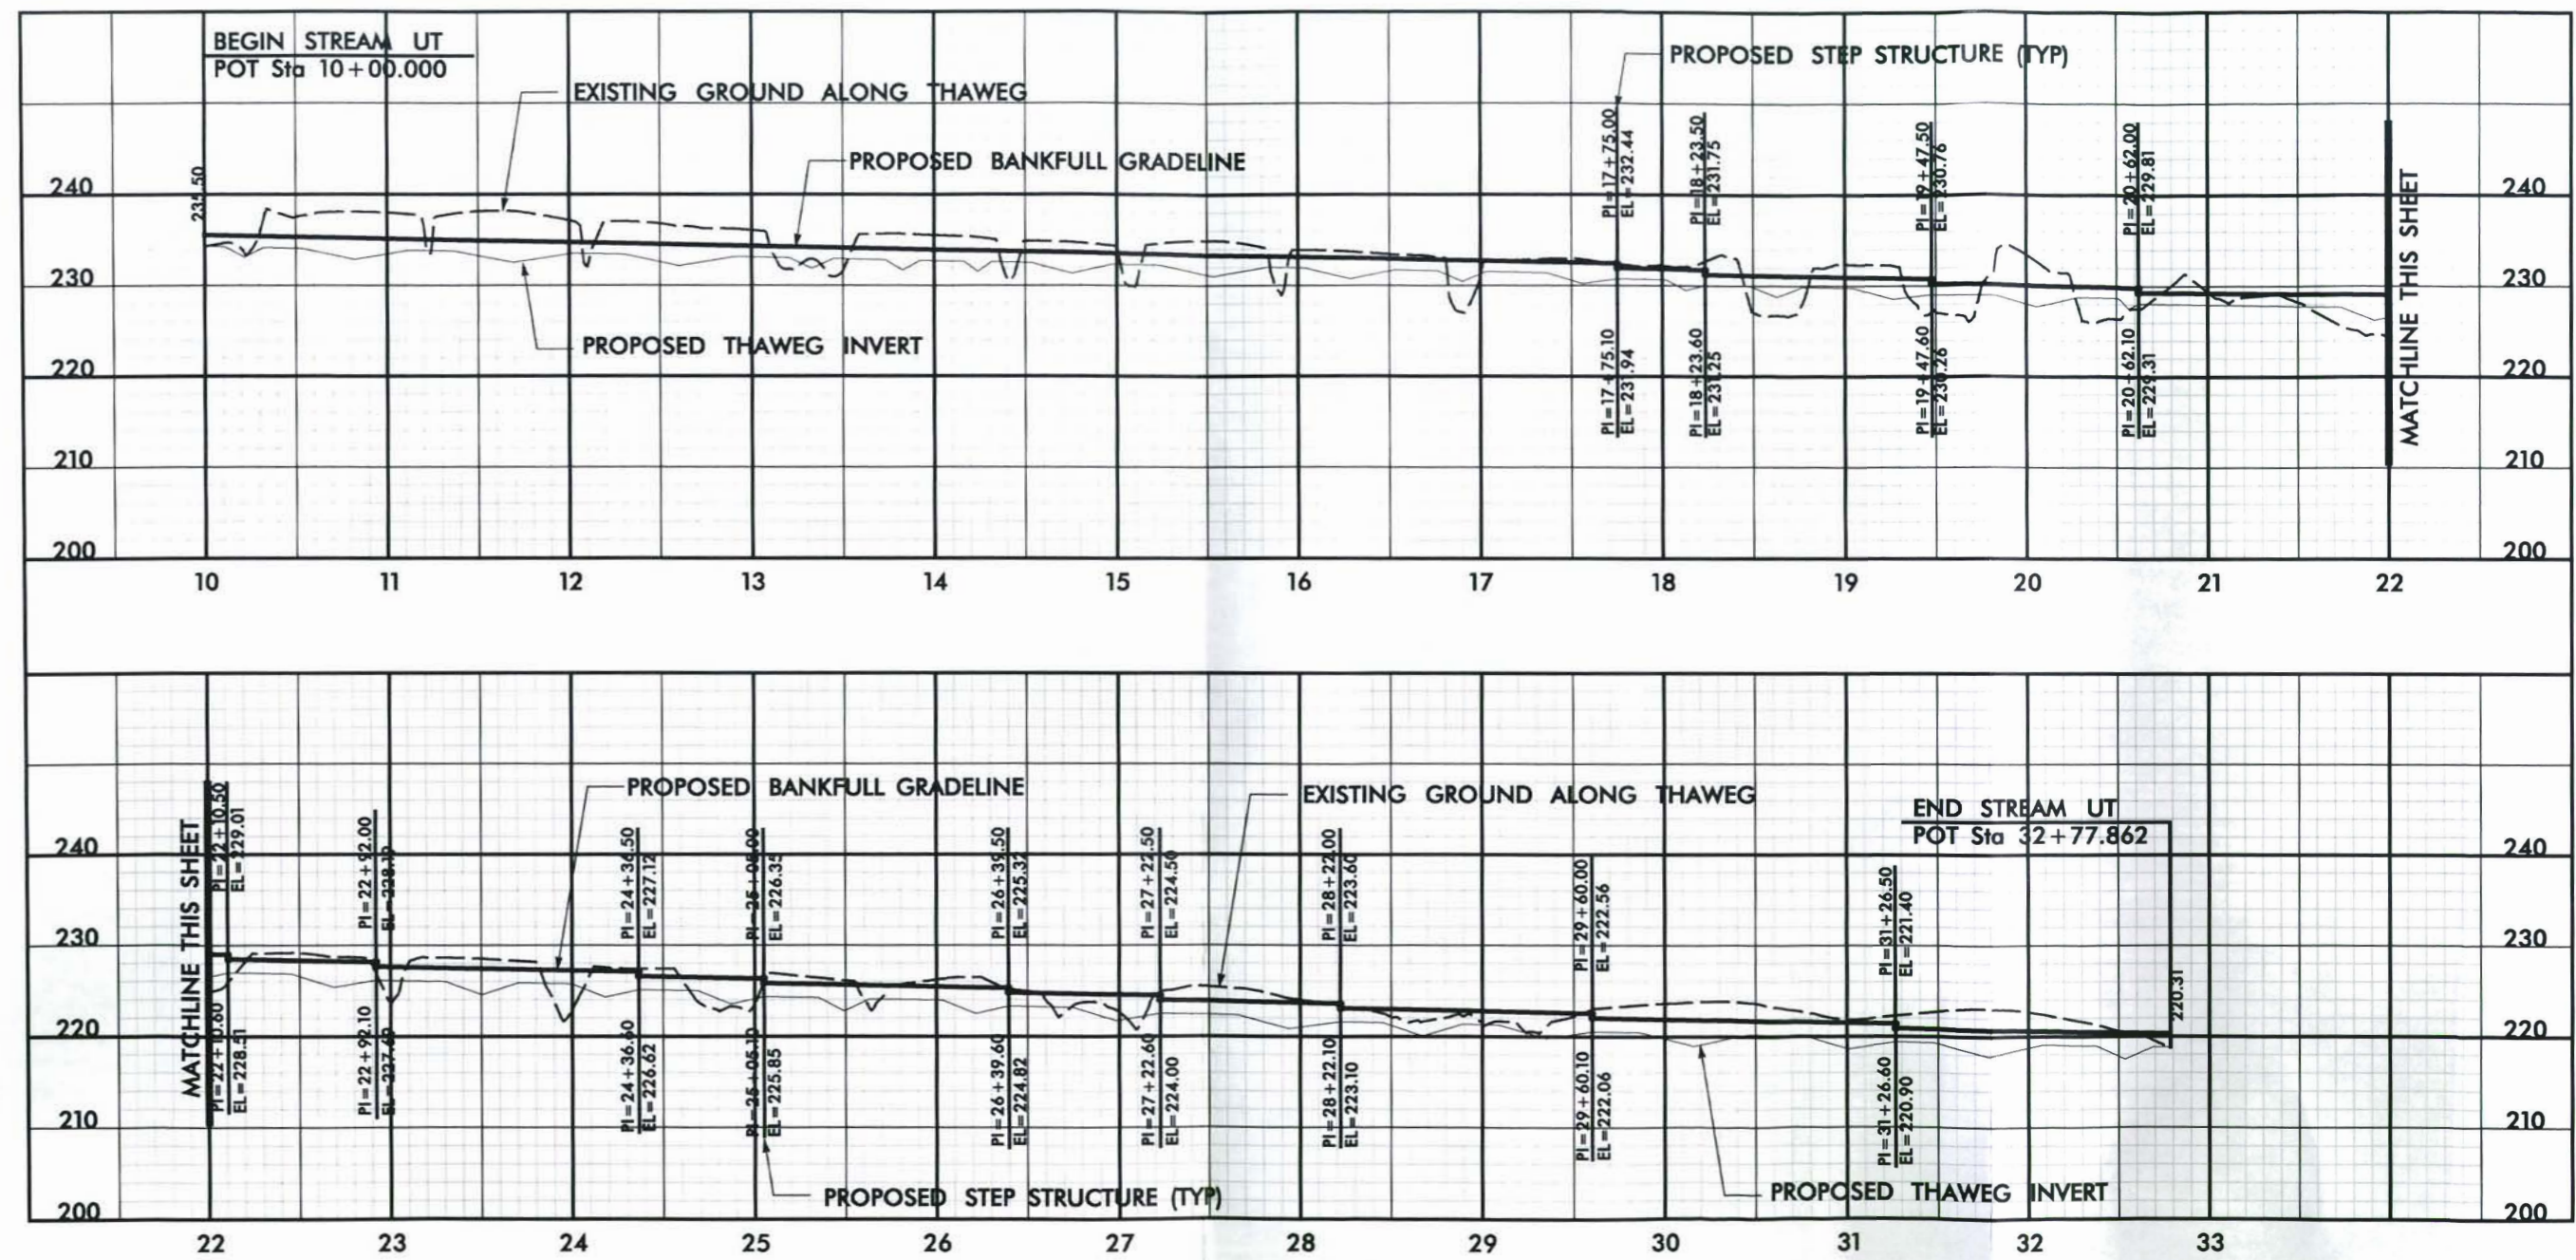
NOTE: GRADE BETWEEN DROP STRUCTURES = 0.3947%

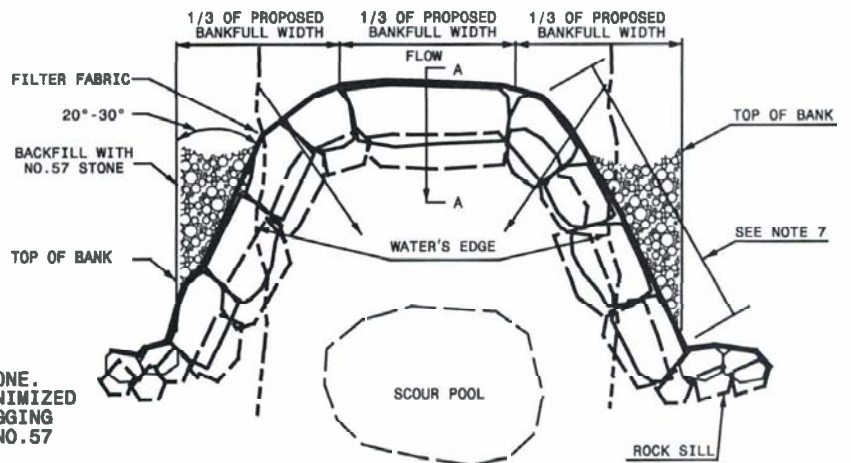
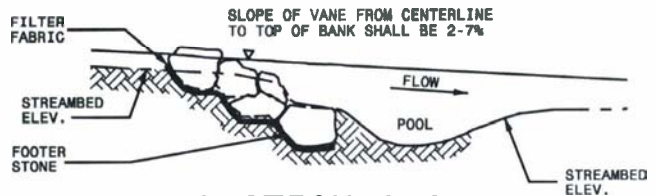
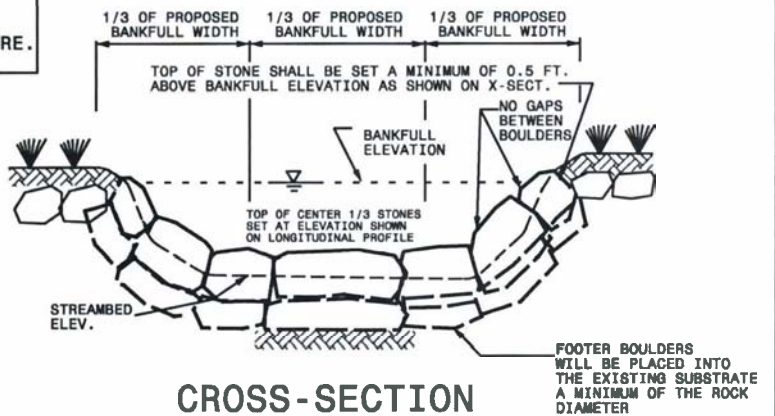
Figure: 7.2

# ROCK CROSS VANE

- NOTES:**
1. ALL STONES ARE TO BE STRUCTURE STONE.
  2. GAPS BETWEEN BOULDERS SHALL BE MINIMIZED BY FITTING BOULDERS TOGETHER, PLUGGING WITH STRUCTURE STONE CLASS A AND NO.57 AND LINING WITH FILTER FABRIC.
  3. DIMENSIONS AND SLOPES MAYBE ADJUSTED TO FIT BY THE ENGINEER.
  4. A DOUBLE FOOTER BOULDER SHALL BE UTILIZED IN SAND BED MATERIAL.
  5. CONTRACTOR WILL BE REQUIRED TO FIT BOULDERS TIGHTLY.
  6. FOOTER BOULDERS AND VANE BOULDERS SHALL BE NATIVE STONE OR SHOT ROCK, CUBICAL OR RECTANGULAR IN NATURE.
  7. SLOPE OF VANE FROM CENTERLINE TO TOP OF BANK SHALL BE 2-7%.

FILTER FABRIC SHALL BE PLACED ON THE UPSTREAM SIDE OF THE STRUCTURE TO PREVENT WASHOUT OF SEDIMENT THROUGH BOULDER GAPS. FILTER FABRIC SHALL EXTEND FROM THE BOTTOM OF THE FOOTER BOULDER TO THE FINISHED GRADE ELEVATION AND SHALL BE PLACED THE ENTIRE LENGTH OF STRUCTURE.

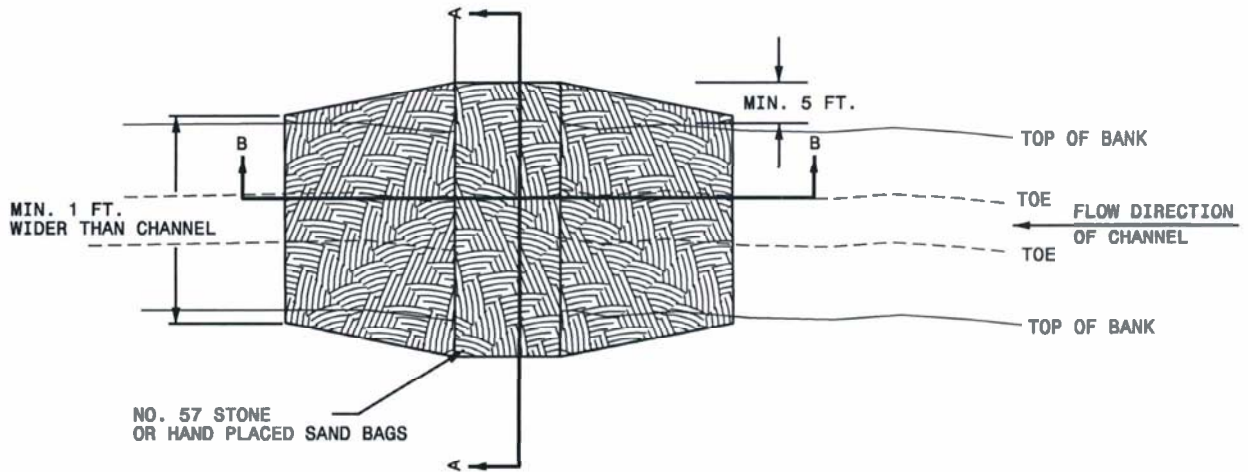
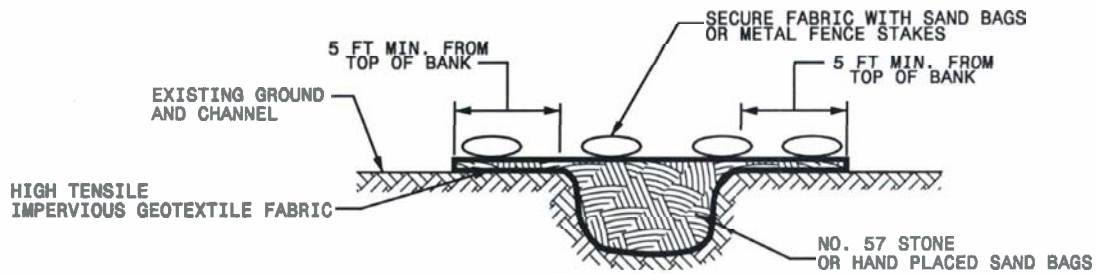
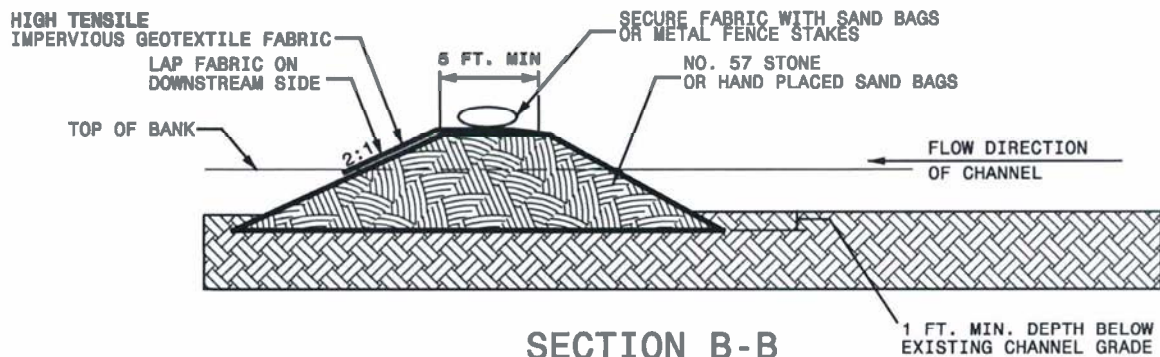
Figure: 7.4

# TEMPORARY IMPERVIOUS STREAM CHANNEL PLUG

PLAN VIEW

SECTION A-A

SECTION B-B

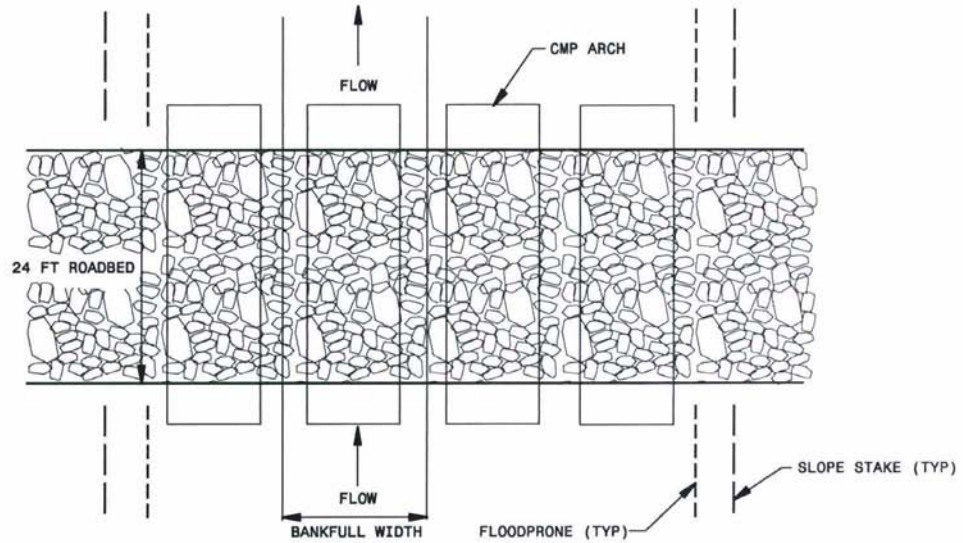
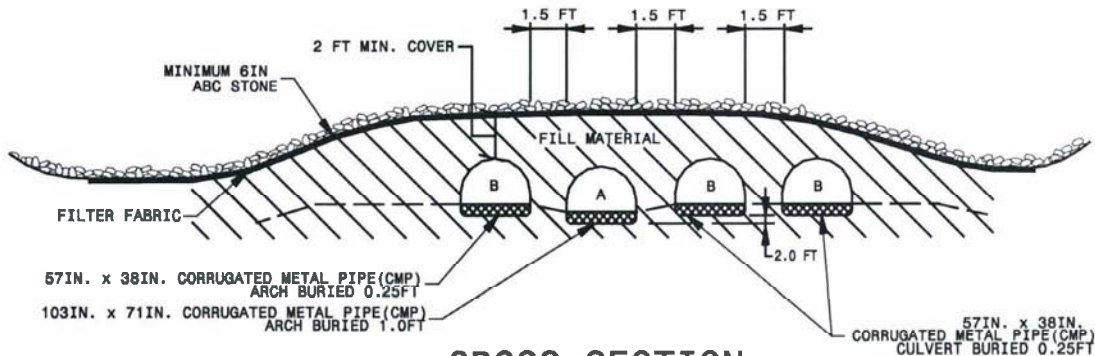
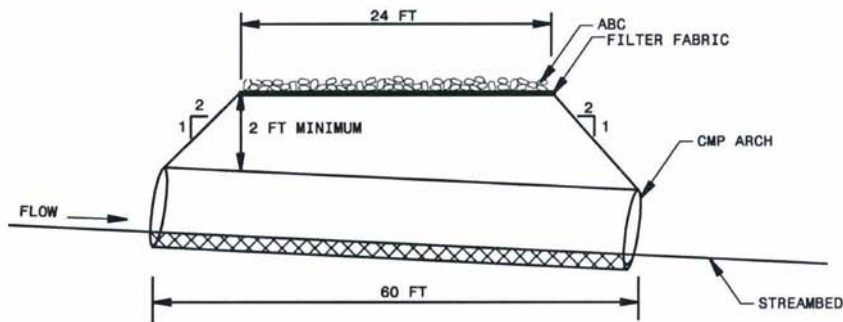
# PERMANENT STREAM CROSSING

PLAN VIEW

CROSS-SECTION

LONGITUDINAL PROFILE

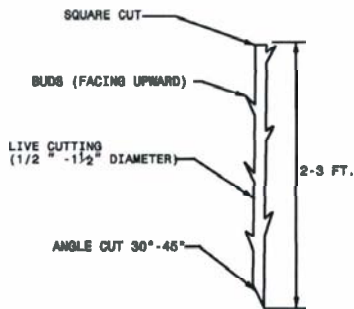
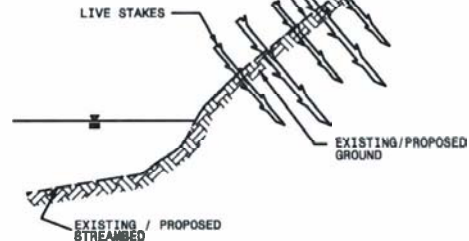
### LIVE STAKE DETAIL

LIVE STAKE

NOTE: STAKING MAY BE REQUIRED THROUGH MATTING, ROCK OR COMPACTED SOILS. A STARTER HOLE MAY BE REQUIRED.

- NOTE:
1. LIVE STAKES SHALL BE EVENLY SPACED 4 FT. APART.
  2. LIVE STAKES SHALL BE DRIVEN UNTIL APPROXIMATELY 3/4 OF LIVE STAKE IS WITHIN GROUND.
  3. IF STARTER HOLE IS NEEDED, MINIMIZE AIR POCKET.
  4. UTILIZE ALL ON SITE TRANSPLANT MATERIALS MADE AVAILABLE BY THE OWNER. ONCE SOURCE OF TRANSPLANT MATERIAL HAS BEEN HARVESTED, THEN UTILIZE LIVE STAKING.

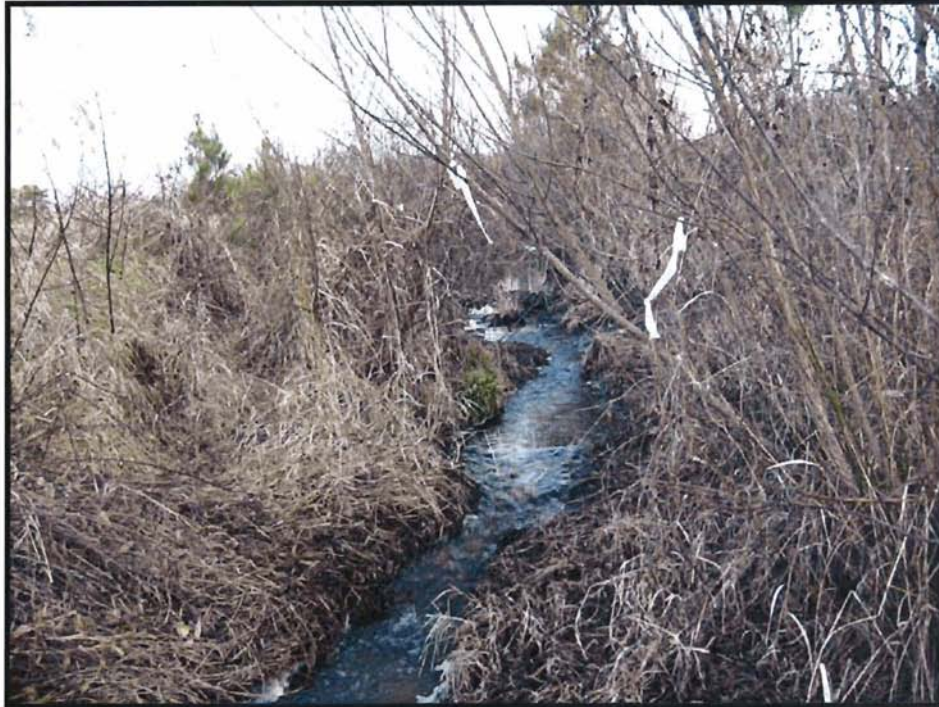
Existing Channel Looking Upstream Near Downstream Limits of Project

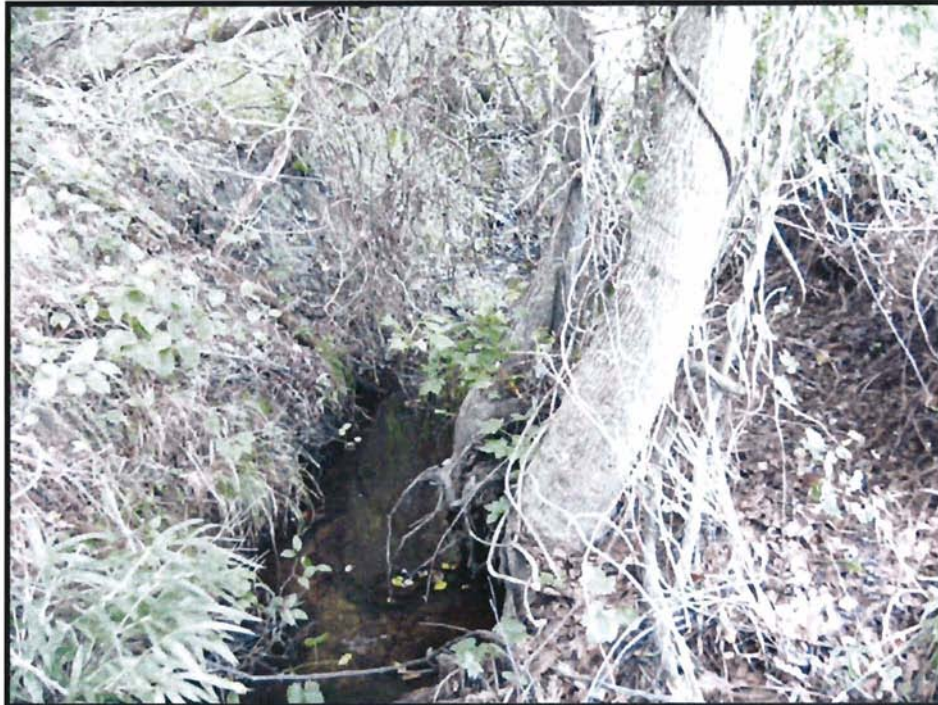
Existing Channel Looking Downstream at the Top of Beaver Dam

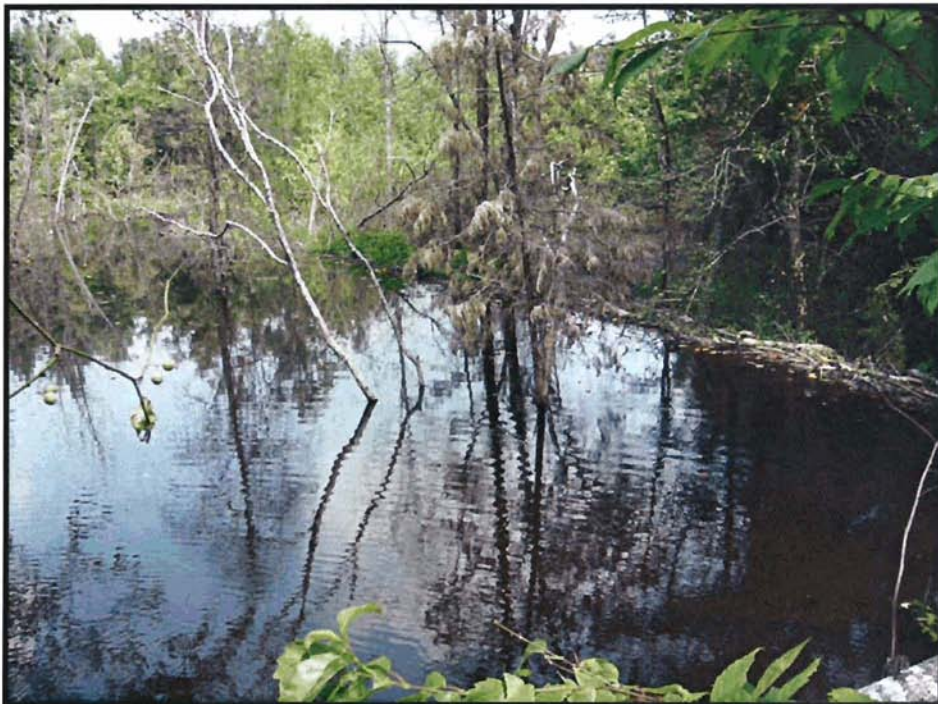
Pond Created by Beaver Dam at Upstream Limits of Project

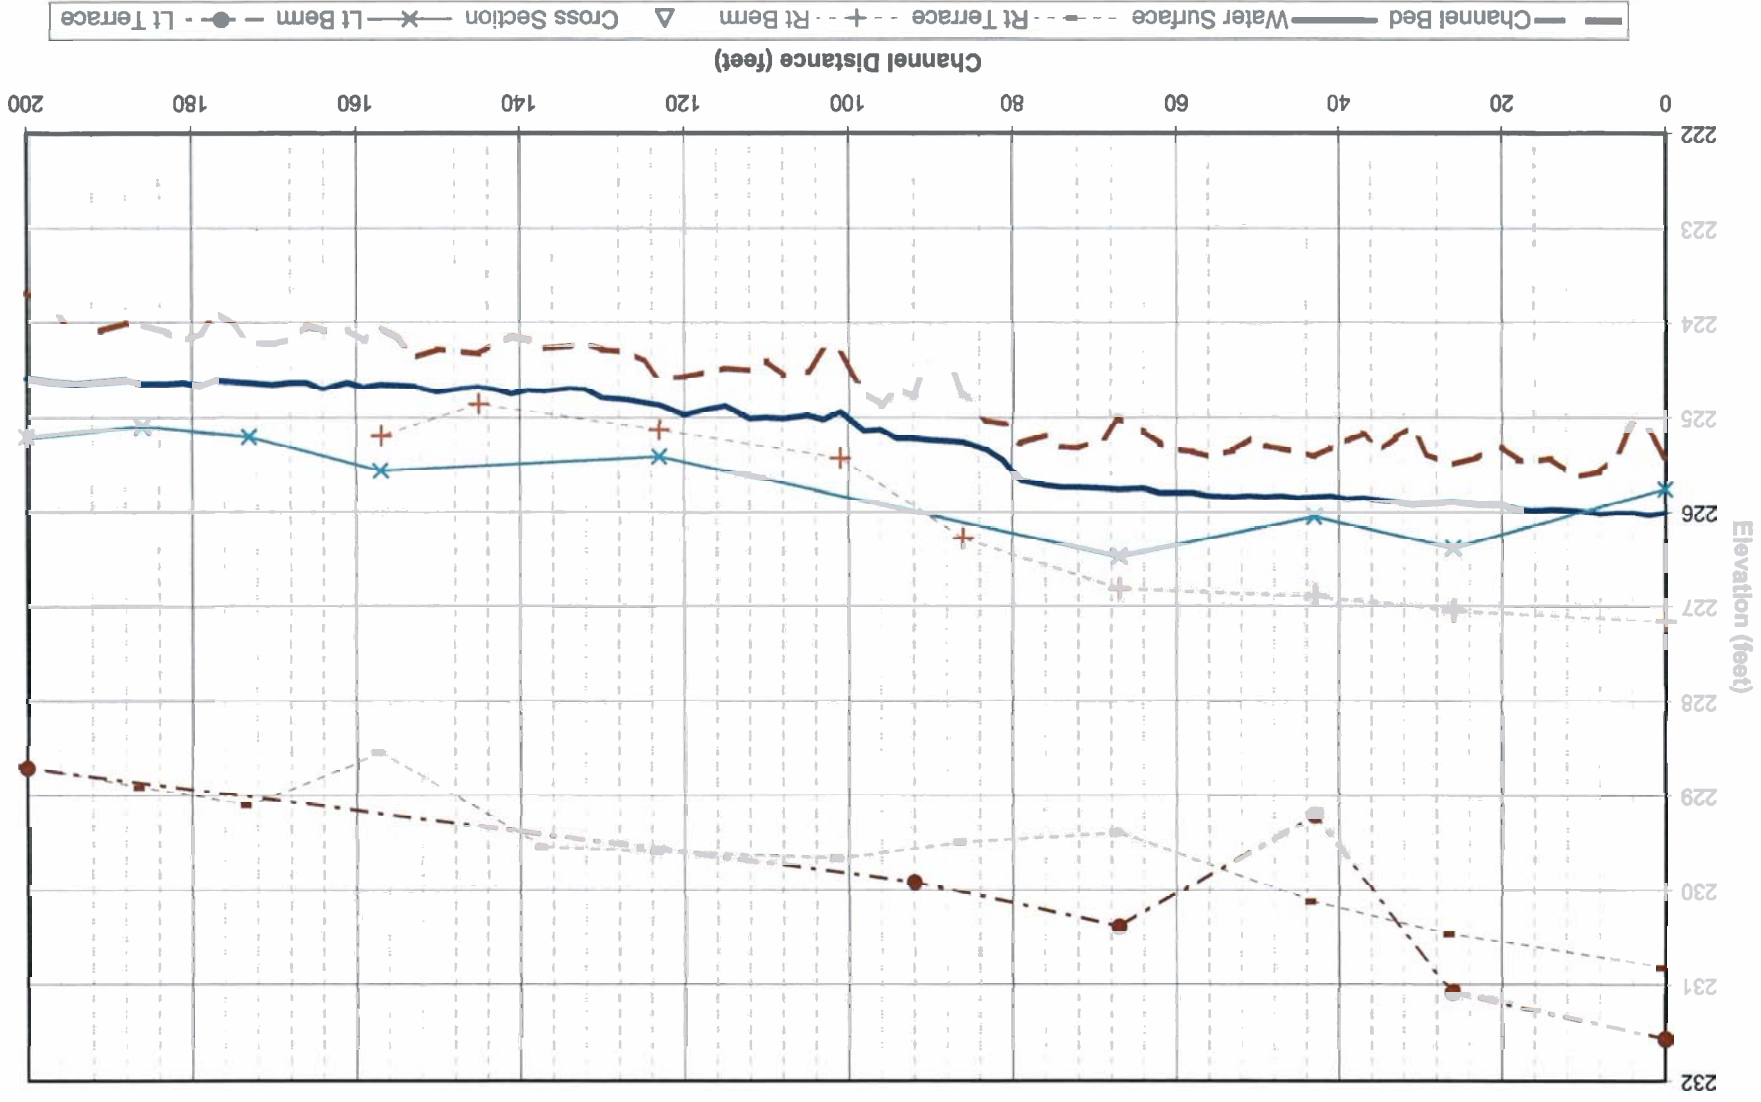
UT to Crooked Creek Existing Longitudinal Profile

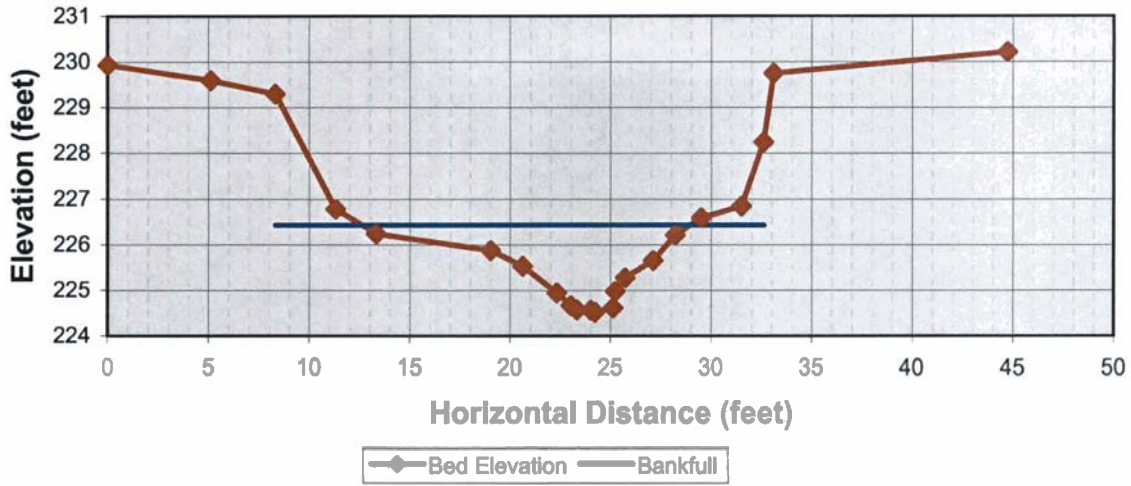
UT to Crooked Creek Existing Riffle Cross-Section

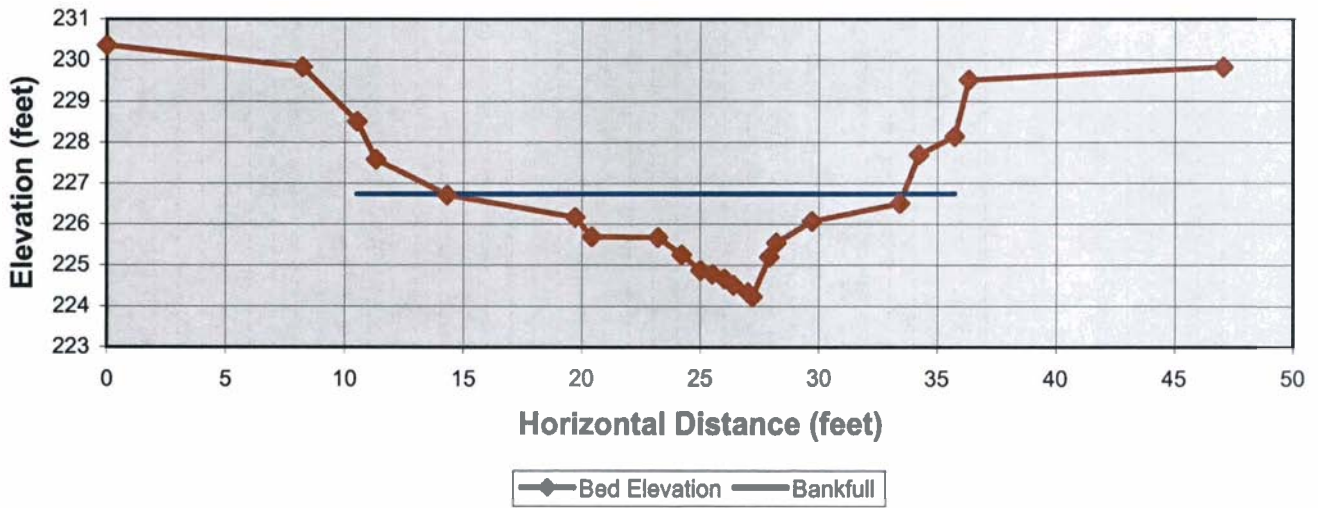
UT to Crooked Creek Existing Pool Cross-Section
