**UNNAMED TRIBUTARY TO CROOKED CREEK
STREAM AND WETLAND RESTORATION PROJECT
Franklin County, NC**

**2007 Annual Monitoring Report
Year 1 of 5**

**NCEEP Project Number 434
Project ID# 040614801**

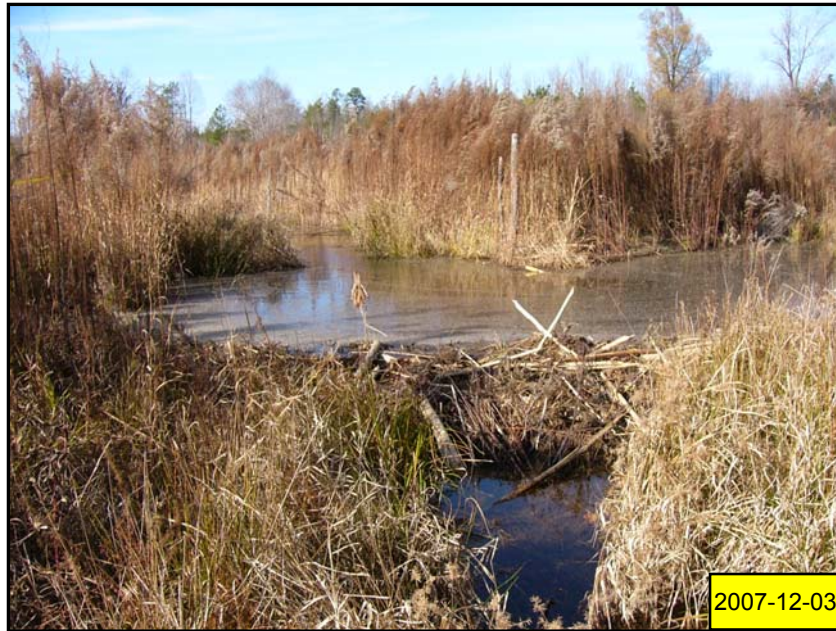
PA – 1 Looking Upstream at Dam

An assessment of channel stability was performed on December 3, 2007 by Ko & Associates, P.C. Problem areas identified were primarily the results of beaver activity within the channel. These problem areas are shown on Figures 2A-2C (Monitoring and Problem Area Plan View). The beaverdams have caused backwater through sections of the project and threaten to silt in (aggrade) the channel where backwater is effecting the channel

Table IX. Stream Problem Areas UTCC EEP #434			
Feature/Issue	Station Numbers	Suspected Cause	Photo Number
Mild Aggradation/Backwater	2575-2687	Beaverdam	PA-1
Mild Aggradation/Backwater	2690-2725	Beaverdam	PA-2
Mild Aggradation/Backwater	2848-2900	Beaverdam	PA-3

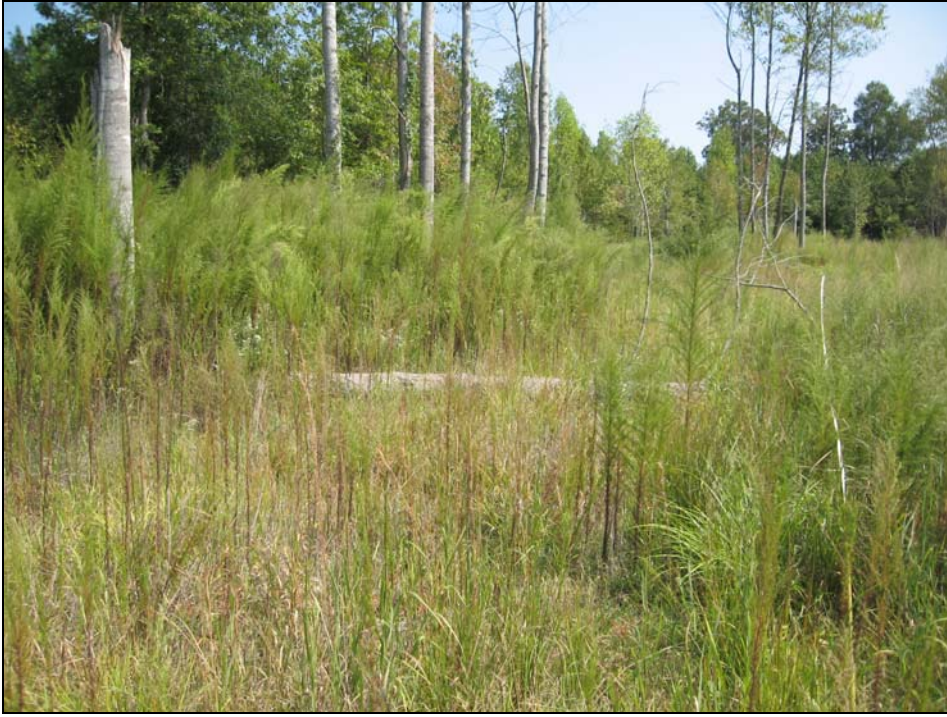
Plot 1

In 2007, all three of the vegetative monitoring plots (100.0%) met the 320 stems/acre success criterion that would be required for Year 3 monitoring (Table VII). Drought conditions throughout the 2007 growing season are the probable cause for any sapling mortality.

The effects of drought conditions in the growing season were observed in all plots, primarily in the form of leaf scorch. Low vigor scores for multiple saplings were attributed to the drought conditions in all three plots. It is unknown what effects the drought during the 2007 growing season will have upon the survival rates of stems for the 2008 monitoring event.

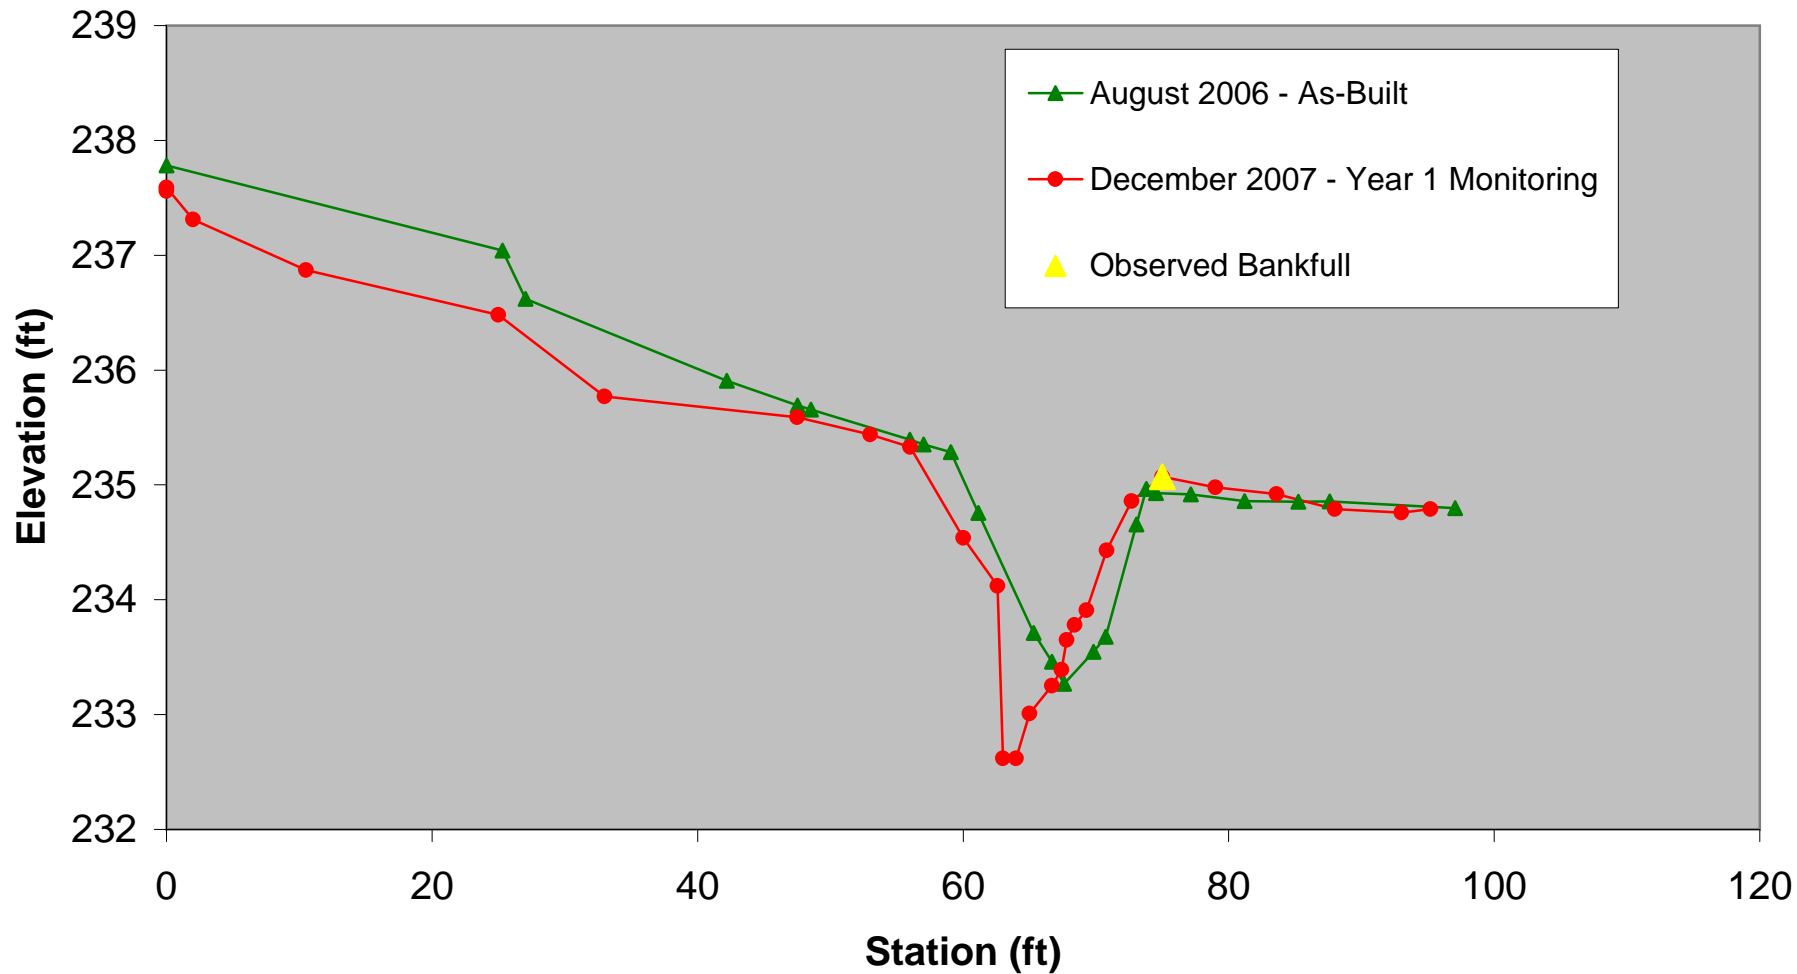
Cross Section 1 - Sta 1159.5 Pool

River Name: Crooked Creek
Reach Name: Upper Reach
Cross Section Name: Sta 1159.5 Pool
Survey Date: 12/03/2007

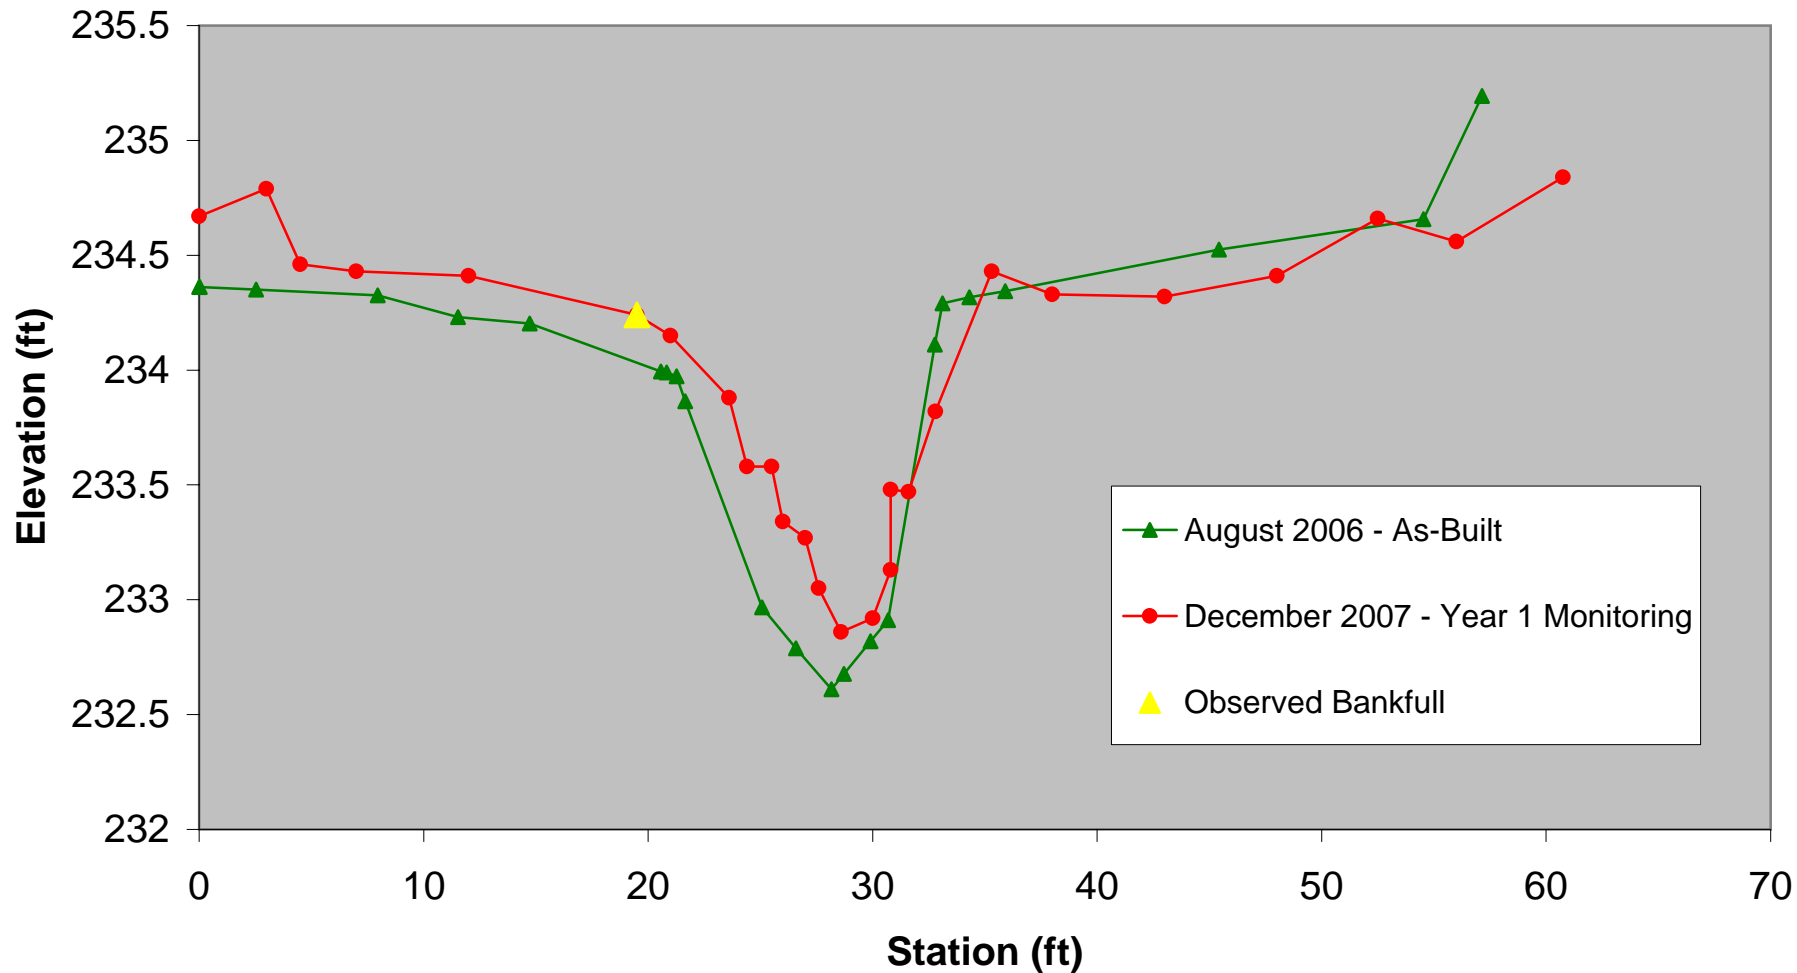
Cross Section 2 - Sta 1324.5 Riffle

River Name: Crooked Creek
Reach Name: Upper Reach
Cross Section Name: Sta 1324.5 Riffle
Survey Date: 12/03/2007

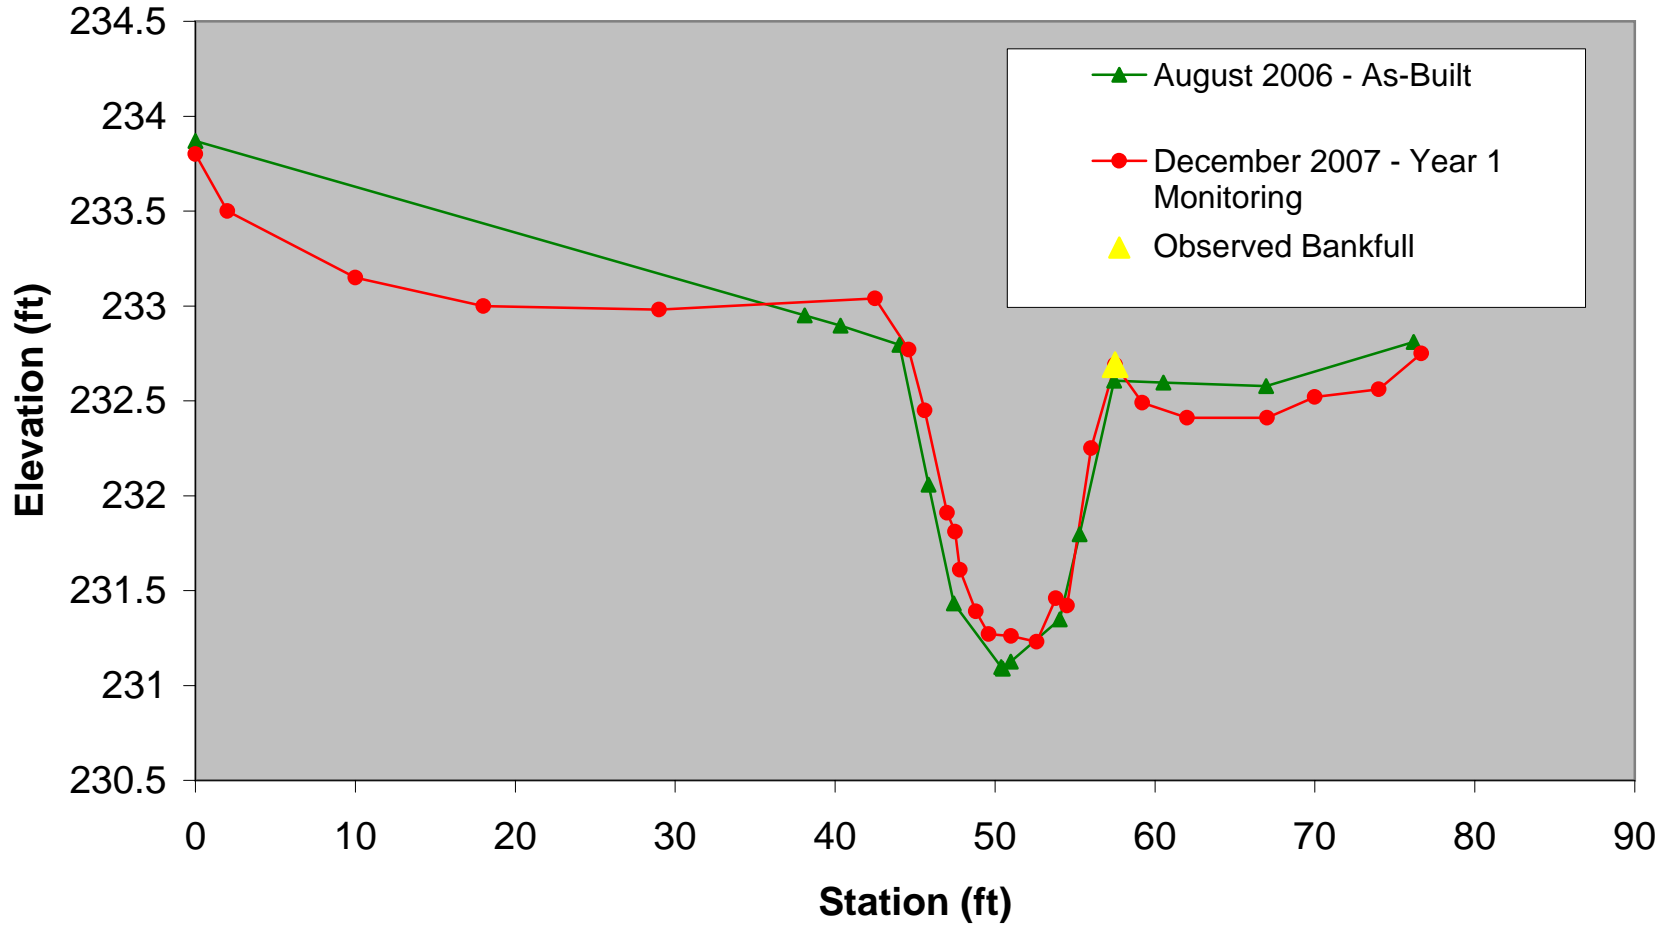
Cross Section 3 - Sta 1739.5 Rifle

River Name: Crooked Creek
Reach Name: Upper Reach
Cross Section Name: Sta 1739.5 Riffle
Survey Date: 12/03/2007

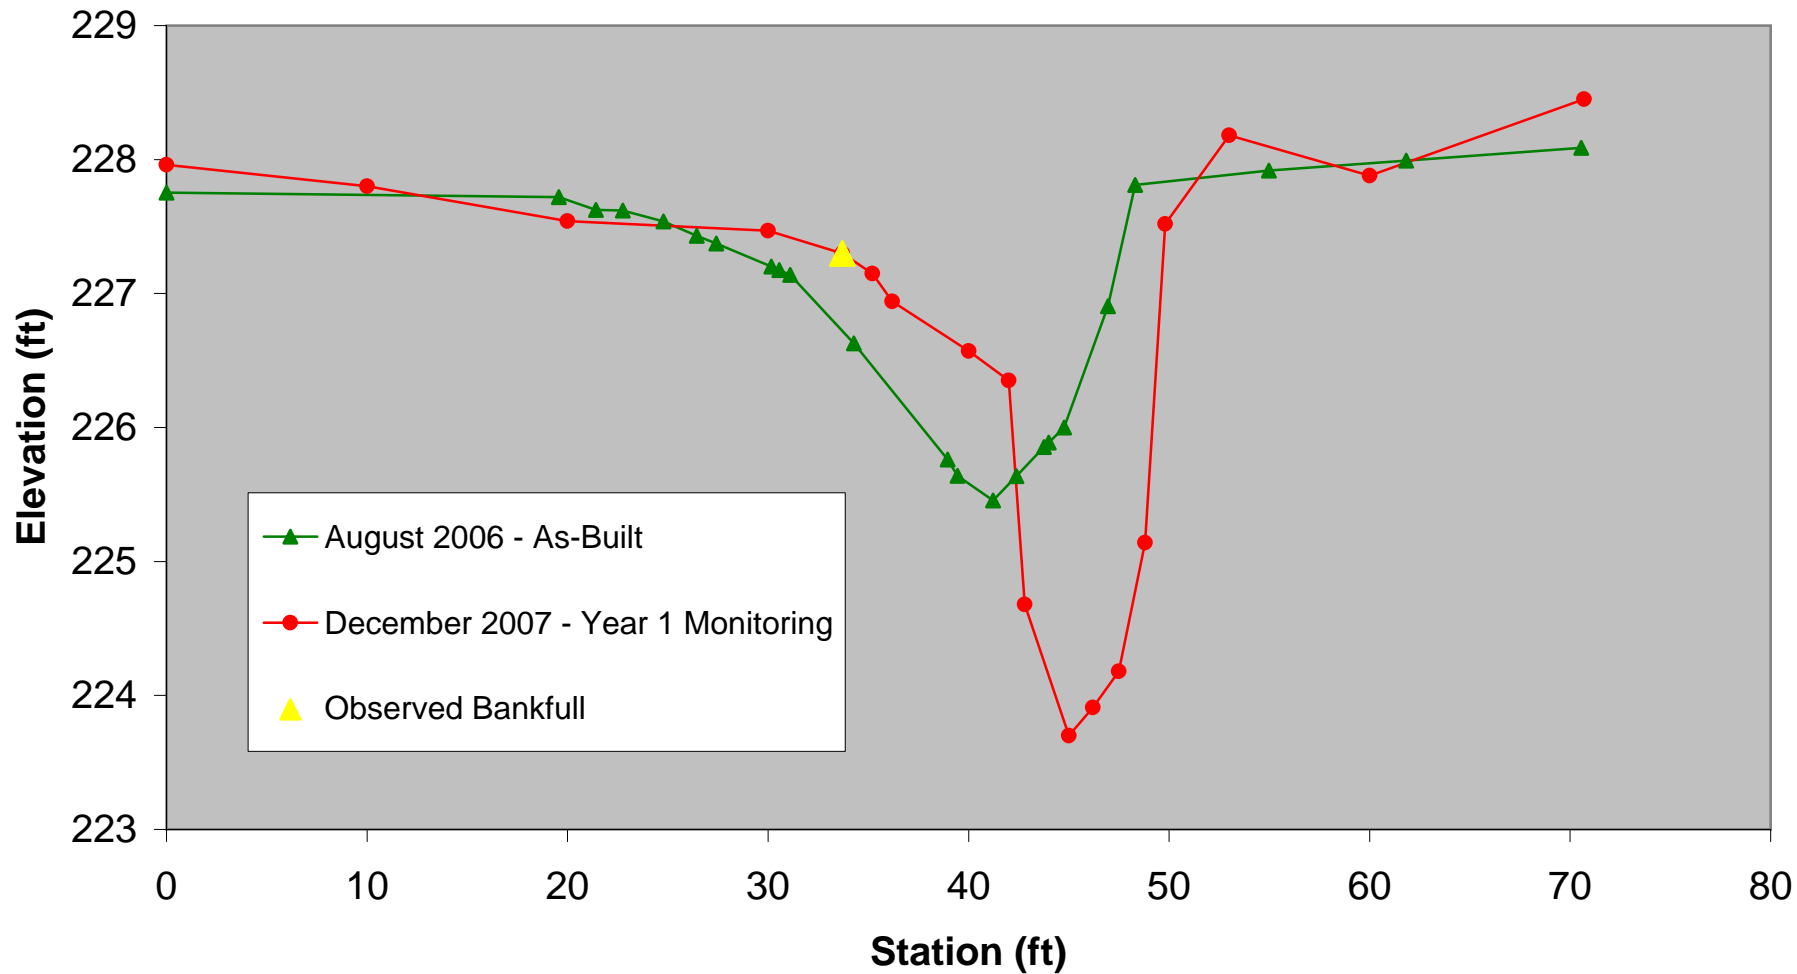
Cross Section 5 - Sta 2450 Pool

River Name: Crooked Creek
Reach Name: Lower Reach
Cross Section Name: Sta 2450 Pool
Survey Date: 12/03/2007

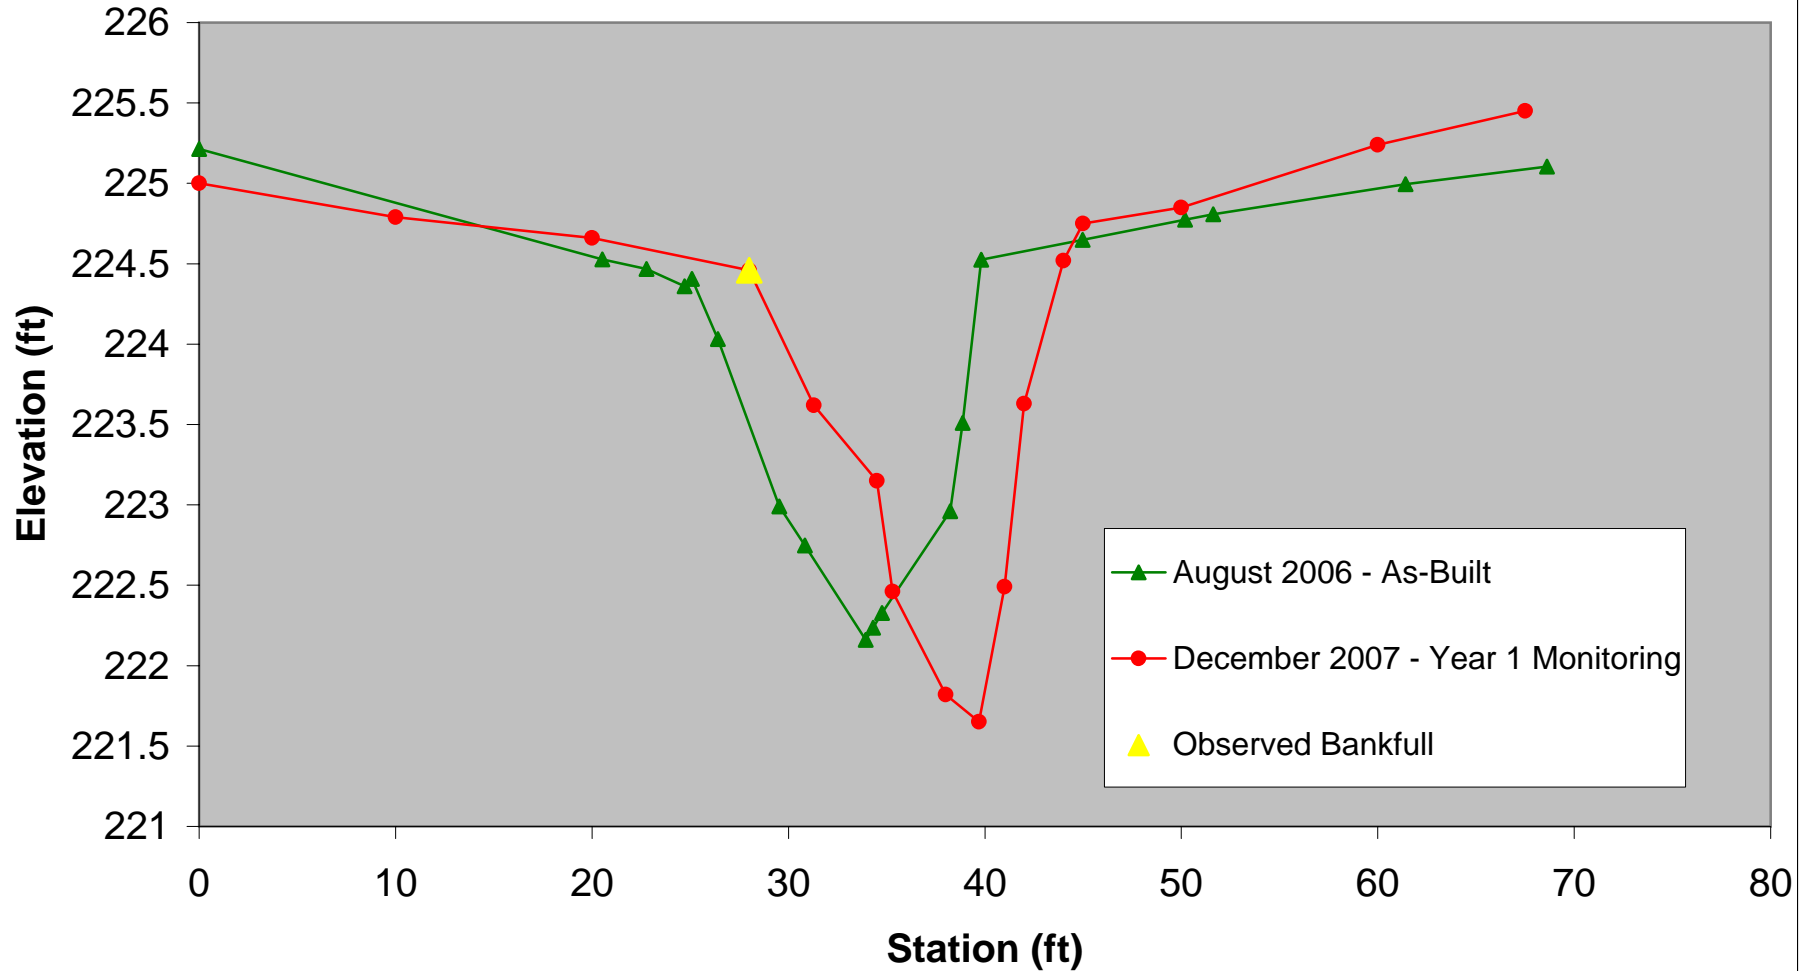
Cross Section 6 - Sta 2798 Pool

River Name: Crooked Creek
Reach Name: Lower Reach
Cross Section Name: Sta 2798 Pool
Survey Date: 12/03/2007

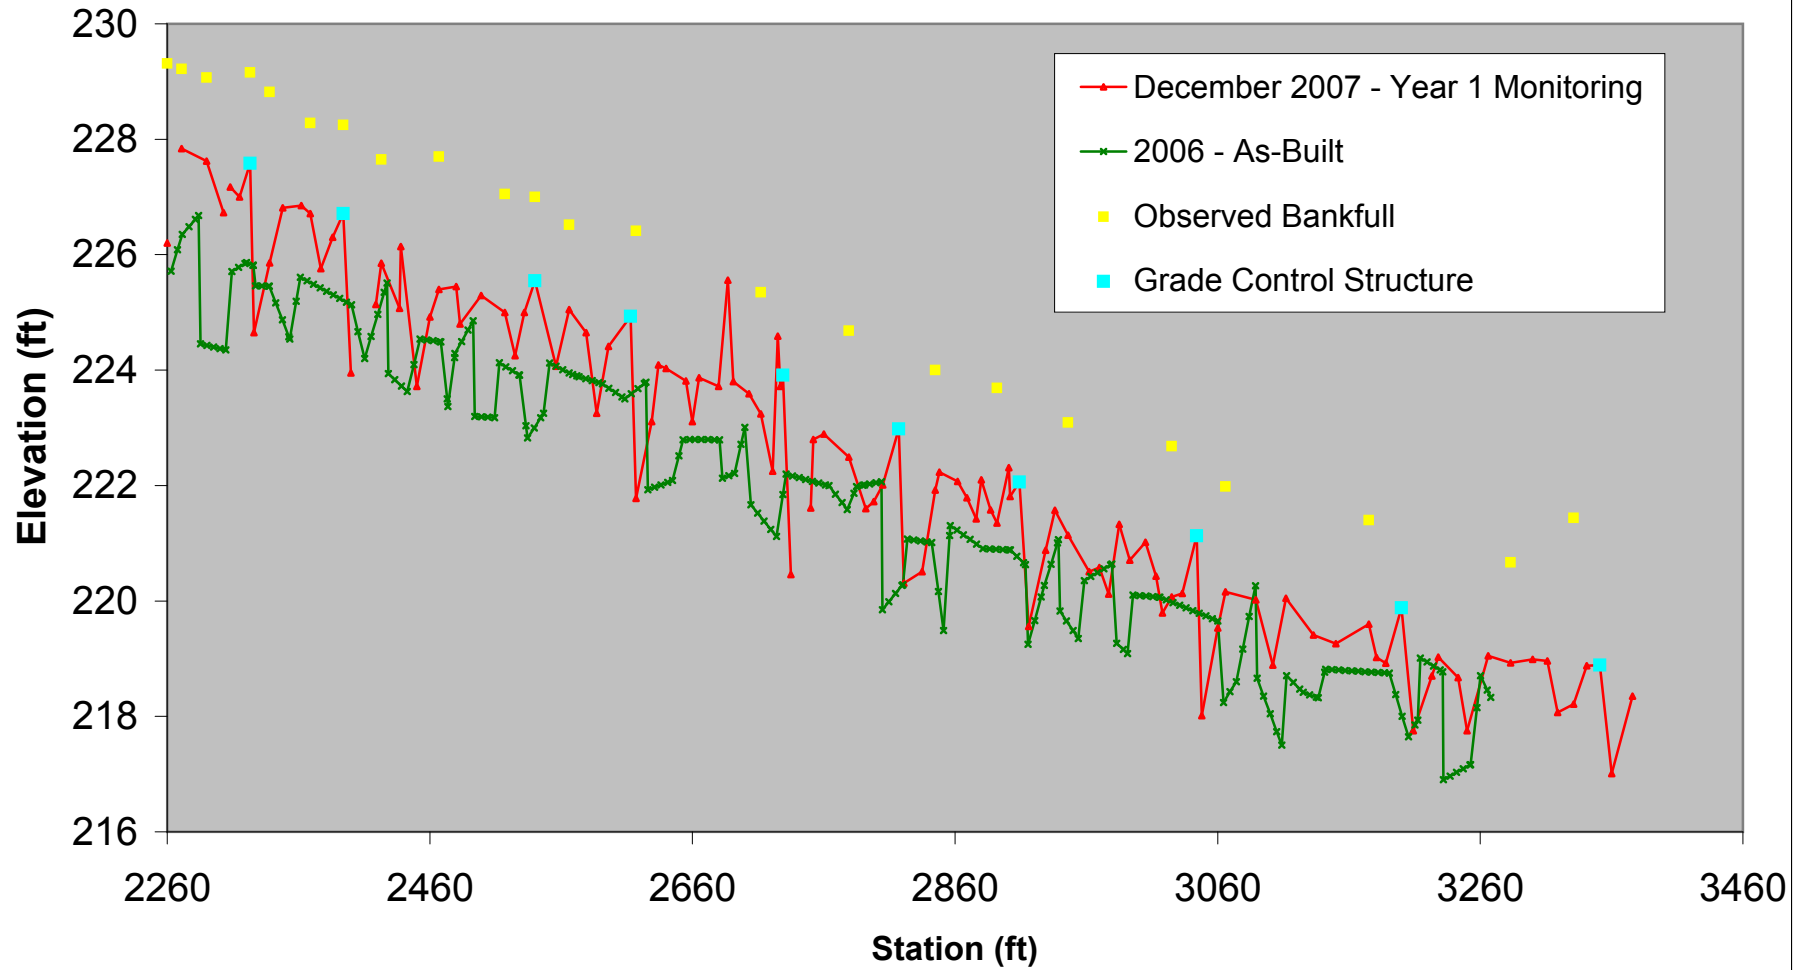
River Name: Crooked Creek
Reach Name: Lower Reach
Profile Name: Lower Reach
Survey Date: 12/03/2007
