**FINAL**  
**ANNUAL MONITORING REPORT**  
**UT TO HAW BECKOM RESTORTION SITE**  
**ALAMANCE COUNTY, NORTH CAROLINA**  
**(EEP Project No. 92694)**

Monitoring Year 1 of 5 (2011)

Prepared by:  
Axiom Environmental, Inc.  
218 Snow Ave.  
Raleigh, North Carolina 27603

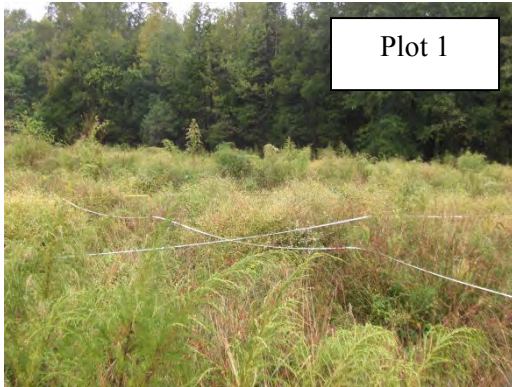
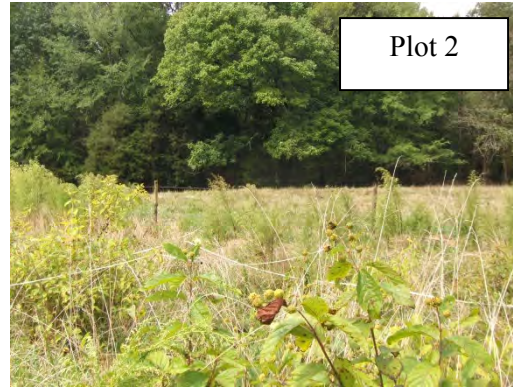
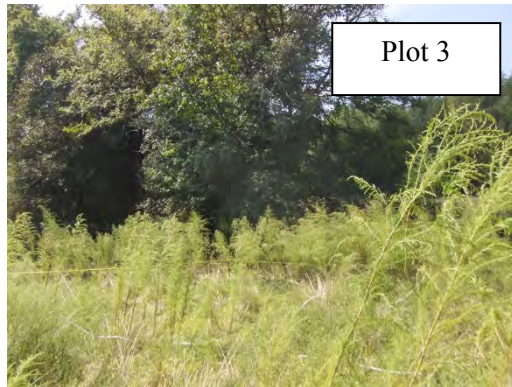
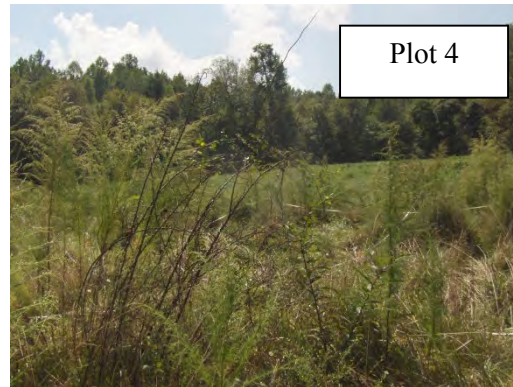
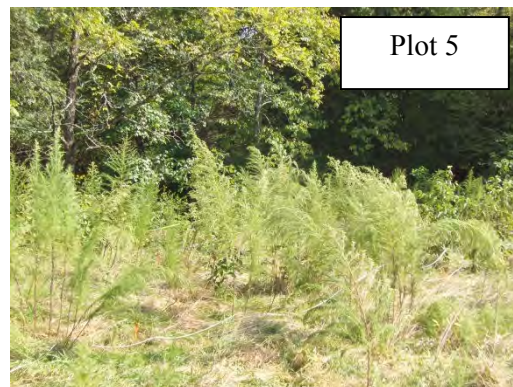
**UT Haw (Beckom) 2011 Year 1  
Vegetation Monitoring Photographs  
Taken September 2011**

| Vegetation Category | Definitions | Mapping Threshold | CCPV Depiction | Number of Polygons | Combined Acreage | % of Planted Acreage |
|--|--|---|---|---|---|---|
| 3. Areas of Poor Growth Rates or Vigor | Herbaceous vegetation within the Site is vigorous most notably in the northern portion of the Site. This has resulted in overtopping of smaller trees. | NA | NA | NA | 2.00 | 39.2% |
