**FINAL
ANNUAL MONITORING REPORT
UT TO HAW BECKOM RESTORTION SITE
ALAMANCE COUNTY, NORTH CAROLINA
(EEP Project No. 92694, Contract No. 004545)**

Monitoring Year 2 of 5 (2012)

Prepared by:
Axiom Environmental, Inc.
218 Snow Ave.
Raleigh, North Carolina 27603

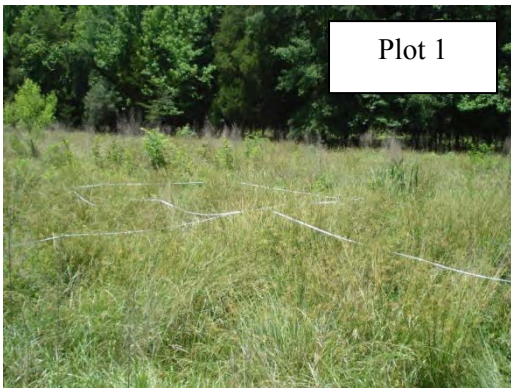
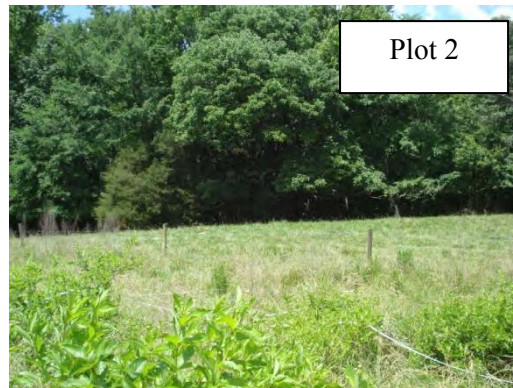
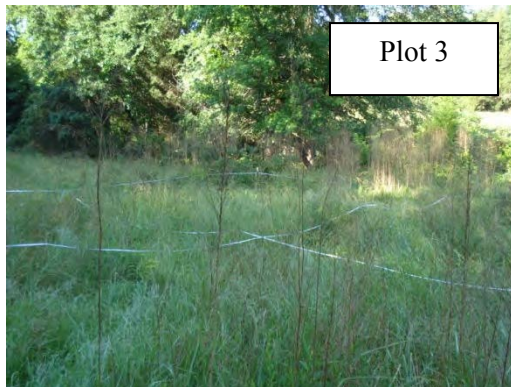
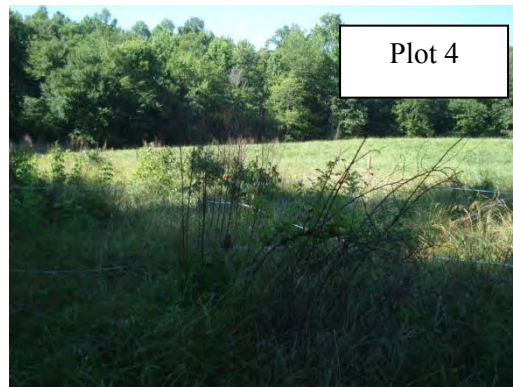
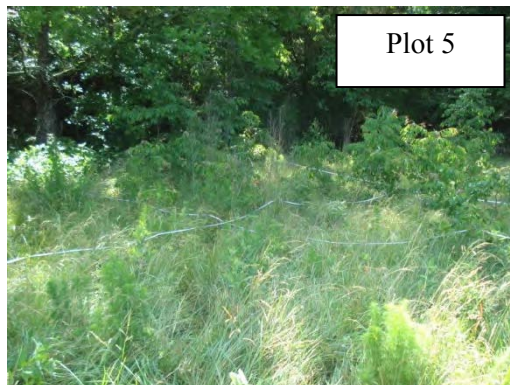
**UT Haw (Beckom) 2012 Year 2
Vegetation Monitoring Photographs
Taken June 2012**

In general herbaceous grasses within the Site, primarily tearthumb (*Polygonum sagittatum*) in wetter areas and fescue (*Festuca* sp.) in drier areas, is vigorous and overtopping many of the smaller planted trees. As a result some of the smaller trees died due to grasses and some of the larger trees died over the summer of 2011 from dry, hot conditions. Despite these conditions, the majority of living planted trees are doing well. These issues should continue to be monitored closely in subsequent monitoring years. The Site was replanted as part of planting warranty on November 1, 2011 including 369 bare root seedlings were planted in Swamp Forest areas and 28 bare root seedlings were planted in floodplain areas of the Site. Planted species and number of stems of each are as follows.
