**FINAL**  
**ANNUAL MONITORING REPORT**  
**UT TO HAW BECKOM RESTORATION SITE**  
**ALAMANCE COUNTY, NORTH CAROLINA**  
**(EEP Project No. 92694, Contract No. 004545)**

Monitoring Year 3 of 5 (2013)

**SITE LOCATION**  
 UT TO HAW (BECKOM) SITE (EEP #92694)  
 Alamance County, North Carolina

**CURRENT CONDITIONS PLAN VEIW  
 UT TO HAW BECKOM SITE  
 Alamance County, North Carolina**

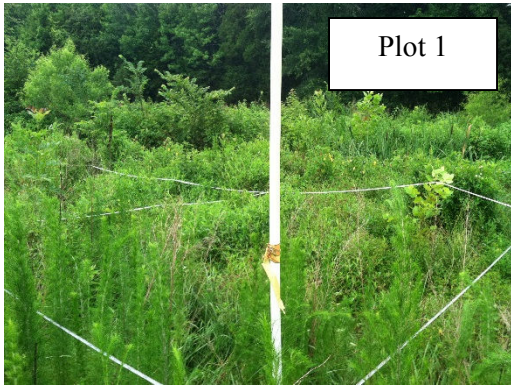
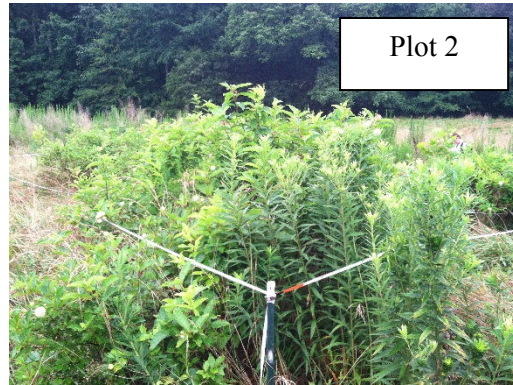
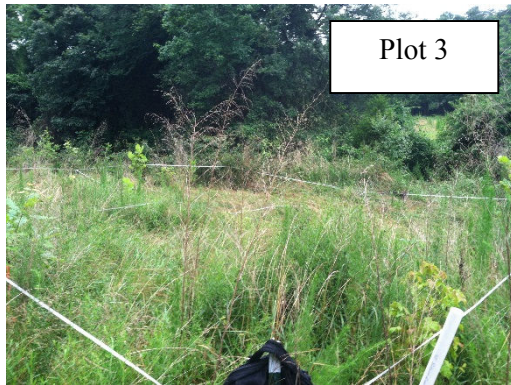
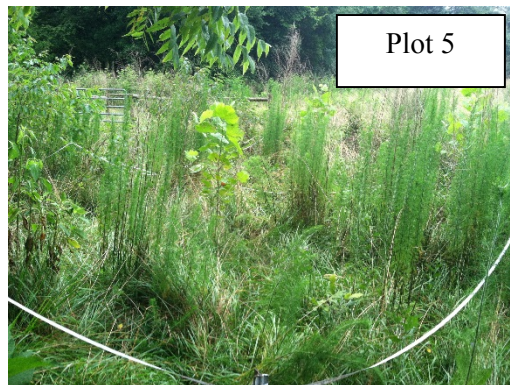
**UT Haw (Beckom) Year 3 - 2013**  
**Vegetation Monitoring Photographs**  
**Taken July 2013**

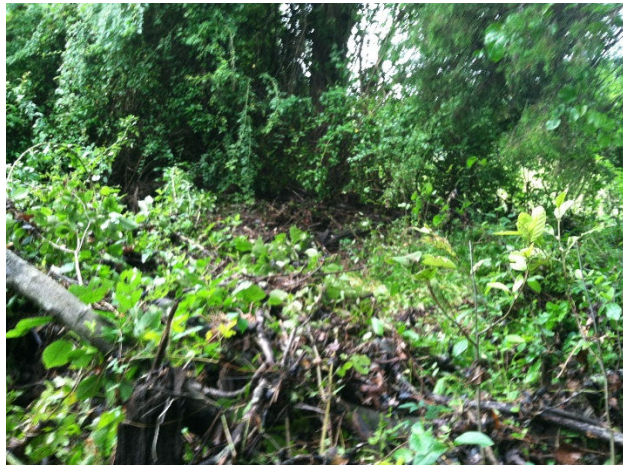
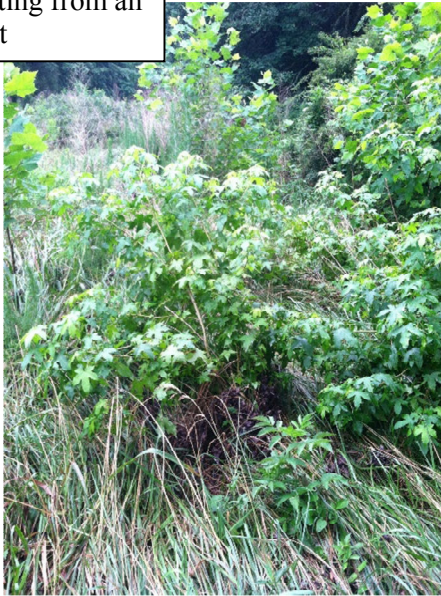
Date of Data Collection	Date of Occurrence	Method	Photo (if available)
September 30, 2011	June 28, 2011	Total of 2.83 inches* of rain reported to fall over 2 days (June 27-28, 2011)	--
September 30, 2011	September 24, 2011	Total of 3.61 inches* of rain reported to fall over 4 days (September 21-24, 2011) with an additional 0.85 inches* of rain the following 3 days (Sept 25-27, 2011)	--
July 18, 2012	July 11, 2012	Total of 4.84 inches* of rain reported to fall over 3 days (July 9-11, 2012)	--
July 11, 2013	June 31, 2013	Visual observations of overbank event including wrack lines and sediment deposition resulting from 14 days (June 25-July 8) of heavy rainfall totaling 6.27 inches.	1-2

Bankfull Event Photos 1 and 2 showing wrack lines resulting from an overbank event
