**FINAL
ANNUAL MONITORING REPORT
UT TO HAW BECKOM RESTORATION SITE
ALAMANCE COUNTY, NORTH CAROLINA
(DMS Project No. 92694, Contract No. 004545)**

Monitoring Year 5 of 5 (2015)

November 2015

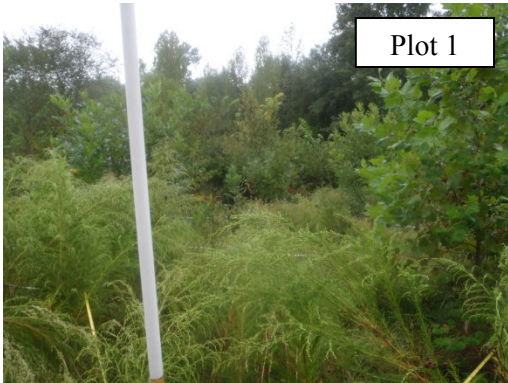
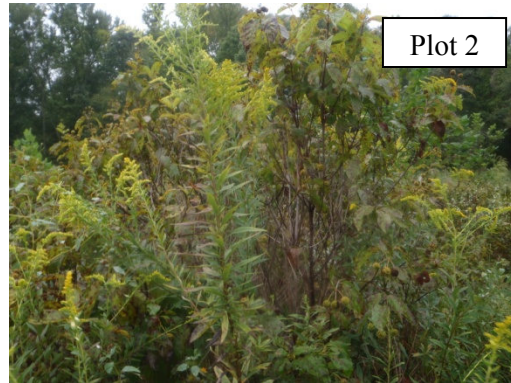
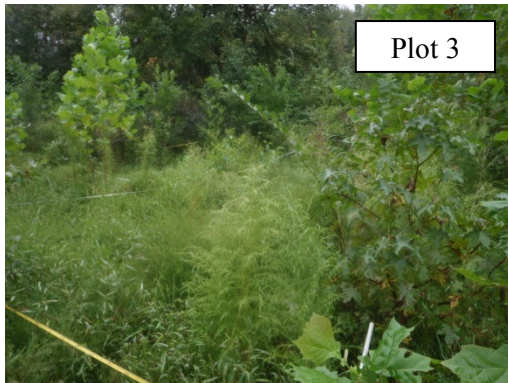
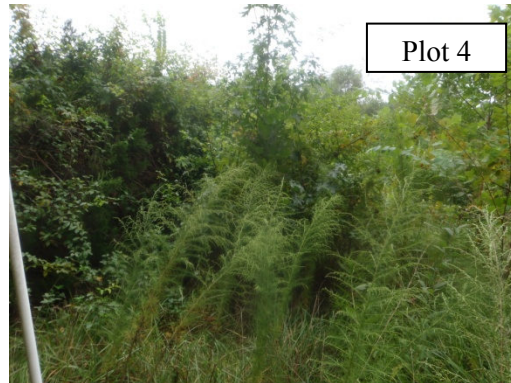
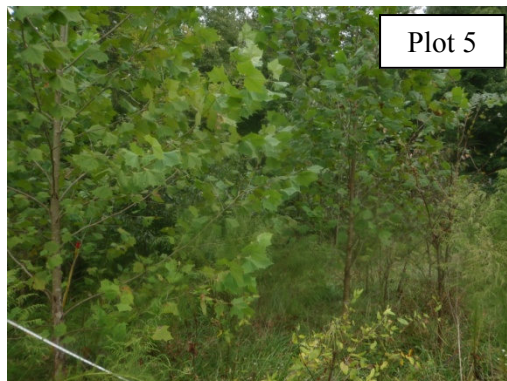
Planted stems throughout the site, including bare roots planted in 2011 are vigorous. A small area in the upstream portion of the site previously reported as having low stem densities due to ponding by beavers has become vegetated with native hardwood species. Many of the planted stems in this area were stunted due to competition with herbaceous species after removal of beaver, currently these trees are vigorous and should continue to thrive unless beaver activity resumes.

UT Haw (Beckom) Year 5 - 2015
Vegetation Monitoring Photographs
Taken September 2015

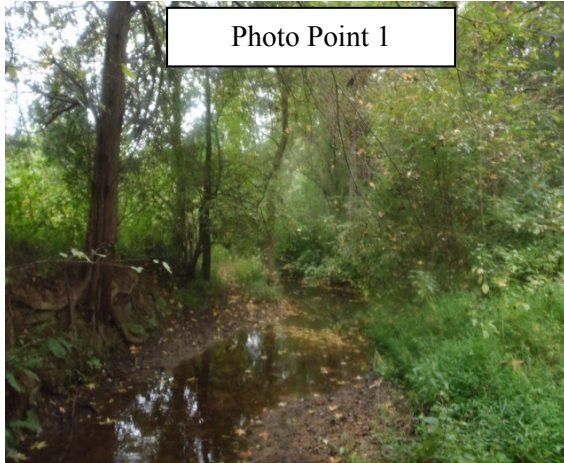
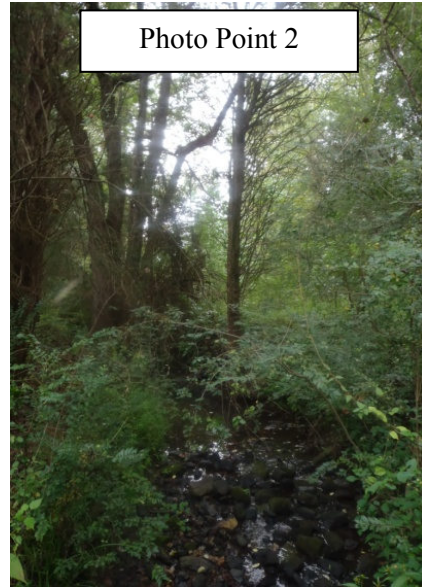
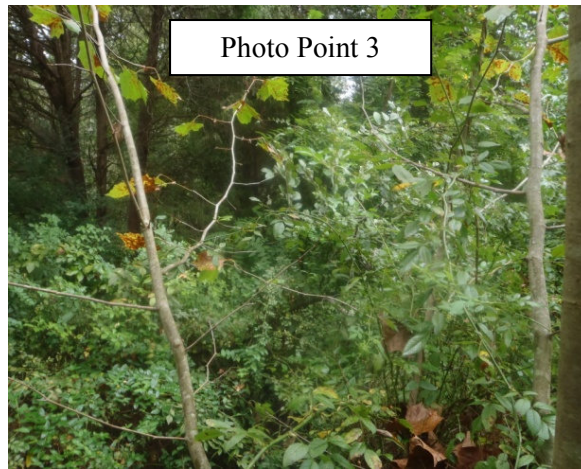
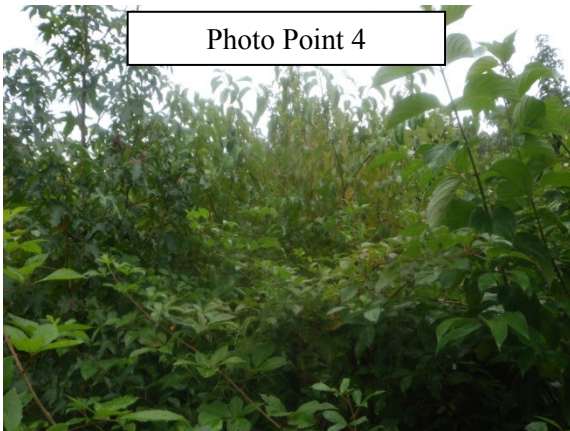
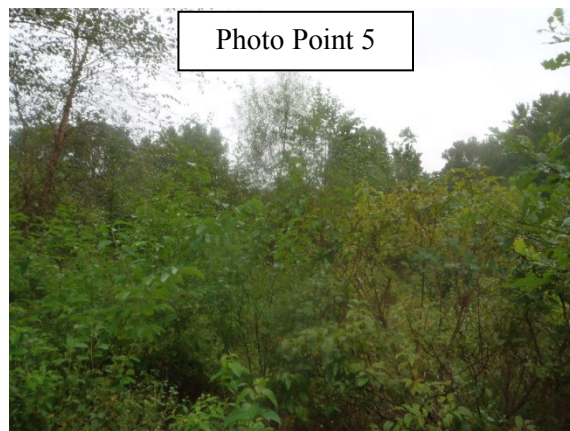
UT Haw (Beckom) Year 5 - 2015
Fixed-Station Photos
Taken September 2015

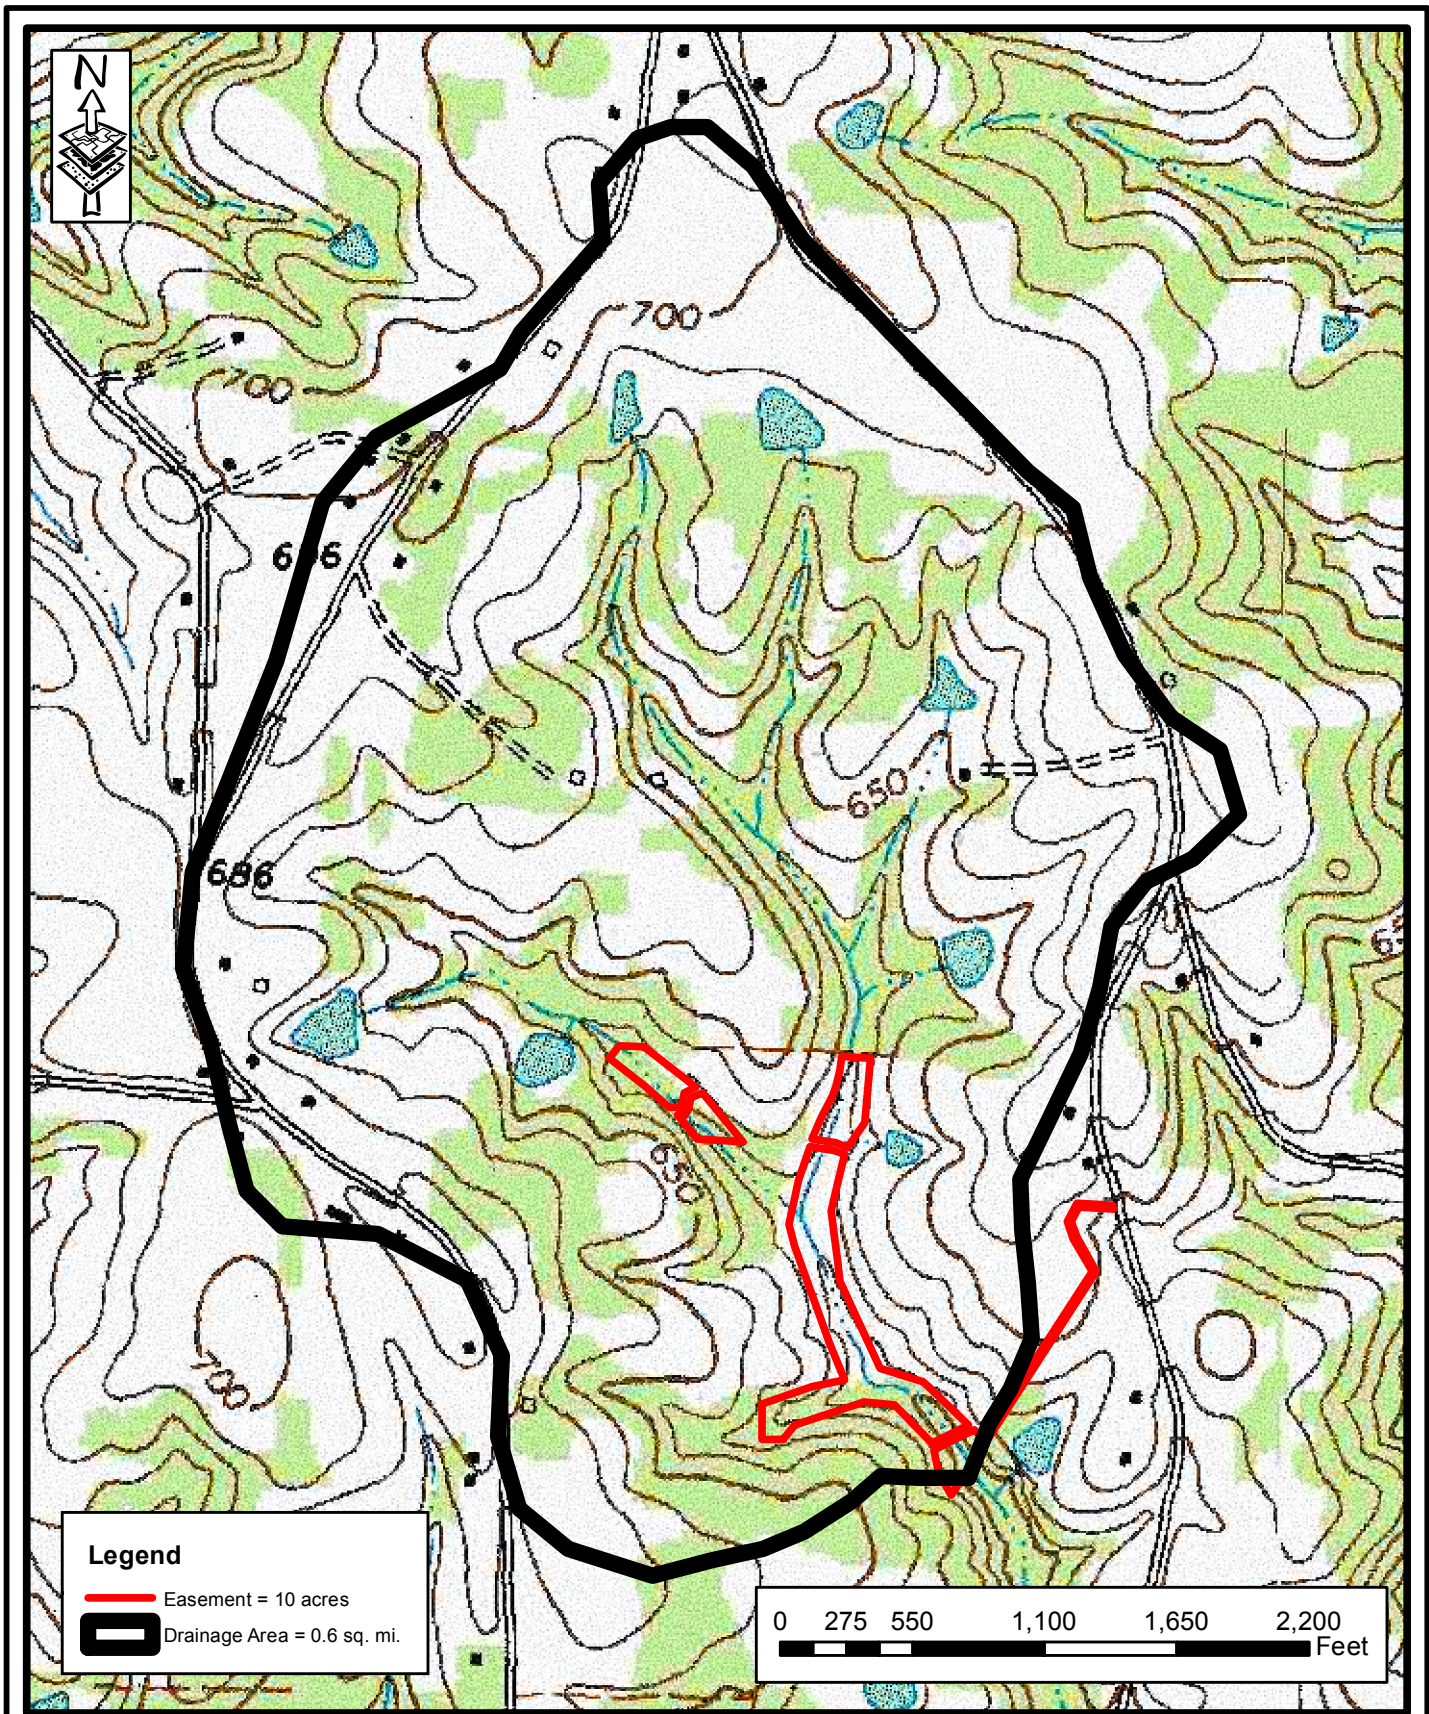
FIGURE
3

**TOPOGRAPHY AND DRAINAGE AREA
 UT TO HAW (BECKOM) SITE (DMS# 92694)
 Alamance County, North Carolina**
