**FINAL**  
**ANNUAL MONITORING REPORT**  
**UT TO HAW (GWYNN) SITE**  
**ALAMANCE COUNTY, NORTH CAROLINA**  
**(EEP Project No. 92753)**

Monitoring Year 2 of 5 (2011)

June 2011

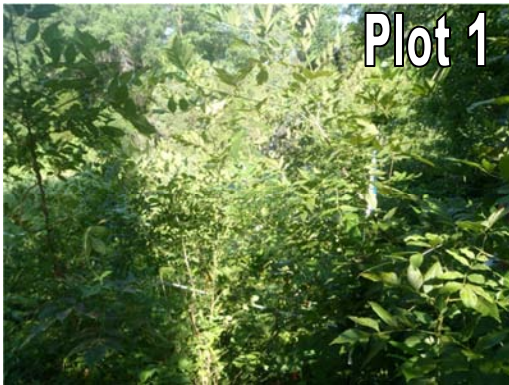
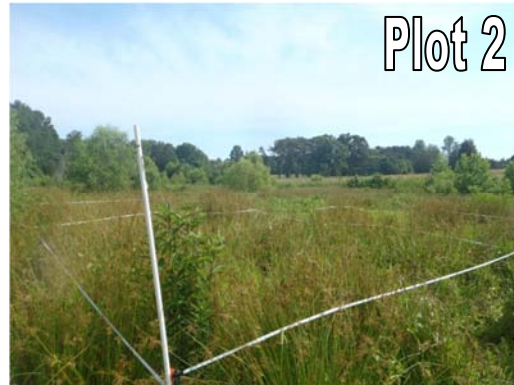
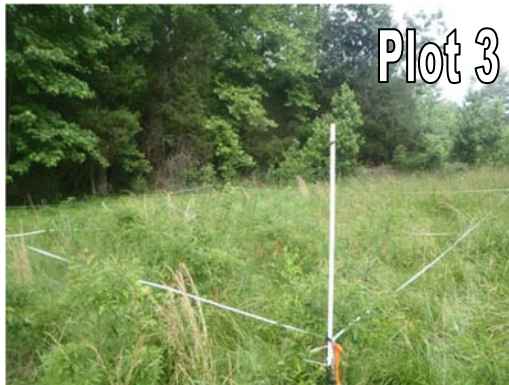
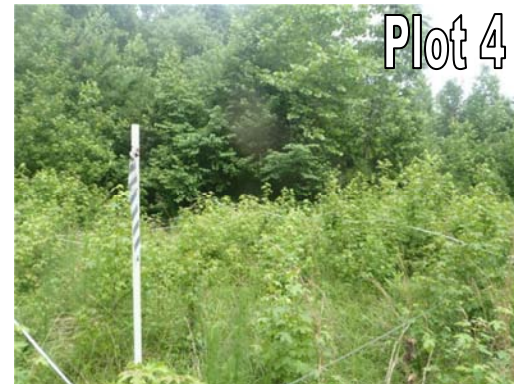
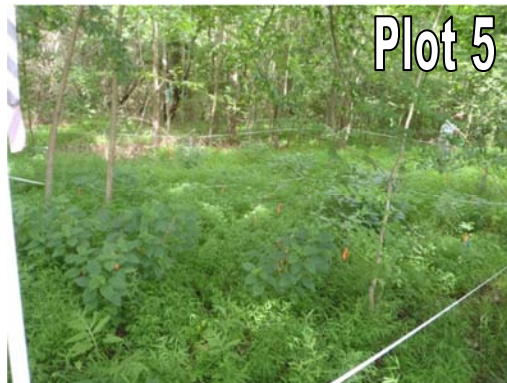
**UT to Haw (Gwynn) Restoration Site  
Year 2 (2011) Annual Monitoring  
Vegetation Plot Photos (taken June 17, 2011)**

Vegetation Plot ID	Vegetation Survival Threshold Met?	Tract Mean
1	Yes	100%
2	Yes	
3	Yes	
4	Yes	
5	Yes

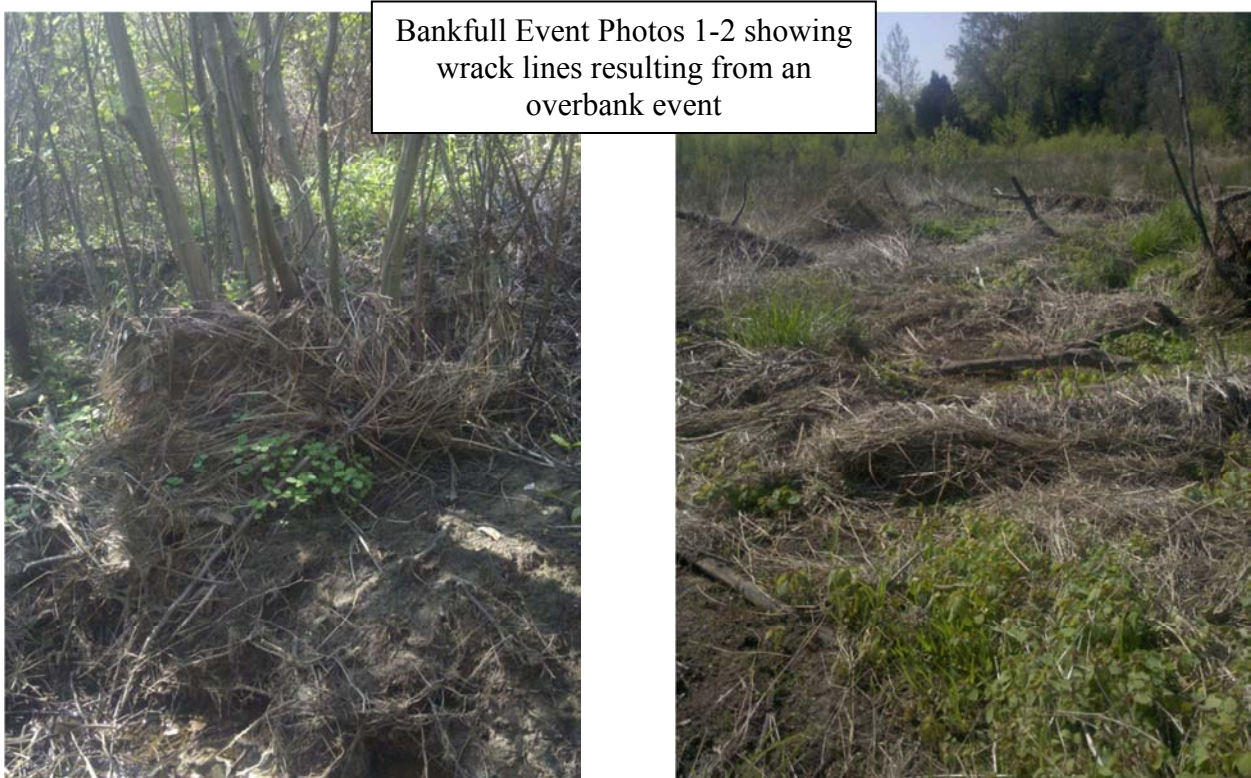
Date of Data Collection	Date of Occurrence	Method	Photo (if available)
February 17, 2010	February 5, 2010	Visual observations of overbank event including wrack lines and sediment deposition resulting from a 1.36 inch* rainfall event on February 5, 2010 that occurred after numerous rainfall events, within the 3 weeks prior, that totaled 3.52 inches.	1-2
June 16, 2010	May 17, 2010	Visual observations of overbank event including wrack lines and sediment deposition resulting from a 4.1 inch* rainfall event on May 16-17, 2010.	--
October 5, 2010	September 30, 2010	A 4.43-inch* rainfall event occurring between September 26-October 2, 2010.	--
