**FINAL
ANNUAL MONITORING REPORT
UT TO HAW (GWYNN) SITE
ALAMANCE COUNTY, NORTH CAROLINA
(EEP Project No. 92753, Contract No. 004543)**

Monitoring Year 5 of 5 (2014)

Prepared by:
Axiom Environmental, Inc.
218 Snow Avenue
Raleigh, North Carolina 27603

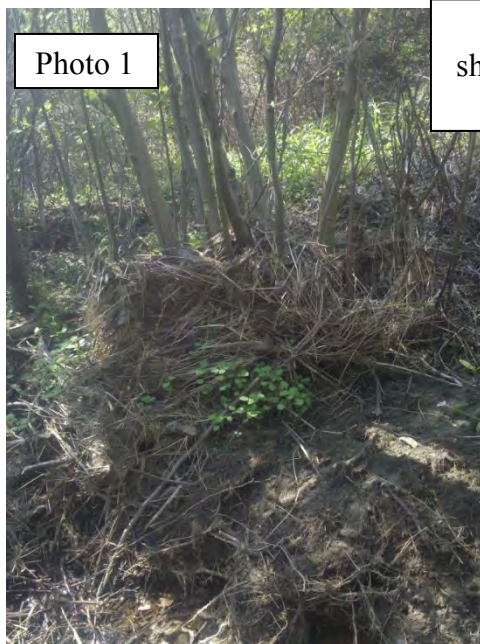
Photo 1

Bankfull Event Photos 1 and 2 showing wrack lines resulting from overbank events

Date of Data Collection	Date of Occurrence	Method	Photo (if available)
February 17, 2010	February 5, 2010	Visual observations of overbank event including wrack lines and sediment deposition resulting from a 1.36 inch* rainfall event on February 5, 2010 that occurred after numerous rainfall events, within the 3 weeks prior, that totaled 3.52 inches.	1
June 16, 2010	May 17, 2010	Visual observations of overbank event including wrack lines and sediment deposition resulting from a 4.1 inch* rainfall event on May 16-17, 2010.	--
October 5, 2010	September 30, 2010	A 4.43-inch* rainfall event occurring between September 26-October 2, 2010.	--
September 30, 2011	June 28, 2011	Total of 2.83 inches* of rain reported to fall over 2 days (June 27-28, 2011)	--
September 30, 2011	September 24, 2011	Total of 3.61 inches* of rain reported to fall over 4 days (September 21-24, 2011) with an additional 0.85 inches* of rain the following 3 days (Sept 25-27, 2011)	--

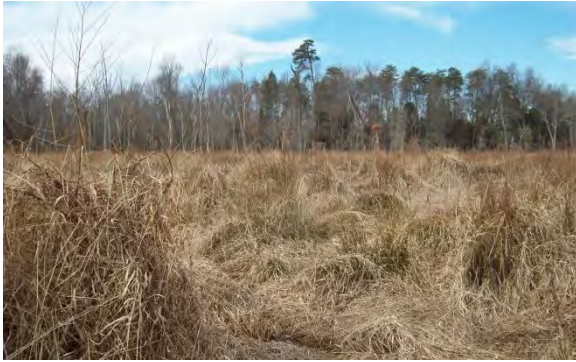
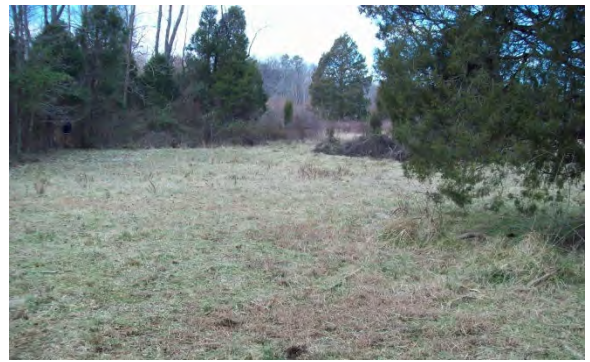
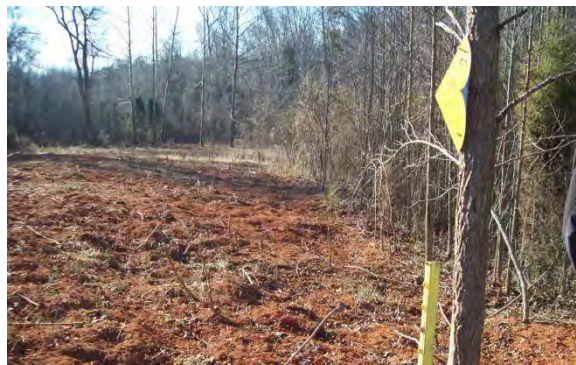
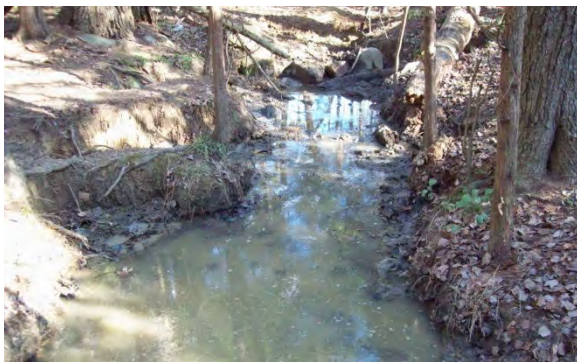
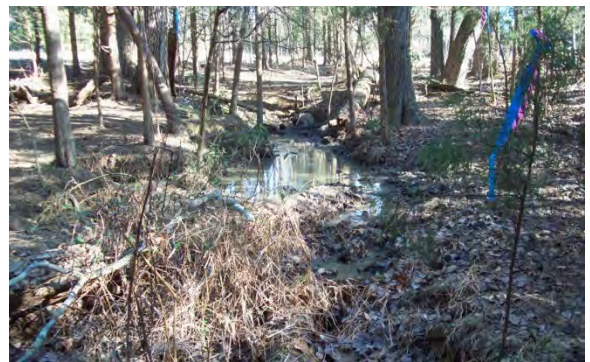
**UT to Haw (Gwynn) Site
Preconstruction Pictures
Taken February 2009**

Prior to construction the Site was characterized by pasture land utilized for livestock grazing, a drained pond, and disturbed forest. Land use practices including the maintenance and removal of riparian vegetation and hoof shear from livestock had resulted in degraded water quality, unstable channel characteristics (stream entrenchment, erosion, and bank collapse), and reduced storage capacity and floodwater attenuation. In addition, hydric soils were disturbed due to regular plowing, vegetation maintenance, and hoof shear from livestock.
