# Baseline and Year 1 Annual Monitoring Document

UT to Haw River (#747)

Alamance County

Data Collection Period: August 2012

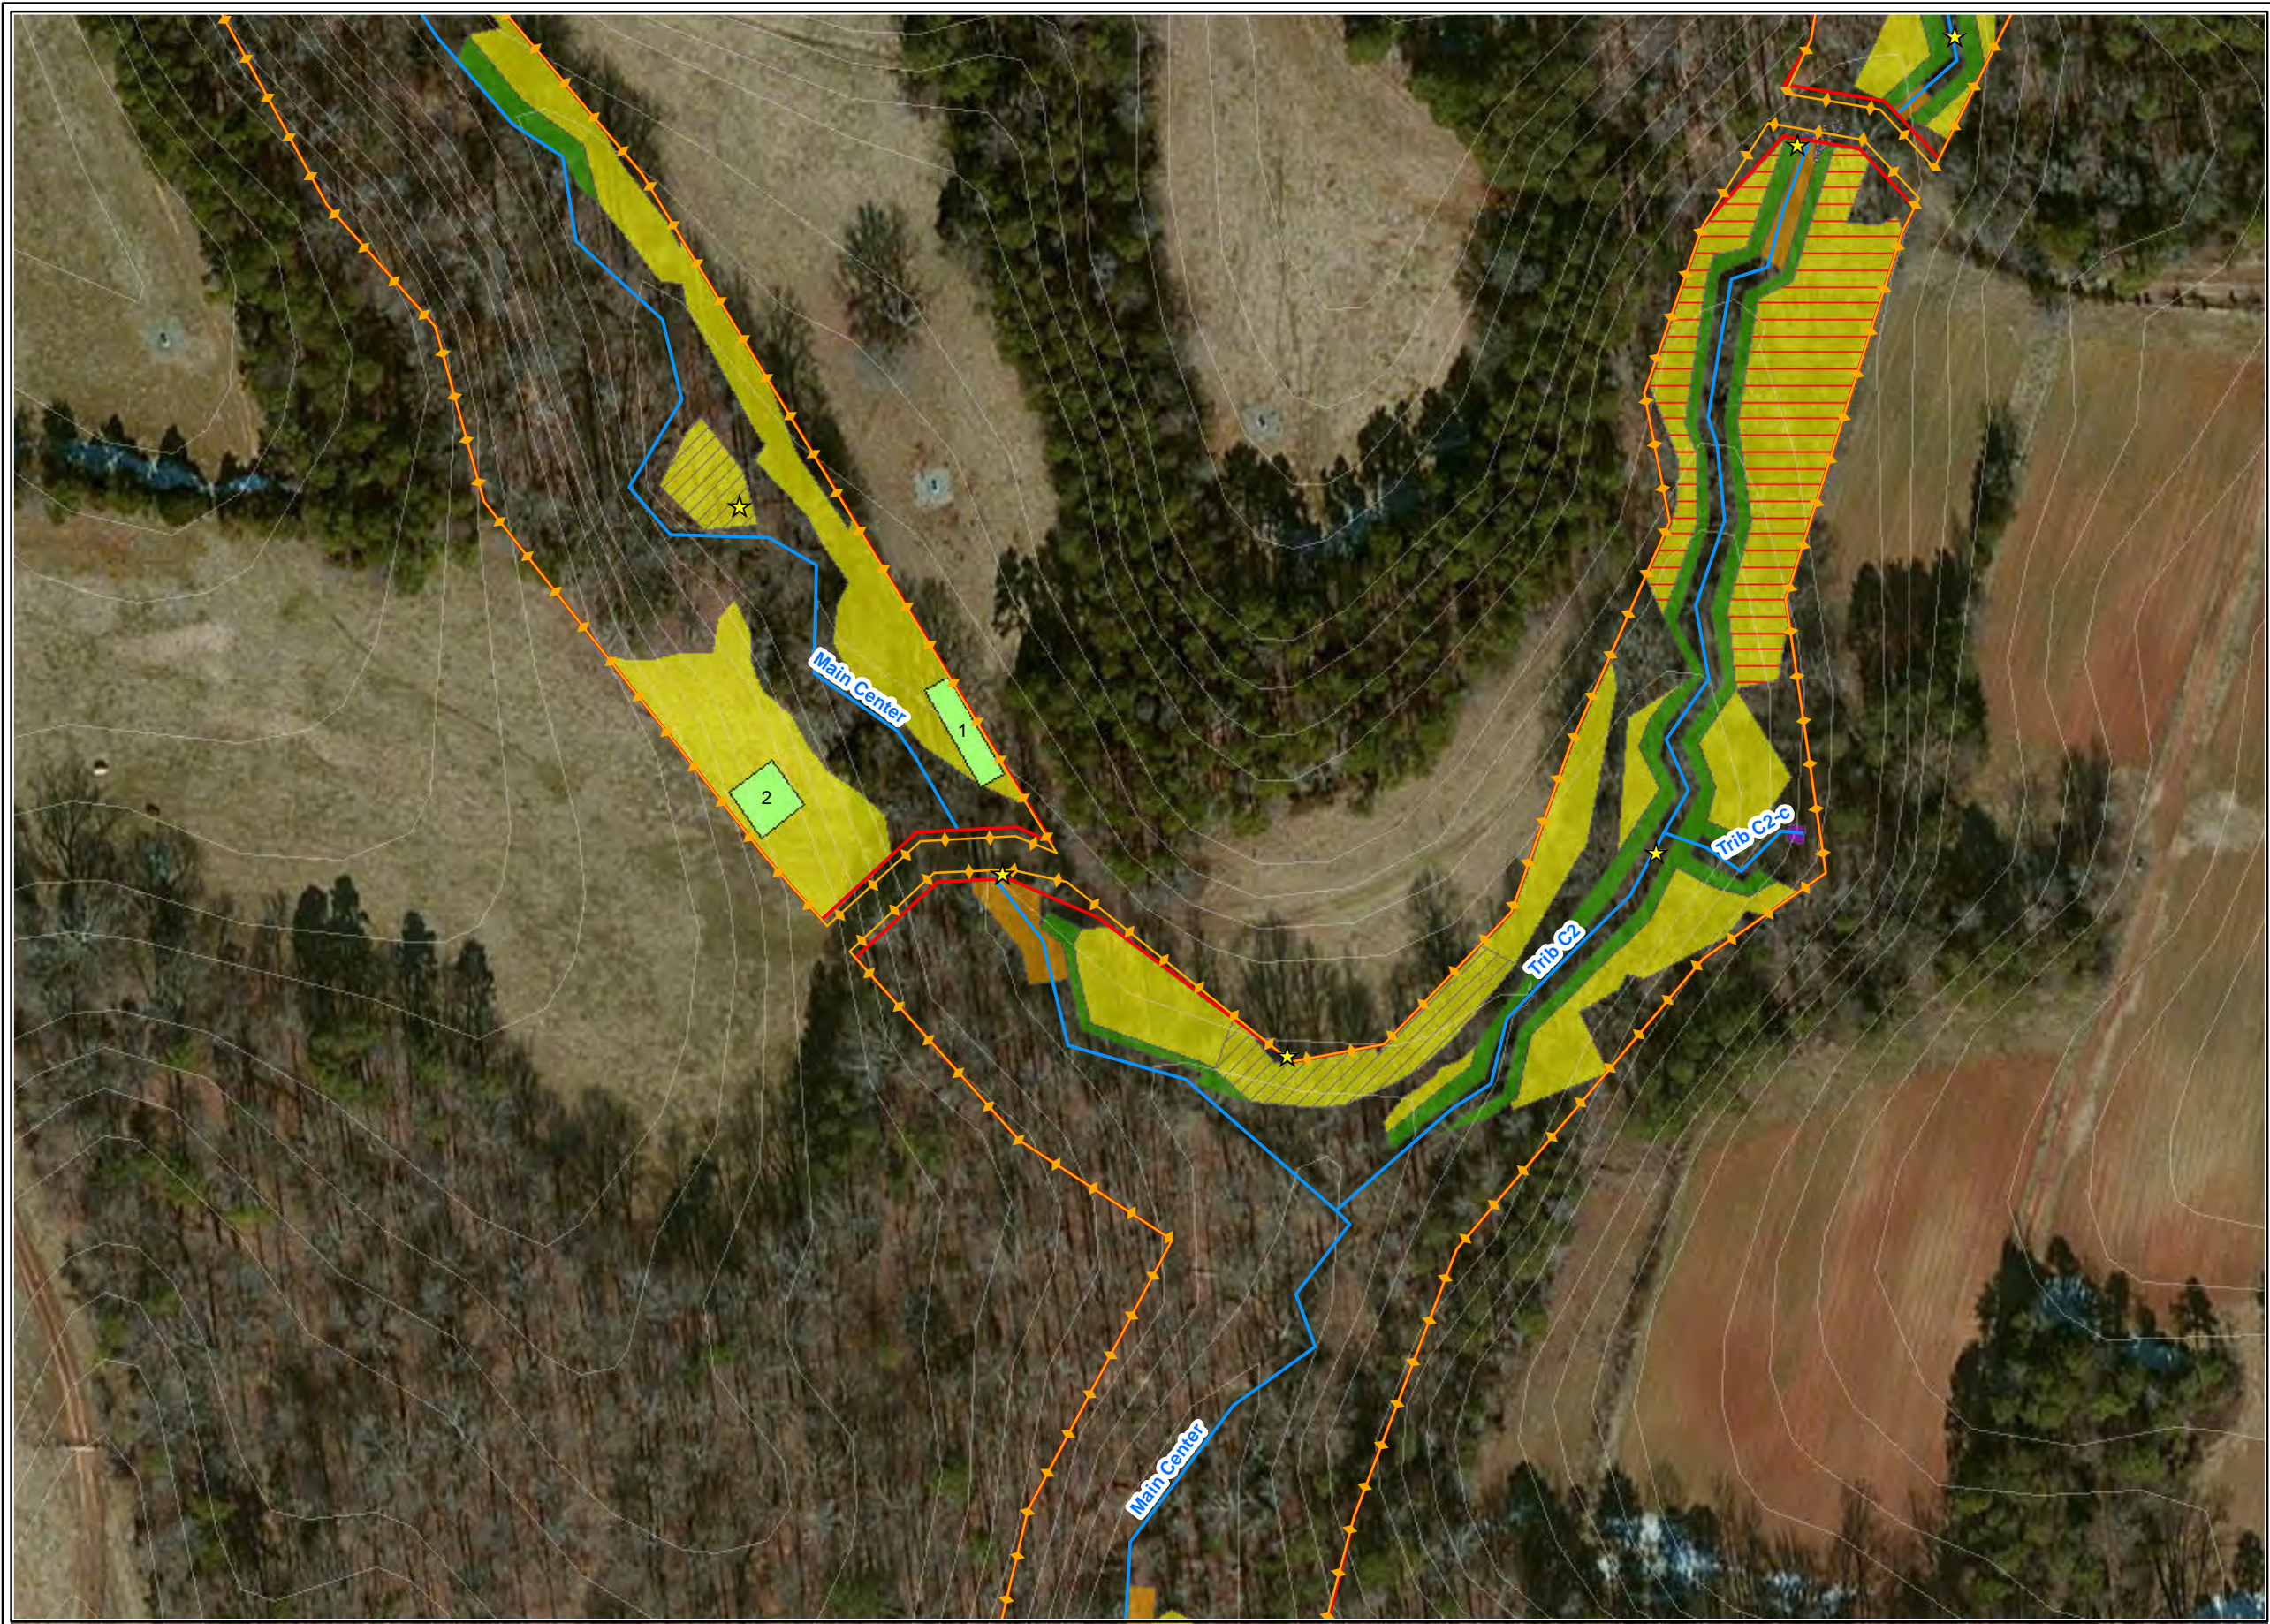
**CURRENT CONDITION PLAN VIEW**

Invasive species observed consisted of *Ligustrum sinense* (Chinese privet). This area of the easement was dense with Chinese privet prior to construction and needs to be observed closely during the monitoring period.
