UT to JUMPING RUN CREEK STREAM & WETLAND
RESTORATION
MONITORING REPORT (YEAR 4 OF 5)
Cumberland County, North Carolina
EEP Project Number 92345
Monitoring Contract Number D09085S

Status of Plan: FINAL
Construction Completed: 2010
Data Collected: 2013
Submission Date: November 2013

Stantec Consulting Services Inc.
801 Jones Franklin Road, Suite 300
Raleigh, NC 27606

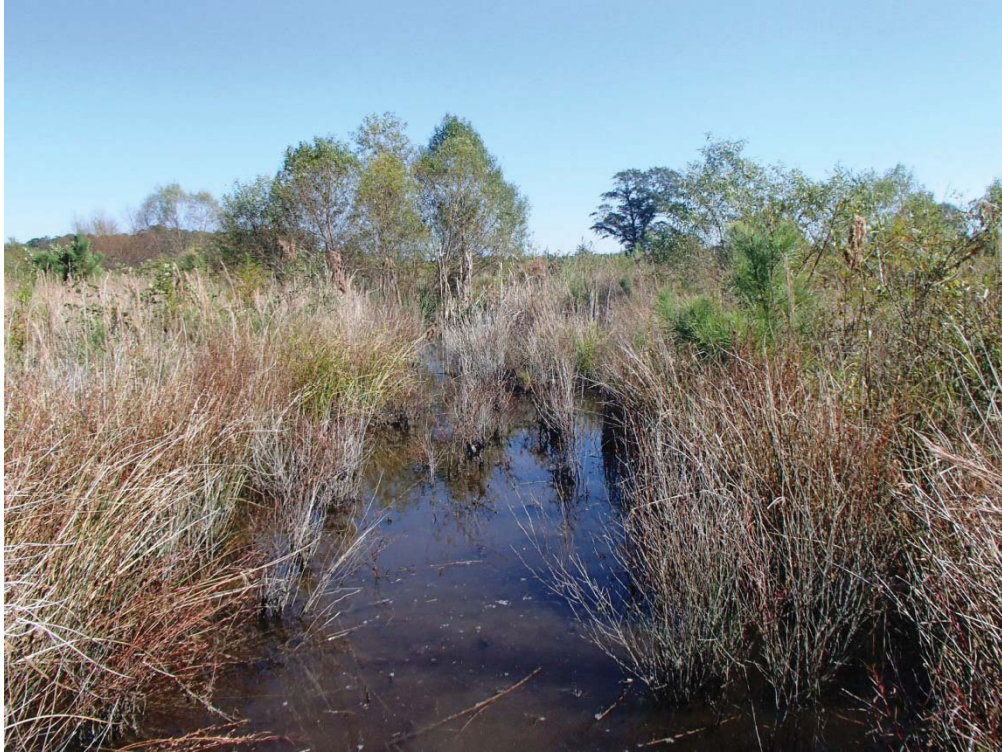
Photo B3 – (Photo Station 3) Cross-section 3 looking downstream at Station 54+98
(10/24/2013 Year 4)

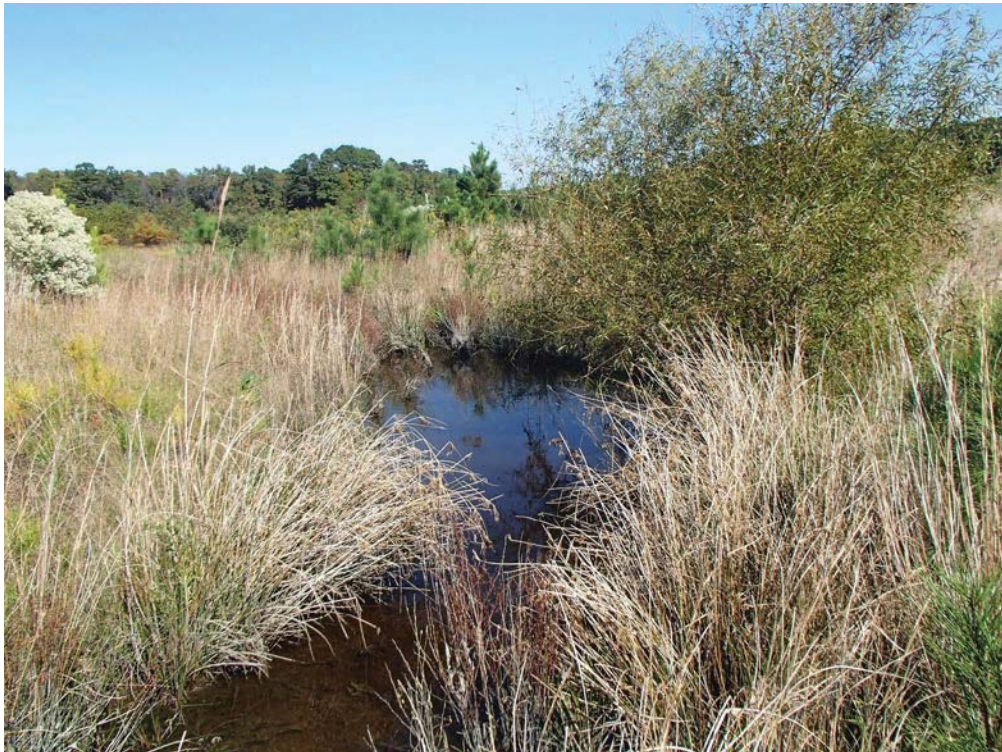
Photo B4 – (Photo Station S4) Cross-section 4 looking downstream at Station 59+09
(10/24/2013 Year 4)

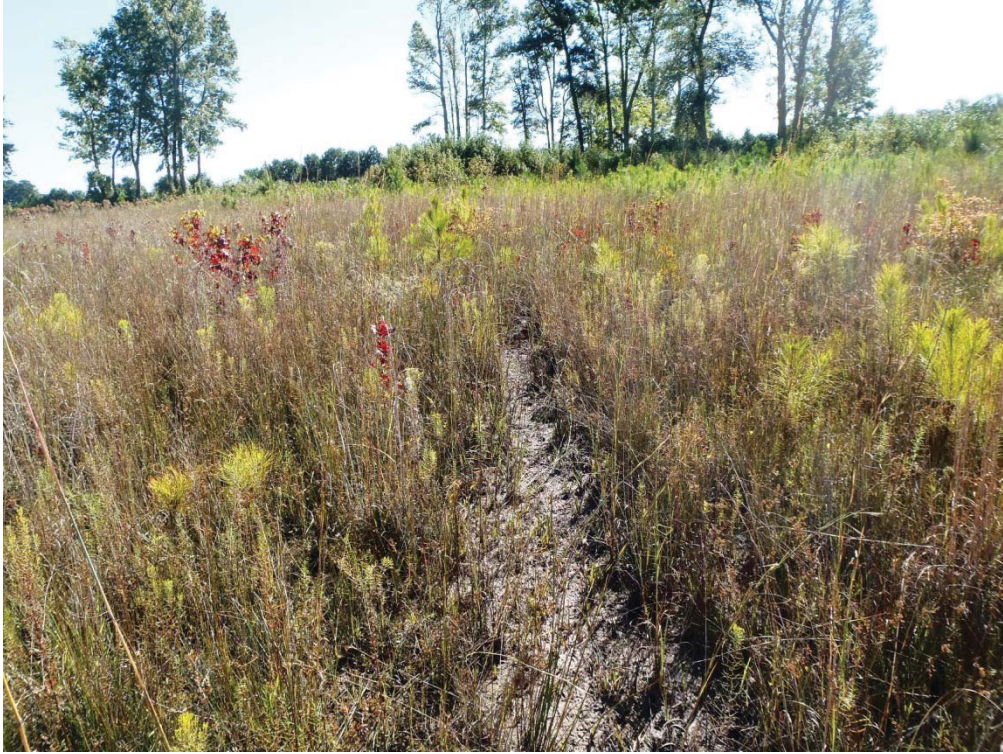
Photo B13 – Evidence of flow observed in headwater system UT1A (10/24/2013 Year 4)

The upstream braided reach (UT1A) is stable and appears to be functioning as designed. There are signs that water is flowing through the multiple braids and collecting in the shallow pool areas. Additionally, fish and amphibians were observed in all three reaches of the stream restoration. The single thread restoration reach (UT1B) was observed to be in generally stable condition. Over the approximately 3600 linear feet of channel restoration, the channel's profile and cross-section has only adjusted minimally from baseline conditions. Two small areas of aggradation reported in 2012, at Station 52+50 and Station 55+50, have begun to scour slightly and are transporting sediment. The *Typha latifolia* was still present in these areas, but has not migrated upstream or downstream relative to what was observed in 2012. Random isolated areas of beaver damage to livestakes exist from STA 65+00 to 82+00 along both banks of the stream. The livestakes were well established, and the root stock should allow regeneration without the need for replanting. These areas will be carefully monitored during future field visits to document any

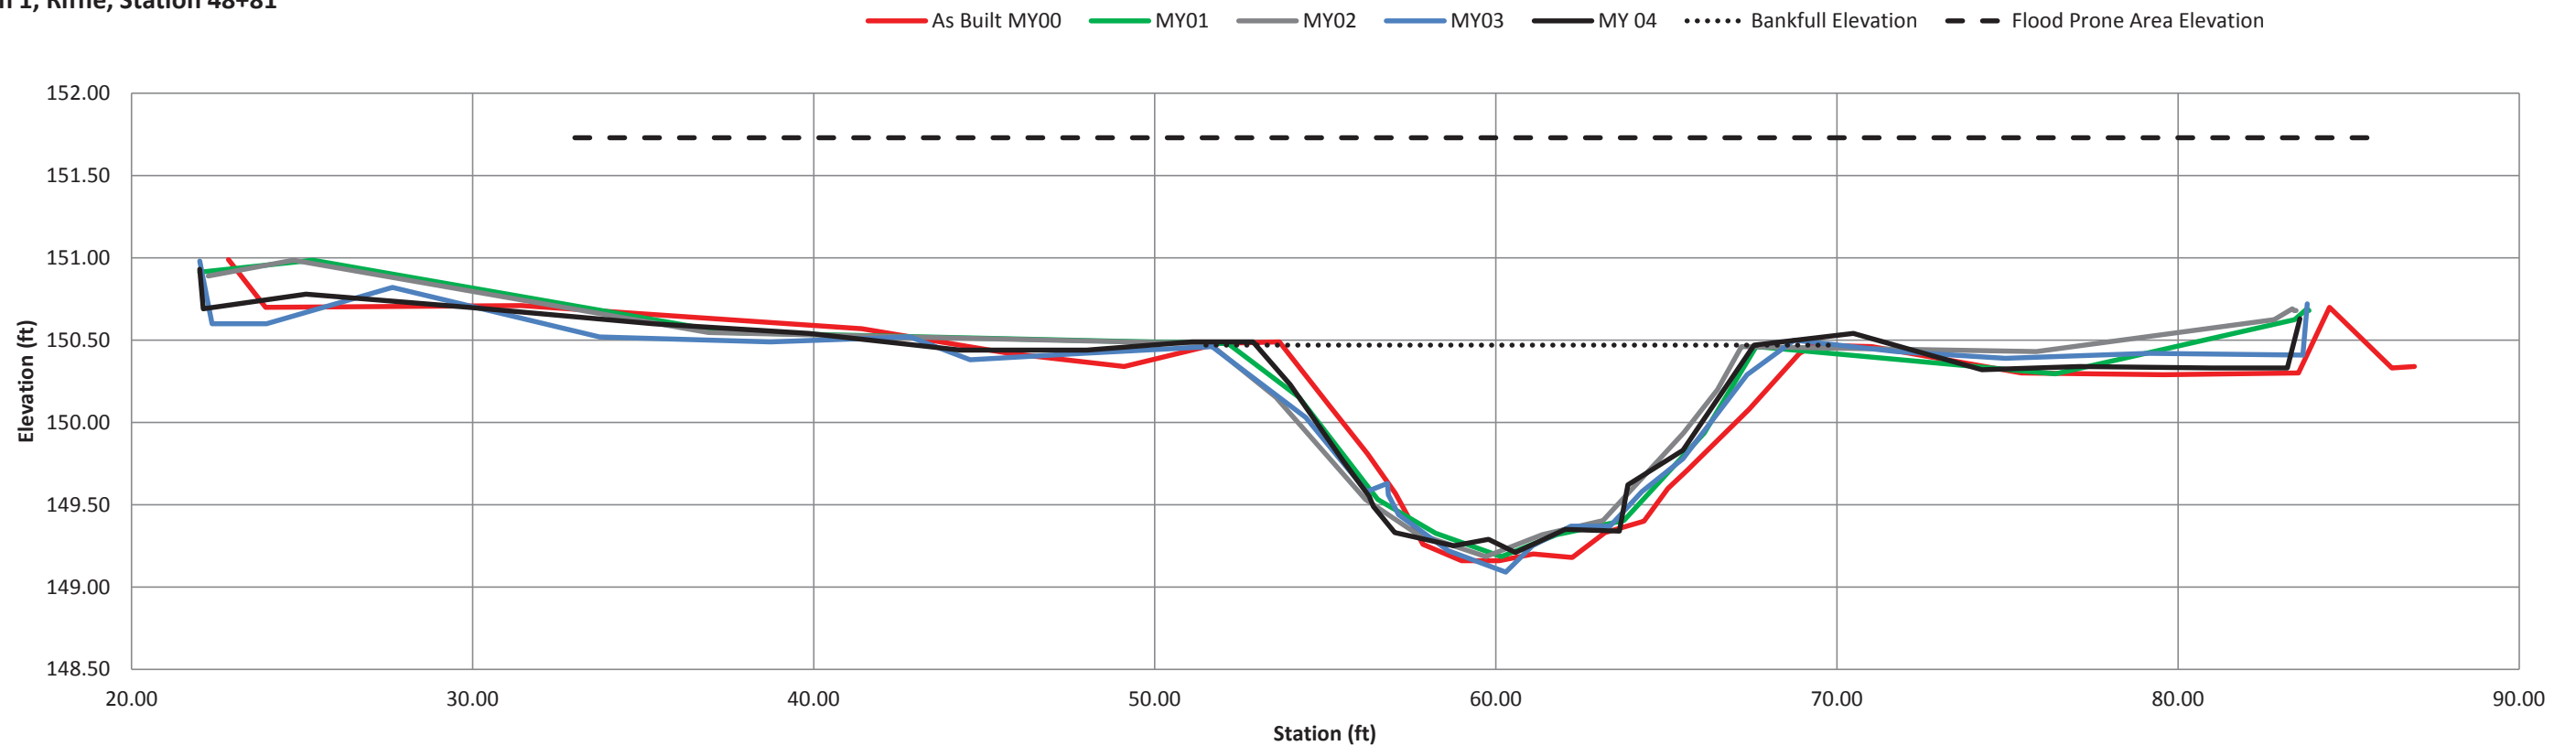
**UT to Jumping Run Creek, Reach UT1B
X-Section 1, Riffle, Station 48+81**

SUMMARY DATA	MY00	MY01	MY02	MY03	MY04
Bankfull Elevation	150.47	150.46	150.48	150.46	150.47
Bankfull Cross-Sectional Area	12.9	13.16	12.52	12.74	12.12
Bankfull Width	15.6	15.35	15.6	16.99	14.61
Flood Prone Area Elevation	151.78	151.74	151.78	151.83	151.73
Flood Prone Width	200	200	200	200	200
Max Depth at Bankfull	1.31	1.28	1.3	1.37	1.26
Mean Depth at Bankfull	0.83	0.79	0.8	0.75	0.83
W/D Ratio	18.73	19.43	19.50	22.65	17.60
Entrenchment Ratio	12.86	13.03	12.82	11.77	13.69
Bank Height Ratio	1.0	1.0	1.0	1.0	1.0
Stream Type	C	C	C	C	C

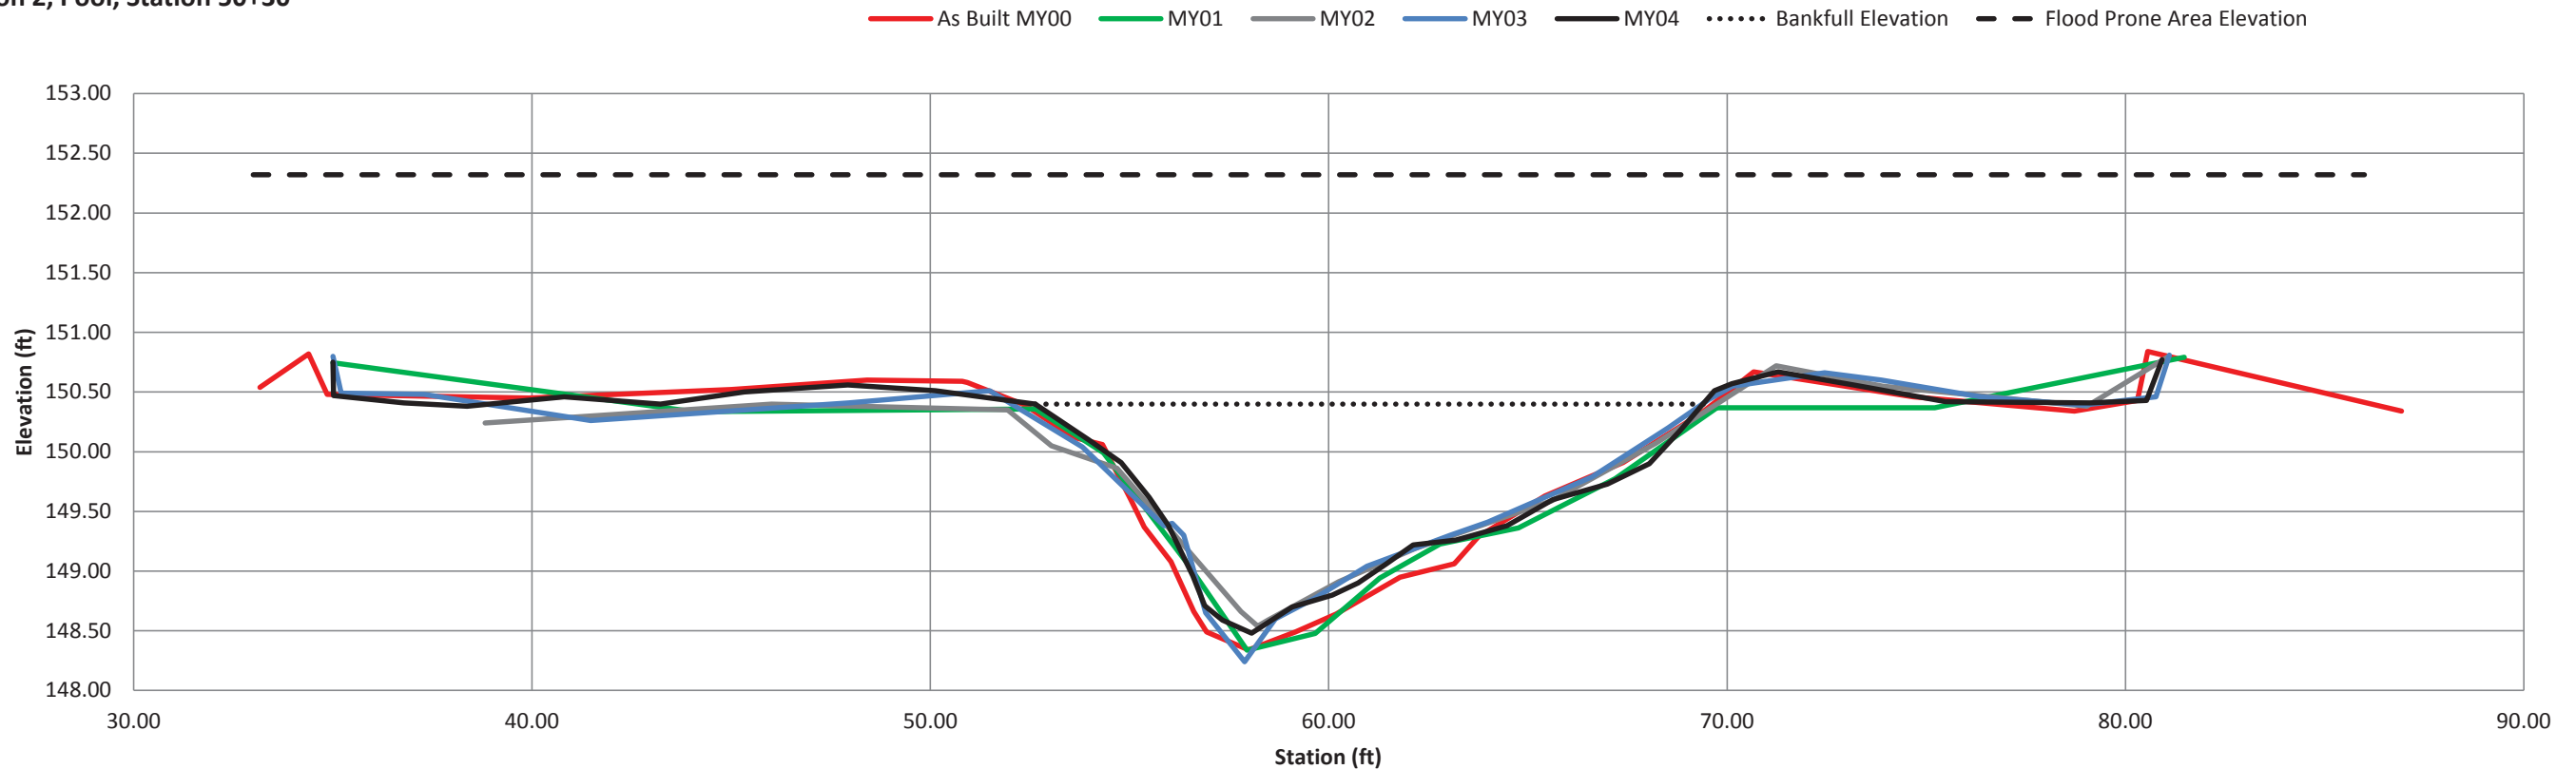
UT to Jumping Run Creek, Reach UT1B
X-Section 2, Pool, Station 50+30

SUMMARY DATA	MY00	MY01	MY02	MY03	MY04
Bankfull Elevation	150.58	150.36	150.35	150.51	150.40
Bankfull Cross-Sectional Area	21.57	17.26	15.57	18.60	16.78
Bankfull Width	19.33	17.30	17.56	18.53	16.77
Flood Prone Area Elevation	152.82	152.38	152.16	152.78	152.32
Flood Prone Width	200	200	200	200	200
Max Depth at Bankfull	2.25	2.02	1.81	2.27	1.92
Mean Depth at Bankfull	1.12	1.01	0.89	1.00	1.00
W/D Ratio	17.26	17.13	17.13	18.53	16.77
Entrenchment Ratio	10.35	11.56	11.56	10.79	11.93
Bank Height Ratio	1.0	1.0	1.0	1.0	1.0
Stream Type	C	C	C	C	C

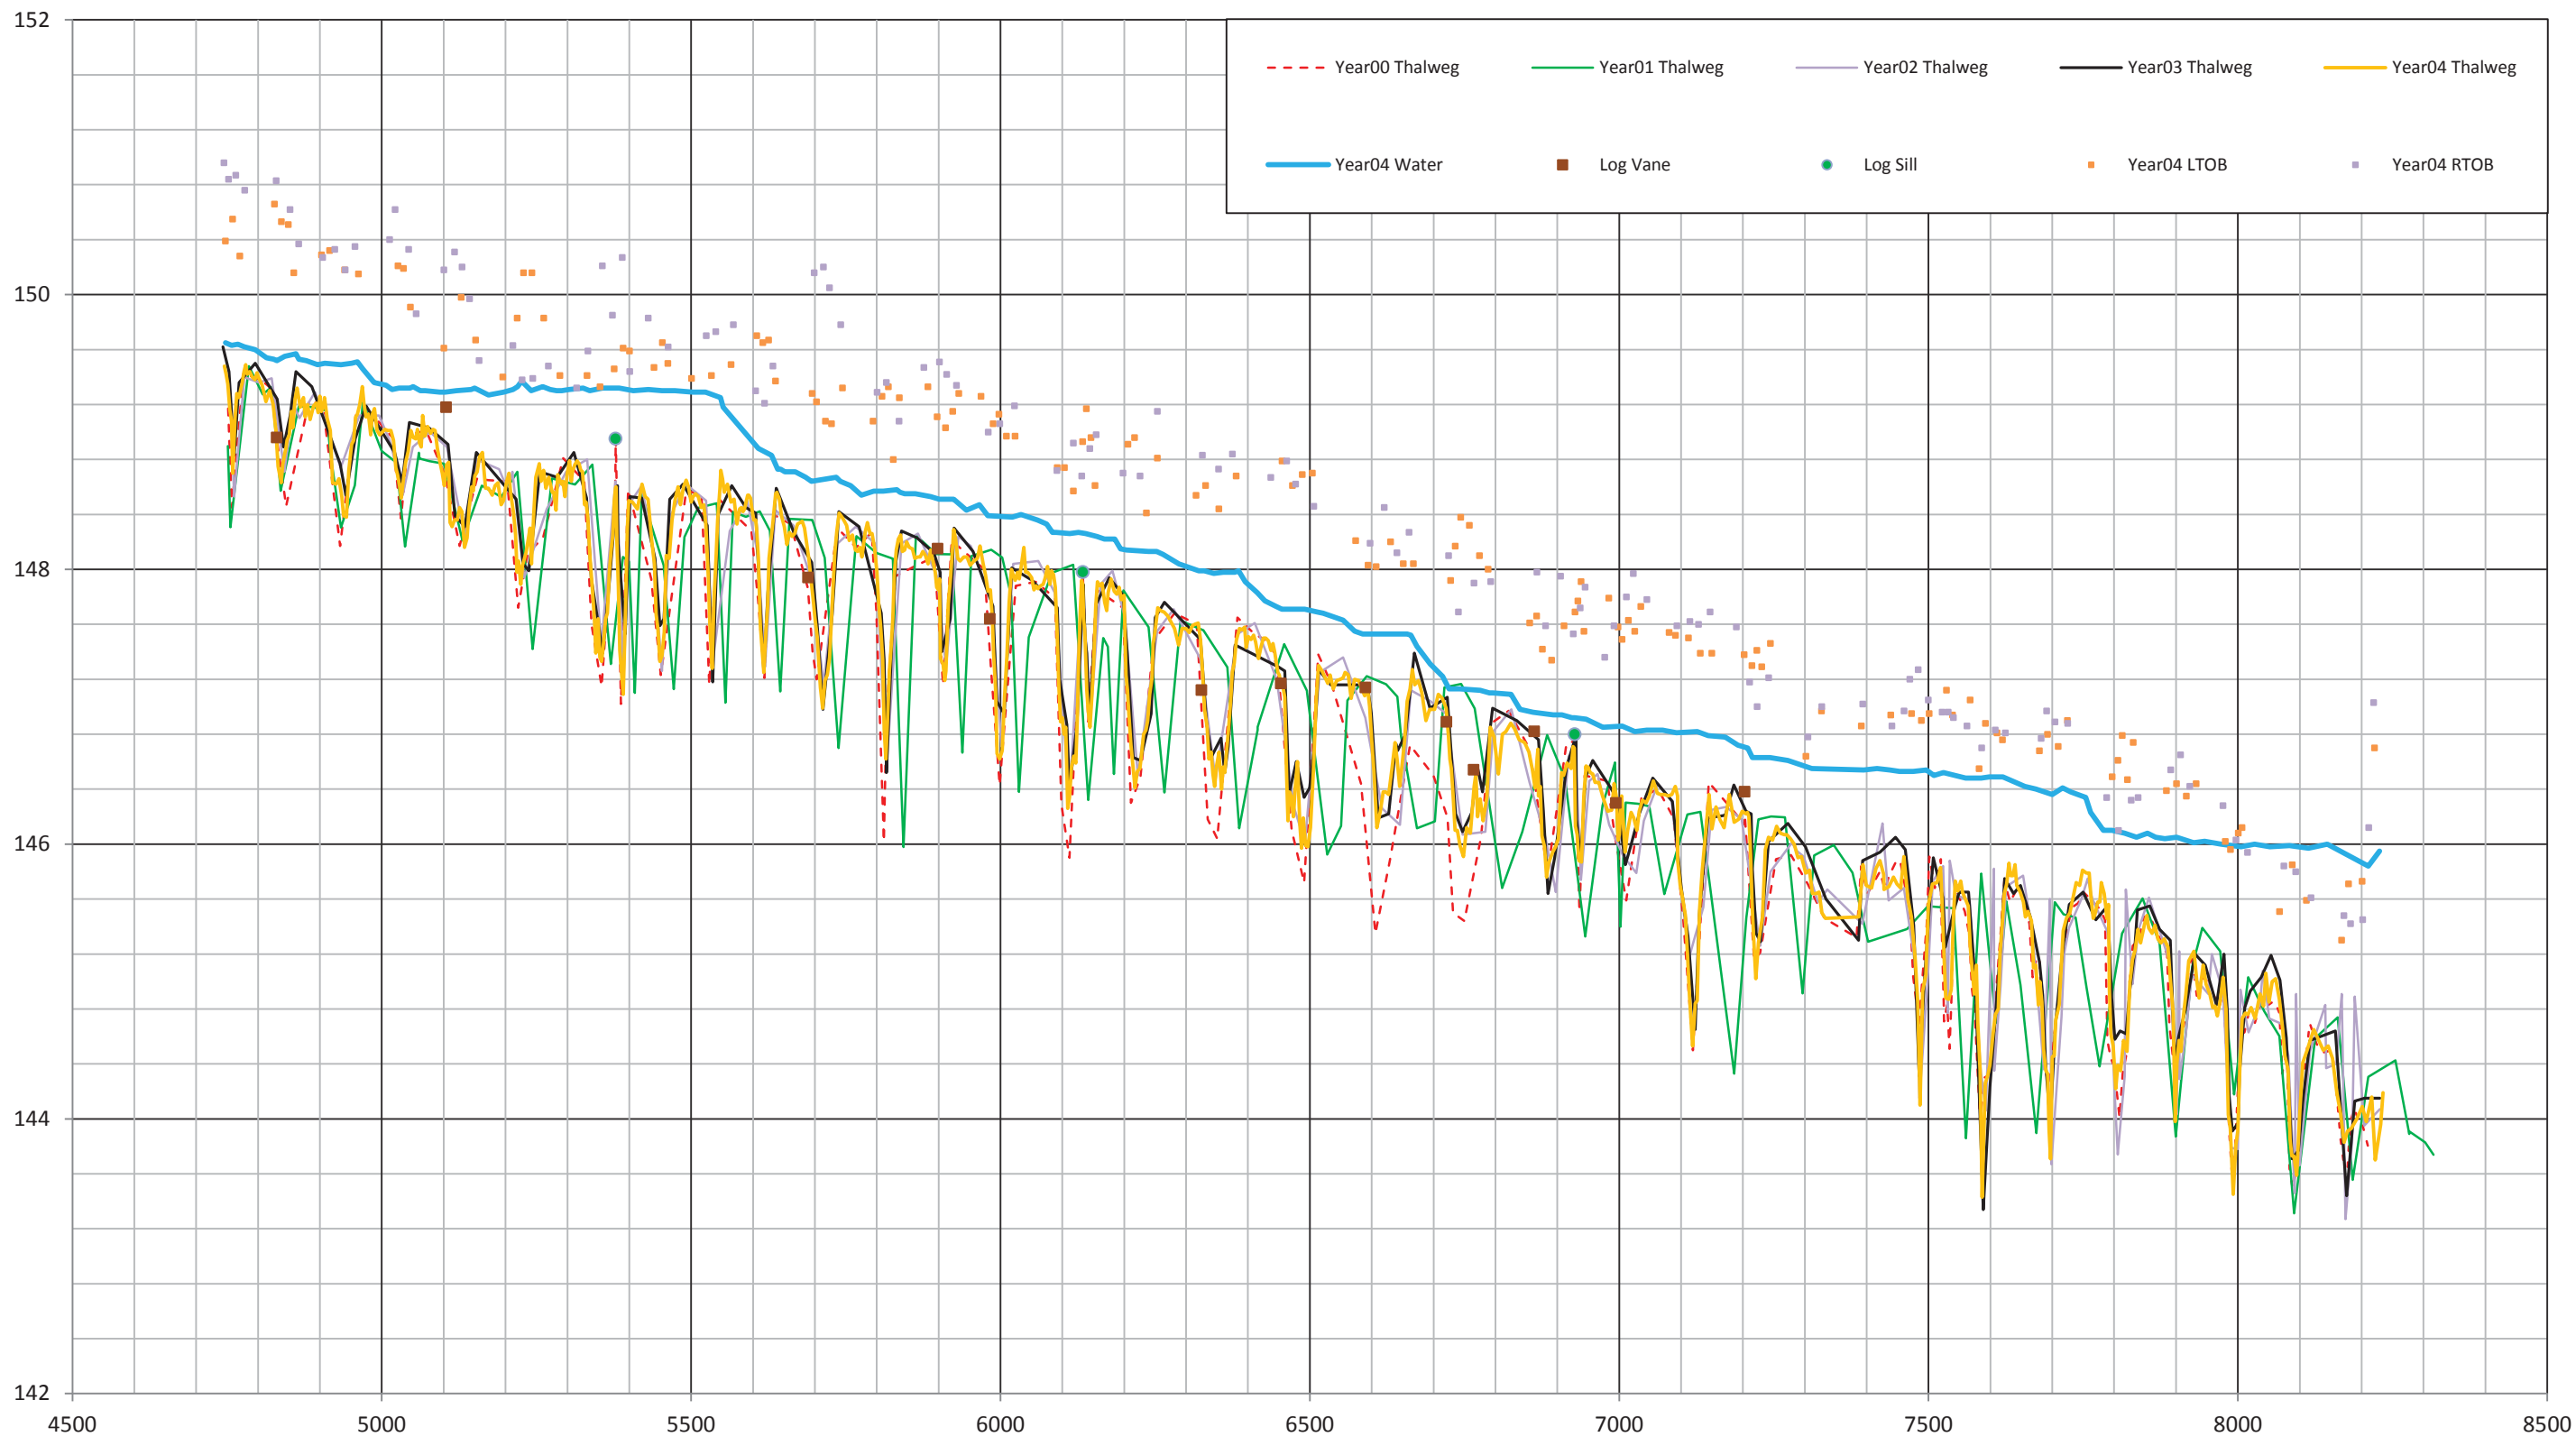
UT to Jumping Run Creek, Reach UT1B
Longitudinal Profile, Year 04, STA 47+45 to 82+10

The entire longitudinal profile of reach UT1B was surveyed (3,661 lf). Stationing from the as-built survey was used. The longitudinal profiles should show that the bedform features are remaining stable. The pools should remain deep with flat water surface slopes, and the riffles should remain steeper and shallower than the pools.

changes. Controlling beaver activity will be essential in allowing these plants to regenerate. The enhancement reach UT1C appears to be stable, with bank pin surveys showing no aggradation or degradation. The above average rainfall recorded from April – July, coupled with the beaver activity, exposed the stream and surrounding floodplain to higher flow conditions that the site had not dealt with before. Overall the stream is visually stable and did an excellent job withstanding the above normal rainfall events and beaver activity. It should be noted that even after the beaver dam was partially removed the water surface survey was still influenced by the backwater (as seen in the longitudinal profile) and limited the number of geomorphic measurements.

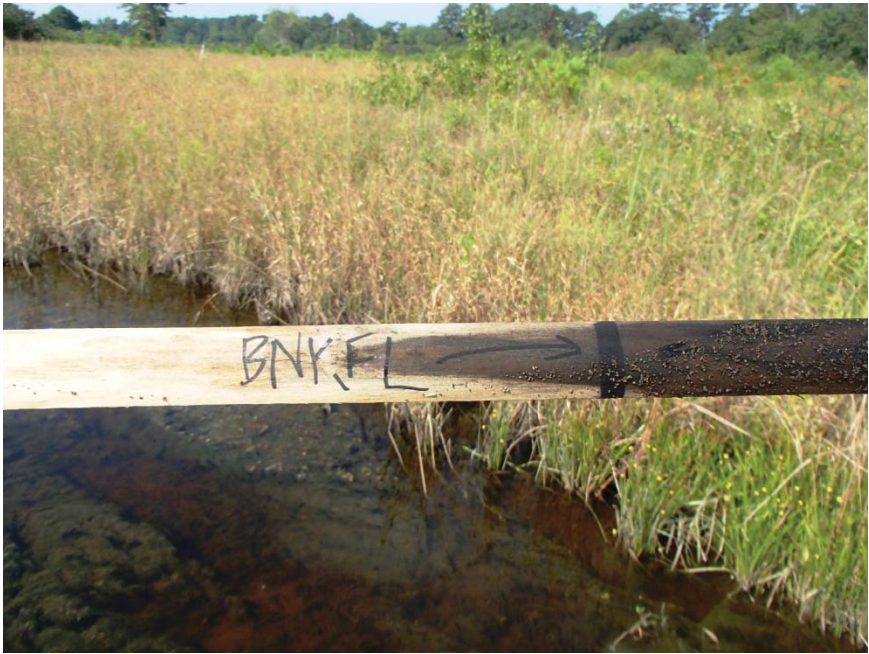
E1 – Crest gauge 1 with cork observed above the bankfull line

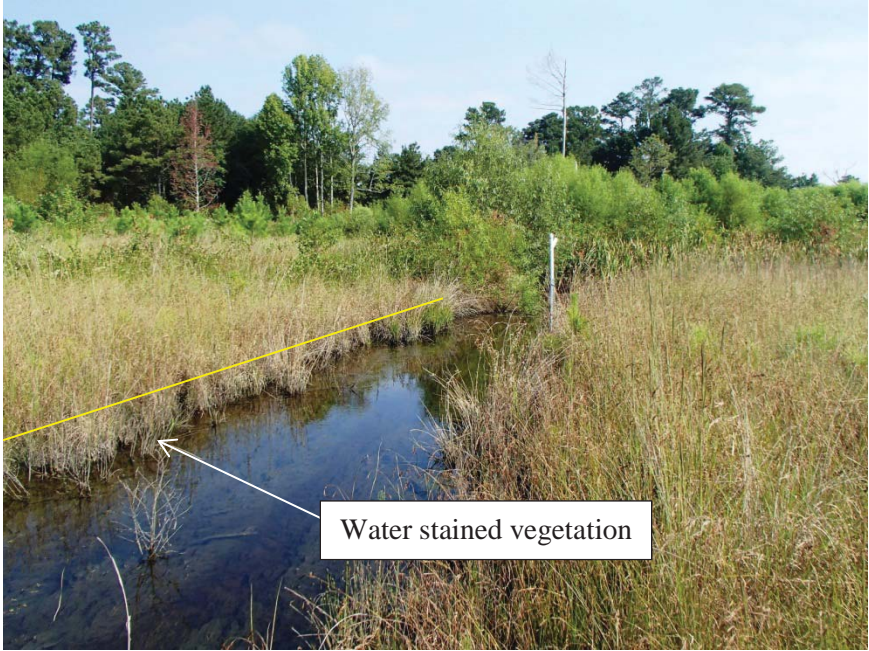
E2 – Water stained vegetation in the vicinity of crest gauge 1

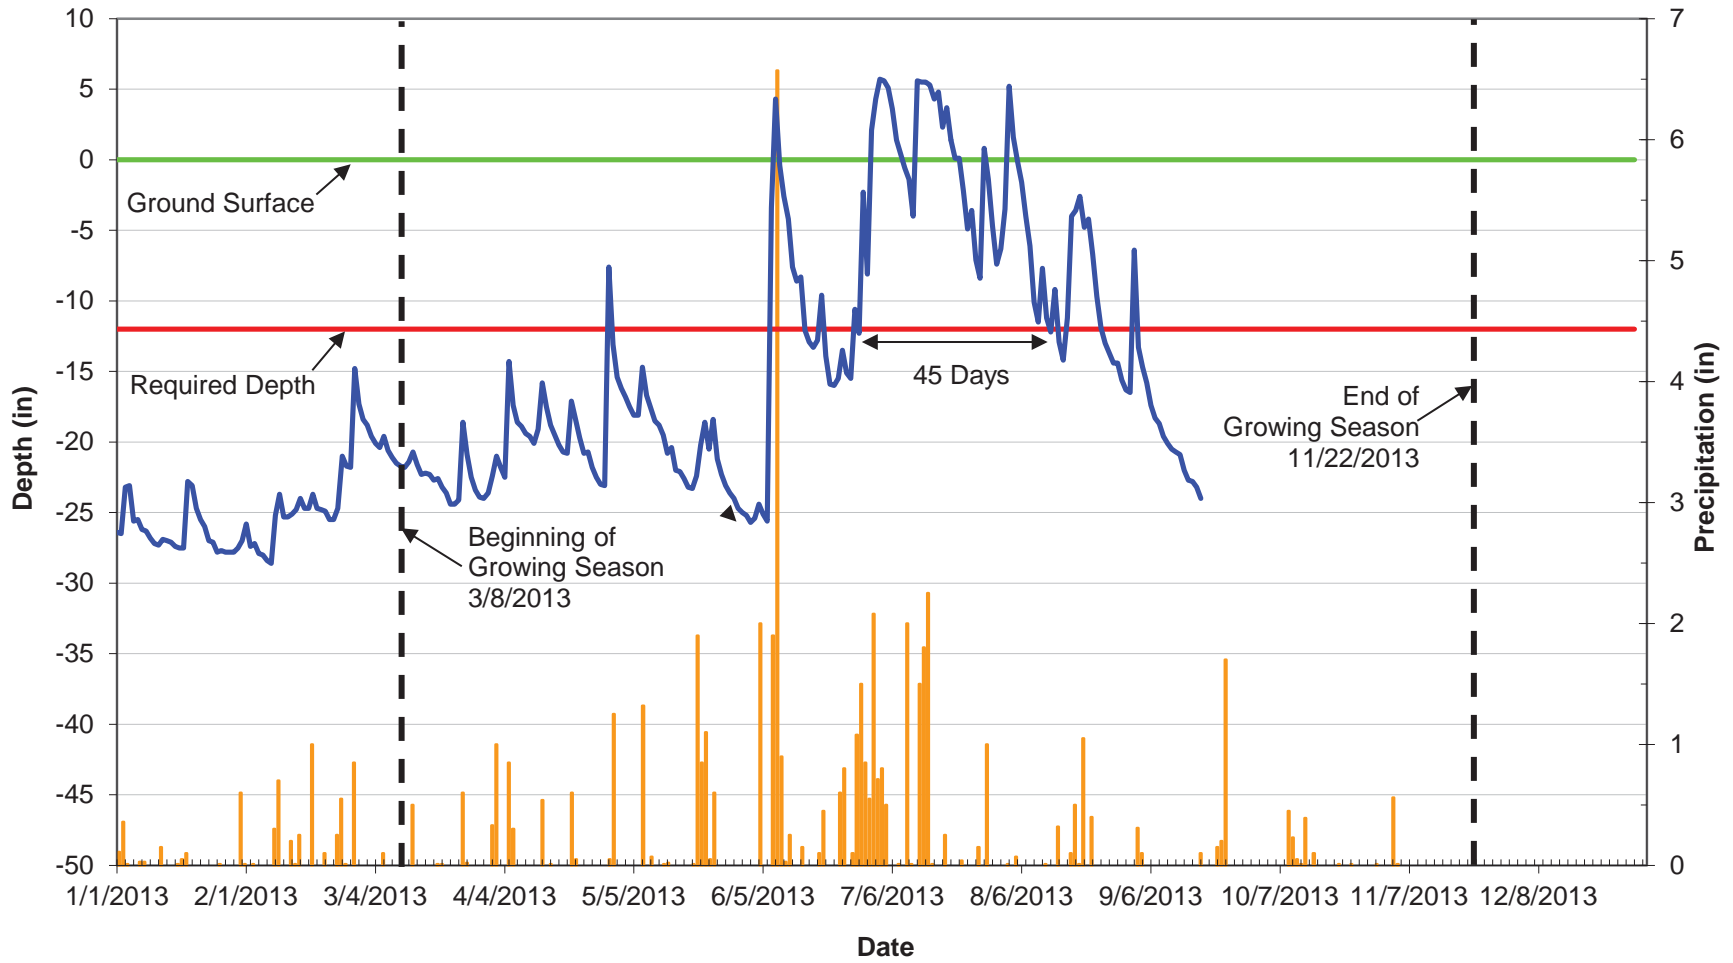
2013 Groundwater Data
Well UTJRC-4A (SN: 00000EBD3CA9)*
*Old Well SN: 000009BEA426 Replaced 9/4/2013

Seventeen of the 19 groundwater monitoring wells onsite met the success criteria. Two wells, GW 4A and GW 6B, did not meet the success criteria. The water table measured within 12 inches of the ground surface at GW 6B during the growing season, but the longest duration lasted 4 days. Well GW 4A had to be replaced, and data needs to be downloaded from the malfunctioning well. However, based on data from nearby well GW 4 it is likely that well GW 4A will meet the success criteria. The reference well located in the wetland adjacent to the restoration site met the success criteria, and measured a water table within 12 inches of the ground surface for 195 days of the growing season. This 195-day period comprises 75% of the growing season. Monthly precipitation totals for 2013 fell below the 30th percentile during the growing season in March, August, September, October, and November. During the months of April, May, June, and July the precipitation measured above the 70th percentile.

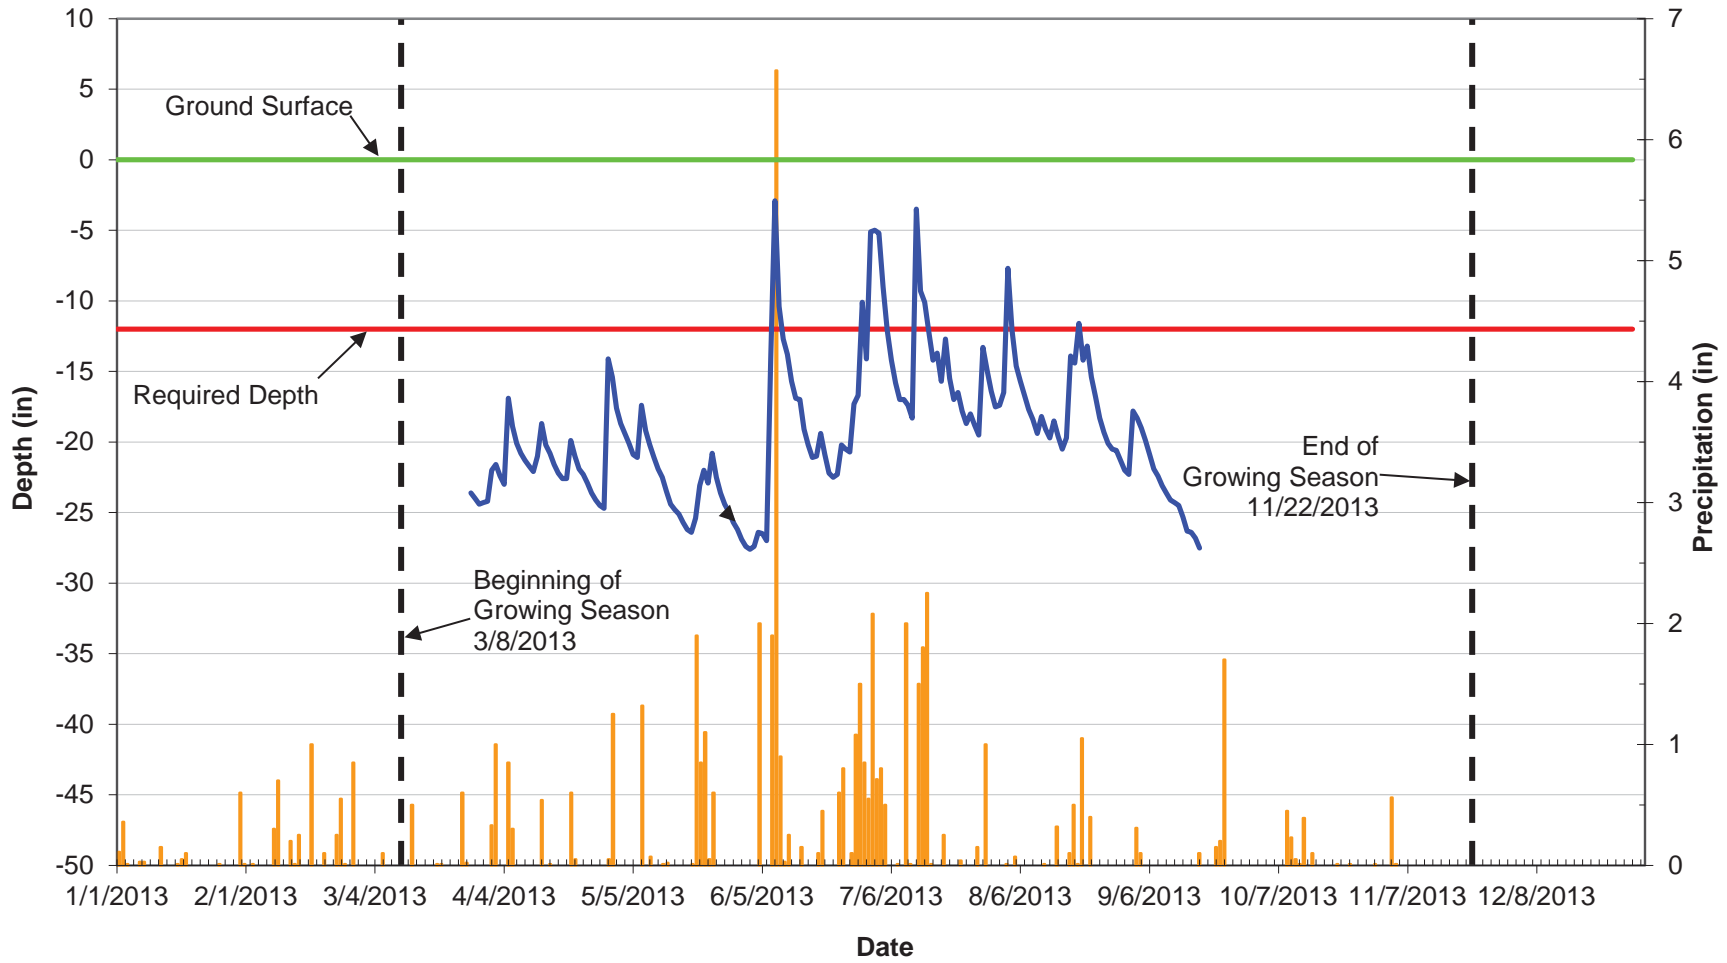
2013 Groundwater Data
Well UTJRC-6B* (SN: EBDC7A3)
*Well Replaced 3/26/13 Old Well SN: EBD2B2A

Riparian	GW 6A	n/a	n/a	n/a	Yes/195 days (75 percent)	
Riparian	GW 6B	n/a	n/a	n/a	No/4 days (2 percent)	
Riparian	GW 6C	n/a	n/a	n/a	Yes/96 days (37 percent)	
Non-Riparian	GW 7	Yes/63 days (24 percent)	Yes/44 days (17 percent)	No/19 days (7 percent)	Yes/195 days (75 percent)	
Riparian	GW 8	Yes/63 days (24 percent)	Yes/92 days (36 percent)	Yes/136 days (53 percent)	Yes/195 days (75 percent)	
Riparian	GW 9	Yes/141 days (55 percent)	Yes/ 112 days (43%)	Yes/197 days (76 percent)	Yes/37 days (14 percent)	
Non-Riparian	GW 10	Yes/62 days (24 percent)	Yes/80 days (31 percent)	Yes/78 days (30 percent)	Yes/195 days (75 percent)	
Riparian	GW 11	Yes/54 days (21 percent)	Yes/79 days (31 percent)	Yes/80 days (31 percent)	Yes/191 days (74 percent)	
Riparian	GW 12	Yes/147days (57 percent)	Yes/ 121 days (47%)	Yes/258 days (100 percent)	Yes/195 days (75 percent)	
Non-Riparian	GW 13	Yes/45 days (17 percent)	Yes/ 47 days (18%)	No/12 days (5 percent)	Yes/104 days (40 percent)
