# UT to Lilliput Creek (Hog Branch Ponds) Stream and Wetland Restoration Project

SCO No. 07-07155-01  
DENR Contract No. D08049S  
EEP Project No. 290  
Brunswick County North Carolina

**Year 3 of 5 Monitoring Report**  
**Data Collection: January through December 2012**  
**Submission Date: March 8, 2013**

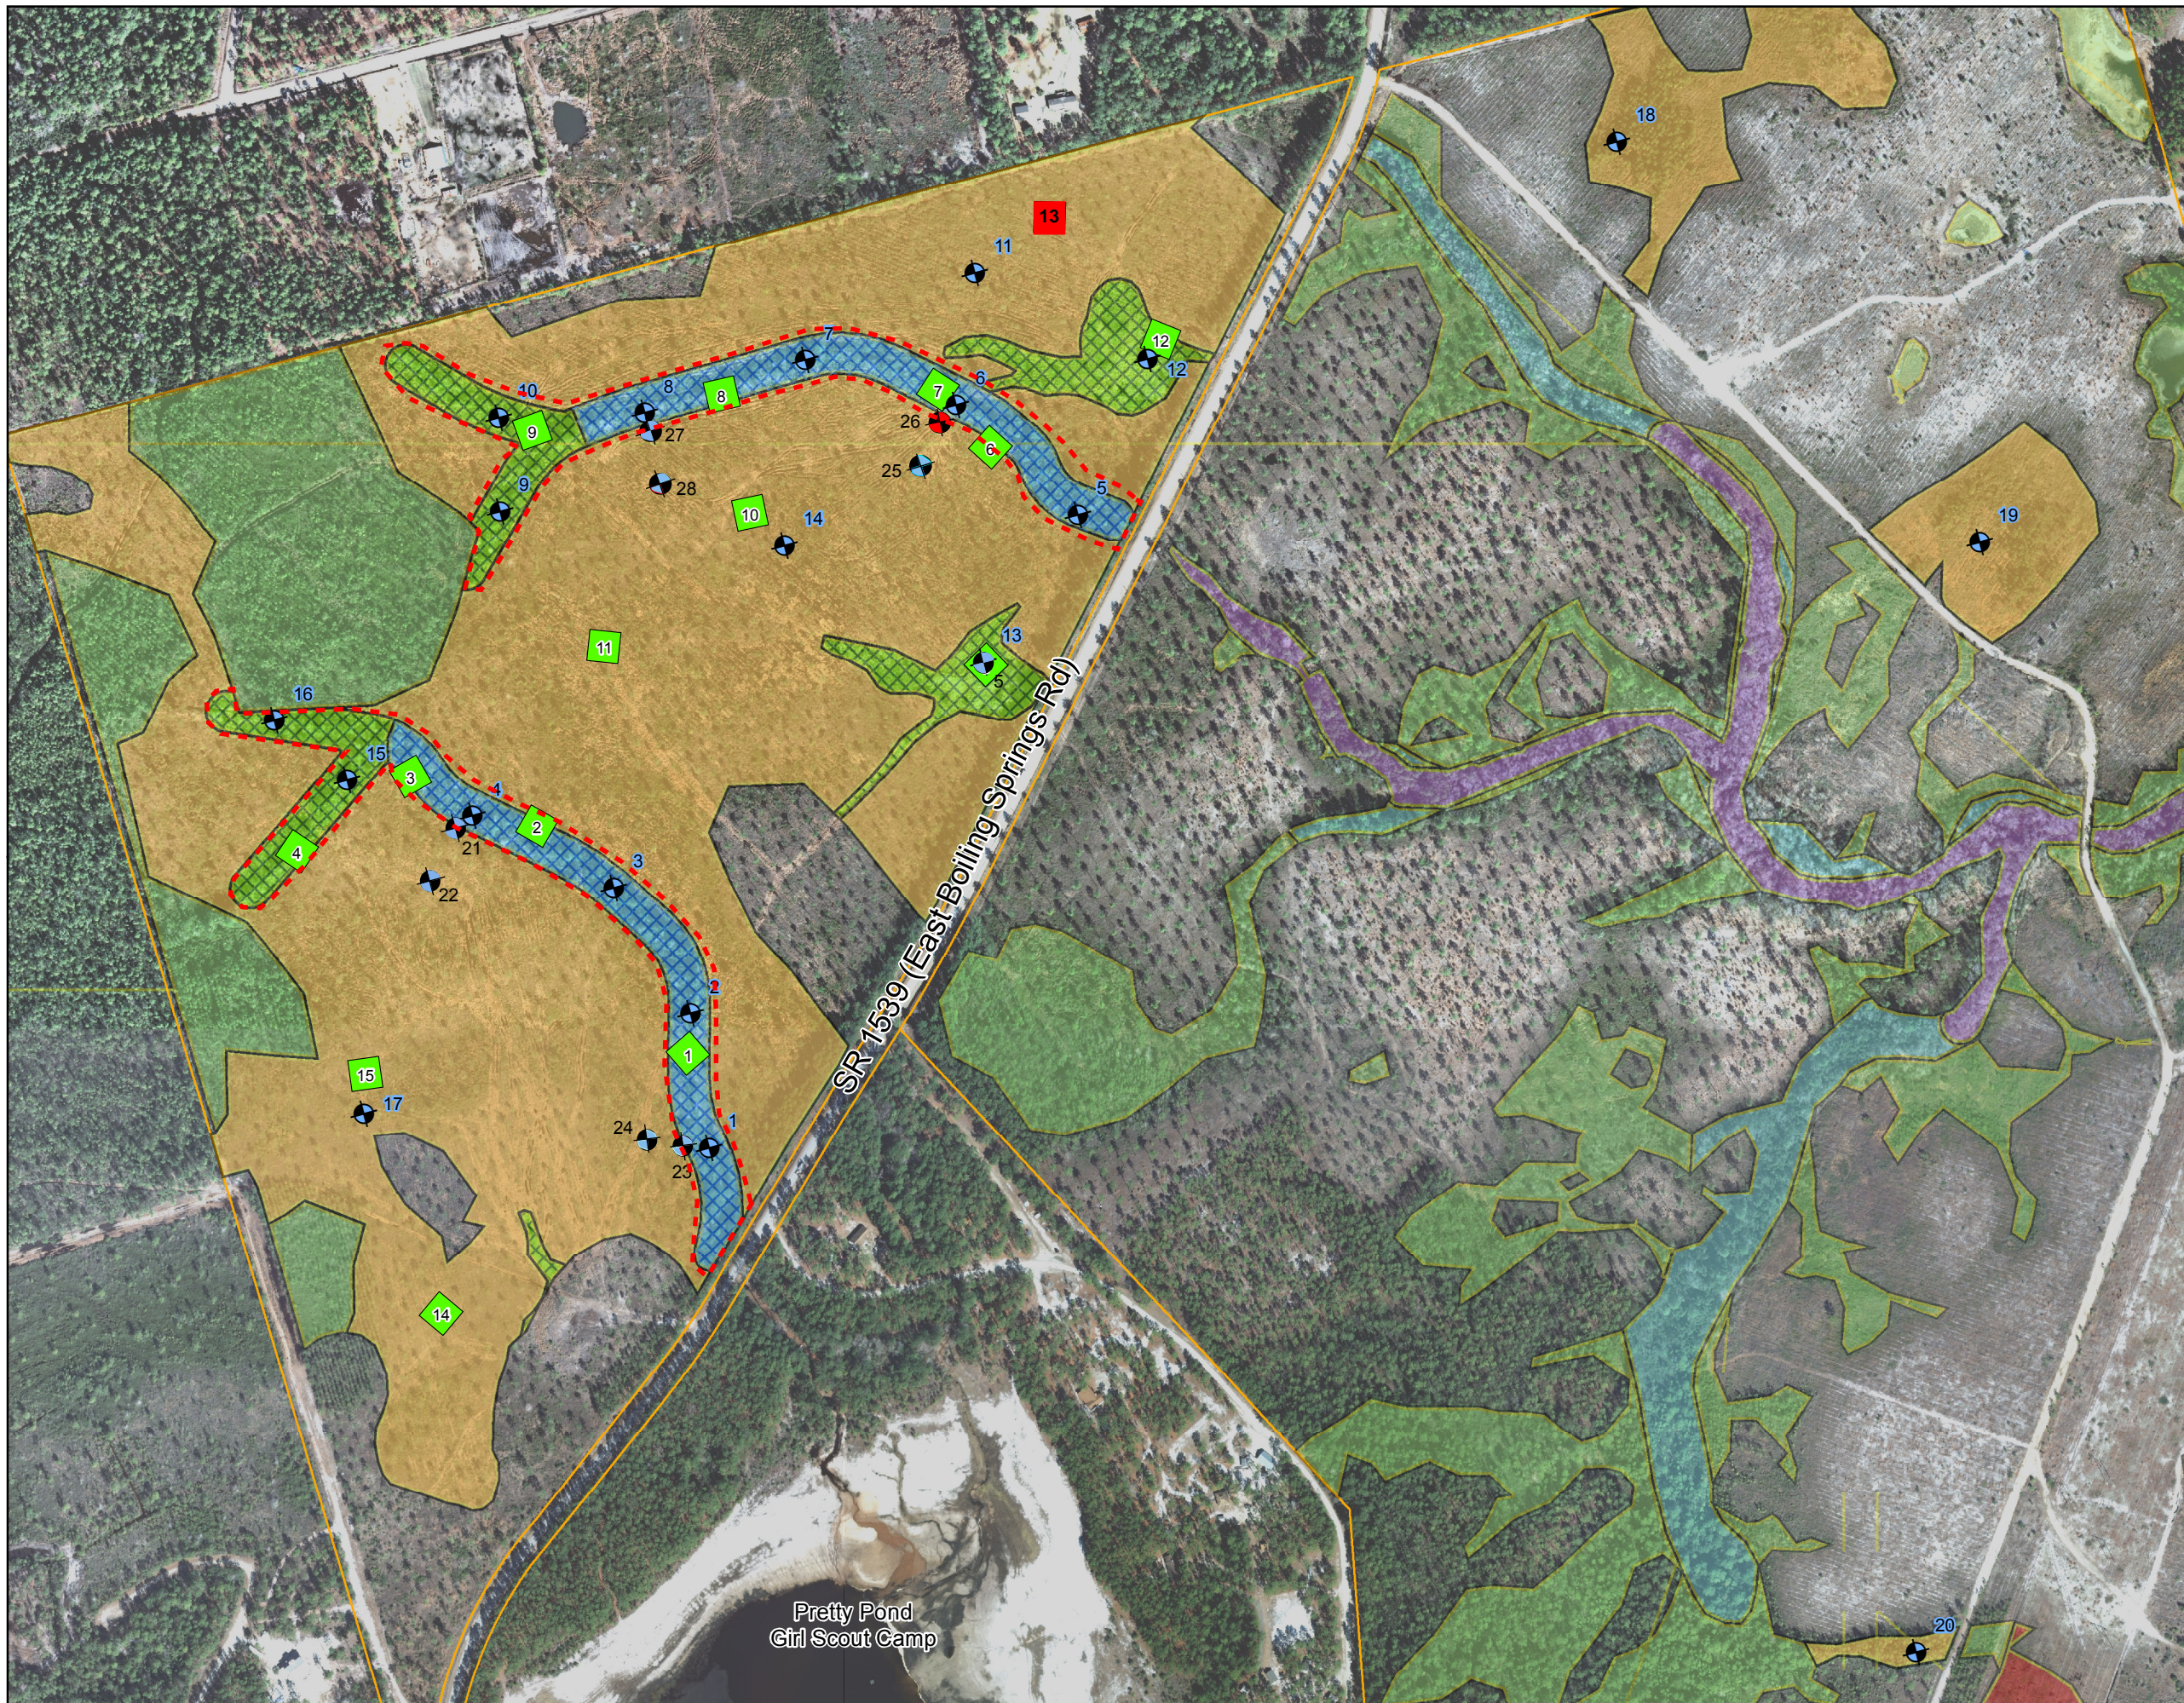
**FIGURE 2**

Current Conditions Plan View

During Monitoring Year 3 (MY3) 2012, twenty-seven of the 28 groundwater monitoring gauges located within the restoration site exhibited groundwater within 12 inches of the soil surface for a duration in excess of the 12% hydrologic success criterion. Gauge 26 did not meet the success criterion and exhibited groundwater within 12 inches of the soil surface for 8% of the growing season. The hydrographs of this gauge show groundwater levels were within 12 inches of the soil surface for much of the 2012 growing season. However, water levels were elevated for brief periods and occasionally fell below 12 inches to an extent that the criterion of 33 consecutive days was not achieved. This gauge is positioned on the shoulder of the stream valley. Groundwater is continuously being discharged to the low part of the valley, resulting in fluctuating water levels. Gauge 26 (along with five other gauges) did not meet the hydrological success criterion in MY2 (2011). Please see Figure 2 for gauge locations.

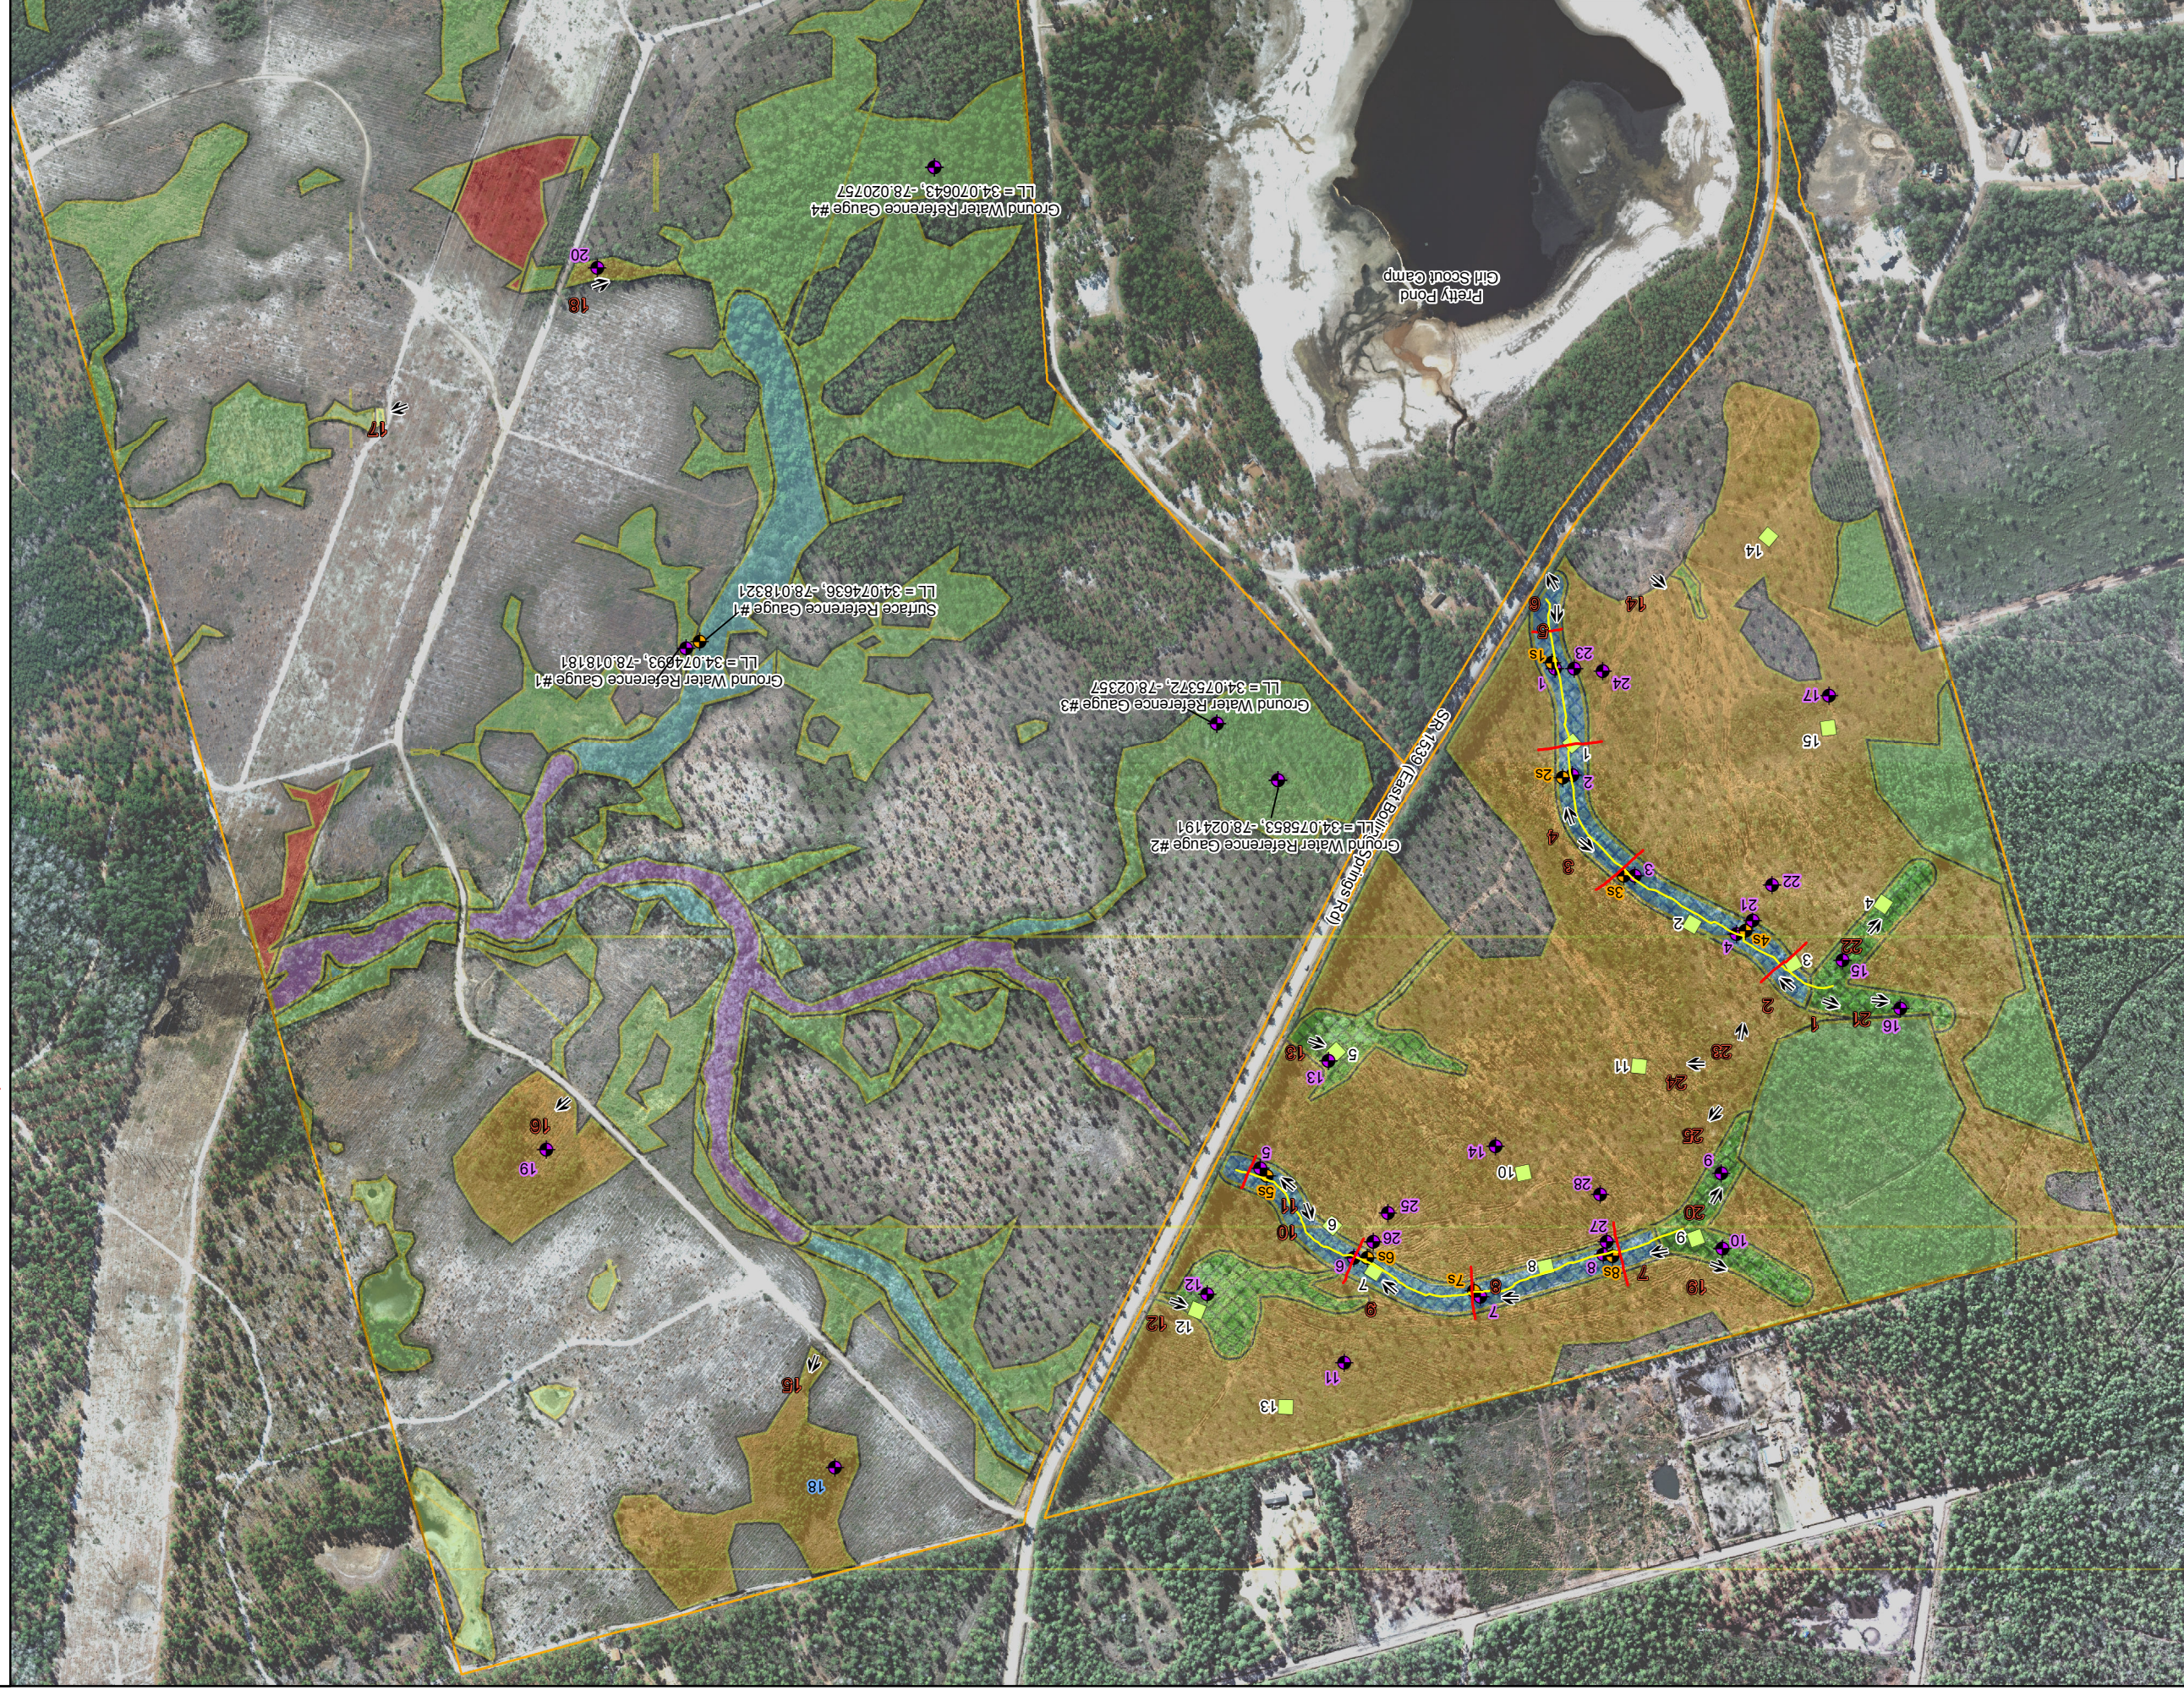
**FIGURE 3**

Monitoring Plan Features

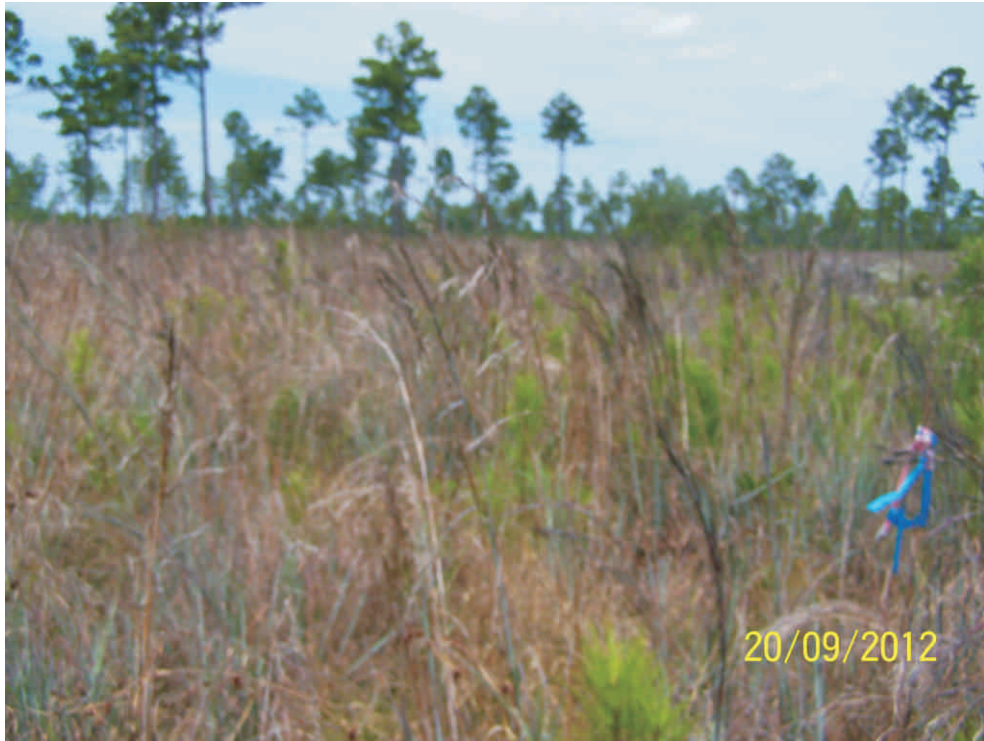
**Photo Station 4. Southern Tributary Station 23+00 - SCX2 - Looking downstream**

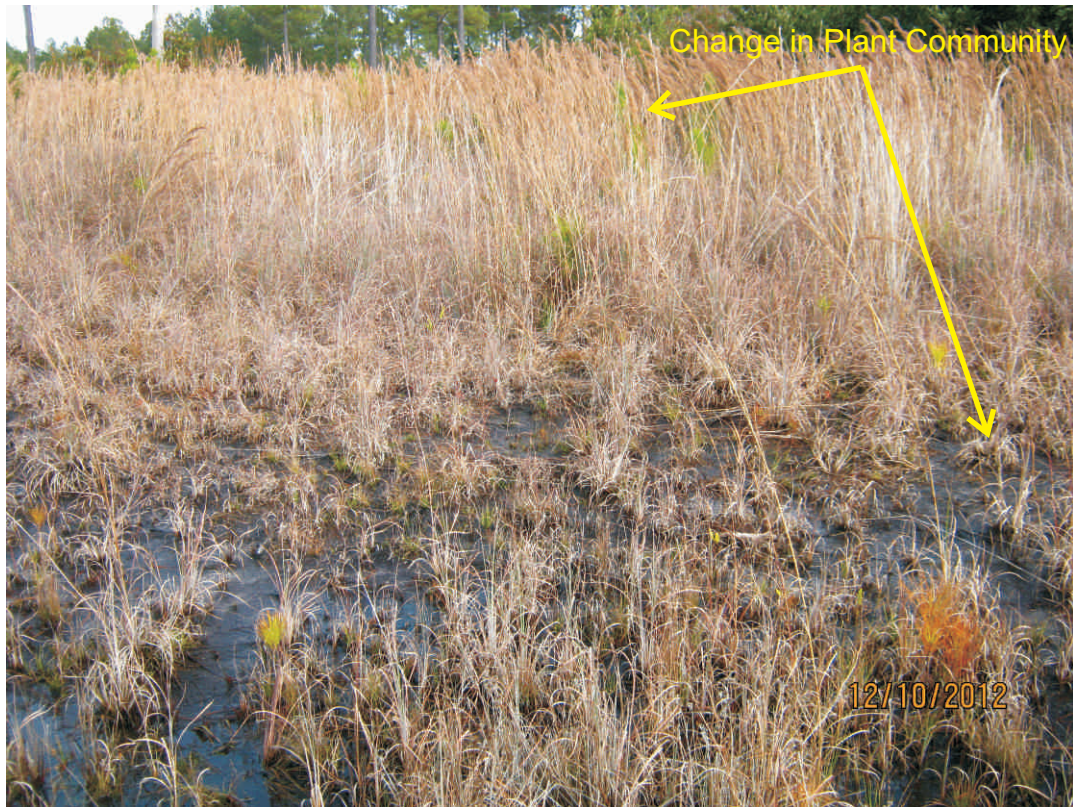
**View of OHWM on North Tributary**

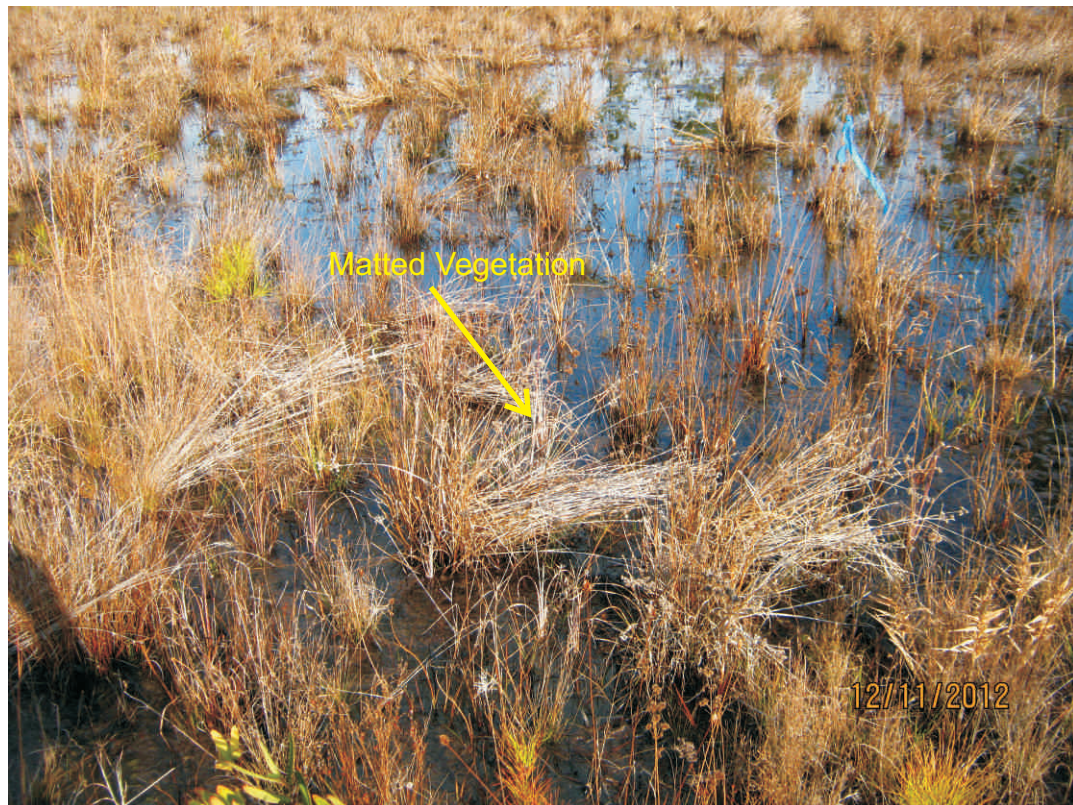
**View of OHWM on North Tributary**

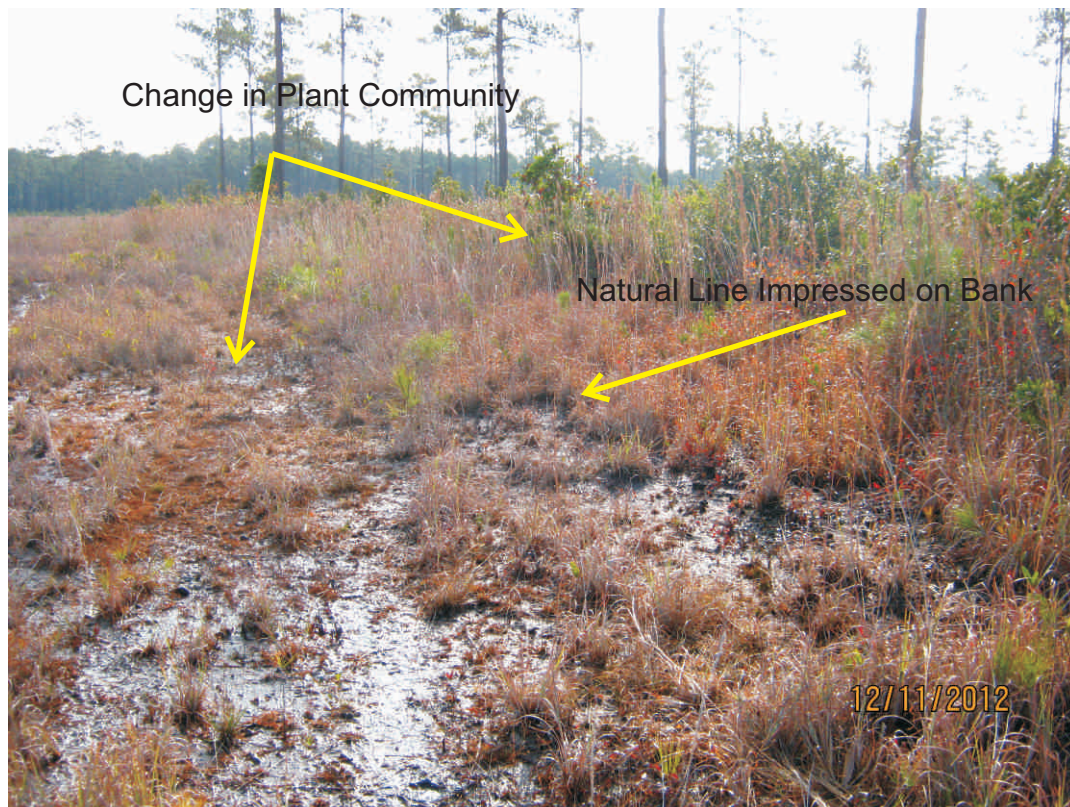
**View of OHWM on South Tributary**

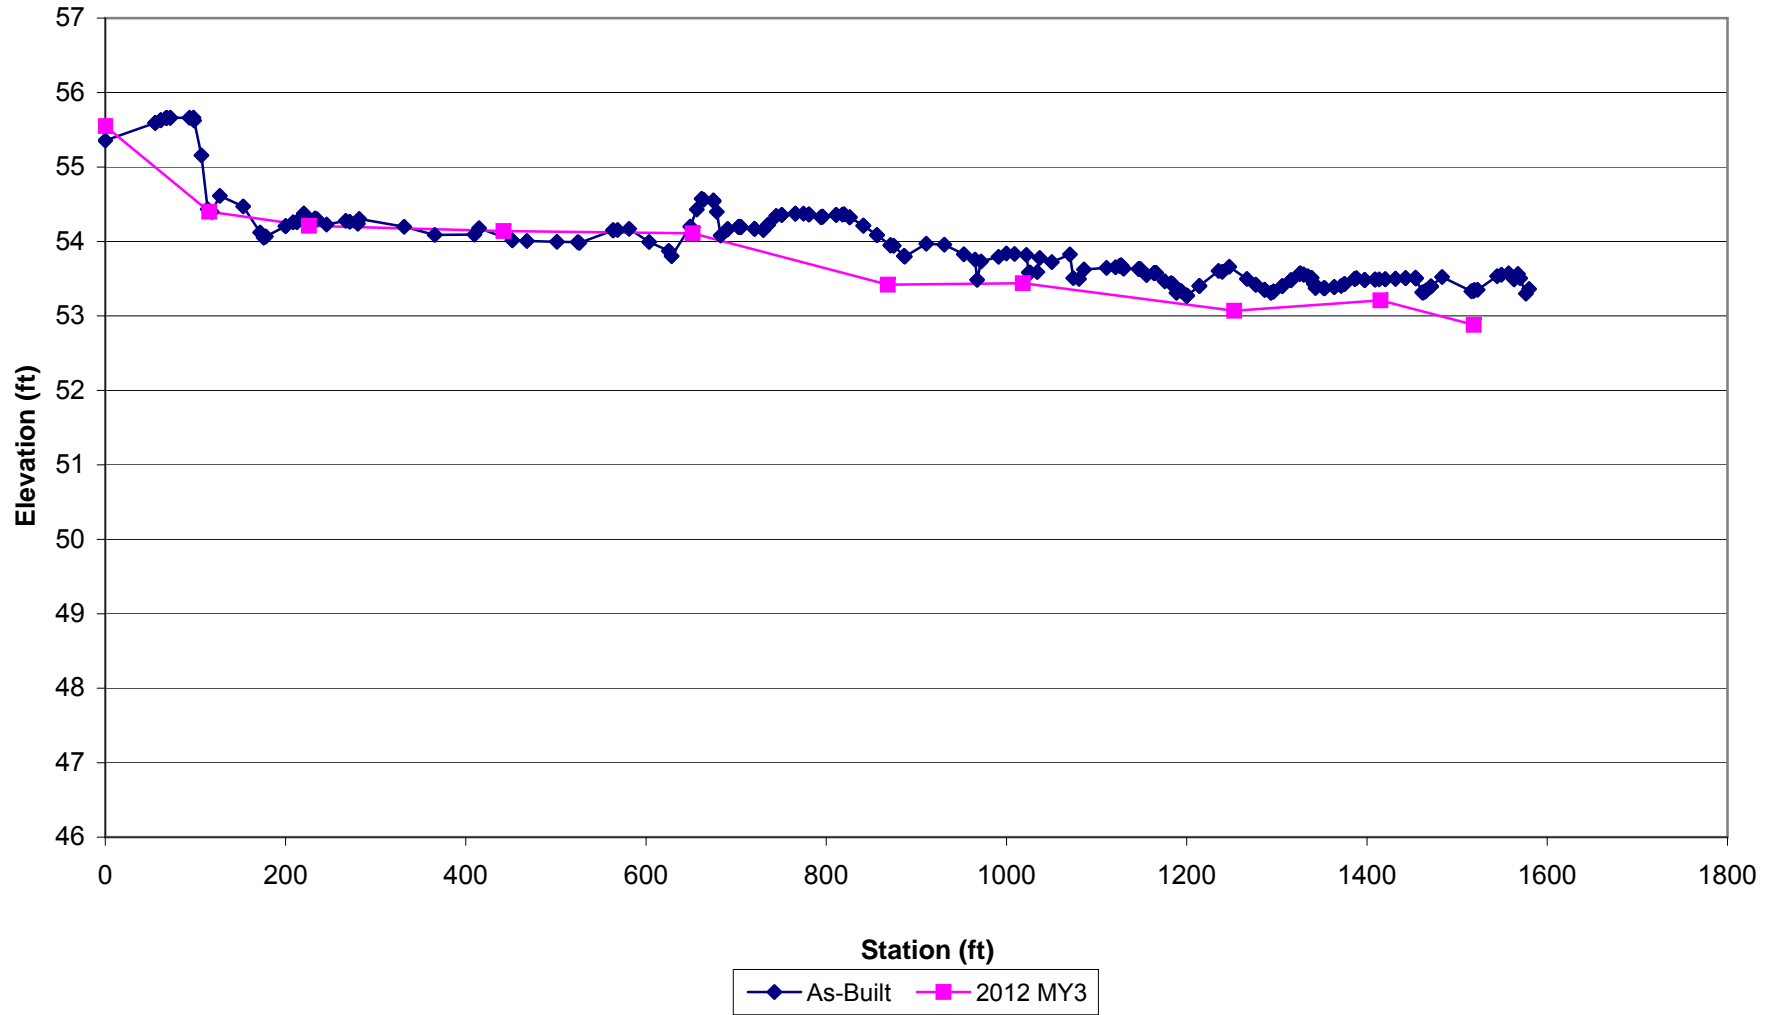
**UT to Lilliput Stream and Wetland Restoration Project**  
**Longitudinal Profile**  
**Northern Tributary**

morphology. No areas of significant degradation or rill erosion were noted. Based on survey data collected from longitudinal profiles and eight fixed cross sections, the UT to Lilliput Stream Restoration Channel dimension and pattern are similar to as-built conditions (Appendix D).

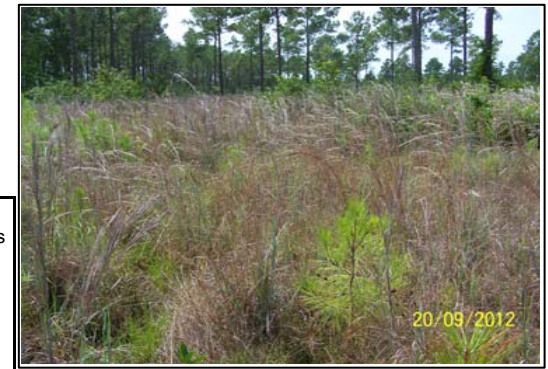
Southern Tributary Station 29+00 - SCX1  
Looking downstream

Project Name	UT to Lilliput
Watershed	Lilliput, MY 3
Cross Section	1S
Drainage Area	66.94 ac
Date	2/28/2013
Crew	Paramounte

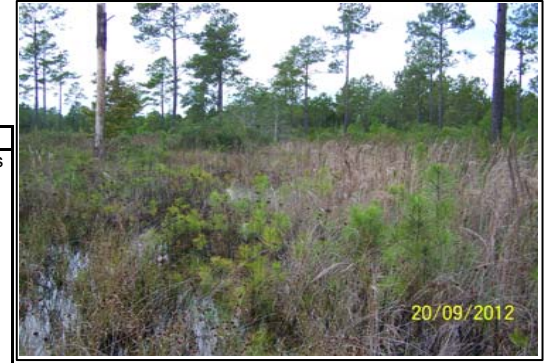
Southern Tributary Station 15+00 - SCX4  
Looking downstream

UT Lilliput 2012 MY3  
Cross Section 4 - Southern Tributary

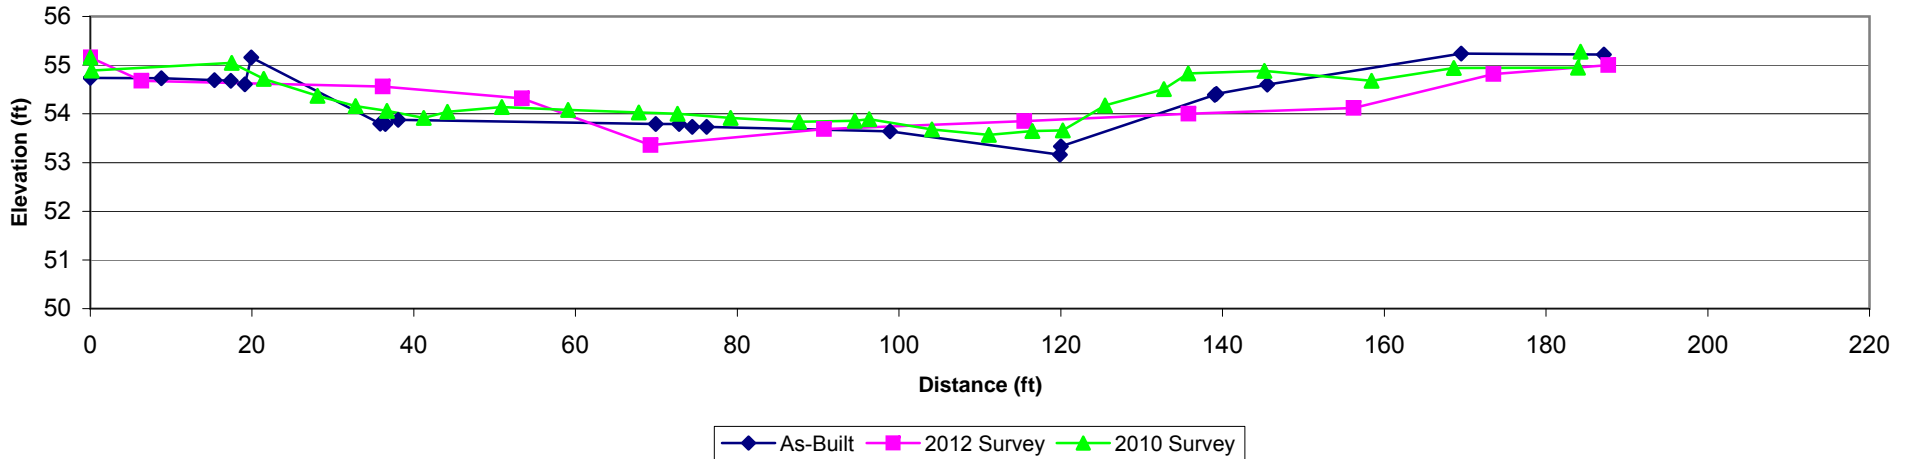
Project Name UT to Lilliput  
 Watershed Lilliput, MY 3  
 Cross Section 4S  
 Drainage Area 66.94 ac  
 Date 2/28/2013  
 Crew Paramounte

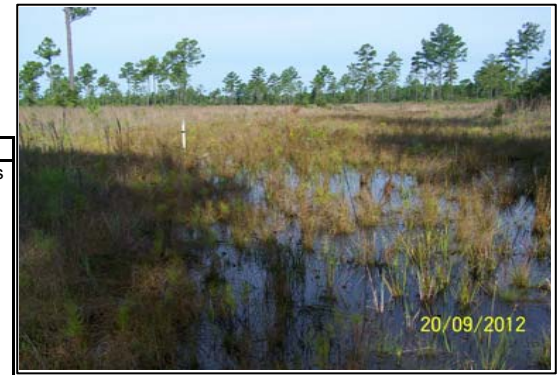
Northern Tributary Station 28+25 - NCX1  
 Looking upstream

Project Name UT to Lilliput  
 Watershed Lilliput, MY 3  
 Cross Section N1  
 Drainage Area 52.49  
 Date 2/28/2013  
 Crew Paramounte
