# UT to Lilliput Creek (Hog Branch Ponds) Stream and Wetland Restoration Project

SCO No. 07-07155-01  
DENR Contract No. D08049S  
EEP Project No. 290  
Brunswick County North Carolina

**Year 4 of 5 Monitoring Report**  
**Data Collection: January through December 2013**  
**Submission Date: April 25, 2014**

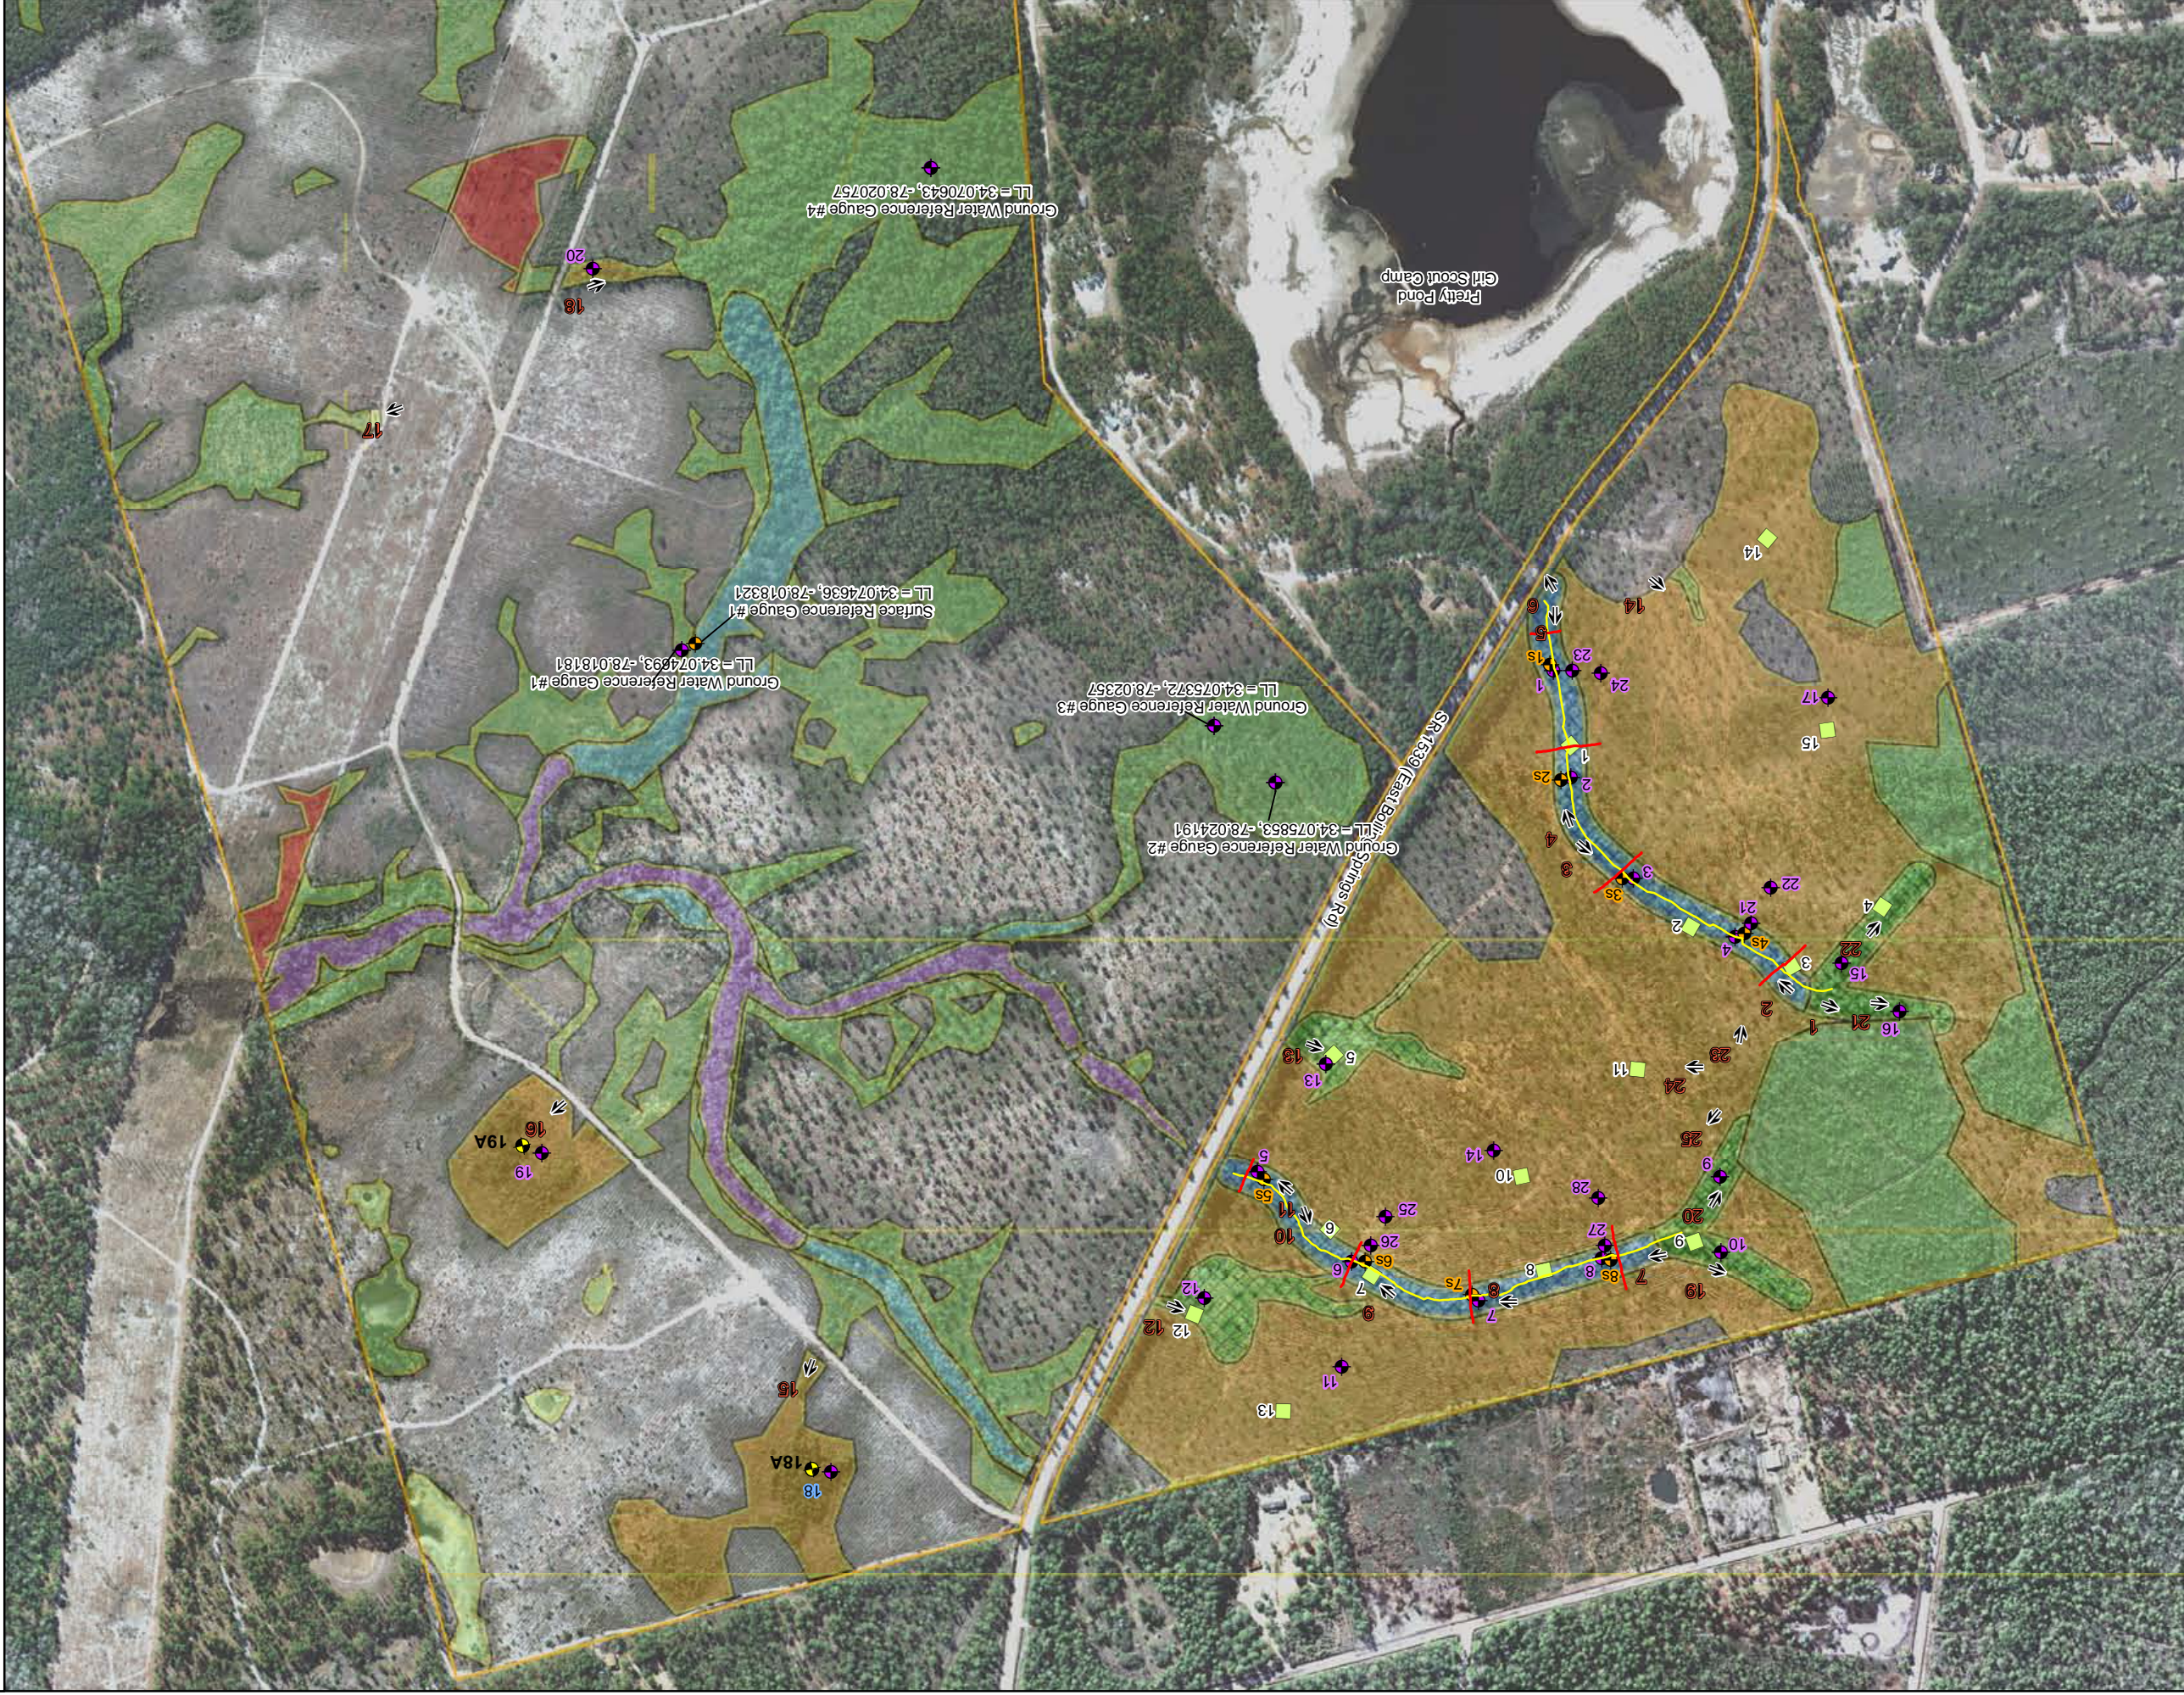
**FIGURE 3**

Monitoring Plan Features

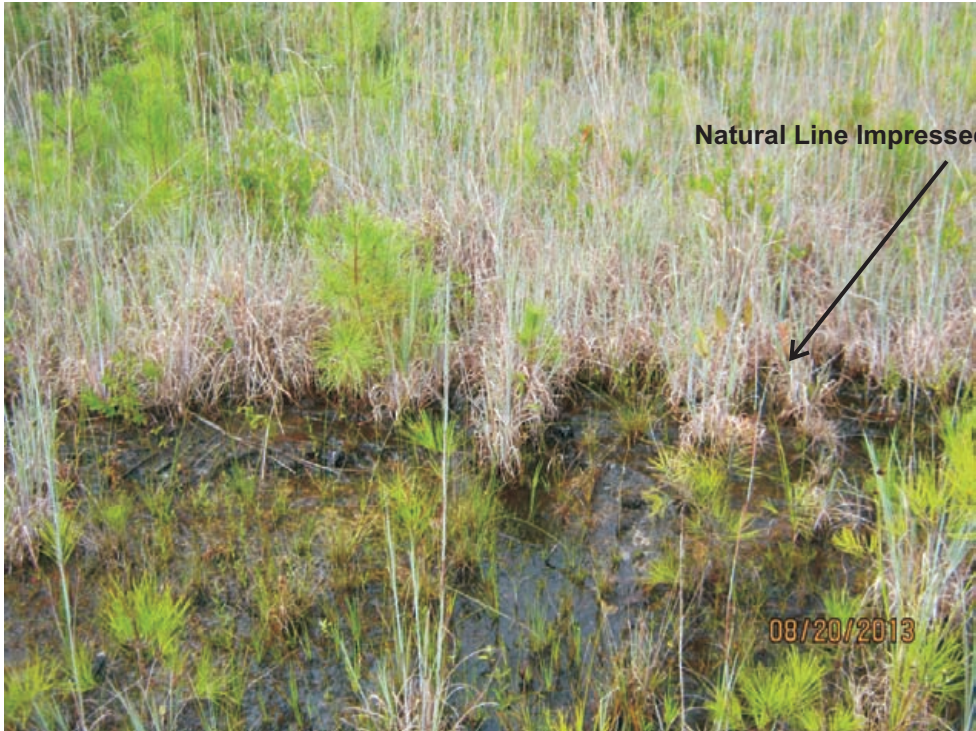
Natural Line Impressed on Bank

View of OHWM on South Tributary

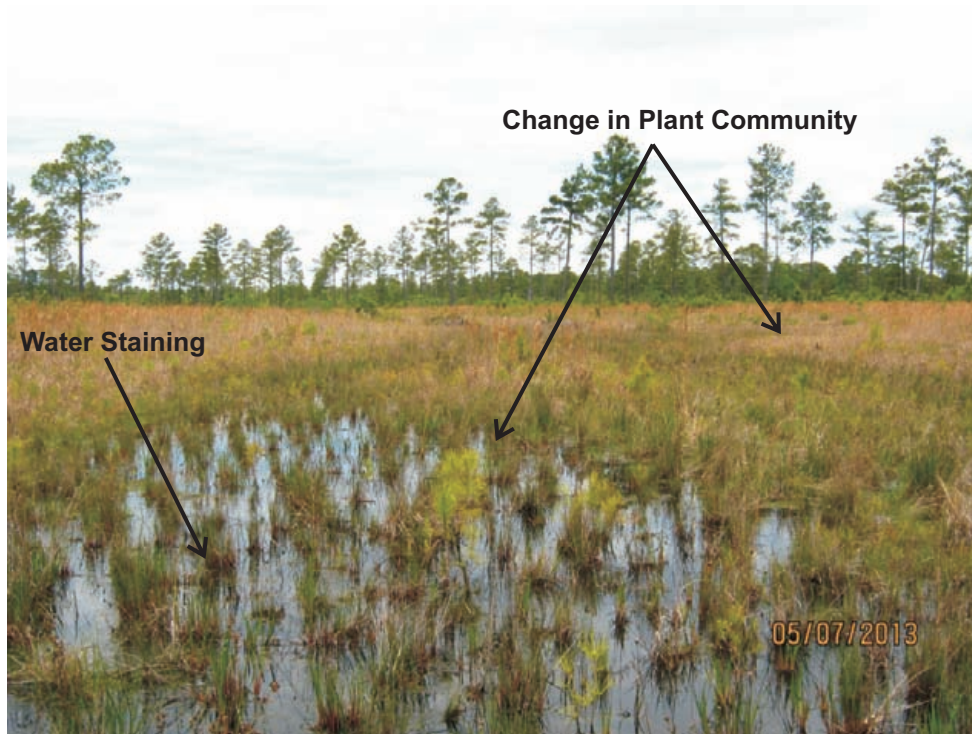
View of OHWM on North Tributary

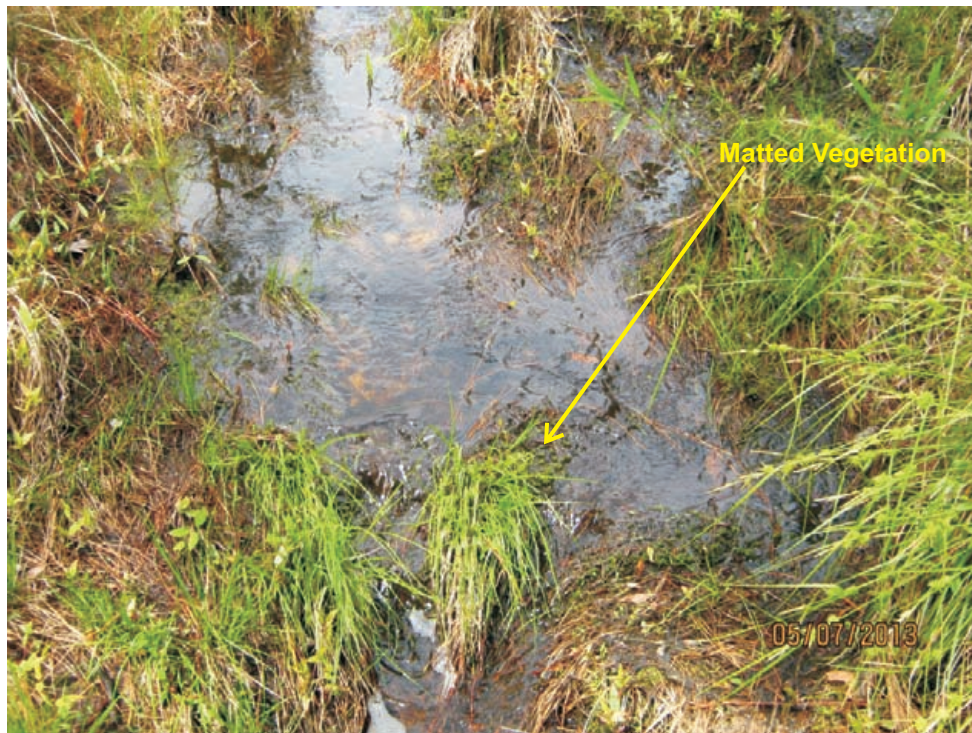
View of OHWM on North Tributary

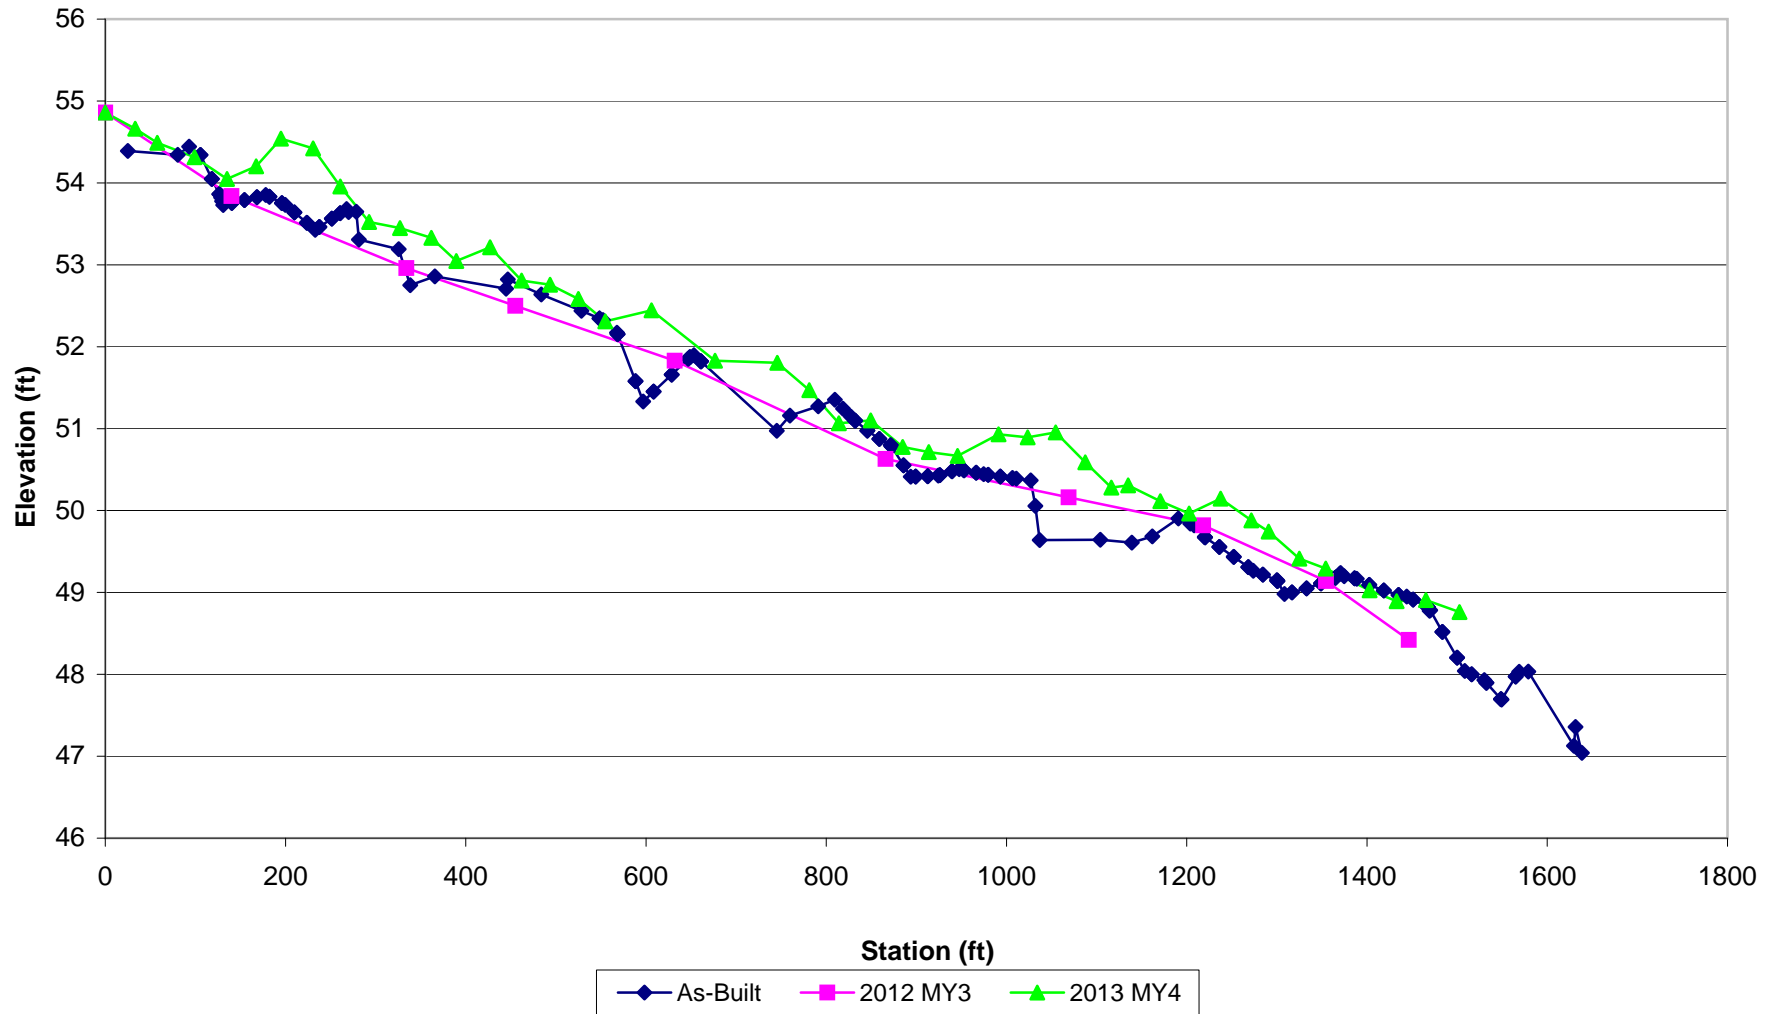
**UT to Lilliput Stream and Wetland Restoration Project**  
**Longitudinal Profile**  
**Southern Tributary**

As in prior years, stream monitoring in MY4 (2013) consisted of both visual and morphological (i.e. survey) assessment of the channels. Both channels exhibited evidence of the “braided” stream type featured in the Zero to First Order outer coastal plain stream morphology. No areas of significant degradation or rill erosion were noted. Based on survey data collected from longitudinal profiles and eight fixed cross sections, the UT to Lilliput Stream Restoration Channel dimension and pattern are similar to as-built conditions (Appendix D).

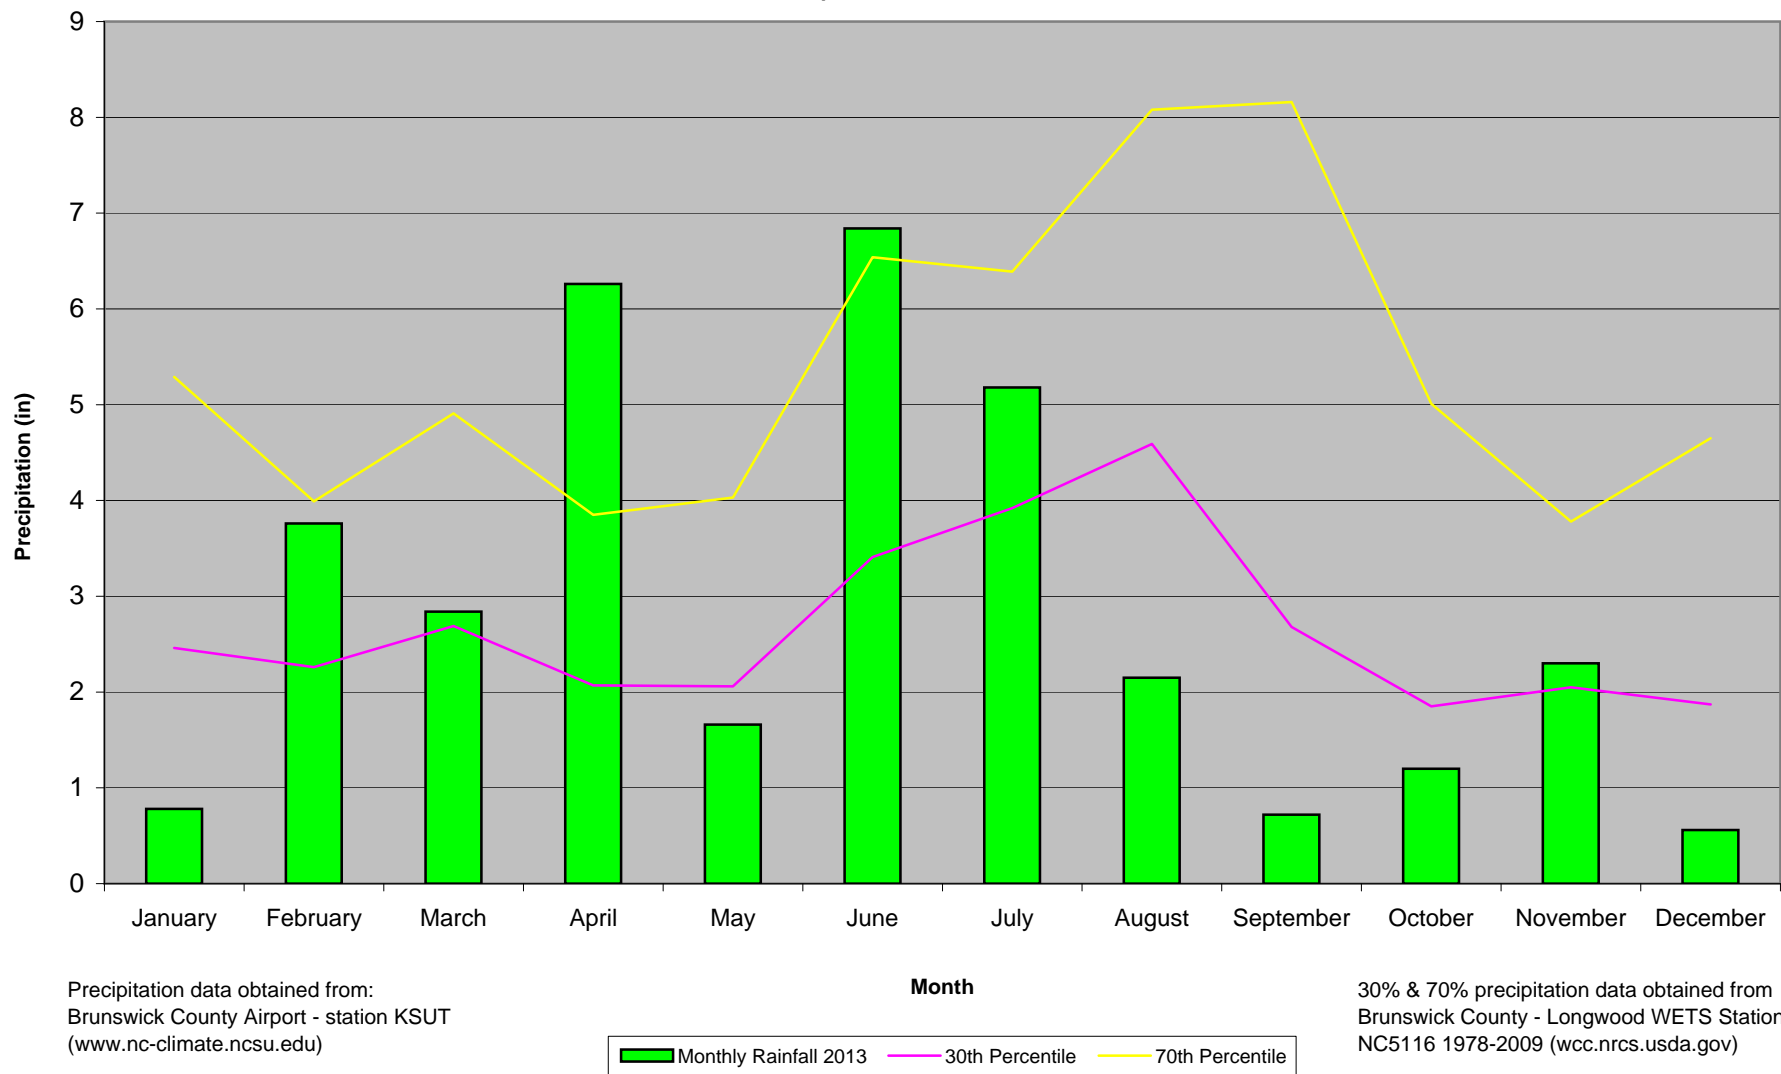
## UT to Lilliput Stream and Wetland Restoration Project 30 & 70 Percentile Graph for Rainfall in 2013

Precipitation data obtained from:  
Brunswick County Airport - station KSUT  
([www.nc-climate.ncsu.edu](http://www.nc-climate.ncsu.edu))

30% & 70% precipitation data obtained from  
Brunswick County - Longwood WETS Station  
NC5116 1978-2009 ([wcc.nrcs.usda.gov](http://wcc.nrcs.usda.gov))
