**UT to Little Coharie Stream and Buffer
Restoration Project
Sampson County
North Carolina**

**CU: 030030006
SCO# 040634201
EEP Project No. 314**

**1st Year Monitoring Report
February 2010**

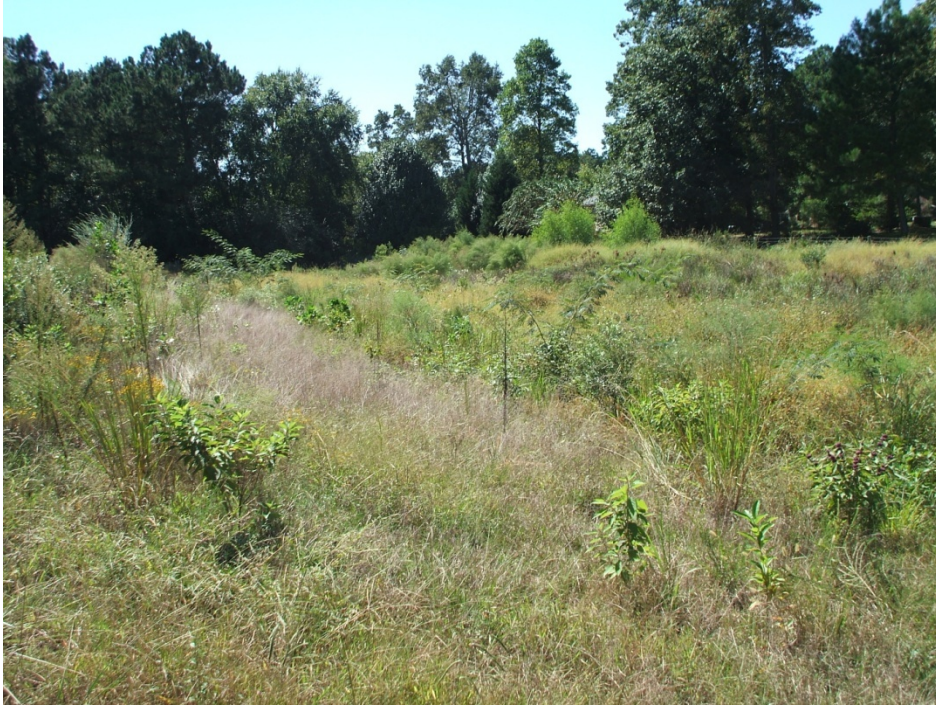
Main Reach Station 2+20 – Looking upstream

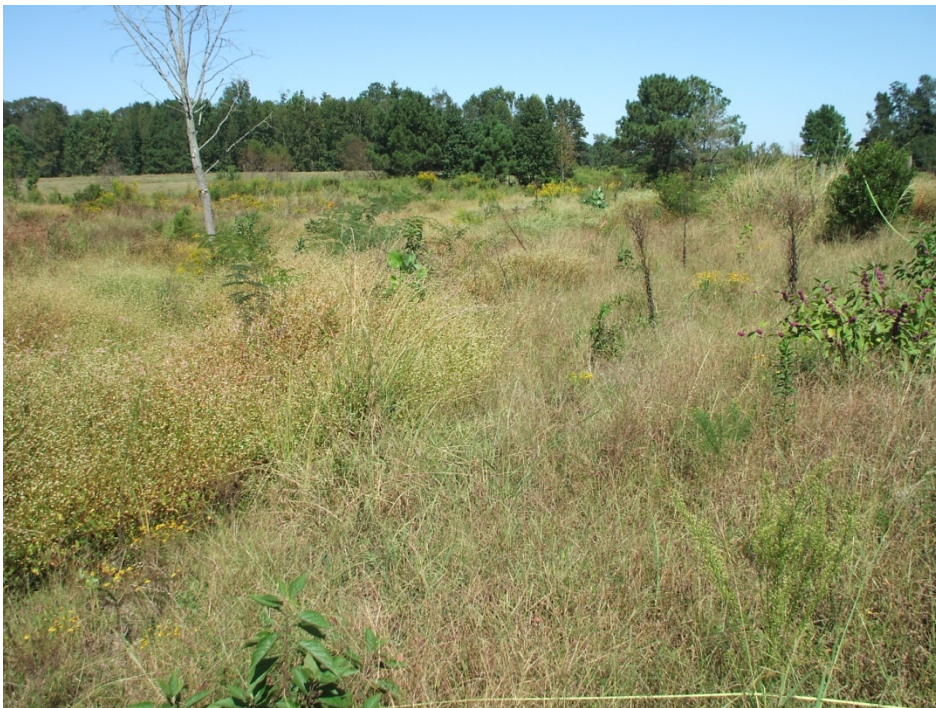
Main Reach Station 2+20 – Looking downstream

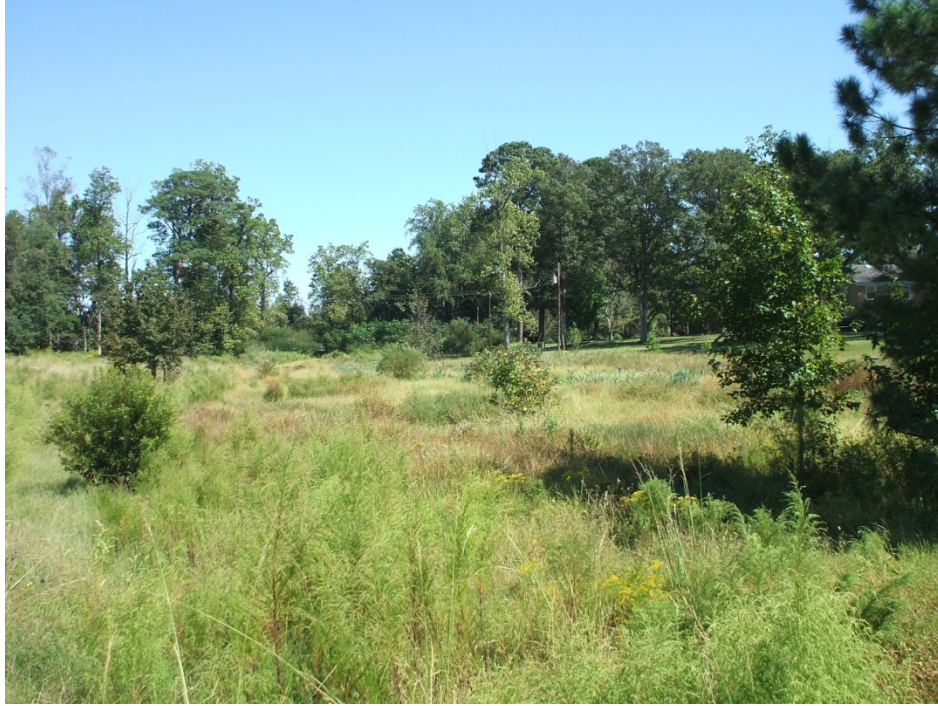
Main Reach Station 4+00 – Looking downstream across the site

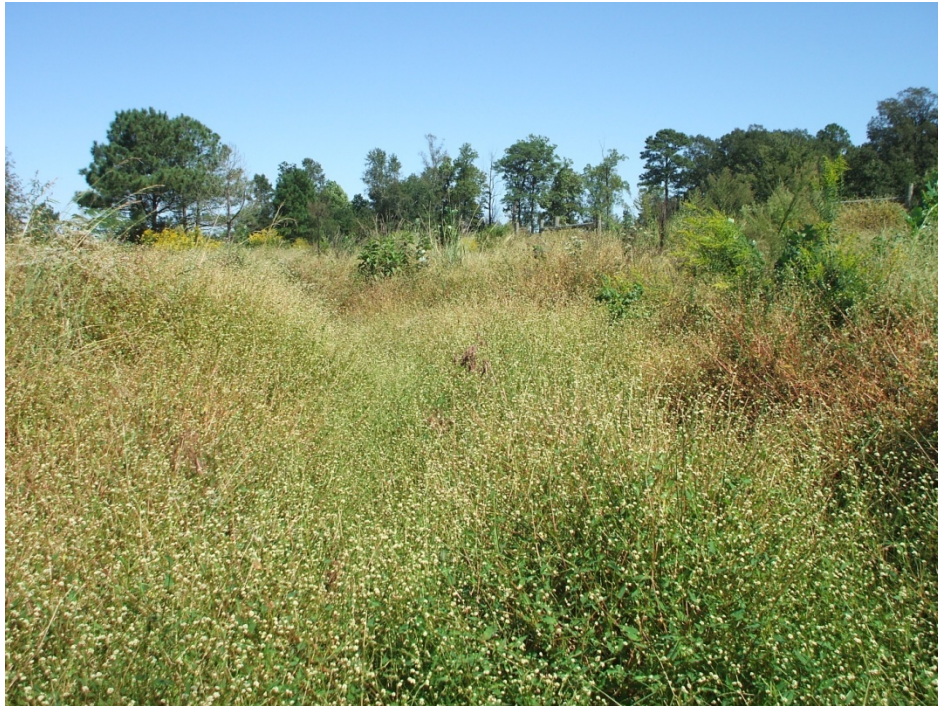
Main Reach Station 4+00 – Looking downstream

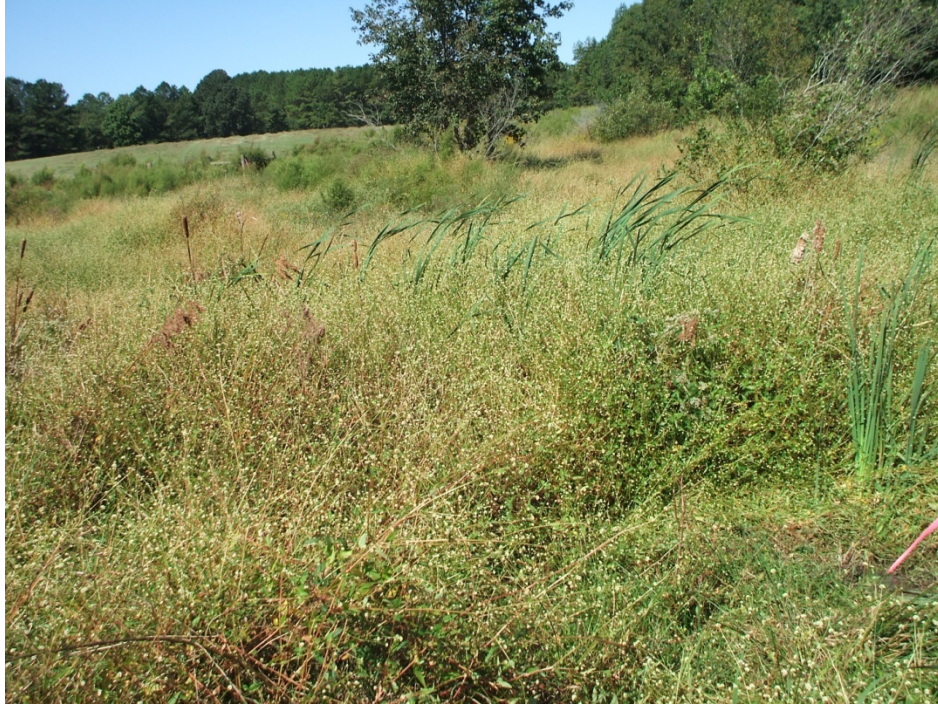
Main Reach Station 9+00 – Looking to Northern Reach confluence

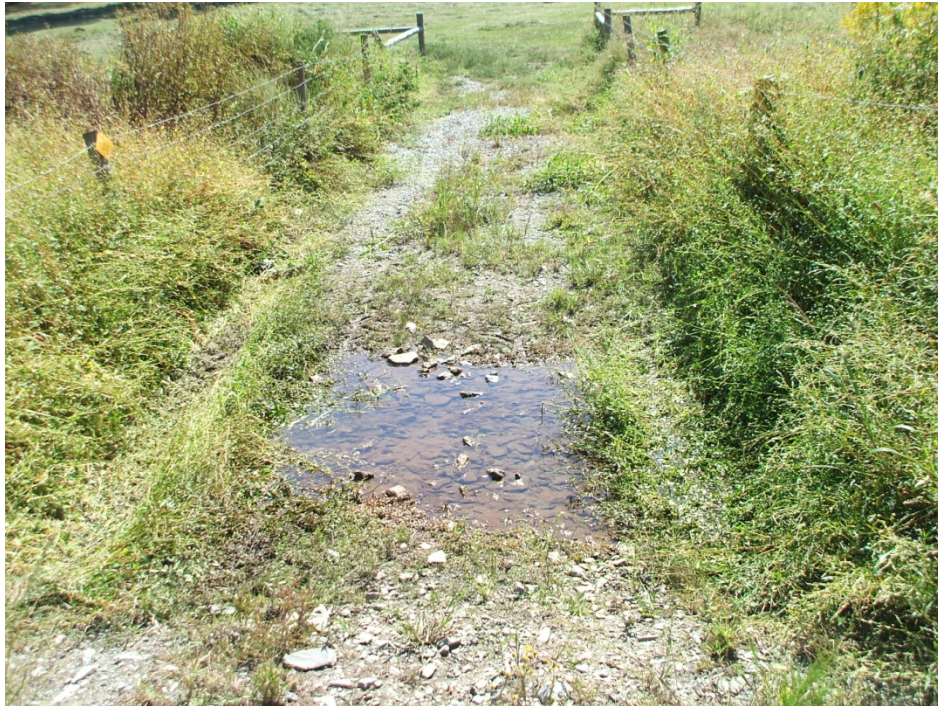
Main Reach Station 10+50 – Stream Crossing

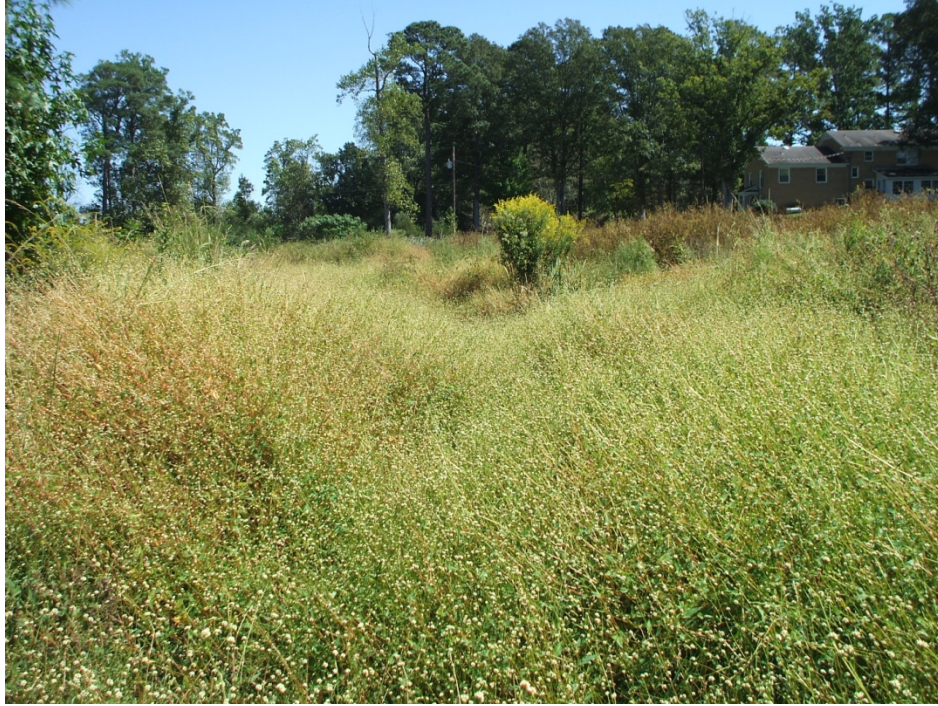
Main Reach Station 11+50 – Looking Downstream

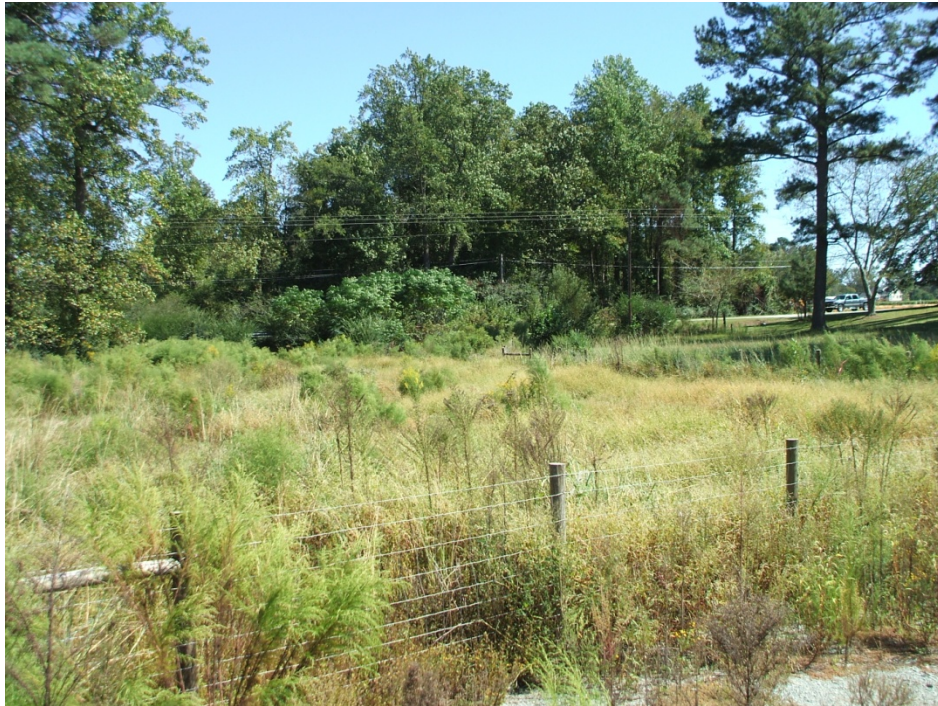
Northern Reach Station 0+50 – Looking across site to HWY 242

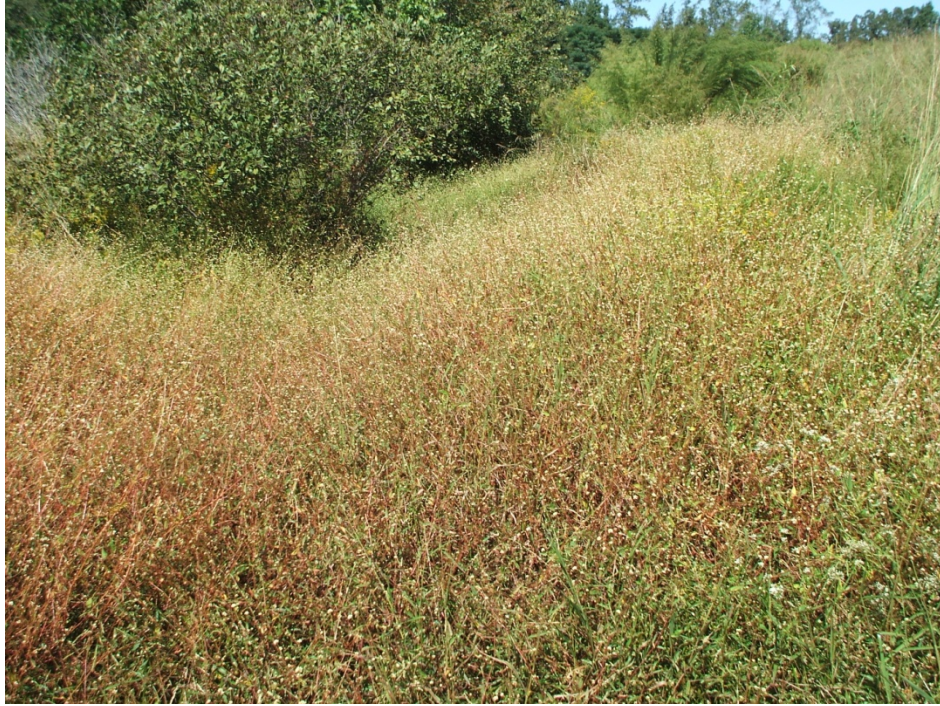
Northern Reach Station 2+50 – Looking upstream

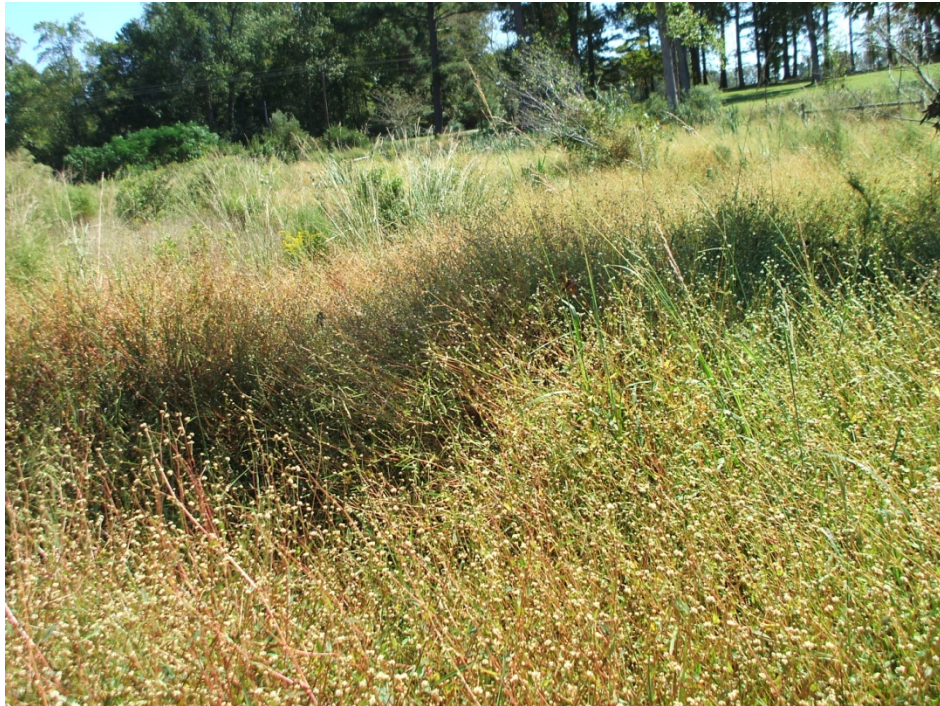
Northern Reach Station 2+50 – Looking downstream

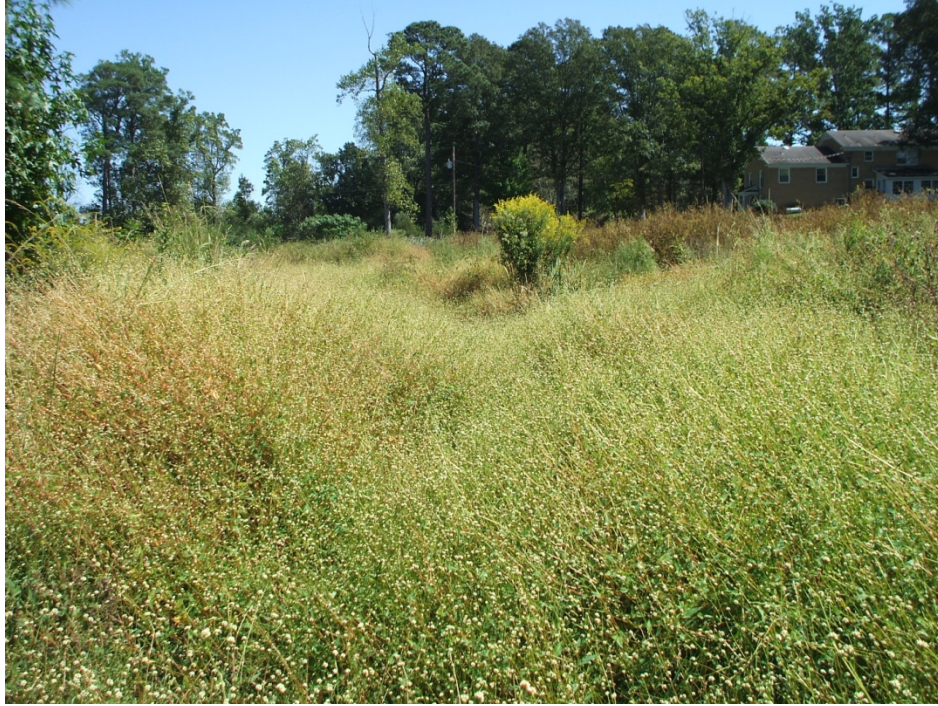
Northern Reach Station 3+00 – Looking downstream to confluence with Main Reach

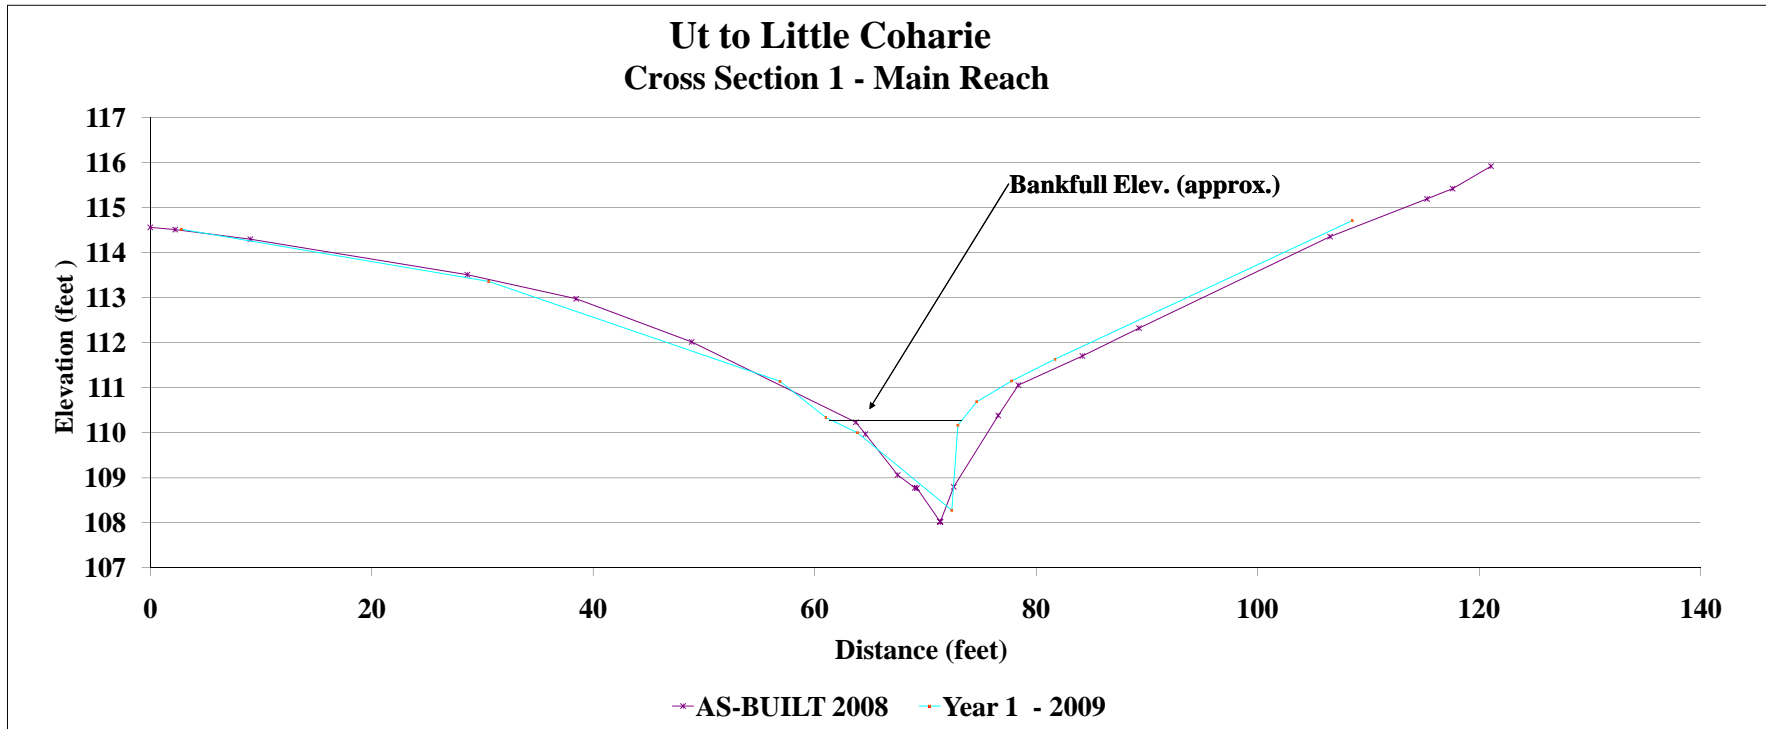
Year 5	Year 4 - 2012	Year 3 - 2011	Year 2 - 2010	Year 1 - 2009	AS-BUILT 2008
Area					10.2	13.5
Width					11.3	12.7
Mean Depth					0.9	1.1
Max Depth					2.0	2.2
W/D					12.5	11.9

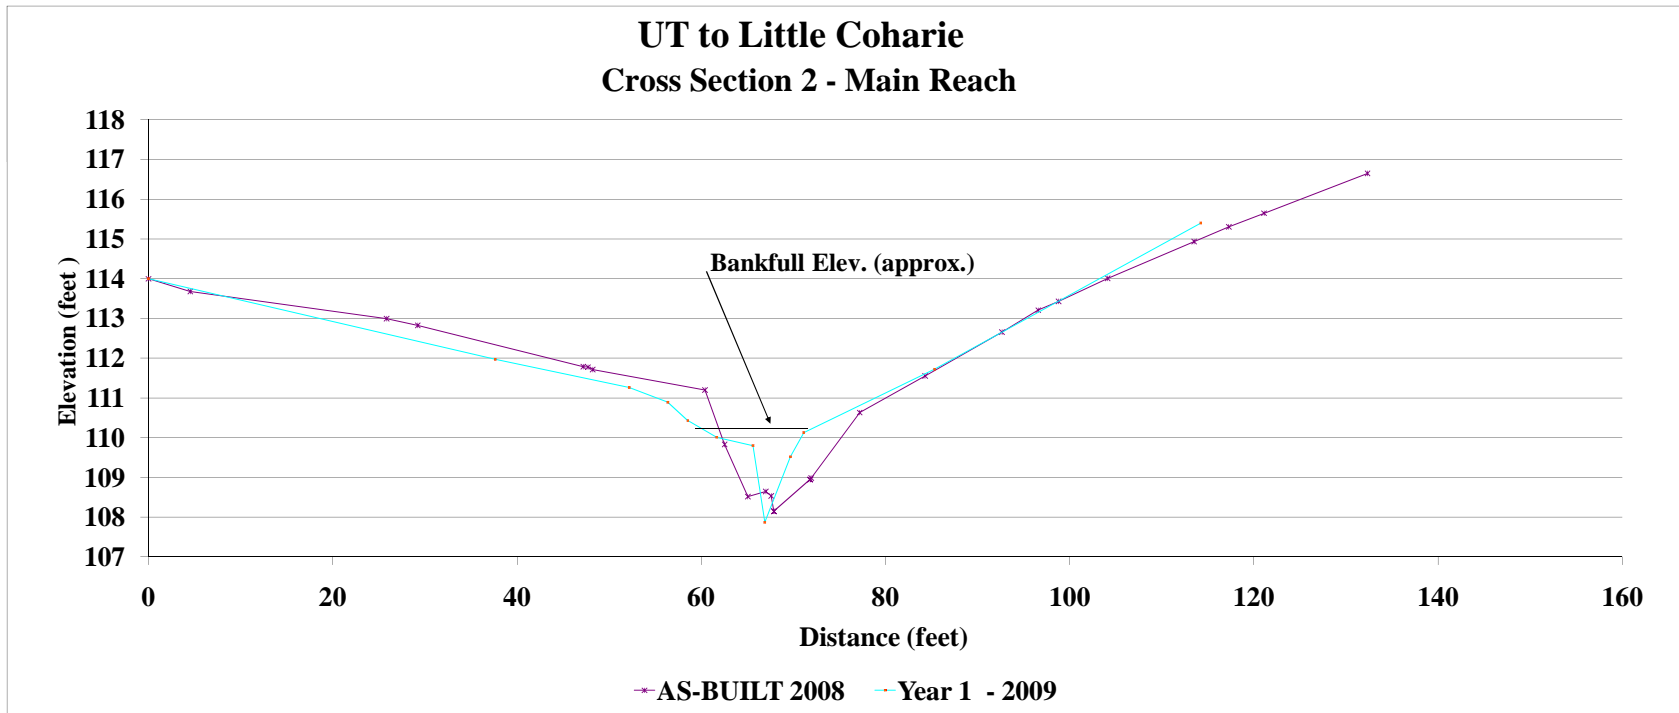
Year 5	Year 4 - 2012	Year 3 - 2011	Year 2 - 2010	Year 1 - 2009	AS-BUILT 2008
Area					14.4	43.6
Width					15.9	24.9
Mean Depth					0.9	1.8
Max Depth					3.1	3.3
WD					17.4	14.2

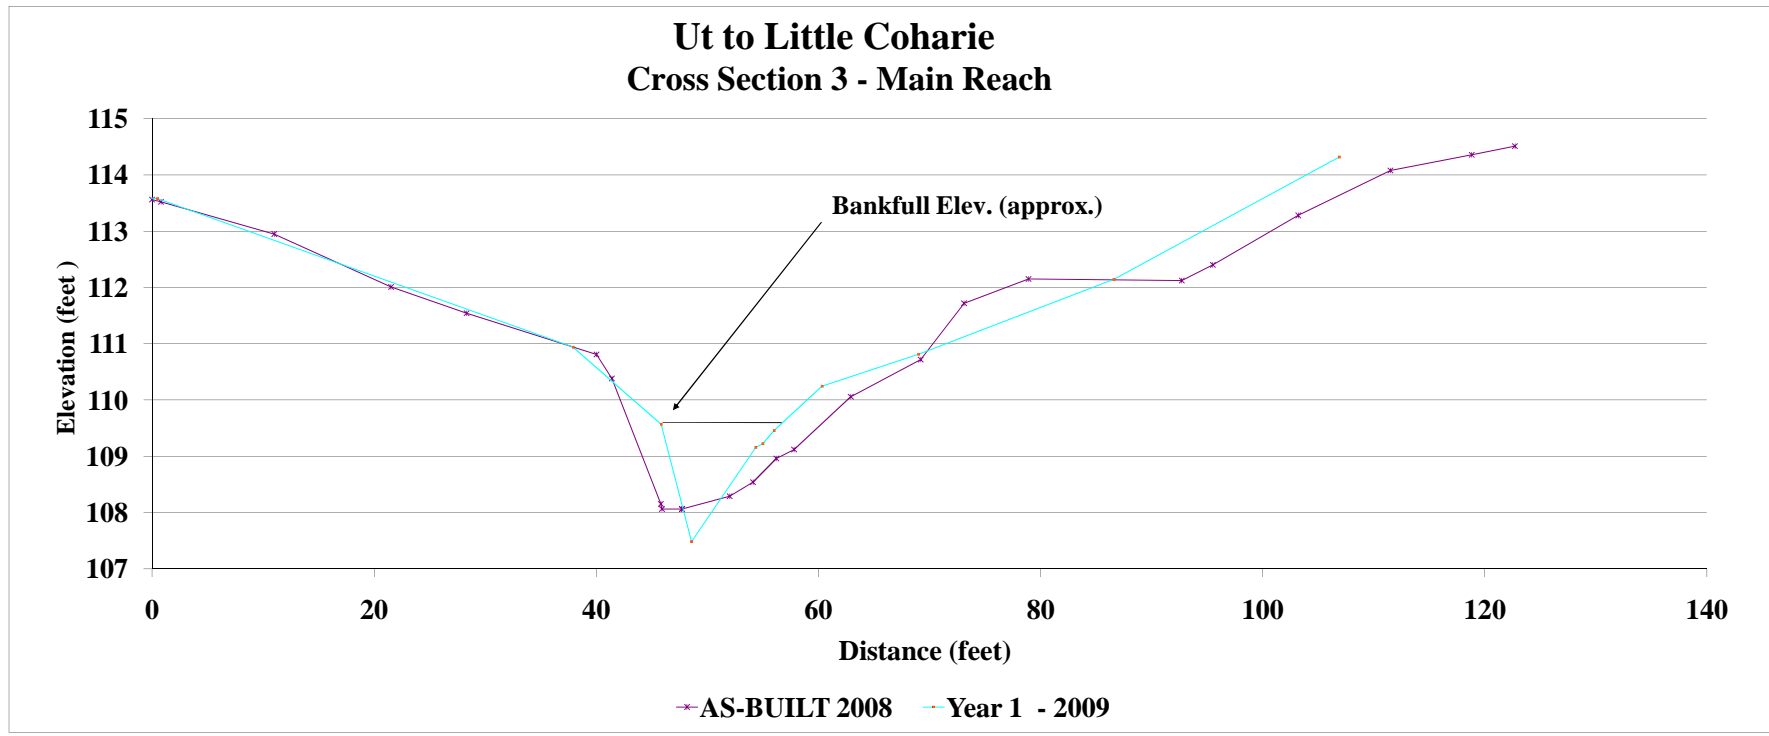
Year 5	Year 4 - 2012	Year 3 - 2011	Year 2 - 2010	Year 1 - 2009	AS-BUILT 2008
Area					10.6	21.5
Width					10.6	14.5
Mean Depth					1.0	1.5
Max Depth					2.1	2.3
W/D					10.6	9.7

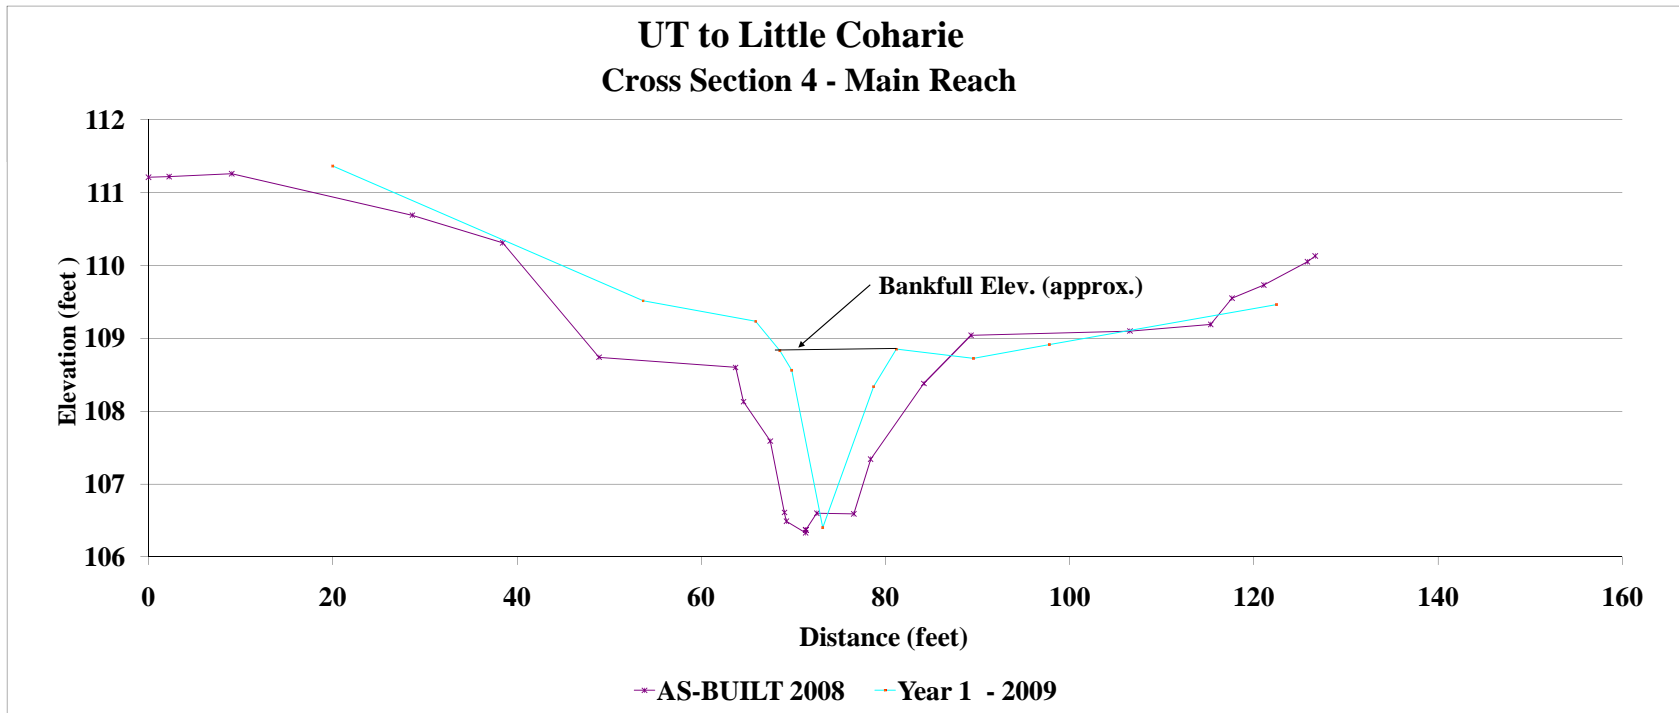
Year 5	Year 4 - 2012	Year 3 - 2011	Year 2 - 2010	Year 1 - 2009	AS-BUILT 2008
Area					14.5	29.0
Width					26.6	27.8
Mean Depth					0.5	1.0
Max Depth					2.4	2.3
WD					49.7	26.7

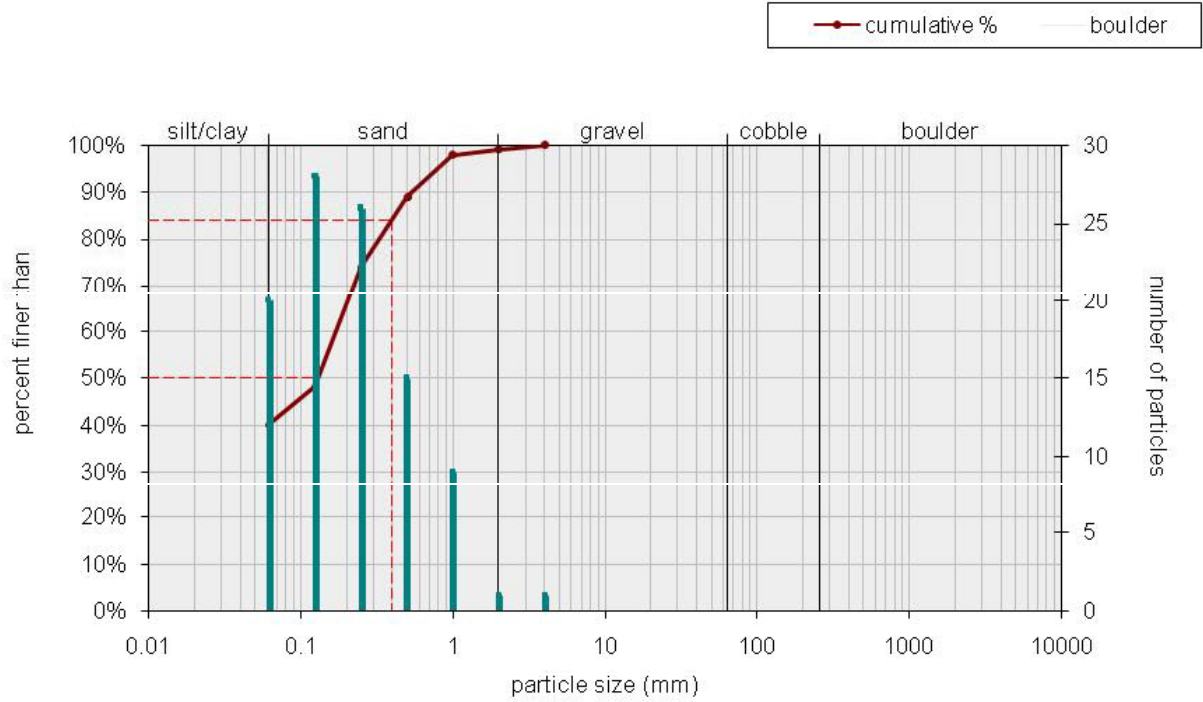
Pebble Count 3 - Main Reach		
Material	Size Range (mm)	Count
silt/clay	0 - 0.062	29
very fine sand	0.062 - 0.125	35
fine sand	0.125 - 0.25	12
medium sand	0.25 - 0.5	17
coarse sand	0.5 - 1	3
very coarse sand	1 - 2	2
very fine gravel	2 - 4	0
fine gravel	4 - 6	1
fine gravel	6 - 8	1
medium gravel	8 - 11	0
medium gravel	11 - 16	
coarse gravel	16 - 22	
coarse gravel	22 - 32	
very coarse gravel	32 - 45	
very coarse gravel	45 - 64	
small cobble	64 - 90	
medium cobble	90 - 128	
large cobble	128 - 180	
very large cobble	180 - 256	
small boulder	256 - 362	
small boulder	362 - 512	
medium boulder	512 - 1024	
large boulder	1024 - 2048	
very large boulder	2048 - 4096	
total particle count:		100
bedrock	-----	
clay hardpan	-----	
detritus/wood	-----	
artificial	-----	
total count:		100
Note: Cross Section 6

Size (mm)	Size Distribution	Type
D16 0.062	mean 0.2	silt/clay 20%
D35 0.062	dispersion 2.6	sand 79%
D50 0.13	skewness 0.09	gravel 1%
D65 0.2		cobble 0%
D84 0.4		boulder 0%
D95 0.79
