**UT to Little Coharie Creek (Roseboro Site)
Stream Restoration Project
Sampson County
North Carolina**

**CU: 030030006
DENR Contract No. 004578
EEP Project No. 314**

**Monitoring Year 4 of 5
Data Collection: July through November 2012
Submission Date: November 30, 2012**

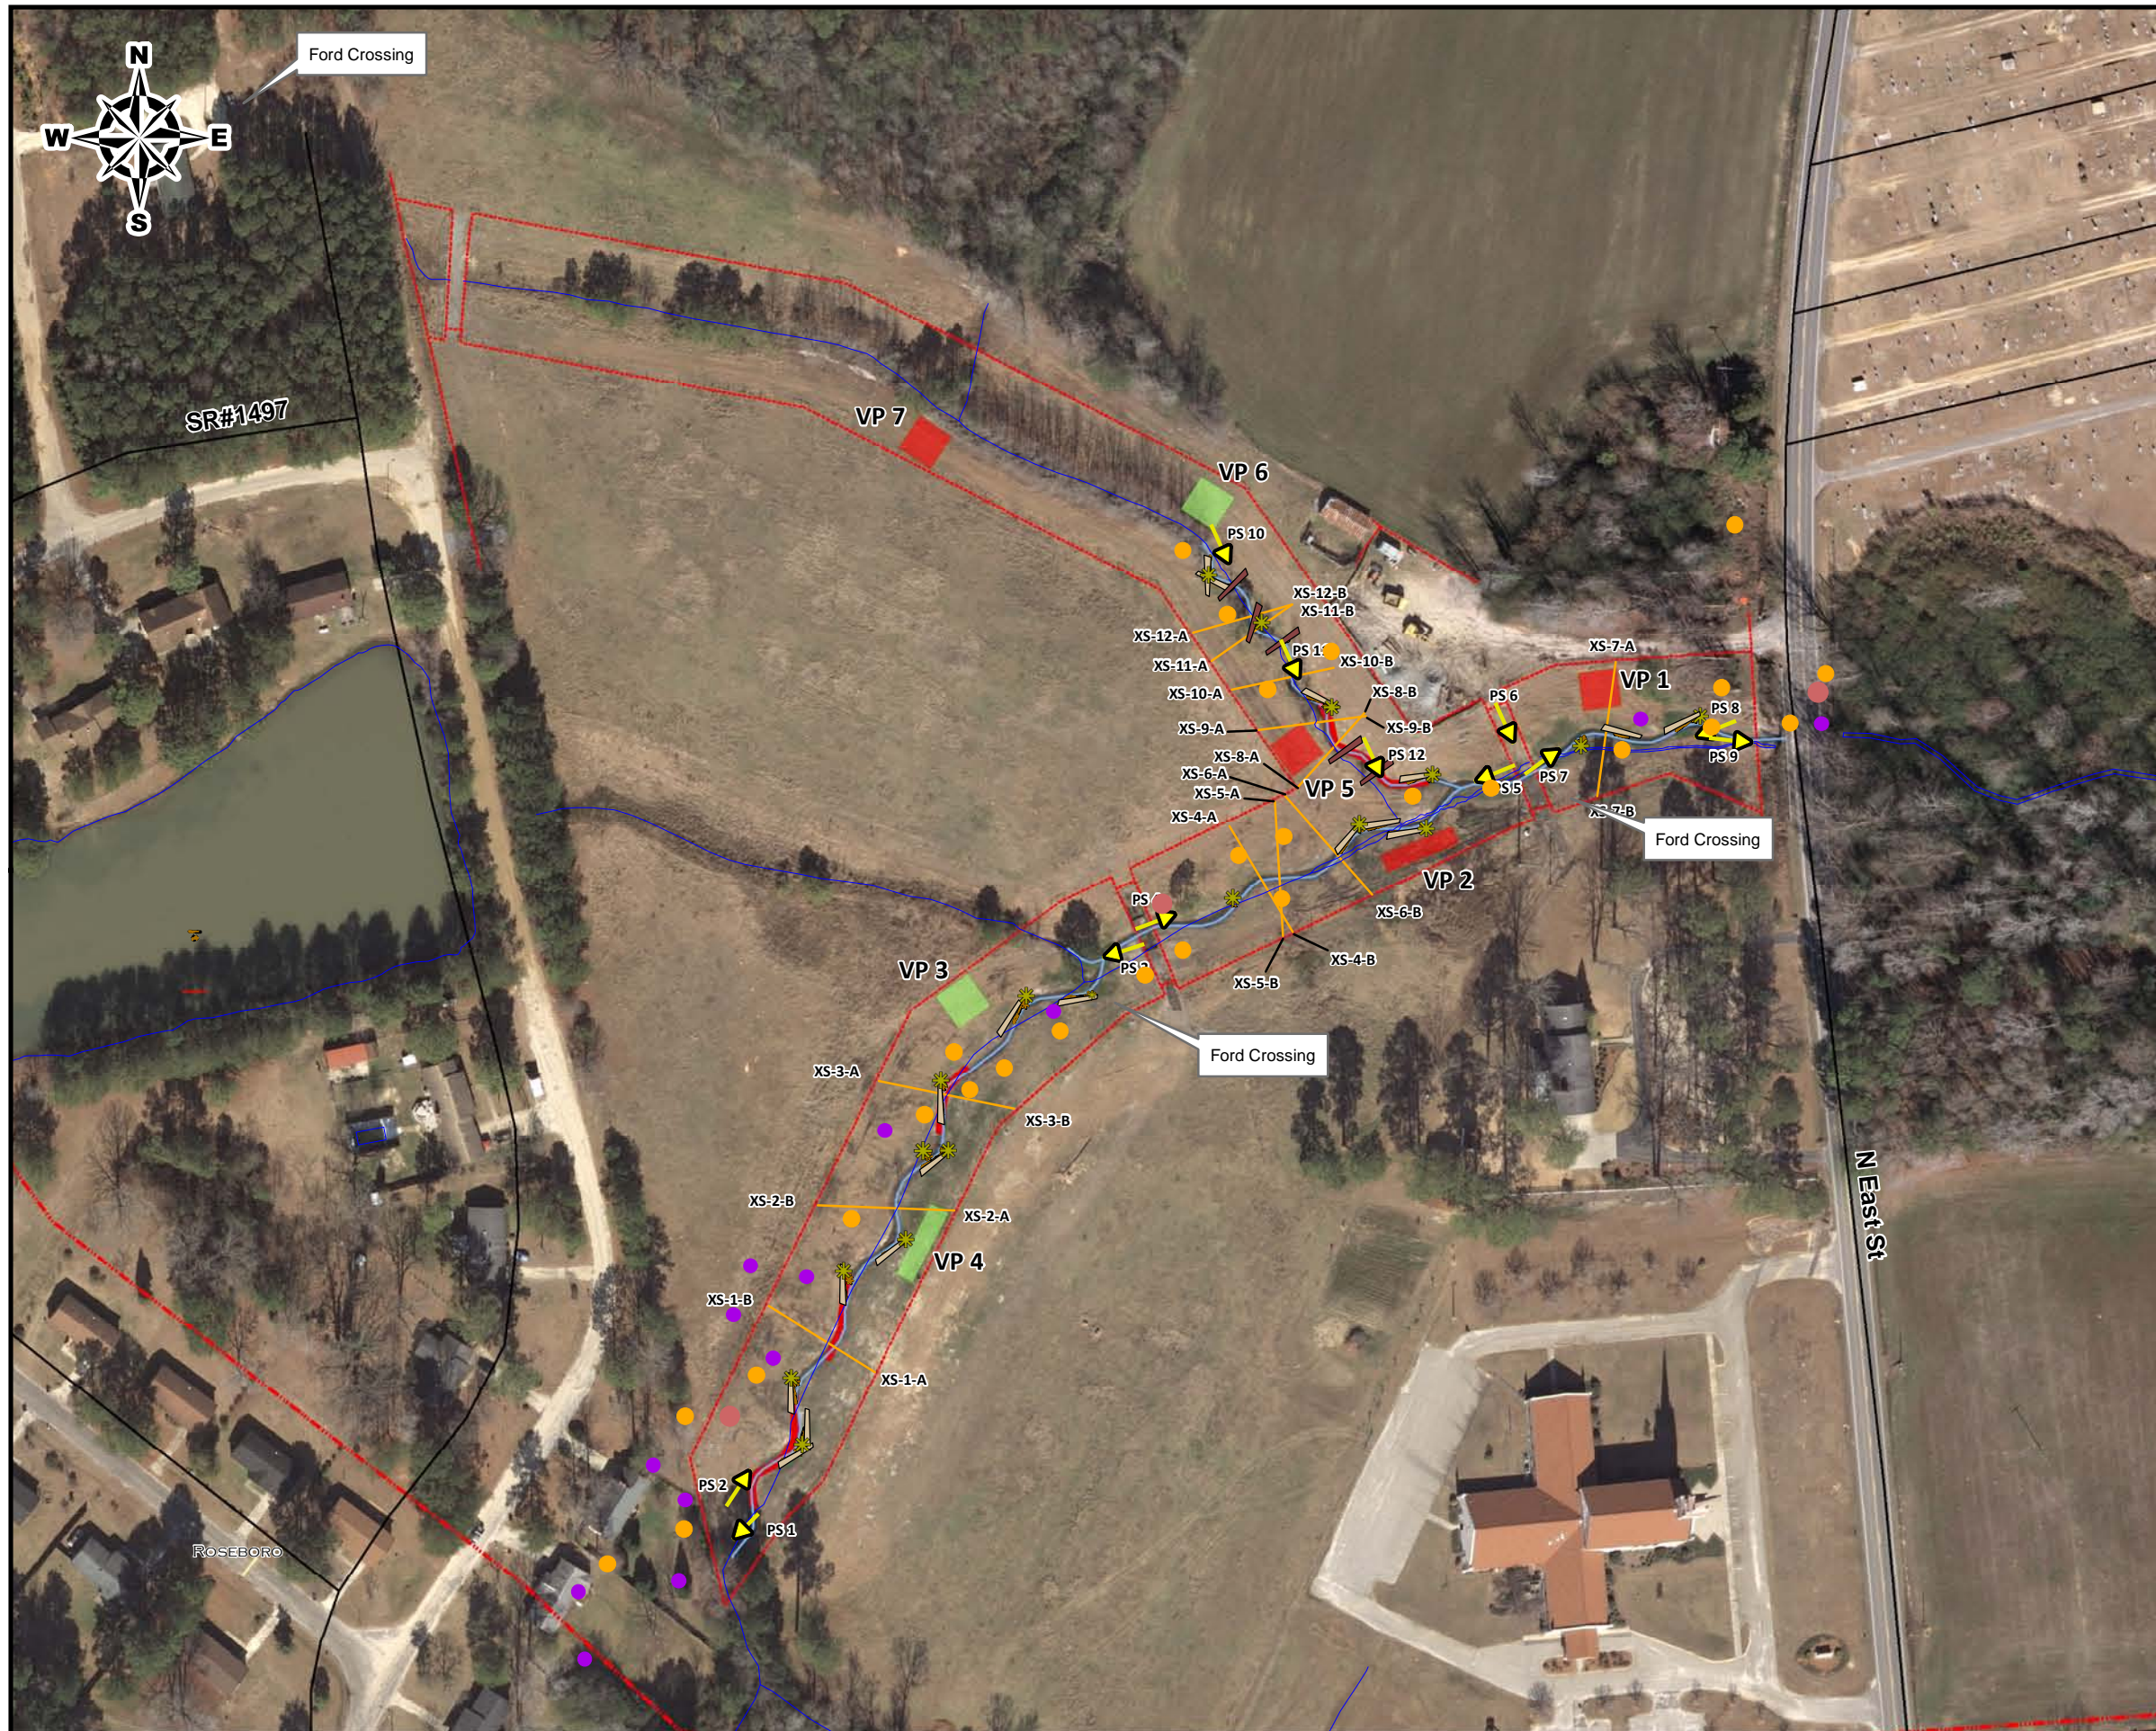
2012 Current Conditions Plan View

Stream Problem Areas			
UT to Little Coharie Stream Restoration Project - EEP No. 314			
Feature Issue	Station Number	Suspected Cause	Photo Number
Aggradation	Main 10+00 to 300+00	Sediment influx from upstream and offsite	Cross Section 1 - 3
Aggradation	Northern 11+40 to 12+40	Trapped Sediment/Low Flow	Figure 2

Vegetation Problem Areas			
UT to Little Coharie Stream Restoration Project - EEP No. 314			
Feature Category	Station Number	Suspected Cause	Photo Number
Cattail	Throughout	Low Flow Conditions	Figure 2
Invasive Vegetation	Various, Refer to Figure to for Location	Offsite seed source	VPA1

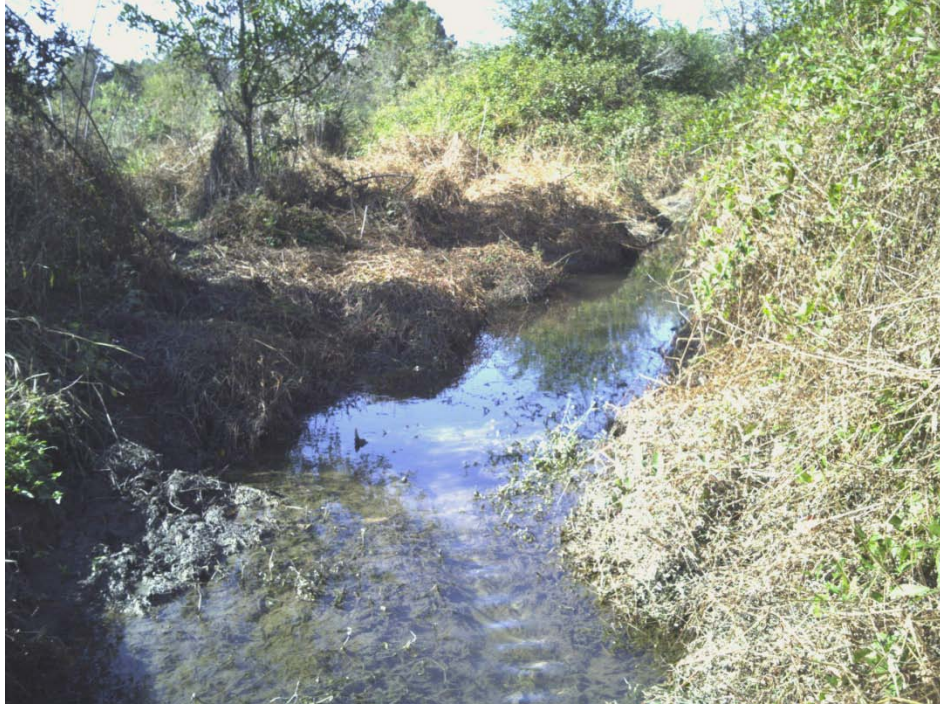
5 - Main Reach Station 9+00 – Looking to Northern Reach confluence

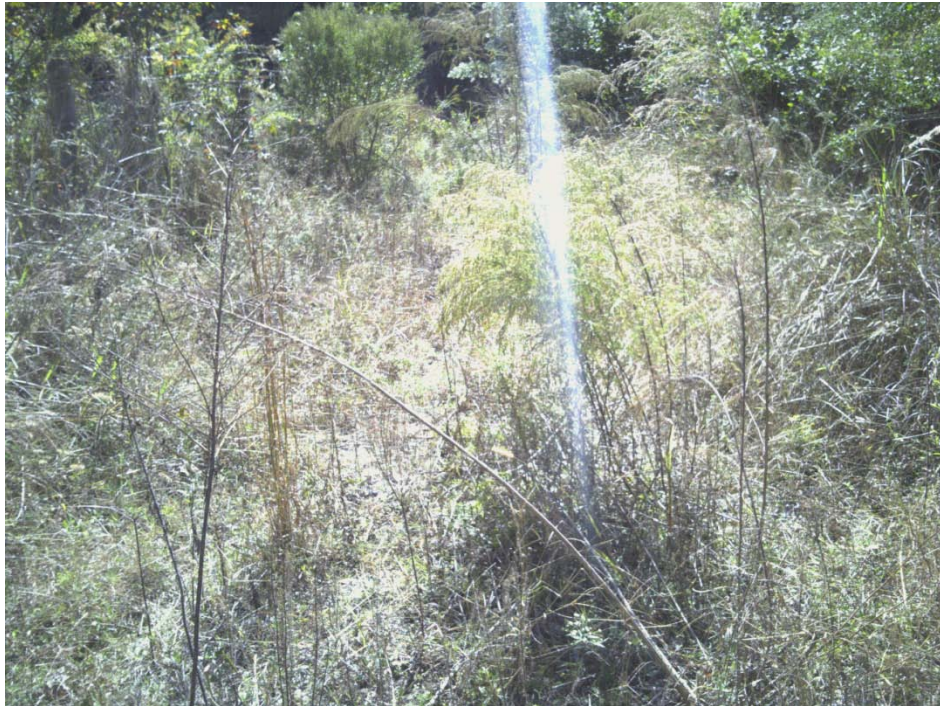
6 - Main Reach Station 10+50 – Stream Crossing

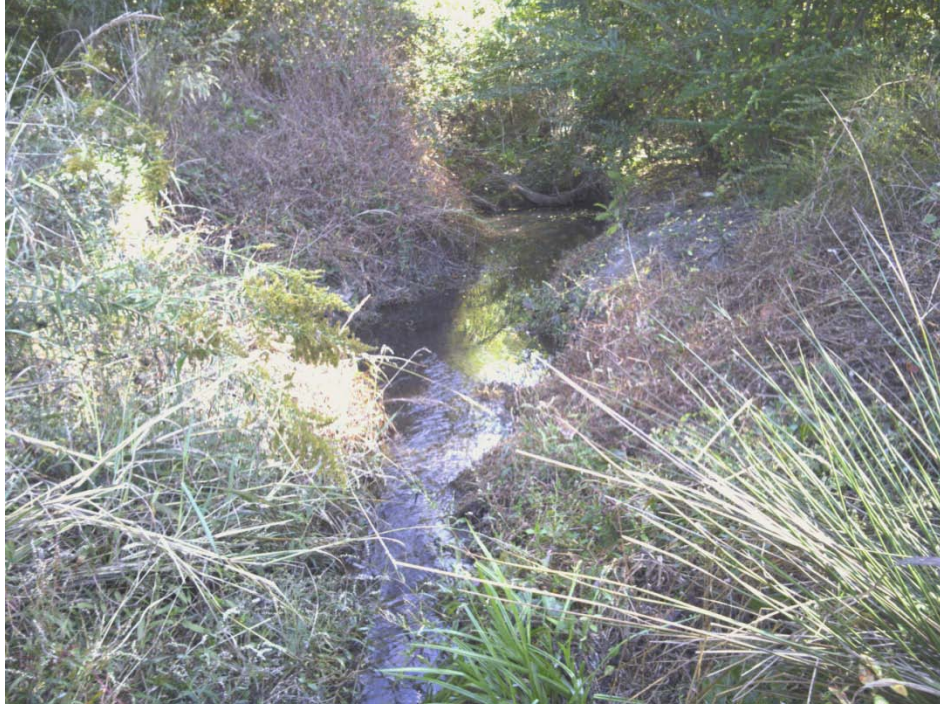
7 - Main Reach Station 10+50 – Looking Downstream

Date of Data Collection	Date of Occurrence	Method	Photo #
November 1, 2012	October 2012	Photographed onsite (Wrack Line)	Stream Photo 7
October 22, 2011	September 2011	Photographed onsite (Wrack Line)	Stream Photo 13 of the 2011 MY3 Monitoring Report
November 13, 2010	September 2010	Photographed onsite (Wrack Line)	Stream Photo 6 of the 2010 MY2 Monitoring Report
October 29, 2009	September 2009*	Wrack line observed onsite	Photographic evidence is not available for this occurrence. 2009 MY1

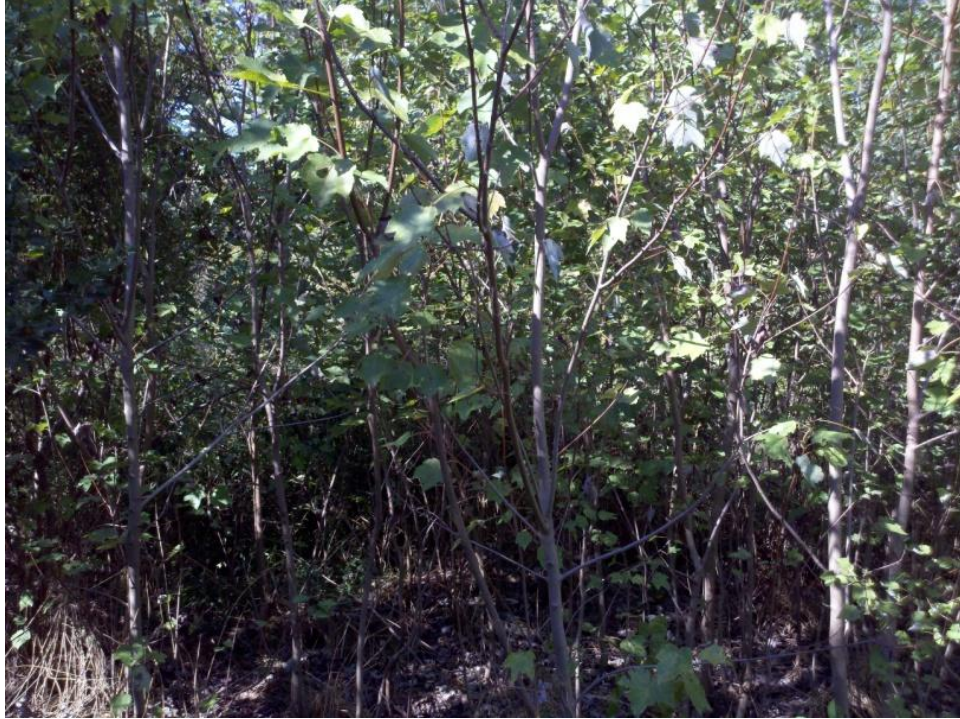
Vegetation Plot 1

Seven (7) permanent vegetation plots were established and used in annual vegetation monitoring. Vegetation plots VP3, VP4, and VP6 exceed the minimum success requirements. Vegetation monitoring plots VP1, VP2, VP5, and VP7 fall below the minimum success requirements. Additional random transect vegetation monitoring is recommended to collect additional data to determine planted stem density. By visual observation, a majority of the site is diverse and numerous of planted stems species. For 2012, MY4, the vegetation monitoring identified stem counts below the minimum success criteria for MY4 resulting in an average density of 234 planted stems per acre for the entire site. The vegetative success criteria based on the US Army Corps of Engineers Stream Mitigation Guidelines (USACE, 2003) will require the survival of 260 planted woody stems per acre at the end of the year 5 monitoring period. UT to Little Coharie Creek utilizes a CVS Level 2 protocol for vegetation data collection. This protocol does include volunteer stems during data collection. For vegetation success criteria, only the planted stems are used to determine stems per acre. Vegetation plot locations are identified in Appendix C. Invasive vegetation species Chinese privet (*Ligustrum sinense*), mimosa (*Mimosa sp.*), kudzu (*Pueraria lobata*), and Asiatic daylily (*Commelina communis*) have been identified onsite and the location of each are depicted in Figure 2. Multiflora rose (*Rosa multiflora*) and fescue (*Festuca sp.*) have also been identified onsite.

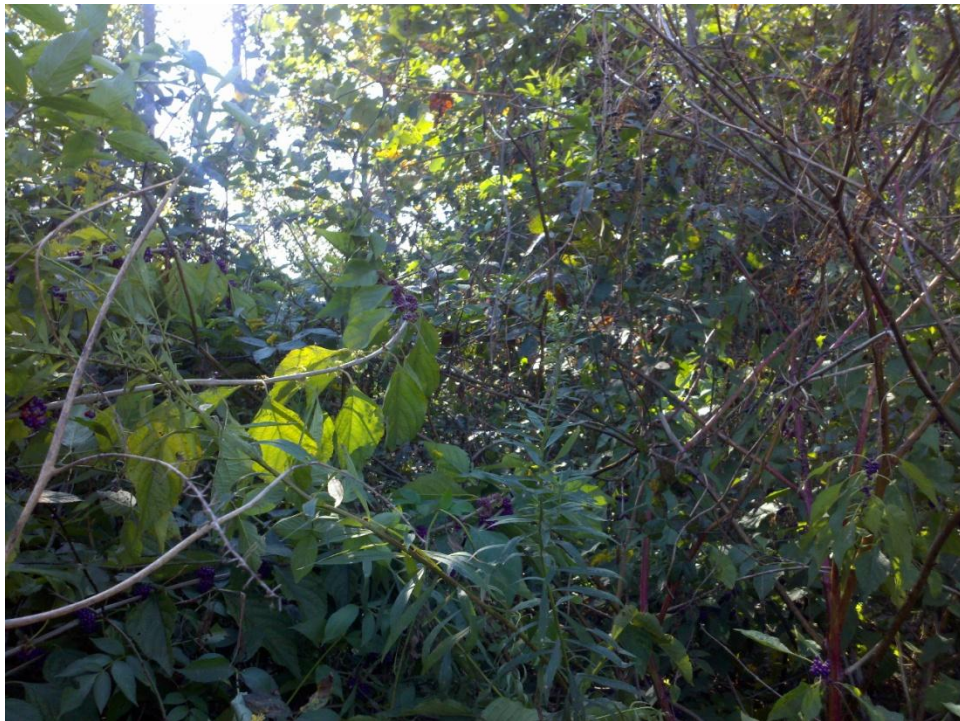
Vegetation Plot 6

In the Winter/Spring of 2011, a wild fire from an adjacent land parcel to the north of the Northern Tributary, caused damage to planted areas as well as easement fencing west of vegetation plot 6. Site damage was minimal and repairs to easement fencing were completed during 2012.

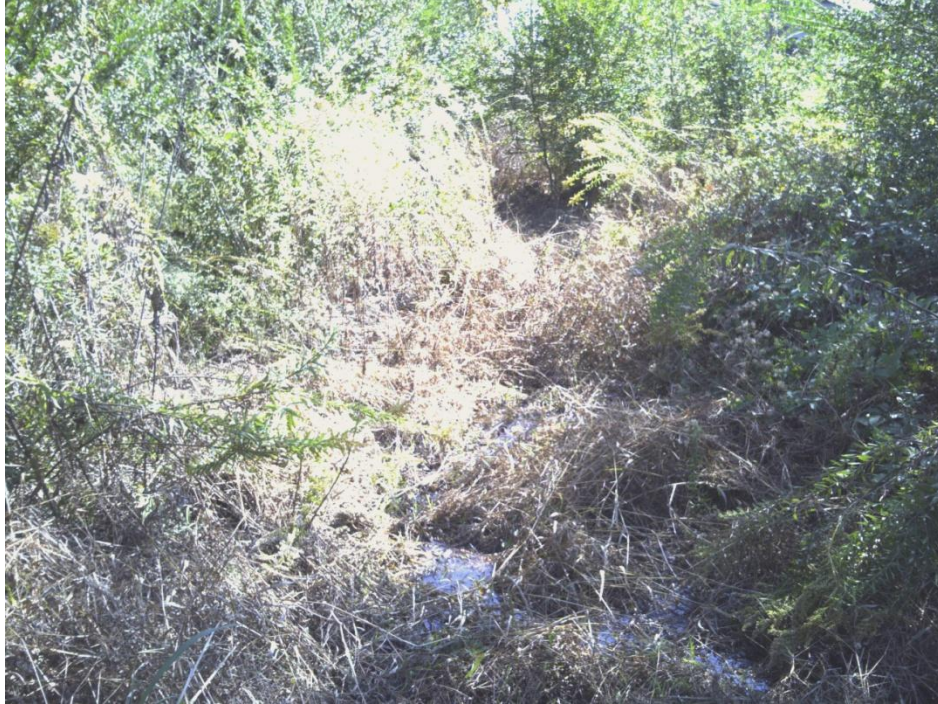
VPA1 – Kudzu Encroachment and Chinese privet (Figure 2)

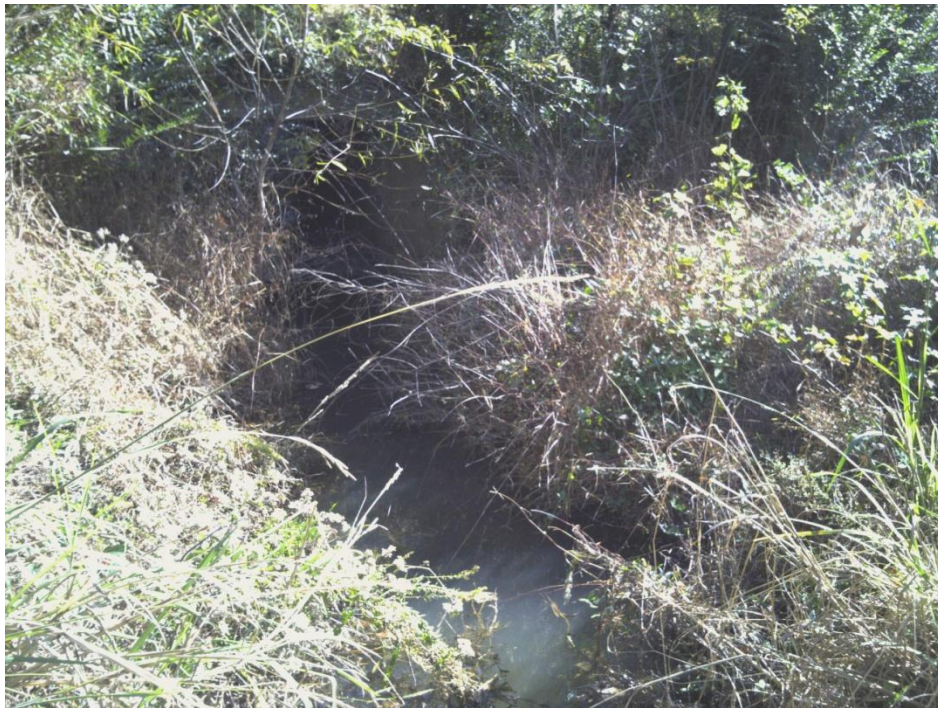
VPA3 – Chinese privet and mimosa (Figure 2)

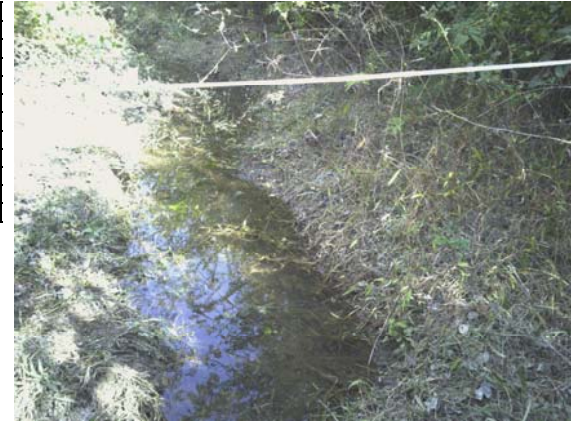
Photo of Cross-Section 1 - Riffle - Looking Downstream

Summary Data	
Bankfull Elev.	110.5
BF Area	9
BF Width	10.4
Flood Prone Elev.	112.61
Flood Prone Width	51.8
Max Depth	2.1
Mean Depth	0.9
W/D Ratio	12
ER	5
Bank Height Ratio	
Stream Type	C5

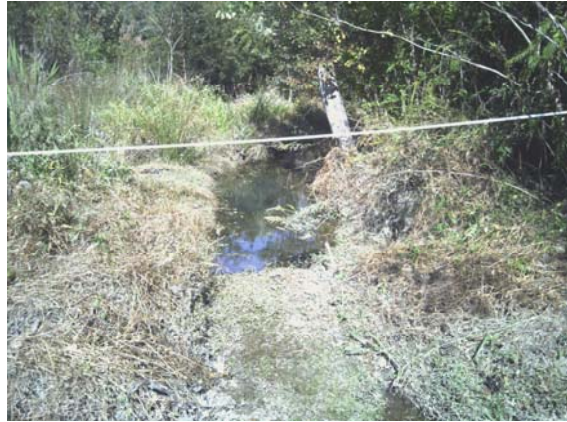
Project Name UT to Little Coharie, MY4
 Watershed
 Cross Section 3
 Drainage Area NA
 Date Nov-12
 Crew Tuft, Singletary

Summary Data	
Bankfull Elv.	111.25'
BF Area	13.8
BF Width	16.7
Flood Prone Elv.	113.92
Flood Prone Width	103.4
Max Depth	2.6
Mean Depth	0.8
W/D Ratio	20.1
ER	6.2
Bank Height Ratio	
Stream Type	C5

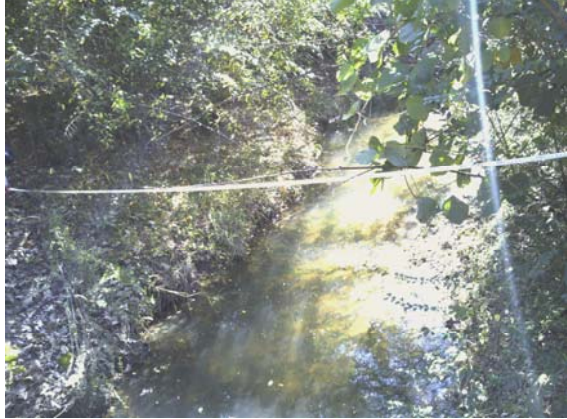
Project Name UT to Little Coharie, MY4
 Watershed
 Cross Section 4
 Drainage Area NA
 Date Nov-12
 Crew Tutt, Singletary

Summary Data	
Bankfull Elv.	110.4
BF Area	15.3
BF Width	16.6
Flood Prone Elv.	112.79
Flood Prone Width	80.1
Max Depth	2.4
Mean Depth	0.9
W/D Ratio	17.9
ER	4.8
Bank Height Ratio	
Stream Type	C5

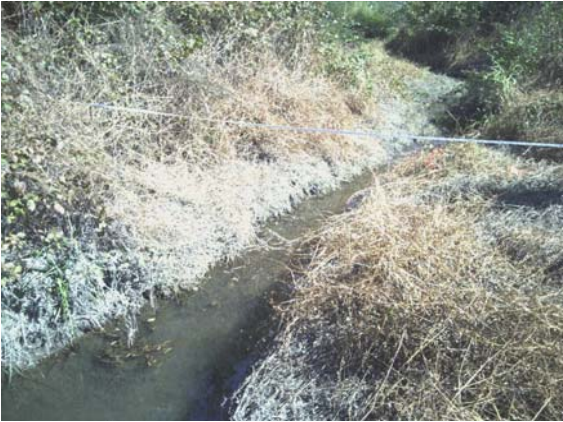
Project Name UT to Little Coharie, MY4
Watershed
Cross Section 6
Drainage Area NA
Date Nov-12
Crew Tutt, Singletary

Summary Data	
Bankfull Elv.	109.2
BF Area	11.1
BF Width	22.8
Flood Prone Elv.	111.49
Flood Prone Width	107.9
Max Depth	2.3
Mean Depth	0.5
W/D Ratio	46.8
ER	4.7
Bank Height Ratio	
Stream Type	C5

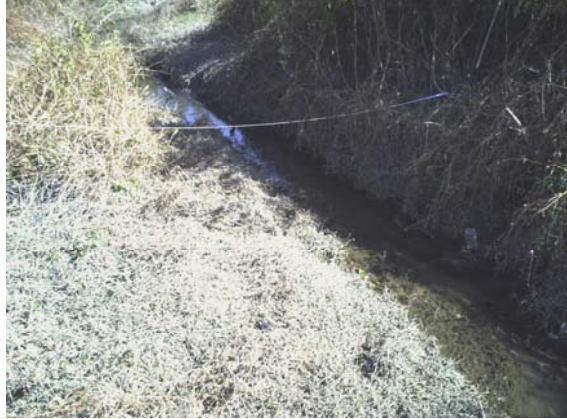
Project Name UT to Little Coharie, MY4
 Watershed
 Cross Section 7
 Drainage Area NA
 Date Nov-12
 Crew Tutt, Singletary

Summary Data	
Bankfull Elv.	109.1
BF Area	17.7
BF Width	42.5
Flood Prone Elv.	111.17
Flood Prone Width	106.5
Max Depth	2.1
Mean Depth	0.4
W/D Ratio	102.1
ER	2.5
Bank Height Ratio	
Stream Type	C5

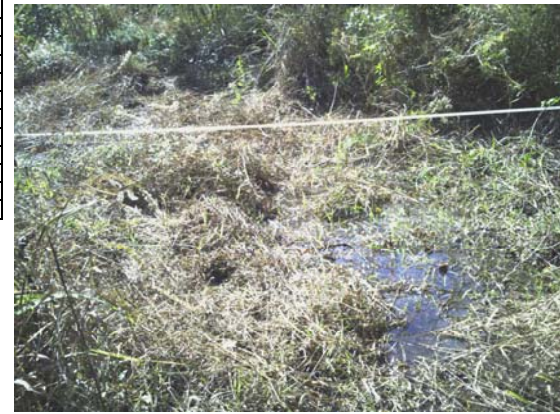
UT Little Coharie 2012
Cross Section 8 - Pool - Northern Reach - Sta. 2+20.89

Summary Data	
Bankfull Elev.	110
BF Area	23.9
BF Width	24.1
Flood Prone Elev.	112.19
Flood Prone Width	83.4
Max Depth	2.2
Mean Depth	1
W/D Ratio	24.4
ER	3.5
Bank Height Ratio	
Stream Type	C5

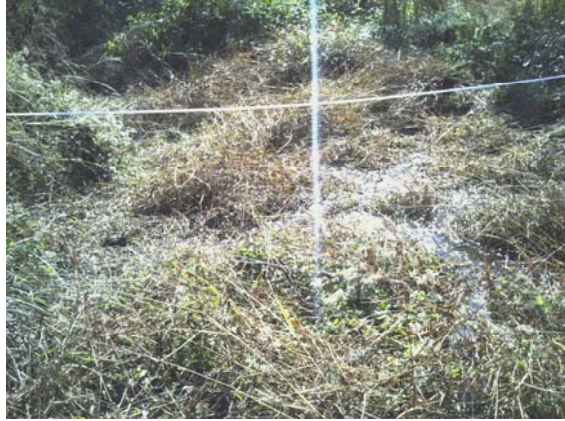
UT Little Coharie 2012
 Cross Section 9 - Riffle - Northern Reach - Sta. 1+96.05

Summary Data	
Bankfull Elev.	109.4
BF Area	9.7
BF Width	11.1
Flood Prone Elev.	110.9
Flood Prone Width	48.2
Max Depth	1.5
Mean Depth	0.9
W/D Ratio	12.6
ER	4.4
Bank Height Ratio	
Stream Type	C5

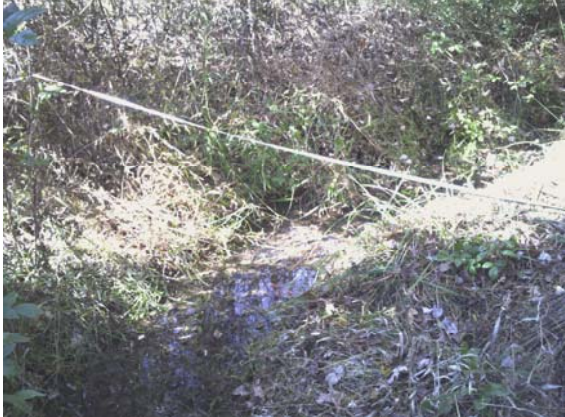
Project Name UT to Little Coharie, MY4
Watershed
Cross Section 12
Drainage Area NA
Date Nov-12
Crew Tutt, Singletary

Summary Data	
Bankfull Elev.	110
BF Area	11.8
BF Width	12.5
Flood Prone Elev.	111.51
Flood Prone Width	42.2
Max Depth	1.5
Mean Depth	0.9
W/D Ratio	13.2
ER	3.4
Bank Height Ratio	
Stream Type	C5

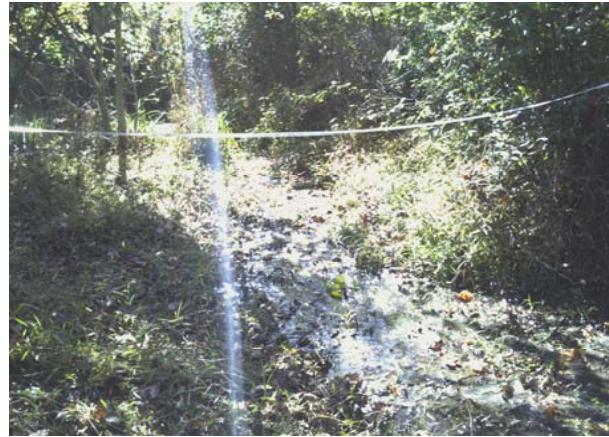
UT to Little Coharie
 (Roseboro Site)
 Longitudinal Profile
 Main Reach
 Station 0+00 to 12+75

Overall, the stream is functioning well and holding grade, however, the stream has areas that are of concern. Channel dimension and pattern are similar to as-built conditions and currently meeting monitoring minimum success requirement thresholds. The Main Reach channel profile appears to be holding grade and maintaining bedform features. Due to sediment influx from upstream and offsite, there has been some aggradation of sediment in the upstream section of the Main Reach. Specifically, station

10+00 to 300+00. The Northern Reach channel profile has areas that appear to have sediment deposition also. This sediment deposition may be caused by vegetation growing within the bankfull channel. Since project construction, North Carolina has been in a moderate to severe drought. The drought has caused low flow periods resulting in vegetation growing within the stream channel. Asiatic daylily and cattail are growing within the stream bed, causing disruption of sediment transport on parts of the project..
