**FINAL**  
**AS-BUILT BASELINE MONITORING REPORT**  
**UT TO MARTIN'S CREEK (CONTRERAS) MITIGATION PROJECT**  
Cherokee County, North Carolina  
EEP Project No. 92766 (Contract No. 005717)  
USACE Action ID No. 2010-00961/DWR Project No. 2010-00448  
SCO No. 08-07249-01

**Data Collection – March-April 2014**

Hiwassee River Basin  
Cataloging Unit 06020002170010

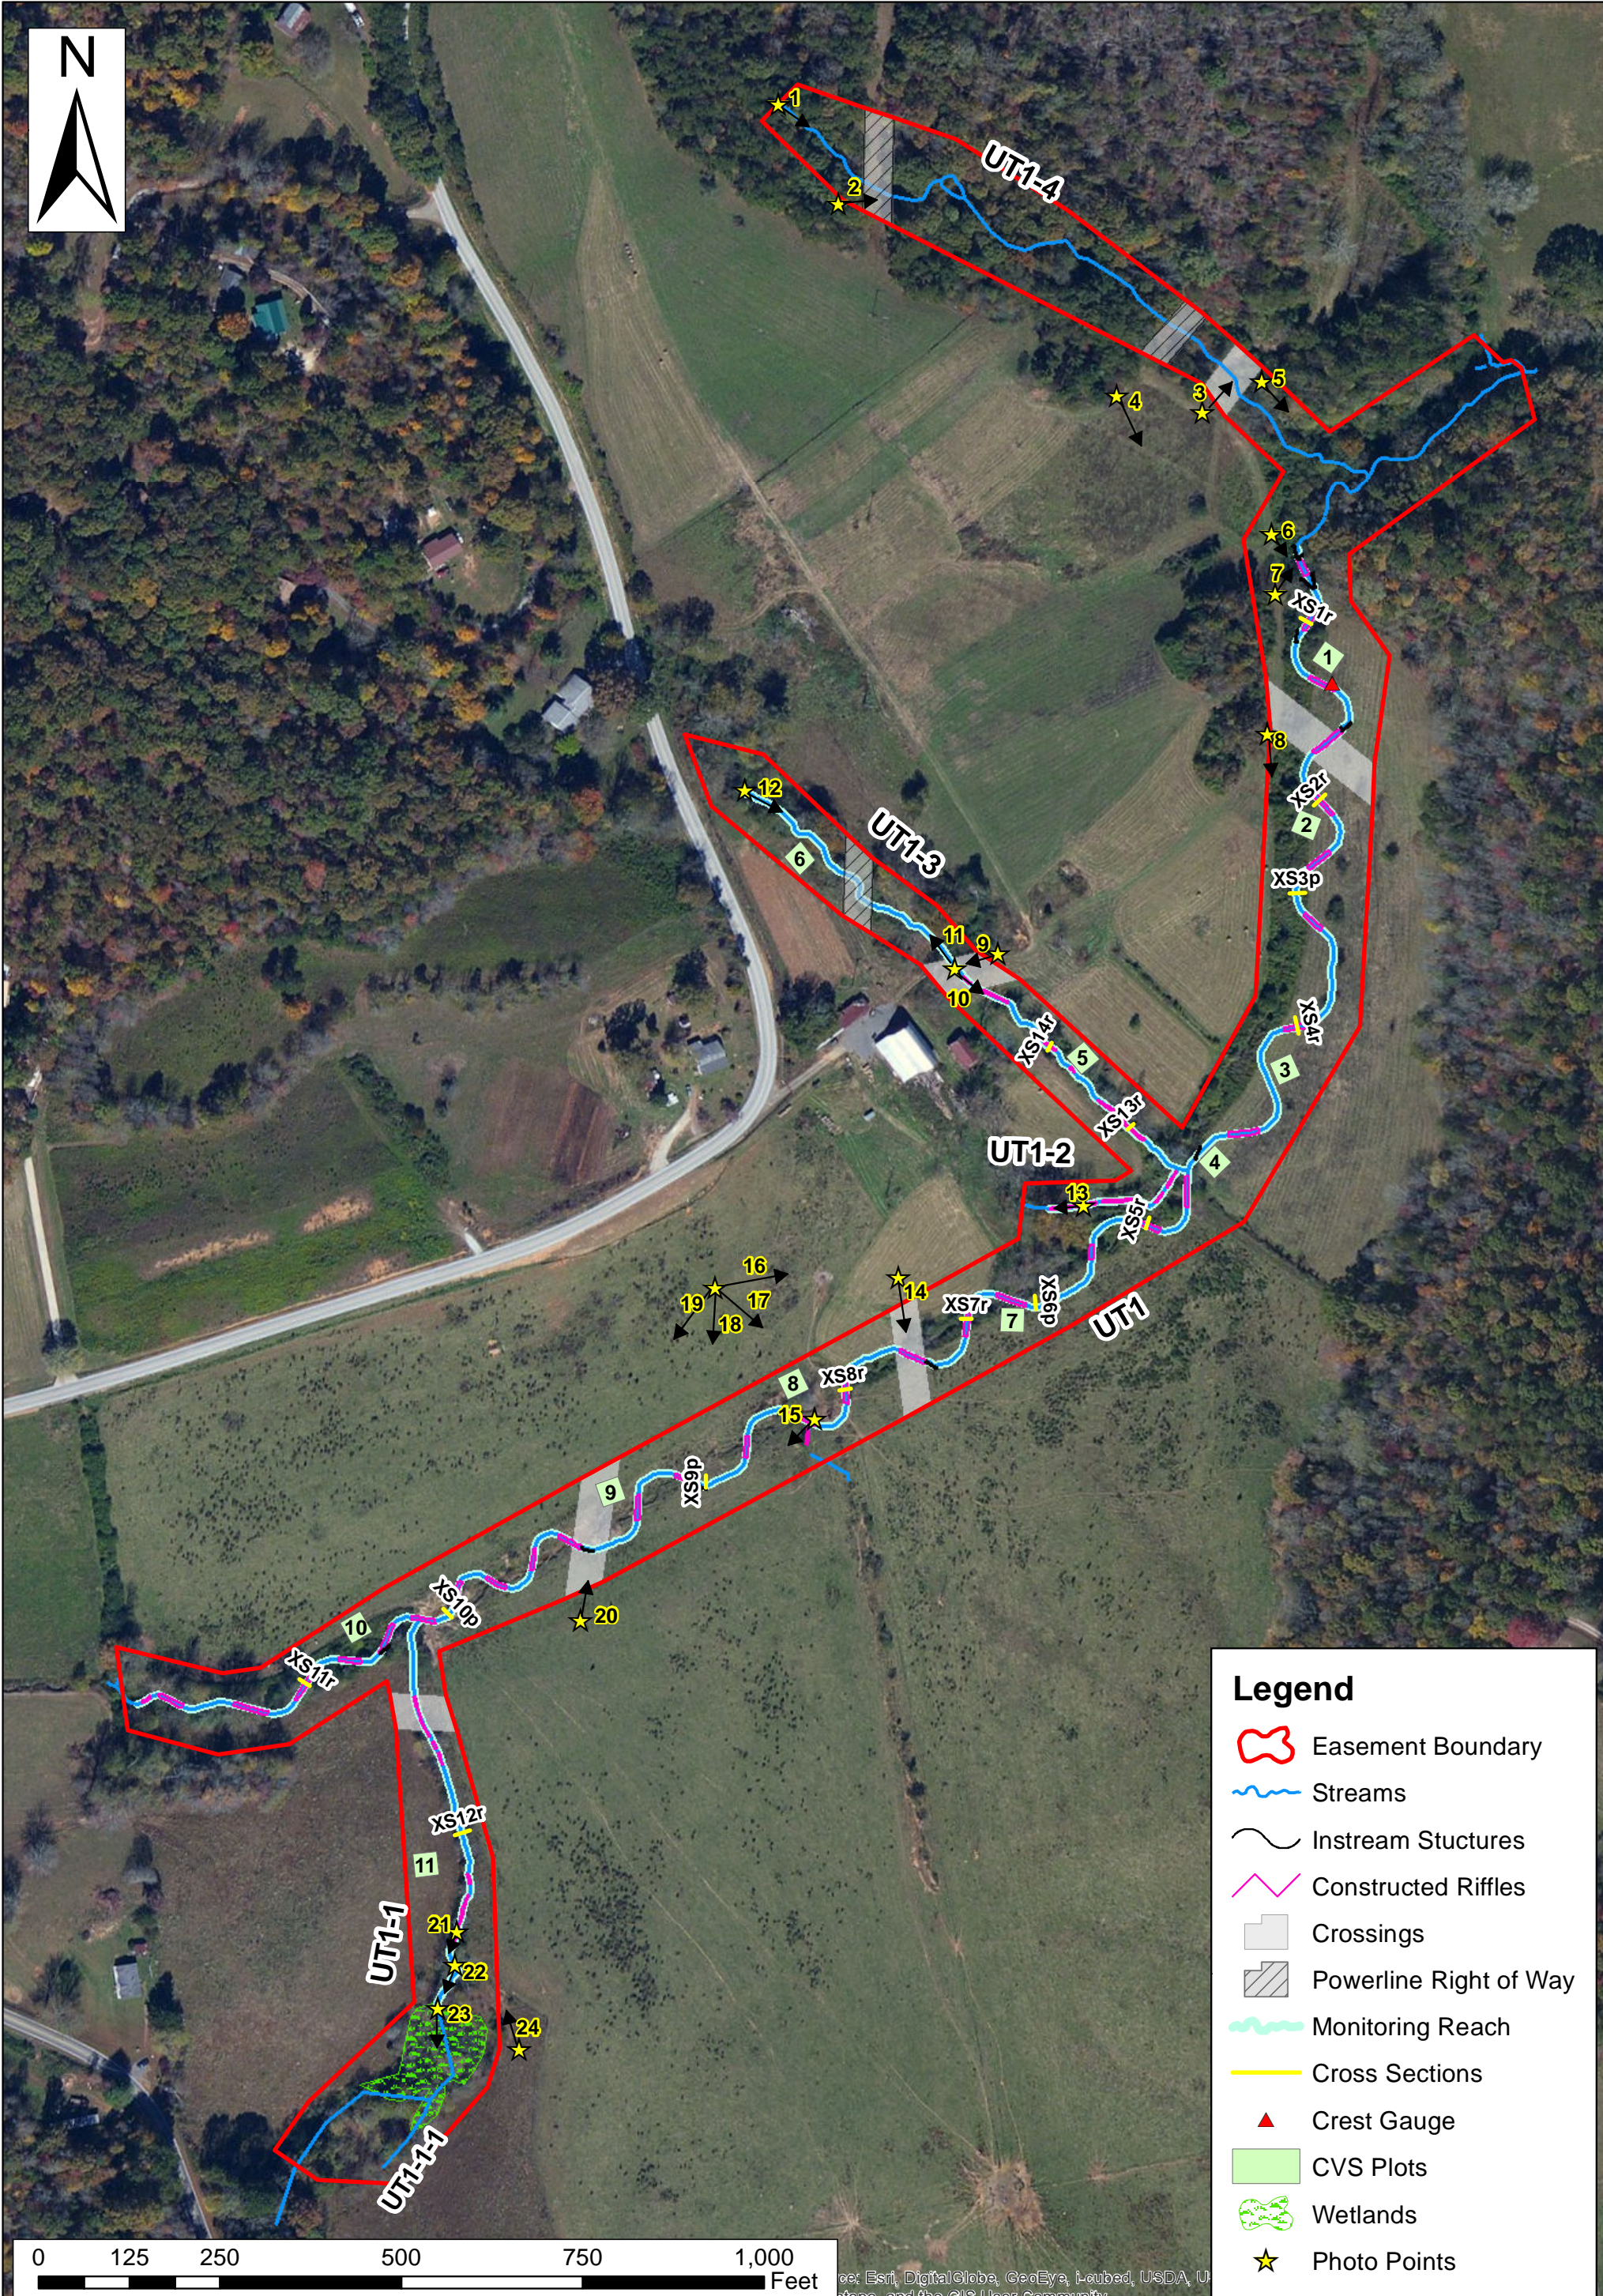
FIGURE  
**2**

**CURRENT CONDITIONS PLAN VIEW  
UT TO MARTINS CREEK (CONTRERAS)  
EEP PROJECT # 92766  
Cherokee County, North Carolina**

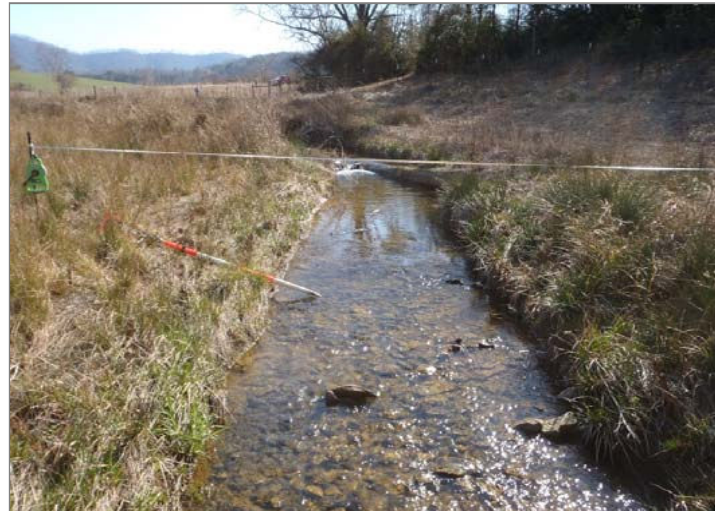
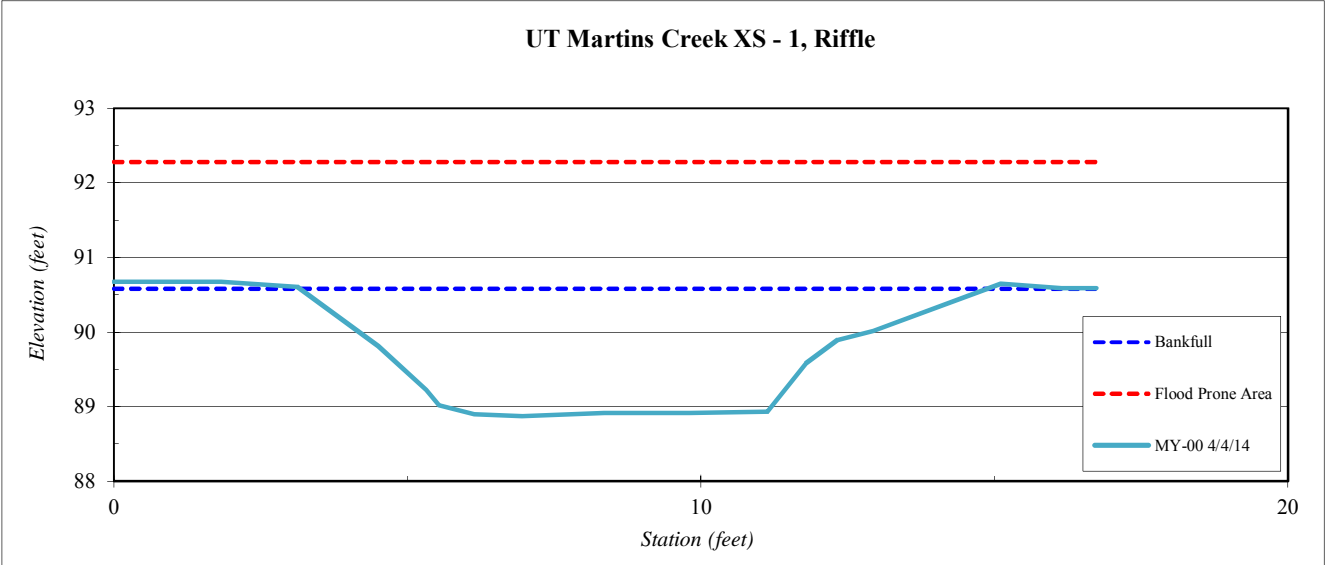
<b>Site</b>	UT to Martins
<b>Watershed:</b>	Hiwassee
<b>XS ID</b>	XS - 1, Riffle
<b>Feature</b>	Riffle
<b>Date:</b>	4/4/2014
<b>Field Crew:</b>	Perkinson, Jernigan

SUMMARY DATA	
<b>Bankfull Elevation:</b>	90.6
<b>Bankfull Cross-Sectional Area:</b>	13.3
<b>Bankfull Width:</b>	11.7
<b>Flood Prone Area Elevation:</b>	92.3
<b>Flood Prone Width:</b>	100.0
<b>Max Depth at Bankfull:</b>	1.7
<b>Mean Depth at Bankfull:</b>	1.1
<b>W / D Ratio:</b>	10.3
<b>Entrenchment Ratio:</b>	8.5
<b>Bank Height Ratio:</b>	1.0

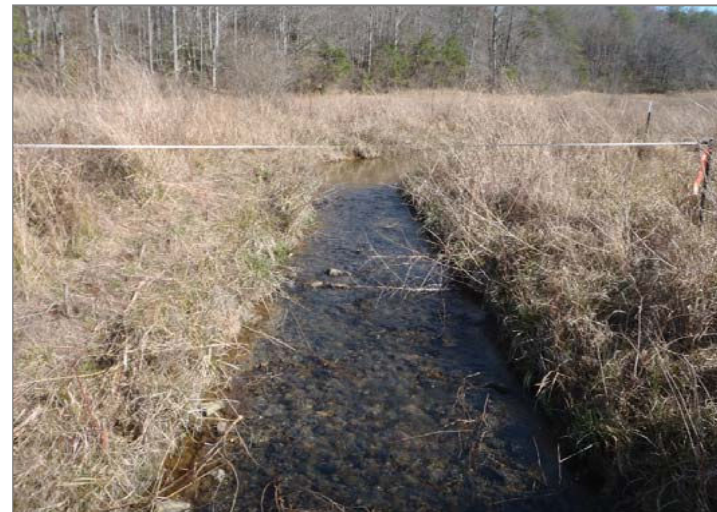
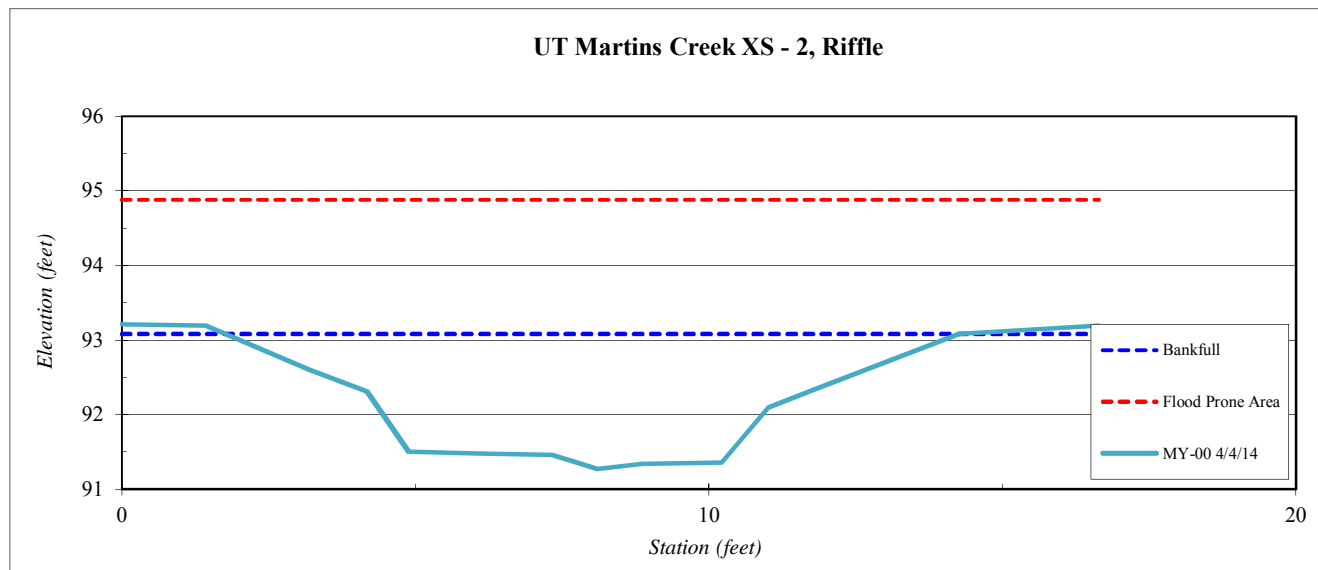
<b>Site</b>	UT to Martins
<b>Watershed:</b>	Hiwassee
<b>XS ID</b>	XS - 2, Riffle
<b>Feature</b>	Riffle
<b>Date:</b>	4/4/2014
<b>Field Crew:</b>	Perkinson, Jernigan

<b>SUMMARY DATA</b>	
<b>Bankfull Elevation:</b>	93.1
<b>Bankfull Cross-Sectional Area:</b>	13.4
<b>Bankfull Width:</b>	12.5
<b>Flood Prone Area Elevation:</b>	94.9
<b>Flood Prone Width:</b>	100.0
<b>Max Depth at Bankfull:</b>	1.8
<b>Mean Depth at Bankfull:</b>	1.1
<b>W / D Ratio:</b>	11.7
<b>Entrenchment Ratio:</b>	8.0
<b>Bank Height Ratio:</b>	1.0

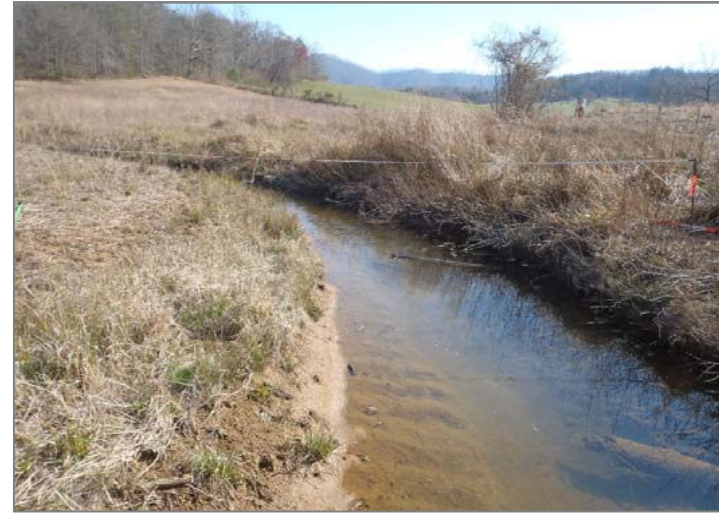
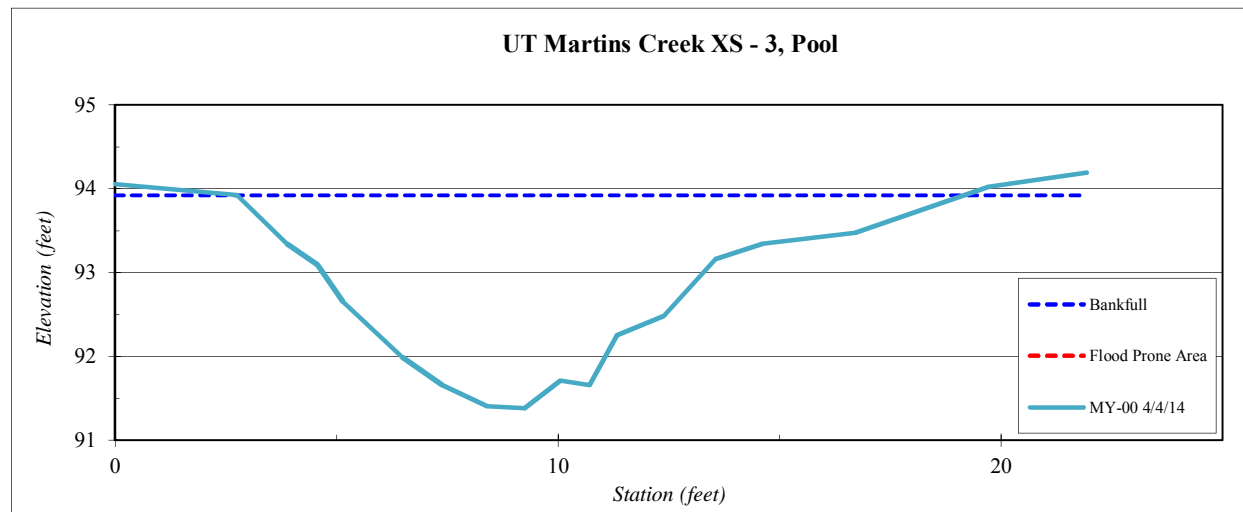
<b>Site</b>	UT to Martins
<b>Watershed:</b>	Hiwassee
<b>XS ID</b>	XS - 3, Pool
<b>Feature</b>	Pool
<b>Date:</b>	4/4/2014
<b>Field Crew:</b>	Perkinson, Jernigan

SUMMARY DATA	
<b>Bankfull Elevation:</b>	93.9
<b>Bankfull Cross-Sectional Area:</b>	19.9
<b>Bankfull Width:</b>	16.4
<b>Flood Prone Area Elevation:</b>	NA
<b>Flood Prone Width:</b>	NA
<b>Max Depth at Bankfull:</b>	2.5
<b>Mean Depth at Bankfull:</b>	1.2
<b>W / D Ratio:</b>	NA
<b>Entrenchment Ratio:</b>	NA
<b>Bank Height Ratio:</b>	1.0

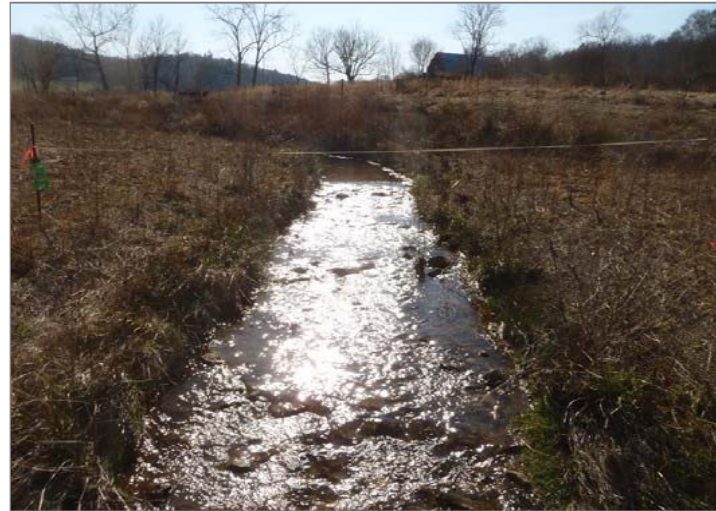
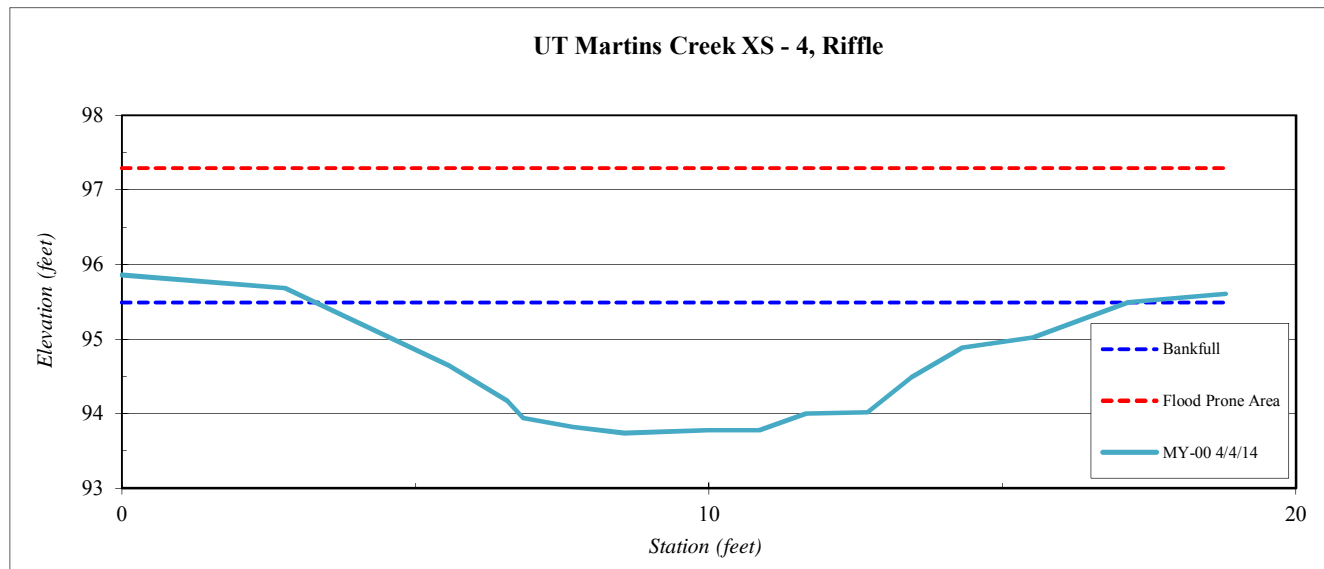
<b>Site</b>	UT to Martins
<b>Watershed:</b>	Hiwassee
<b>XS ID</b>	XS - 4, Riffle
<b>Feature</b>	Riffle
<b>Date:</b>	4/4/2014
<b>Field Crew:</b>	Perkinson, Jernigan

UT Martins Creek XS - 4, Riffle

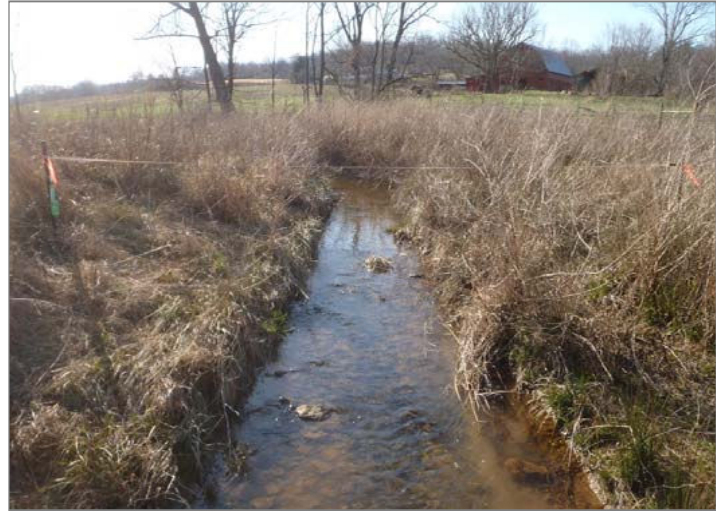
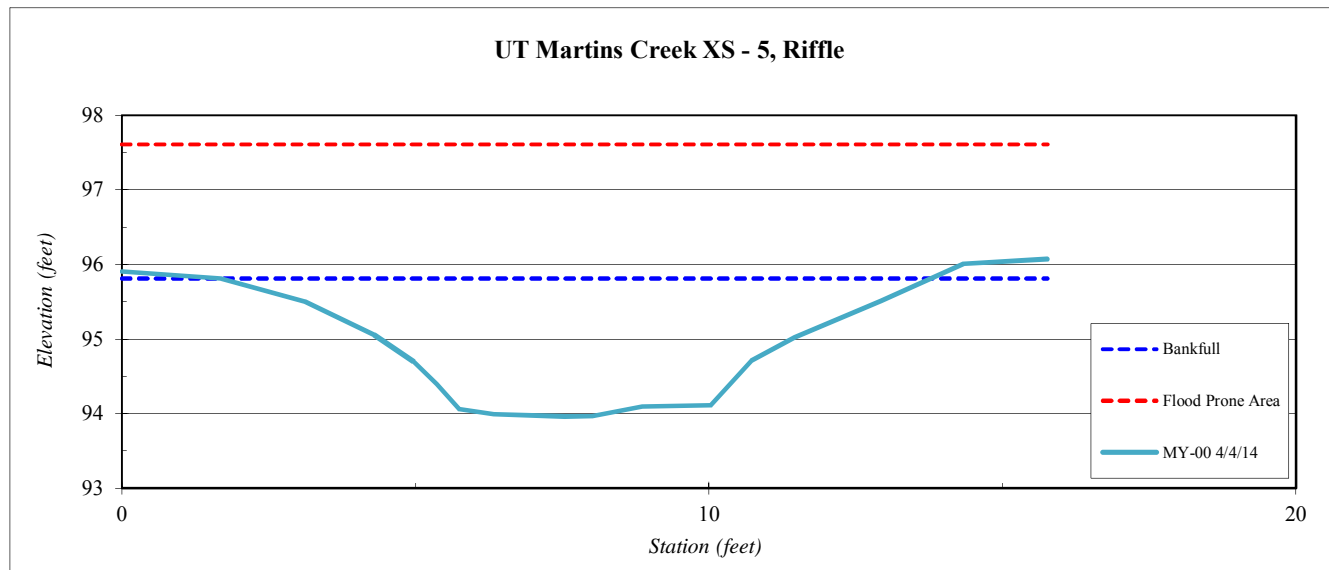
<b>Site</b>	UT to Martins
<b>Watershed:</b>	Hiwassee
<b>XS ID</b>	XS - 5, Riffle
<b>Feature</b>	Riffle
<b>Date:</b>	4/4/2014
<b>Field Crew:</b>	Perkinson, Jernigan

SUMMARY DATA	
<b>Bankfull Elevation:</b>	95.8
<b>Bankfull Cross-Sectional Area:</b>	12.8
<b>Bankfull Width:</b>	12.1
<b>Flood Prone Area Elevation:</b>	97.6
<b>Flood Prone Width:</b>	50.0
<b>Max Depth at Bankfull:</b>	1.8
<b>Mean Depth at Bankfull:</b>	1.1
<b>W / D Ratio:</b>	11.4
<b>Entrenchment Ratio:</b>	4.1
<b>Bank Height Ratio:</b>	1.0

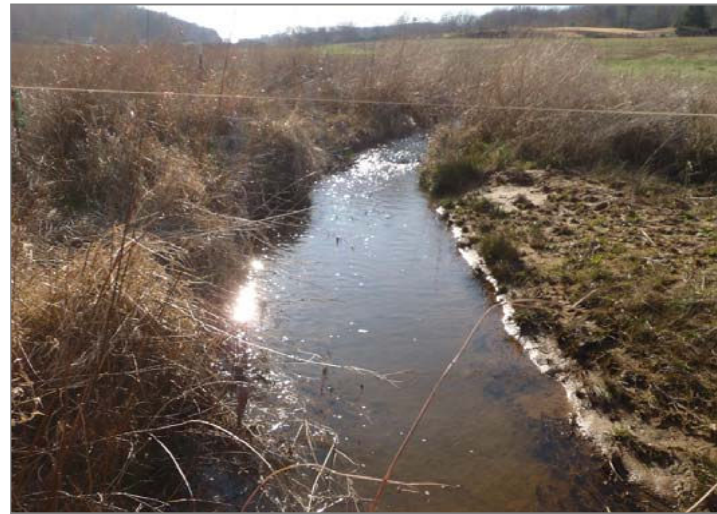
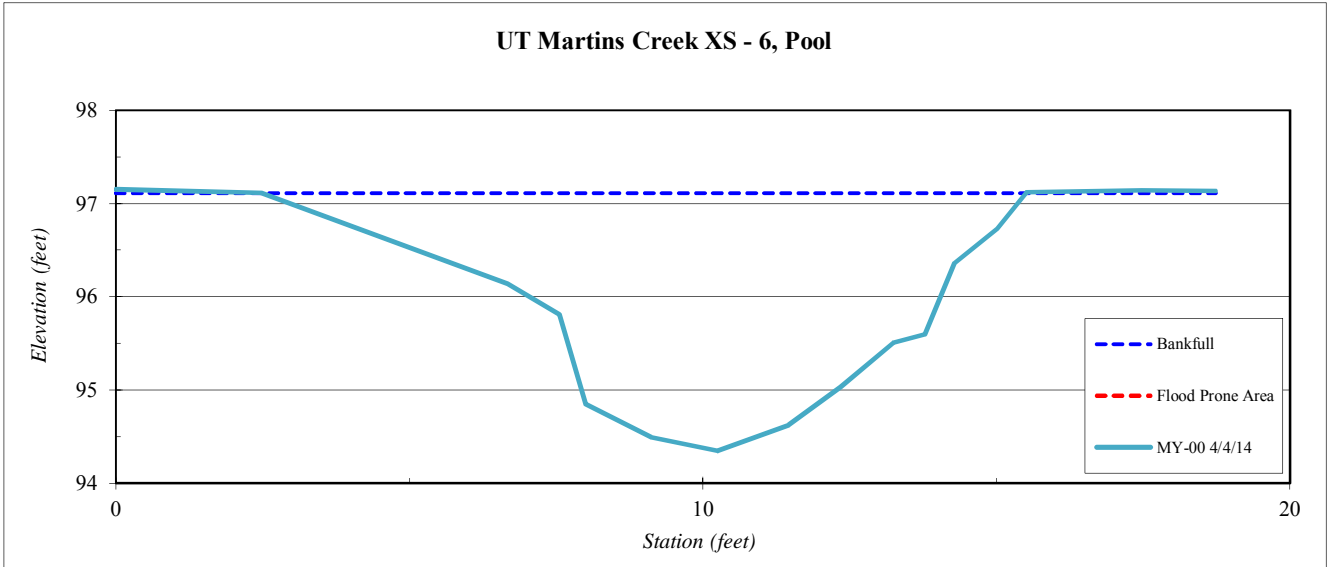
<b>Site</b>	UT to Martins
<b>Watershed:</b>	Hiwassee
<b>XS ID</b>	XS - 6, Pool
<b>Feature</b>	Pool
<b>Date:</b>	4/4/2014
<b>Field Crew:</b>	Perkinson, Jernigan

Station	Elevation
0.00	97.15
2.48	97.11
6.67	96.14
7.56	95.81
8.00	94.85
9.12	94.49
10.25	94.35
11.46	94.62
12.34	95.03
13.24	95.50
13.78	95.60
14.28	96.36
15.02	96.73
15.52	97.12
17.48	97.14
18.73	97.13

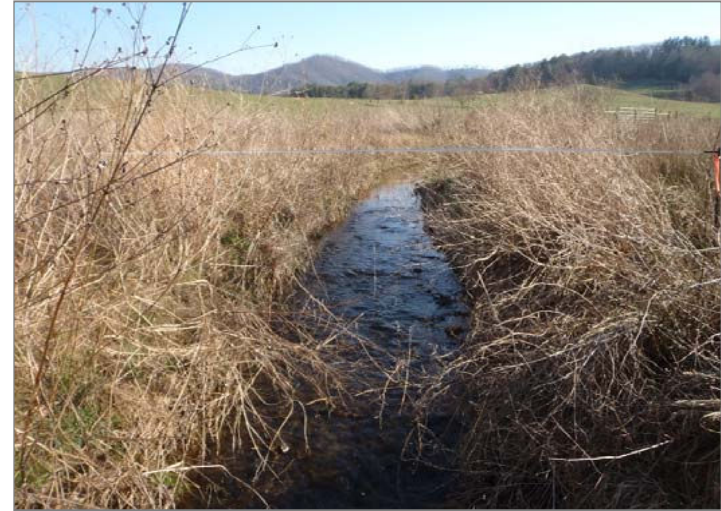
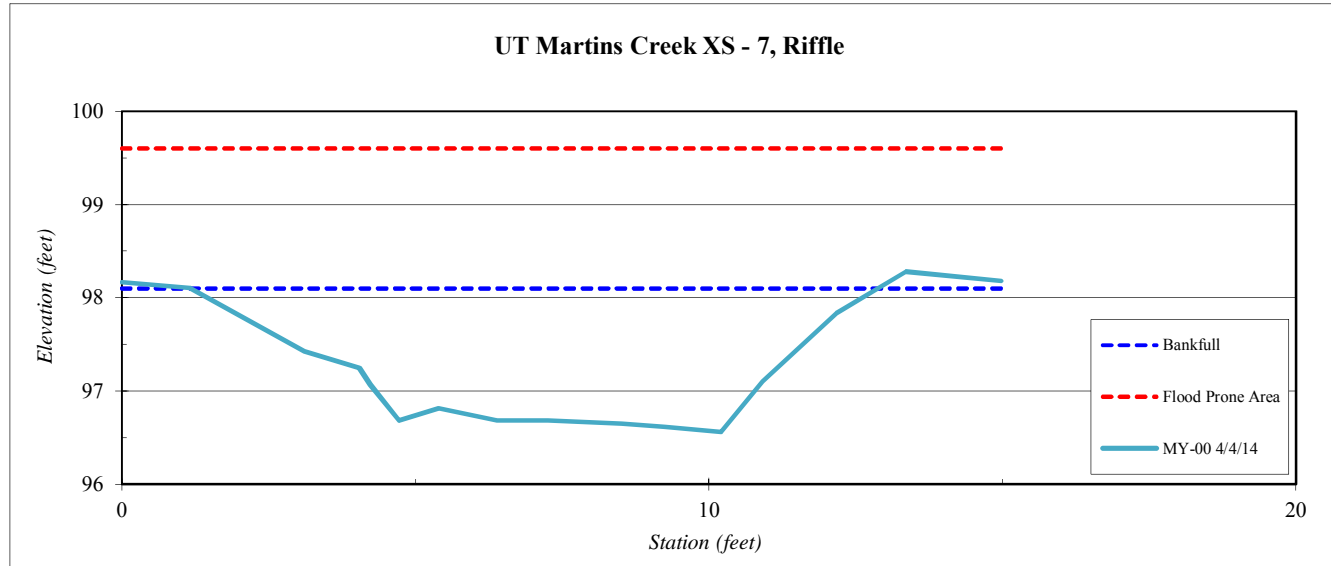
<b>Site</b>	UT to Martins
<b>Watershed:</b>	Hiwassee
<b>XS ID</b>	XS - 7, Riffle
<b>Feature</b>	Riffle
<b>Date:</b>	4/4/2014
<b>Field Crew:</b>	Perkinson, Jernigan

Station	Elevation
0.00	98.16
1.15	98.11
3.11	97.42
4.05	97.25
4.23	97.07
4.72	96.69
5.39	96.81
6.39	96.68
7.26	96.68
8.51	96.65
9.25	96.62
10.20	96.56
10.91	97.10
12.18	97.84
13.36	98.28
15.0	98.18

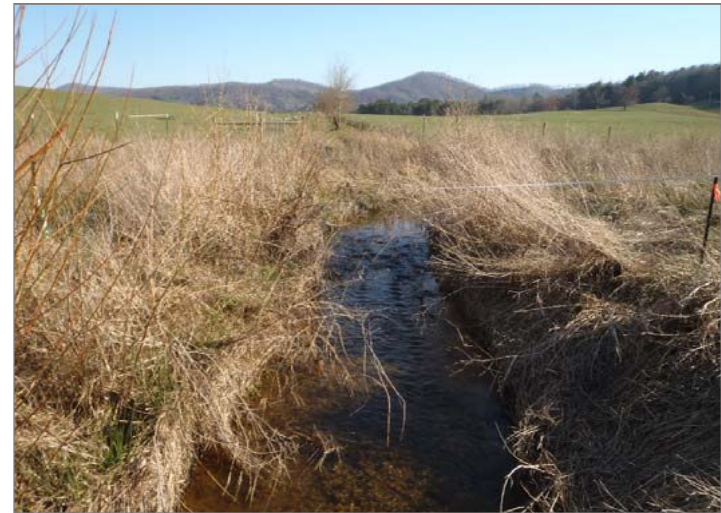
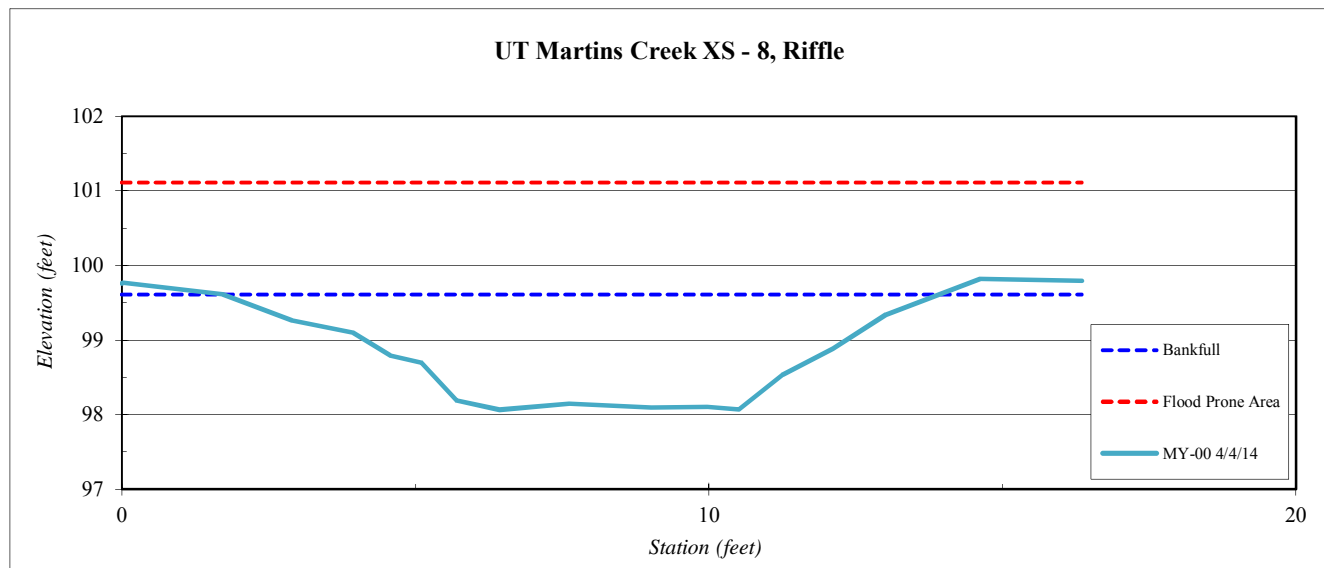
<b>Site</b>	UT to Martins
<b>Watershed:</b>	Hiwassee
<b>XS ID</b>	XS - 8, Riffle
<b>Feature</b>	Riffle
<b>Date:</b>	4/4/2014
<b>Field Crew:</b>	Perkinson, Jernigan

SUMMARY DATA	
<b>Bankfull Elevation:</b>	99.6
<b>Bankfull Cross-Sectional Area:</b>	11.8
<b>Bankfull Width:</b>	12.2
<b>Flood Prone Area Elevation:</b>	101.1
<b>Flood Prone Width:</b>	50.0
<b>Max Depth at Bankfull:</b>	1.5
<b>Mean Depth at Bankfull:</b>	1.0
<b>W / D Ratio:</b>	12.6
<b>Entrenchment Ratio:</b>	4.1
<b>Bank Height Ratio:</b>	1.0

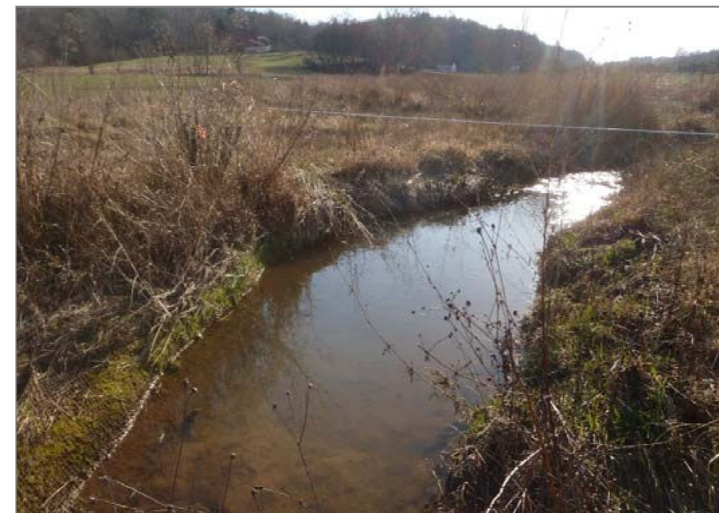
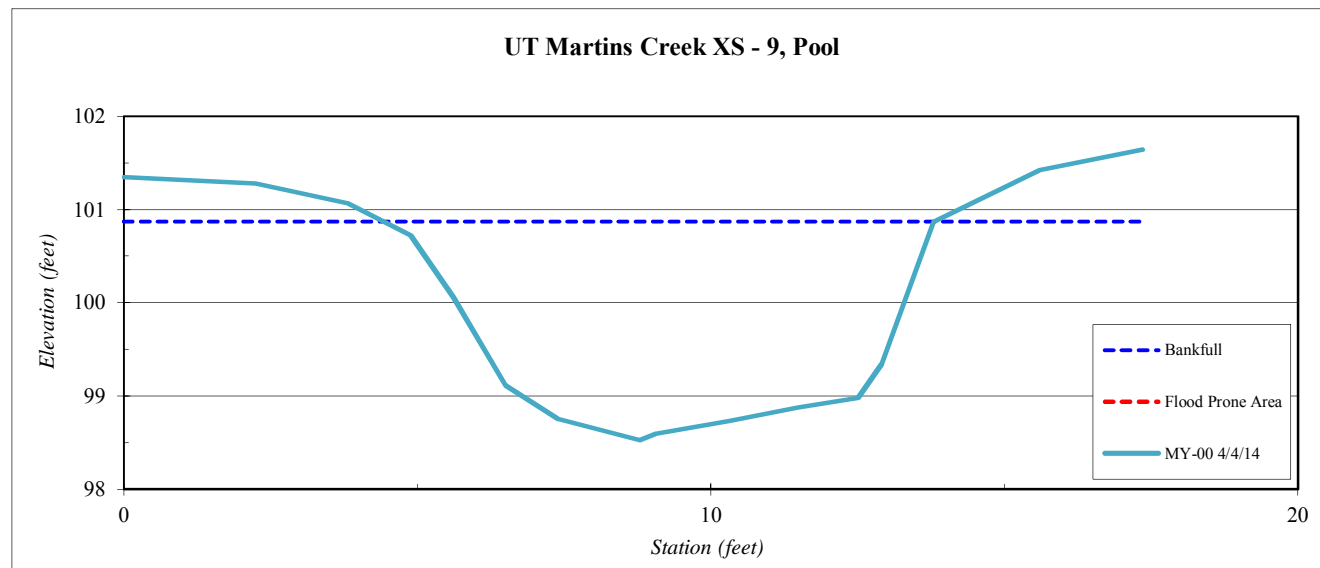
<b>Site</b>	UT to Martins
<b>Watershed:</b>	Hiwassee
<b>XS ID</b>	XS - 9, Pool
<b>Feature</b>	Pool
<b>Date:</b>	4/4/2014
<b>Field Crew:</b>	Perkinson, Jernigan

SUMMARY DATA	
<b>Bankfull Elevation:</b>	100.9
<b>Bankfull Cross-Sectional Area:</b>	15.5
<b>Bankfull Width:</b>	9.4
<b>Flood Prone Area Elevation:</b>	NA
<b>Flood Prone Width:</b>	NA
<b>Max Depth at Bankfull:</b>	2.3
<b>Mean Depth at Bankfull:</b>	1.6
<b>W / D Ratio:</b>	NA
<b>Entrenchment Ratio:</b>	NA
<b>Bank Height Ratio:</b>	1.0

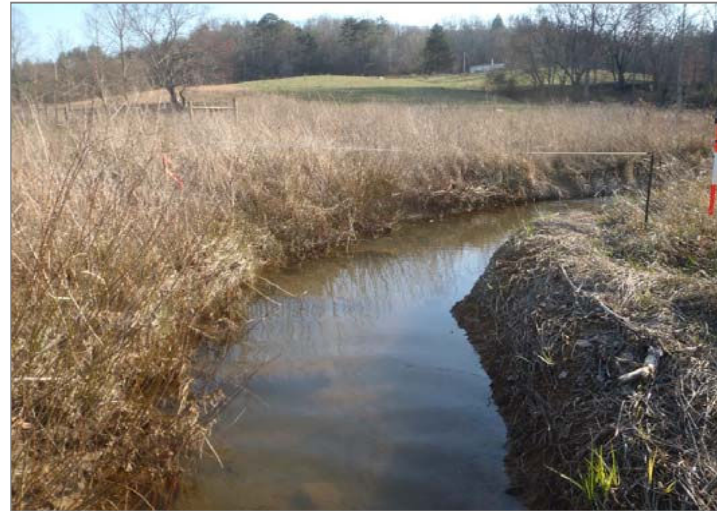
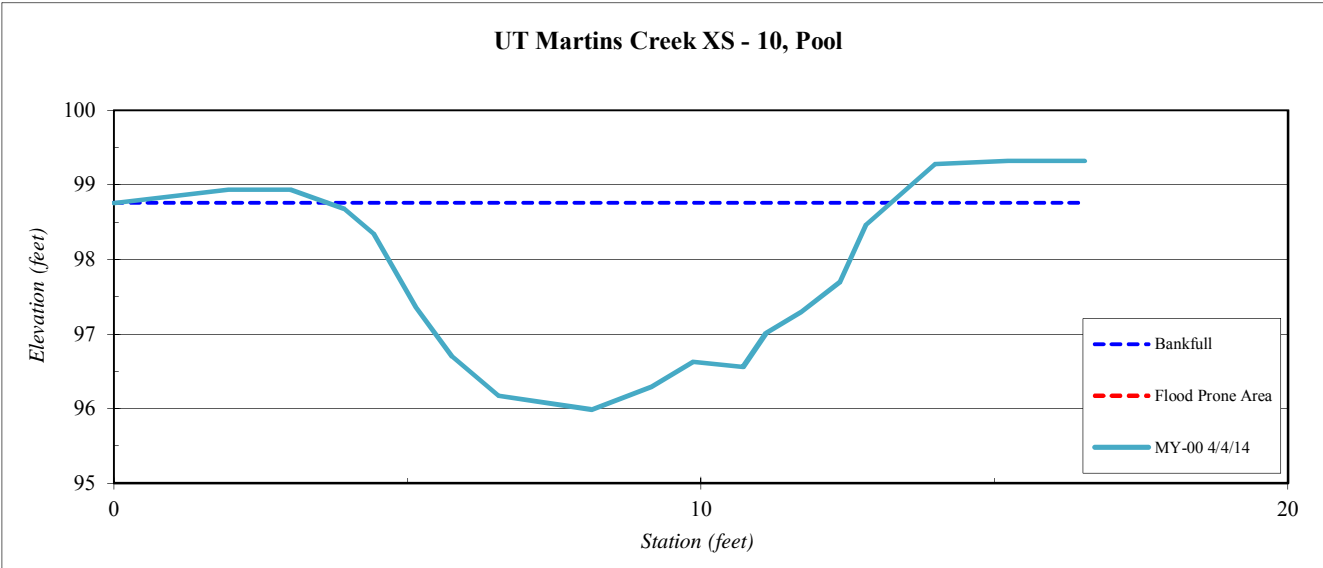
<b>Site</b>	UT to Martins
<b>Watershed:</b>	Hiwassee
<b>XS ID</b>	XS - 10, Pool
<b>Feature</b>	Pool
<b>Date:</b>	4/4/2014
<b>Field Crew:</b>	Perkinson, Jernigan

SUMMARY DATA	
<b>Bankfull Elevation:</b>	98.8
<b>Bankfull Cross-Sectional Area:</b>	17.0
<b>Bankfull Width:</b>	9.6
<b>Flood Prone Area Elevation:</b>	NA
<b>Flood Prone Width:</b>	NA
<b>Max Depth at Bankfull:</b>	2.8
<b>Mean Depth at Bankfull:</b>	1.8
<b>W / D Ratio:</b>	NA
<b>Entrenchment Ratio:</b>	NA
<b>Bank Height Ratio:</b>	1.0

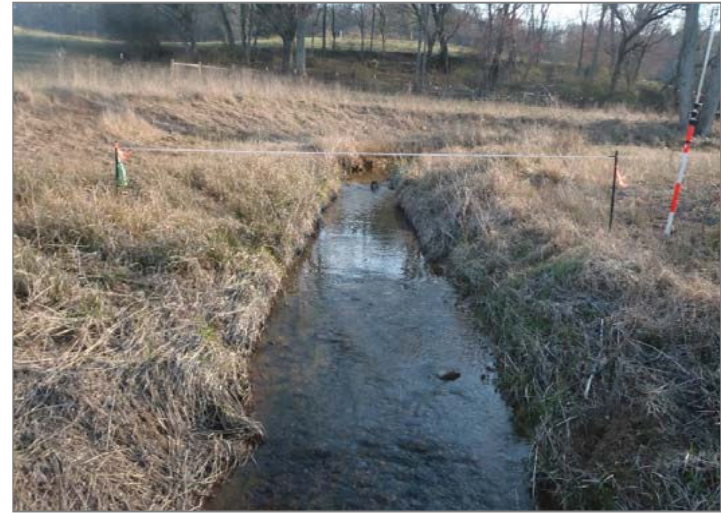
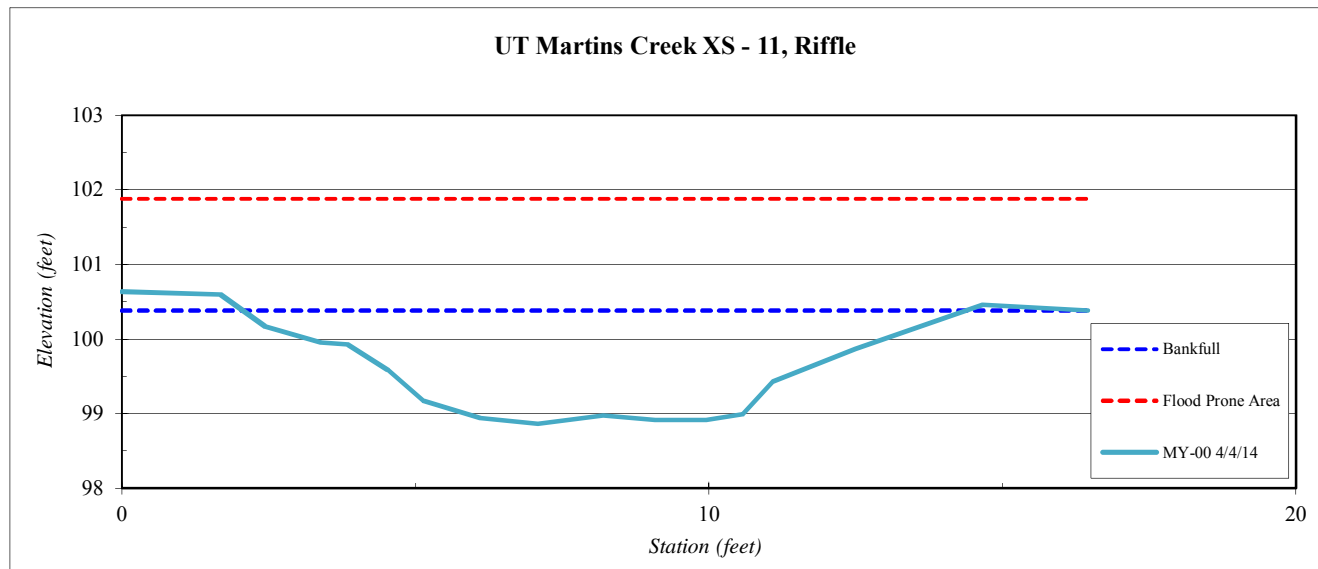
Site	UT to Martins
Watershed:	Hiwassee
XS ID	XS - 11, Riffle
Feature	Riffle
Date:	4/4/2014
Field Crew:	Perkinson, Jernigan

SUMMARY DATA	
Bankfull Elevation:	100.4
Bankfull Cross-Sectional Area:	11.5
Bankfull Width:	12.3
Flood Prone Area Elevation:	101.9
Flood Prone Width:	50.0
Max Depth at Bankfull:	1.5
Mean Depth at Bankfull:	0.9
W / D Ratio:	13.2
Entrenchment Ratio:	4.1
Bank Height Ratio:	1.0

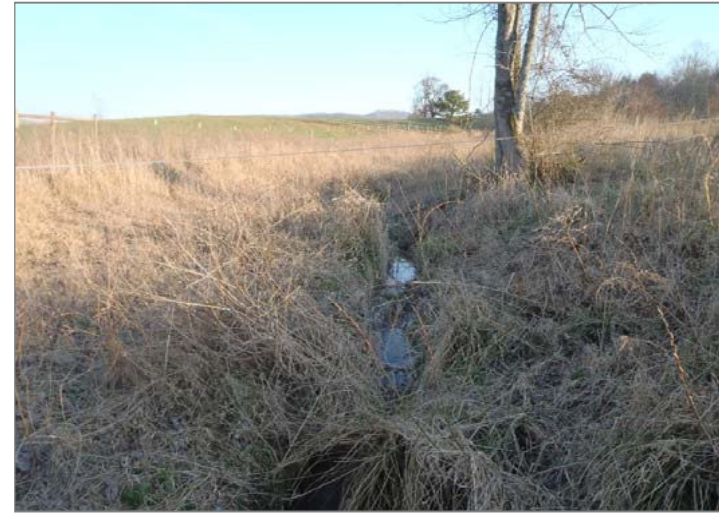
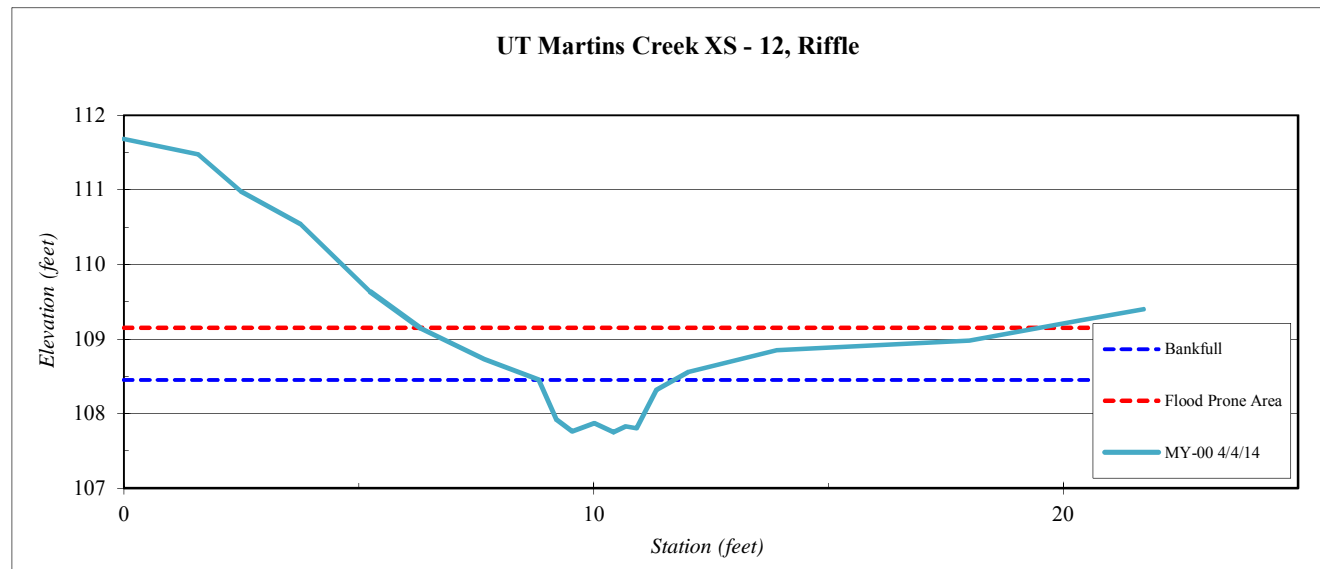
<b>Site</b>	UT to Martins
<b>Watershed:</b>	Hiwassee
<b>XS ID</b>	XS - 12, Riffle
<b>Feature</b>	Riffle
<b>Date:</b>	4/4/2014
<b>Field Crew:</b>	Perkinson, Jernigan

SUMMARY DATA	
<b>Bankfull Elevation:</b>	108.5
<b>Bankfull Cross-Sectional Area:</b>	1.4
<b>Bankfull Width:</b>	2.9
<b>Flood Prone Area Elevation:</b>	109.2
<b>Flood Prone Width:</b>	14.0
<b>Max Depth at Bankfull:</b>	0.7
<b>Mean Depth at Bankfull:</b>	0.5
<b>W / D Ratio:</b>	6.0
<b>Entrenchment Ratio:</b>	4.8
<b>Bank Height Ratio:</b>	1.0

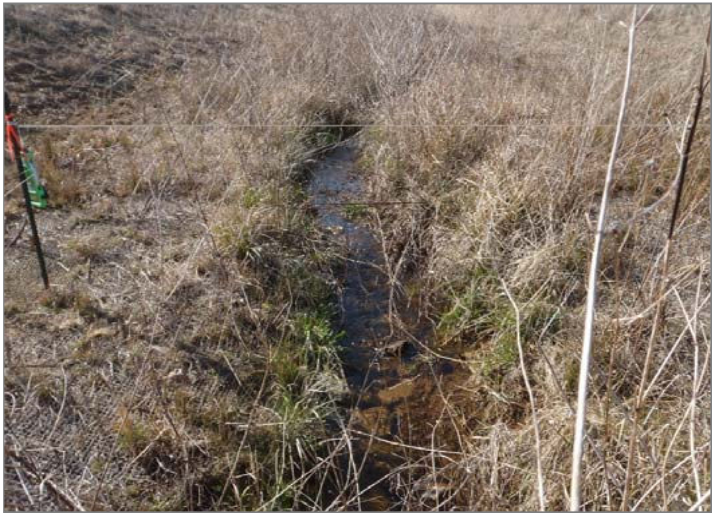
SUMMARY DATA	
<b>Bankfull Elevation:</b>	96.7
<b>Bankfull Cross-Sectional Area:</b>	2.7
<b>Bankfull Width:</b>	5.9
<b>Flood Prone Area Elevation:</b>	97.6
<b>Flood Prone Width:</b>	25.0
<b>Max Depth at Bankfull:</b>	0.9
<b>Mean Depth at Bankfull:</b>	0.5
<b>W / D Ratio:</b>	12.9
<b>Entrenchment Ratio:</b>	4.2
<b>Bank Height Ratio:</b>	1.0

Stream Type      C/E

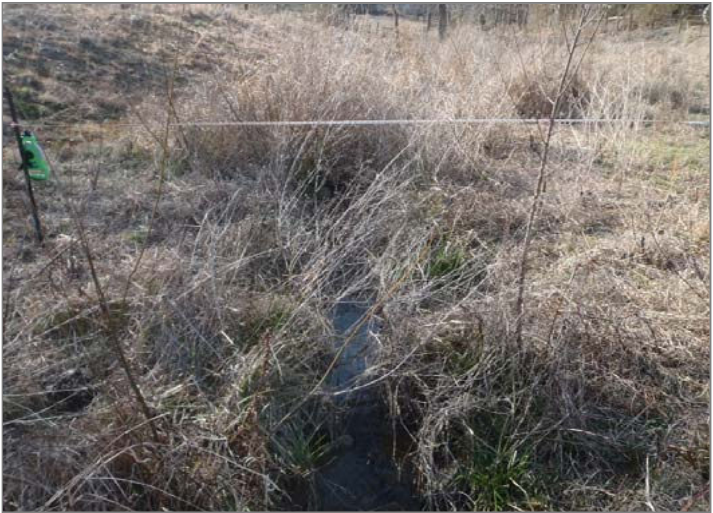
SUMMARY DATA	
<b>Bankfull Elevation:</b>	102.2
<b>Bankfull Cross-Sectional Area:</b>	3.6
<b>Bankfull Width:</b>	7.3
<b>Flood Prone Area Elevation:</b>	103.2
<b>Flood Prone Width:</b>	25.0
<b>Max Depth at Bankfull:</b>	1.0
<b>Mean Depth at Bankfull:</b>	0.5
<b>W / D Ratio:</b>	14.8
<b>Entrenchment Ratio:</b>	3.4
<b>Bank Height Ratio:</b>	1.0

<b>Stream Type</b>	C/E
--------------------	-----

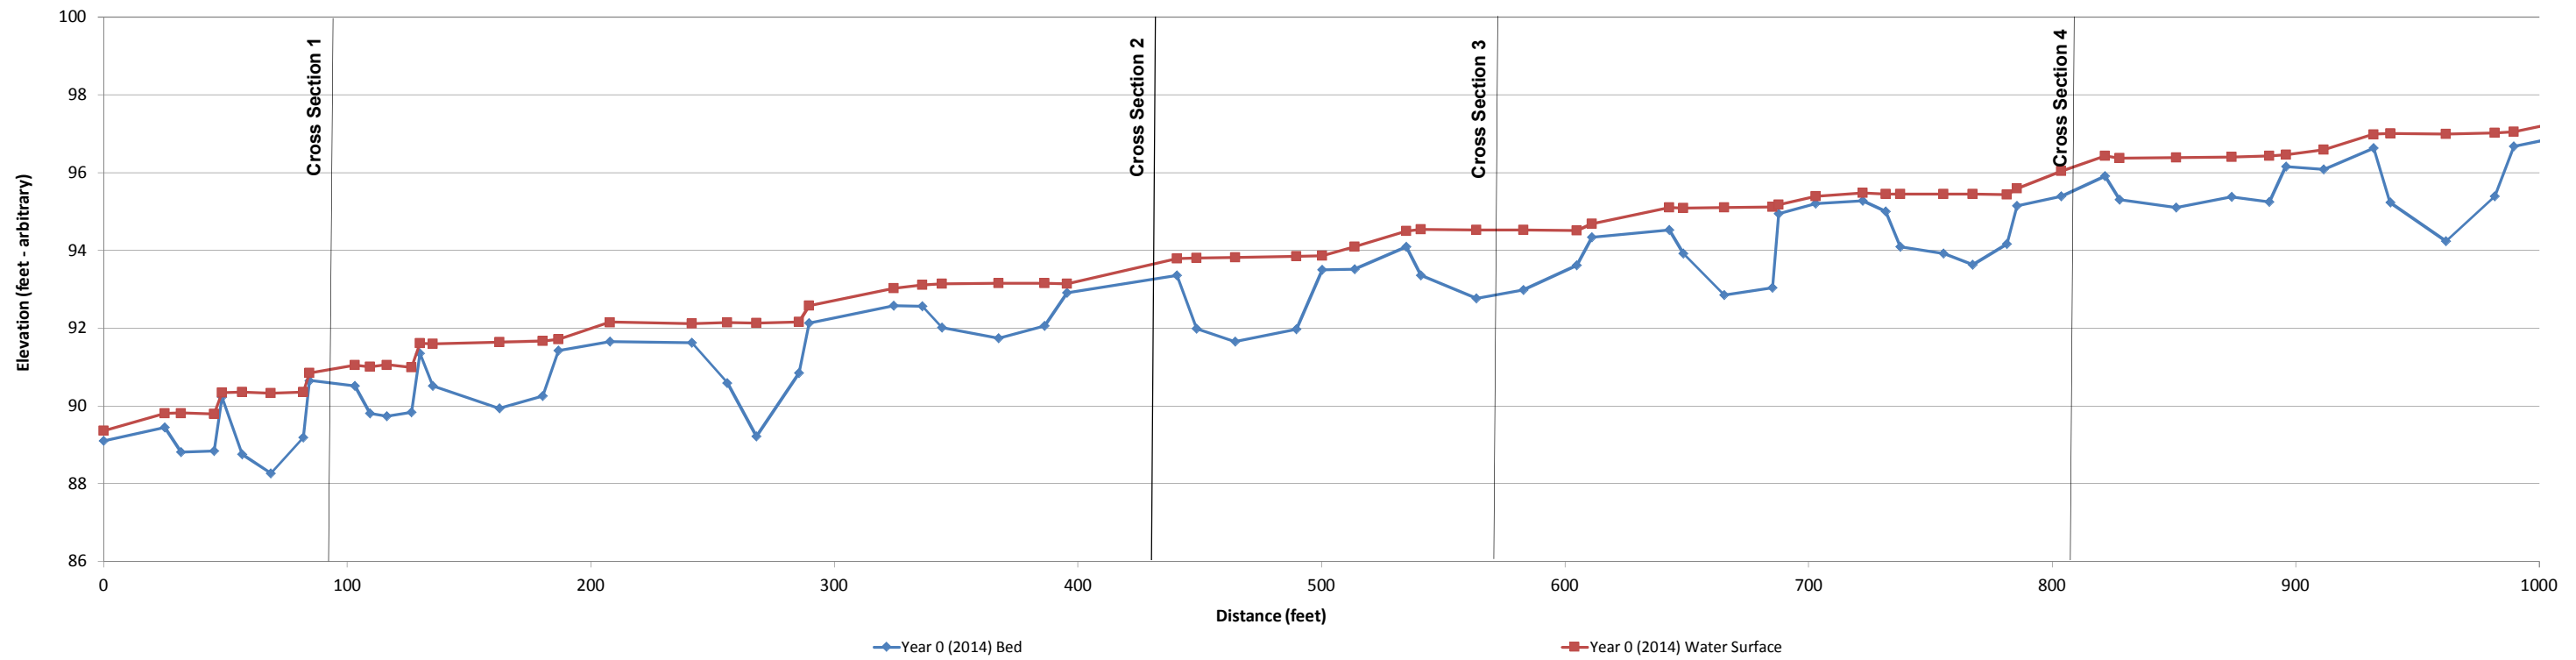
**Project Name** UT to Martins Creek - Profile  
**Reach** UT 1 Station 00+00 - 10+00  
**Feature** Profile  
**Date** 4/4/14  
**Crew** Perkinson, Jernigan

UT to Martins Creek Year 0 (2014) Profile - UT 1 Station 00+00 to 10+00

After Site construction, approximately 4640 linear feet of longitudinal profile was completed to document baseline conditions. Longitudinal profile will be resurveyed annually for the duration of the five-year monitoring period. Measurements include thalweg, water surface, bankfull, and top of low bank. Each of these measurements will be taken at the head of each channel unit (e.g., riffle, pool) and at the maximum pool depth. The survey will be tied to a permanent benchmark.
