**FINAL**  
**AS-BUILT BASELINE MONITORING REPORT**  
**UT TO MARTIN'S CREEK (CONTRERAS) MITIGATION PROJECT**  
Cherokee County, North Carolina  
EEP Project No. 92766 (Contract No. 005717)  
USACE Action ID No. 2010-00961/DWR Project No. 2010-00448  
SCO No. 08-07249-01

**Data Collection – March-April 2014**

Hiwassee River Basin  
Cataloging Unit 06020002170010

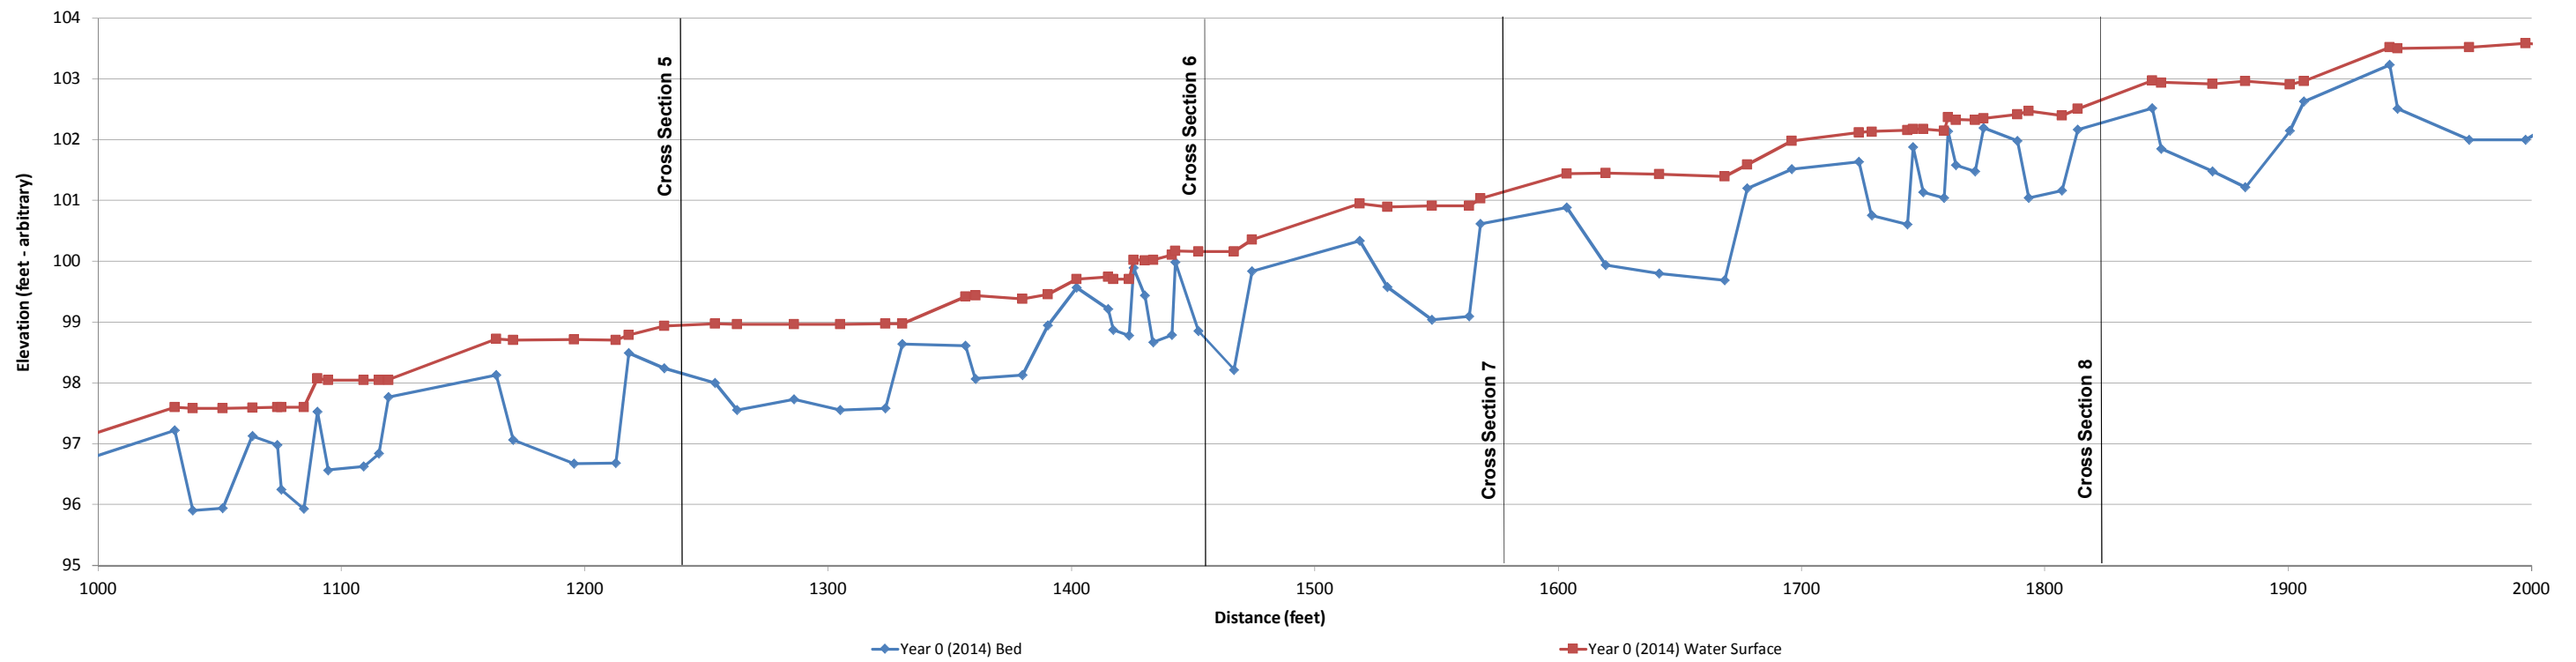
**Project Name** UT to Martins Creek - Profile  
**Reach** UT 1 Station 10+00 - 20+00  
**Feature** Profile  
**Date** 4/4/14  
**Crew** Perkinson, Jernigan

UT to Martins Creek Year 0 (2014) Profile - UT 1 Station 10+00 to 20+00

After Site construction, approximately 4640 linear feet of longitudinal profile was completed to document baseline conditions. Longitudinal profile will be resurveyed annually for the duration of the five-year monitoring period. Measurements include thalweg, water surface, bankfull, and top of low bank. Each of these measurements will be taken at the head of each channel unit (e.g., riffle, pool) and at the maximum pool depth. The survey will be tied to a permanent benchmark.

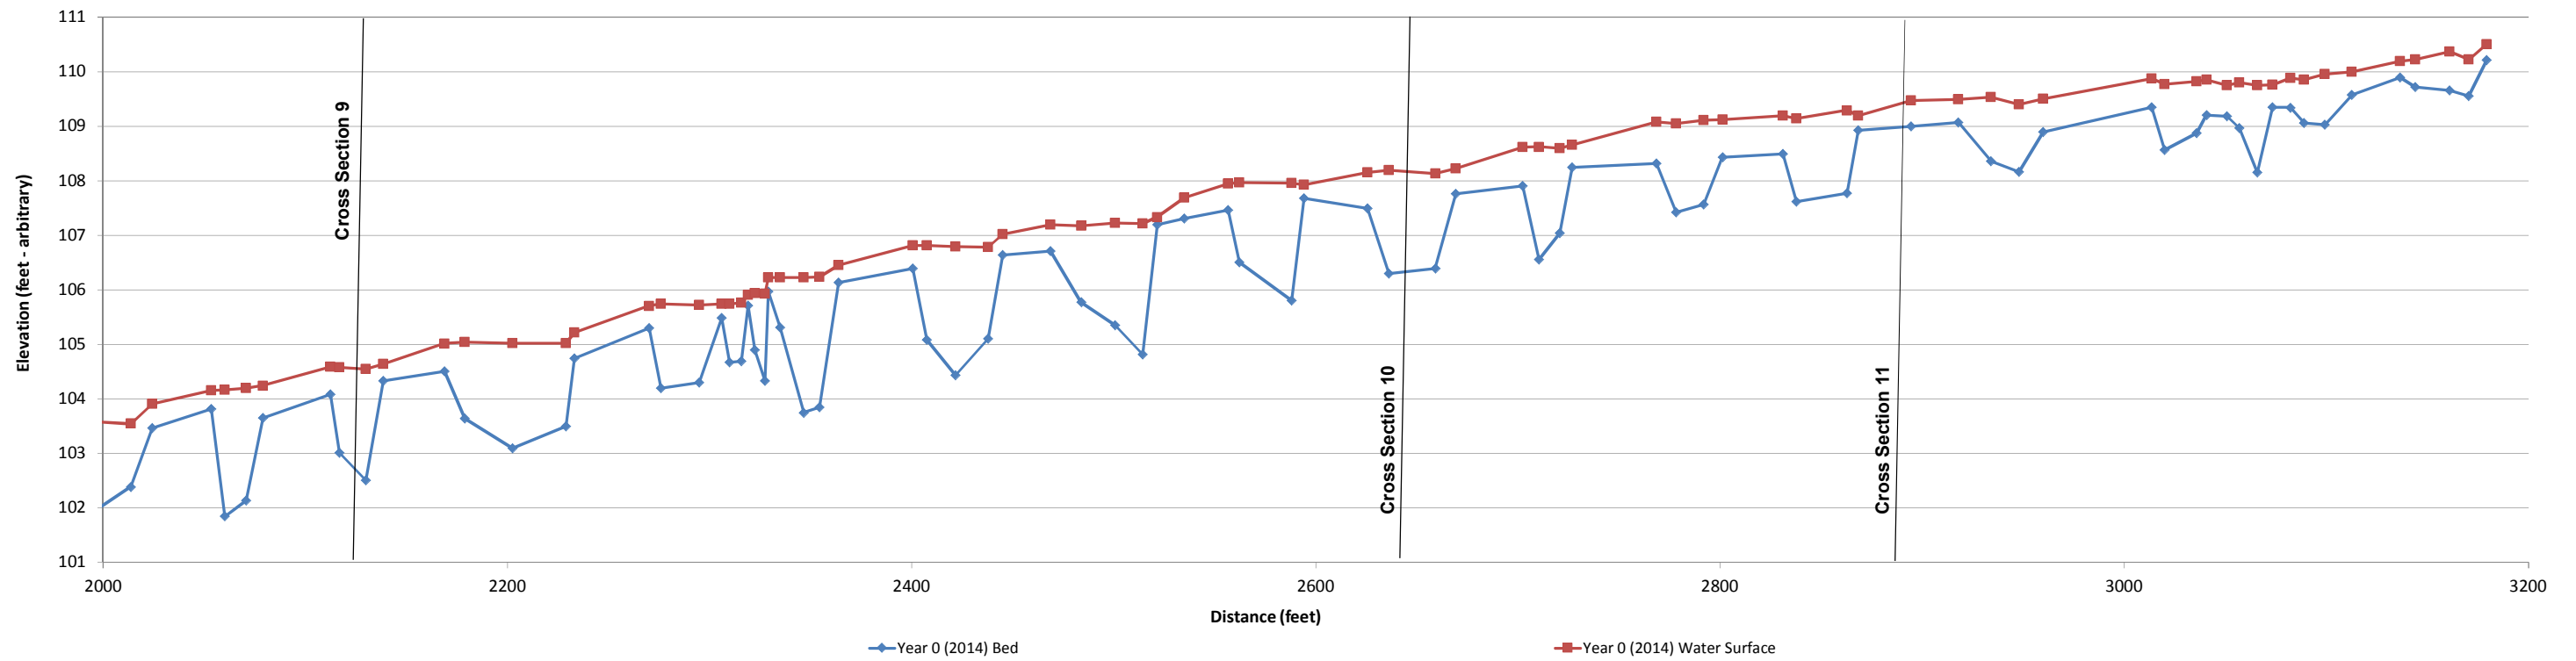
**Project Name** UT to Martins Creek - Profile  
**Reach** UT 1 Station 20+00 - 32+00  
**Feature** Profile  
**Date** 4/4/14  
**Crew** Perkinson, Jernigan

UT to Martins Creek Year 0 (2014) Profile - UT 1 Station 20+00 to 32+00

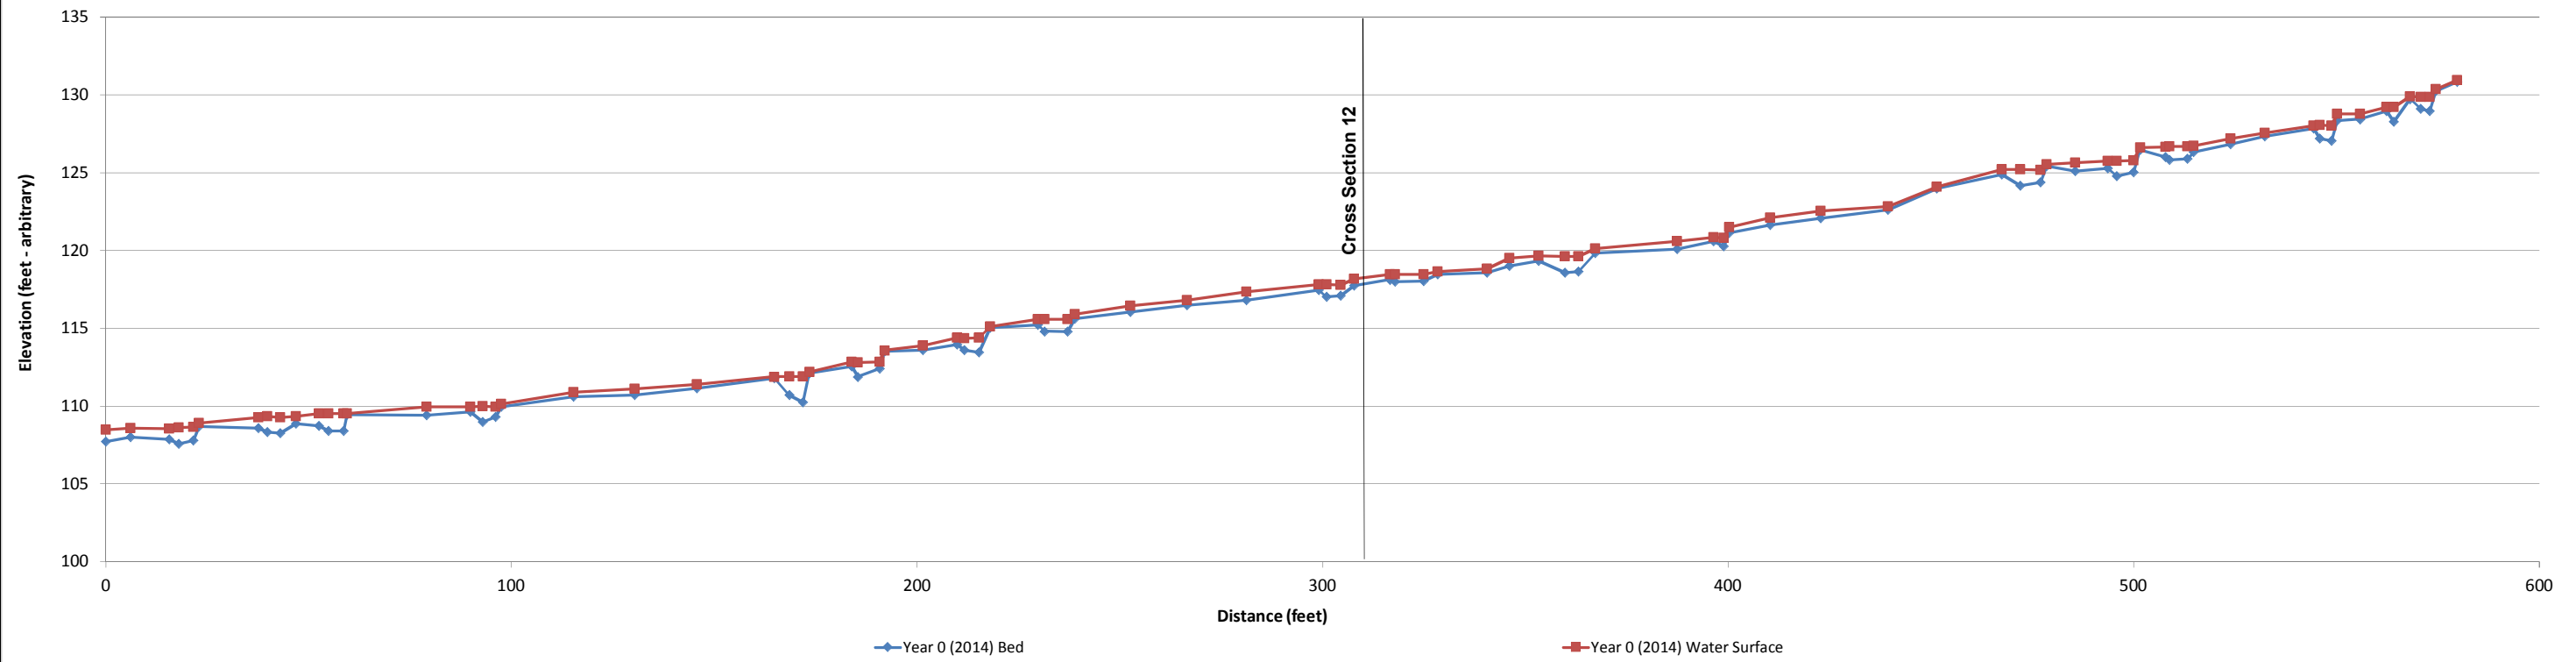
**Project Name** UT to Martins Creek - Profile  
**Reach** UT 1-1 Station 00+00 - 06+00  
**Feature** Profile  
**Date** 4/4/14  
**Crew** Perkinson, Jernigan

UT to Martins Creek Year 0 (2014) Profile - UT 1-1 Station 00+00 to 06+00

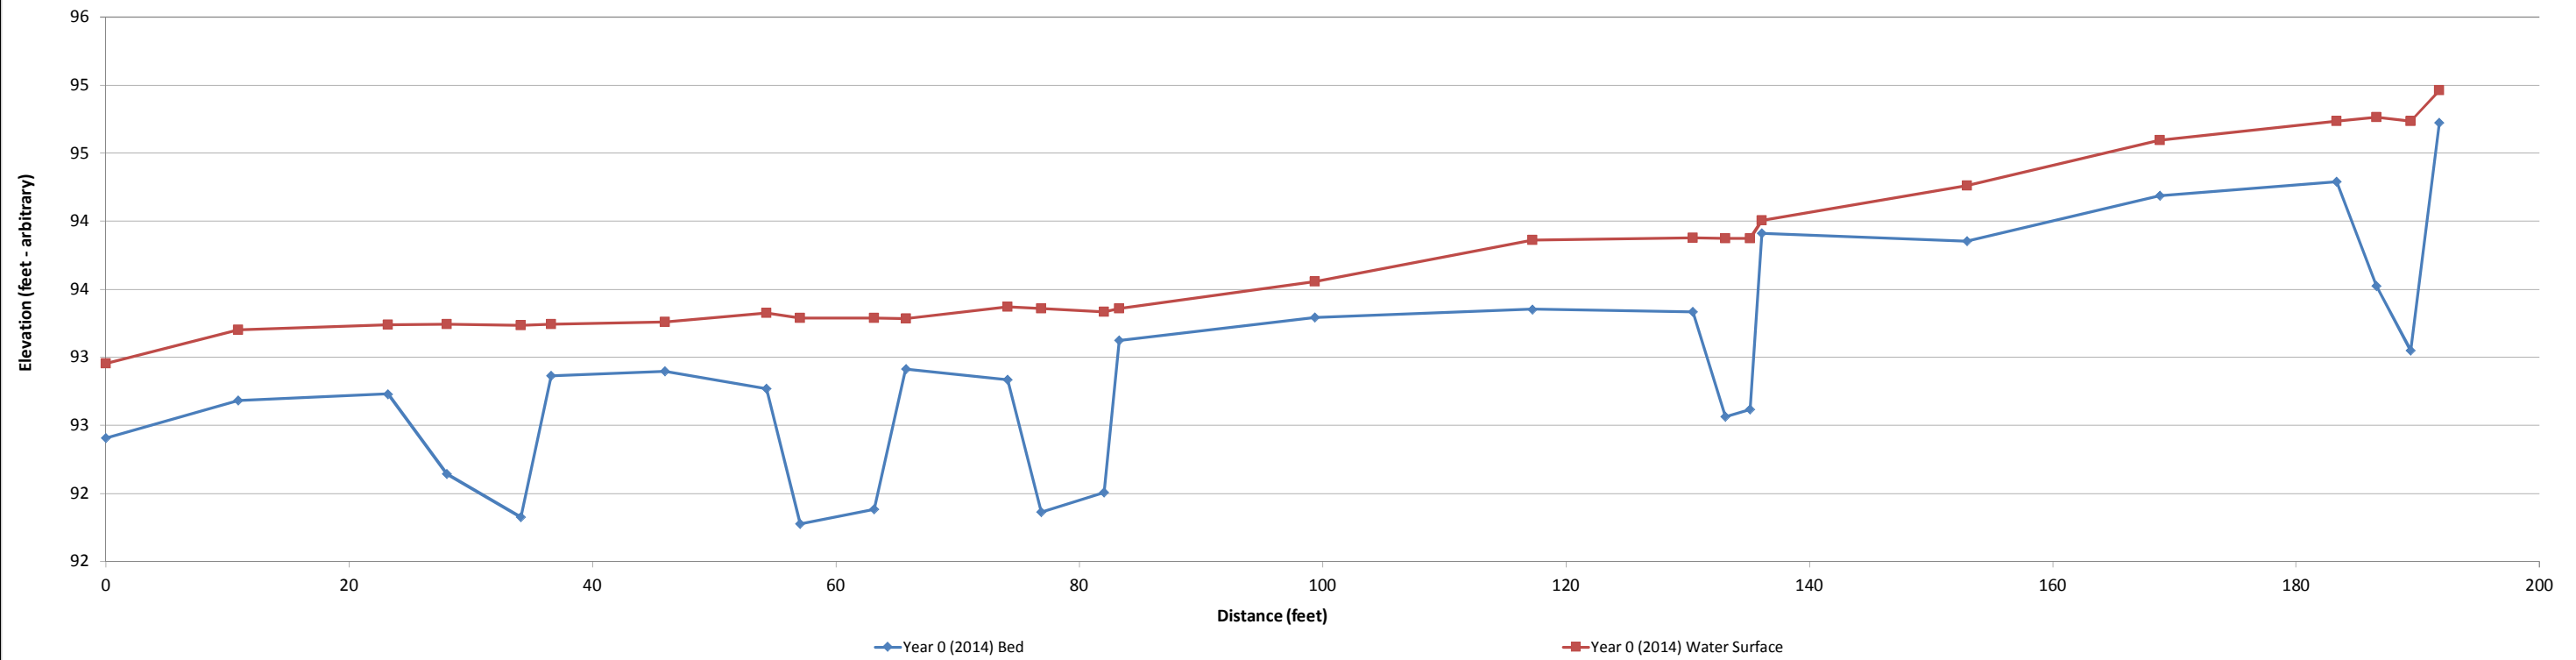
**Project Name** UT to Martins Creek - Profile  
**Reach** UT 1-2 Station 00+00 - 02+00  
**Feature** Profile  
**Date** 4/4/14  
**Crew** Perkinson, Jernigan

UT to Martins Creek Year 0 (2014) Profile - UT 1-2 Station 00+00 to 02+00

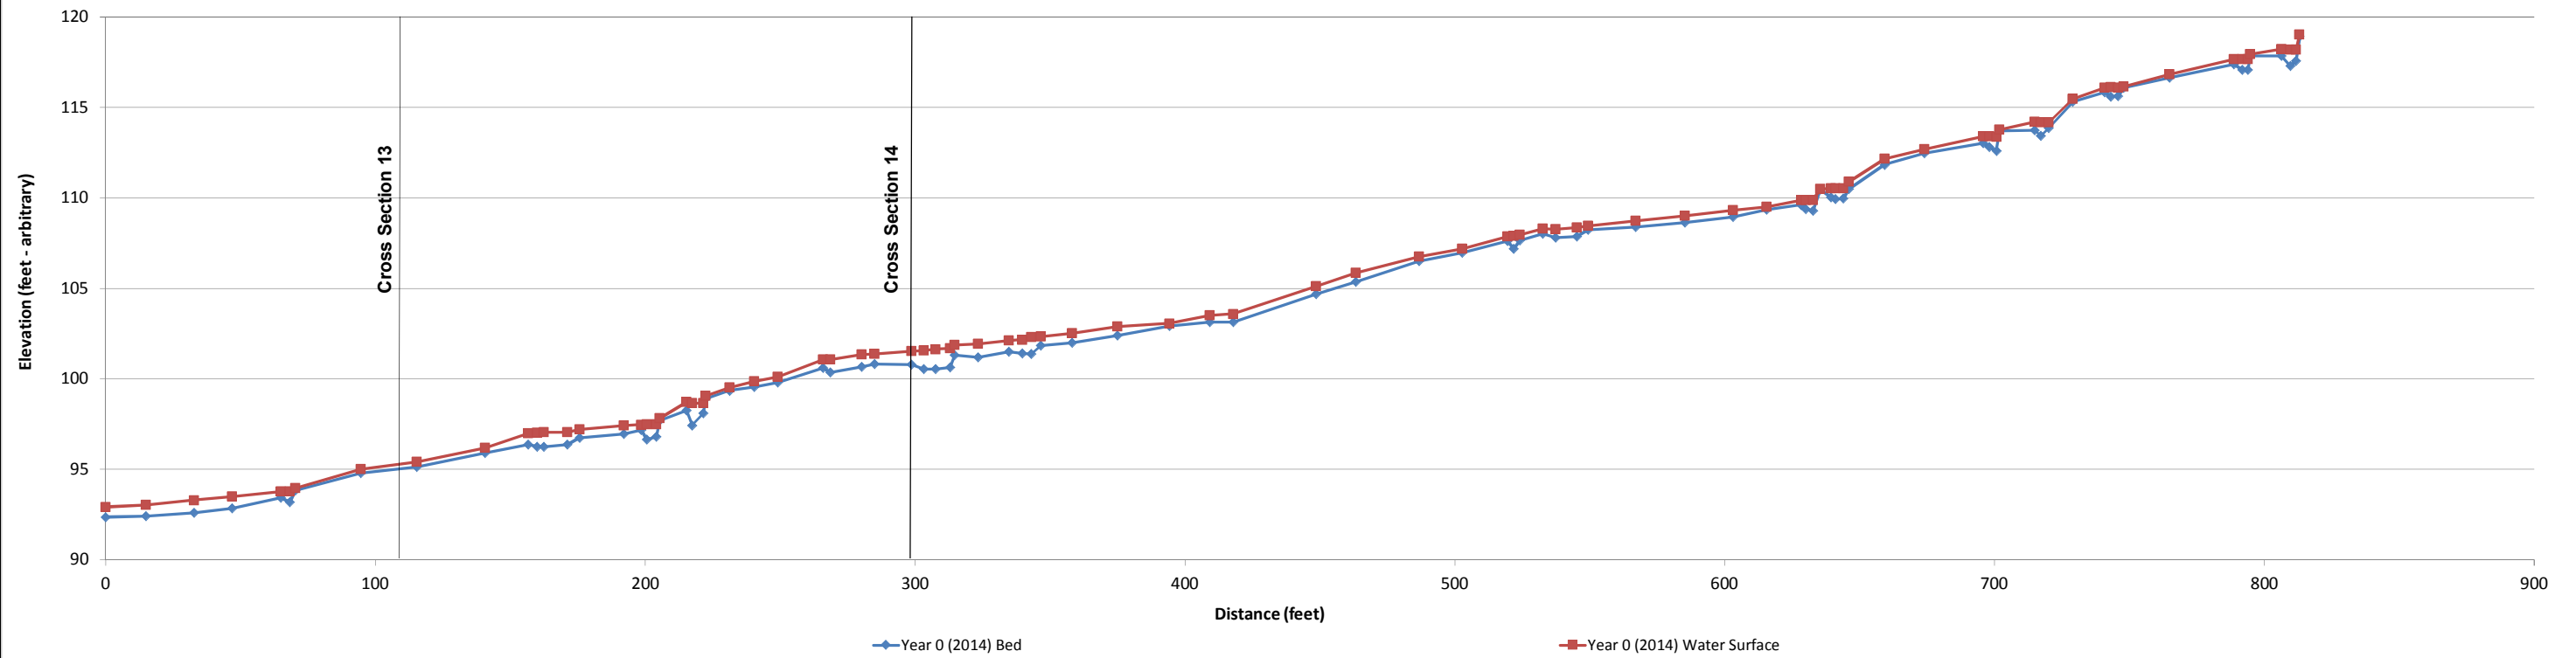
**Project Name** UT to Martins Creek - Profile  
**Reach** UT 1-3 Station 00+00 - 09+00  
**Feature** Profile  
**Date** 4/4/14  
**Crew** Perkinson, Jernigan

UT to Martins Creek Year 0 (2014) Profile - UT 1-3 Station 00+00 to 09+00
