**FINAL**  
**YEAR 5 (2018) MONITORING REPORT**  
**UT TO MARTIN'S CREEK (CONTRERAS) MITIGATION PROJECT**  
Cherokee County, North Carolina  
DMS Project No. 92766 (Contract No. 005717)  
USACE Action ID No. 2010-00961/DWR Project No. 2010-00448  
SCO No. 08-07249-01

**Data Collection – March-November 2018**

Hiwassee River Basin  
Cataloging Unit 06020002170010

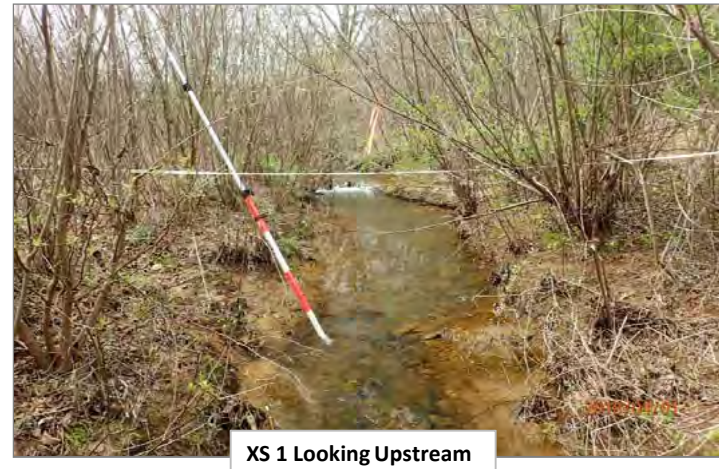
XS 1 Looking Upstream

<b>Site</b>	UT to Martins (Contreras)
<b>Project Number:</b>	92766
<b>XS ID</b>	XS - 1, Riffle
<b>Reach</b>	UT 1
<b>Date:</b>	4/1/2018
<b>Field Crew:</b>	Perkinson, Butler

SUMMARY DATA	
<b>Bankfull Elevation:</b>	90.5
<b>Bankfull Cross-Sectional Area:</b>	11.6
<b>Bankfull Width:</b>	11.4
<b>Flood Prone Area Elevation:</b>	92.2
<b>Flood Prone Width:</b>	100.0
<b>Max Depth at Bankfull:</b>	1.7
<b>Mean Depth at Bankfull:</b>	1.0
<b>W / D Ratio:</b>	11.2
<b>Entrenchment Ratio:</b>	8.8
<b>Bank Height Ratio:</b>	1.0

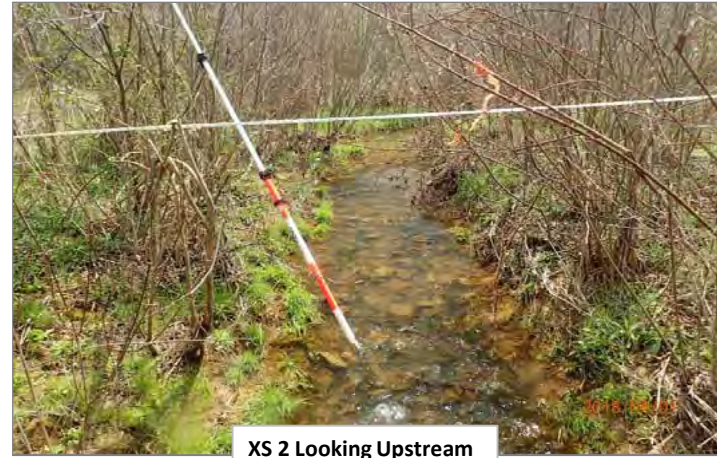
<b>Site</b>	UT to Martins (Contreras)
<b>Project Number:</b>	92766
<b>XS ID</b>	XS - 2, Riffle
<b>Reach</b>	UT 1
<b>Date:</b>	4/1/2018
<b>Field Crew:</b>	Perkinson, Butler

SUMMARY DATA	
<b>Bankfull Elevation:</b>	93.0
<b>Bankfull Cross-Sectional Area:</b>	11.4
<b>Bankfull Width:</b>	12.2
<b>Flood Prone Area Elevation:</b>	94.6
<b>Flood Prone Width:</b>	100.0
<b>Max Depth at Bankfull:</b>	1.6
<b>Mean Depth at Bankfull:</b>	0.9
<b>W / D Ratio:</b>	13.1
<b>Entrenchment Ratio:</b>	8.2
<b>Bank Height Ratio:</b>	1.0

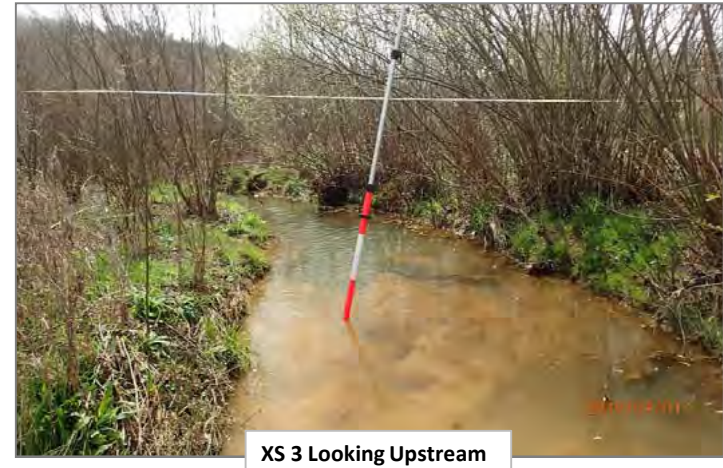
XS 3 Looking Upstream

<b>Site</b>	UT to Martins (Contreras)
<b>Project Number:</b>	92766
<b>XS ID</b>	XS - 3, Pool
<b>Reach</b>	UT 1
<b>Date:</b>	4/1/2018
<b>Field Crew:</b>	Perkinson, Butler

SUMMARY DATA	
<b>Bankfull Elevation:</b>	94.0
<b>Bankfull Cross-Sectional Area:</b>	19.7
<b>Bankfull Width:</b>	17.1
<b>Flood Prone Area Elevation:</b>	NA
<b>Flood Prone Width:</b>	NA
<b>Max Depth at Bankfull:</b>	2.5
<b>Mean Depth at Bankfull:</b>	1.2
<b>W / D Ratio:</b>	NA
<b>Entrenchment Ratio:</b>	NA
<b>Bank Height Ratio:</b>	1.0

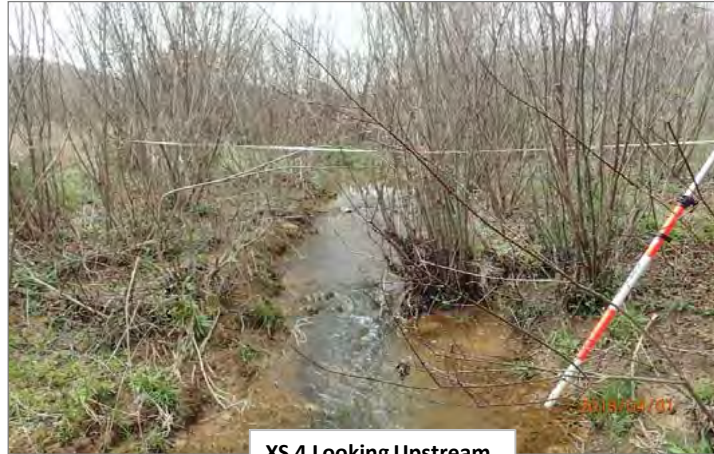
XS 4 Looking Upstream

<b>Site</b>	UT to Martins (Contreras)
<b>Project Number:</b>	92766
<b>XS ID</b>	XS - 4, Riffle
<b>Reach</b>	UT 1
<b>Date:</b>	4/1/2018
<b>Field Crew:</b>	Perkinson, Butler

SUMMARY DATA	
<b>Bankfull Elevation:</b>	95.4
<b>Bankfull Cross-Sectional Area:</b>	11.3
<b>Bankfull Width:</b>	12.5
<b>Flood Prone Area Elevation:</b>	97.2
<b>Flood Prone Width:</b>	100.0
<b>Max Depth at Bankfull:</b>	1.8
<b>Mean Depth at Bankfull:</b>	0.9
<b>W / D Ratio:</b>	13.8
<b>Entrenchment Ratio:</b>	8.0
<b>Bank Height Ratio:</b>	1.0

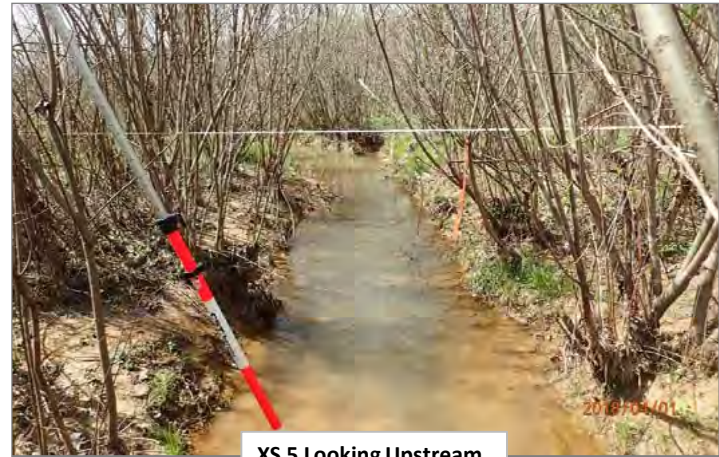
XS 5 Looking Upstream

Site	UT to Martins (Contreras)
Project Number:	92766
XS ID	XS - 5, Riffle
Reach	UT 1
Date:	4/1/2018
Field Crew:	Perkinson, Butler

SUMMARY DATA	
Bankfull Elevation:	95.8
Bankfull Cross-Sectional Area:	12.6
Bankfull Width:	11.3
Flood Prone Area Elevation:	97.8
Flood Prone Width:	50.0
Max Depth at Bankfull:	2.0
Mean Depth at Bankfull:	1.1
W / D Ratio:	10.1
Entrenchment Ratio:	4.4
Bank Height Ratio:	1.0

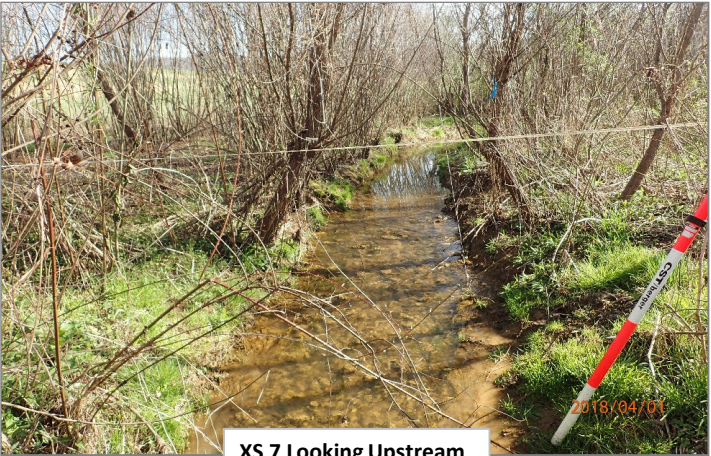
XS 7 Looking Upstream

<b>Site</b>	UT to Martins (Contreras)
<b>Project Number:</b>	92766
<b>XS ID</b>	XS - 7, Riffle
<b>Reach</b>	UT 1
<b>Date:</b>	4/1/2018
<b>Field Crew:</b>	Perkinson, Butler

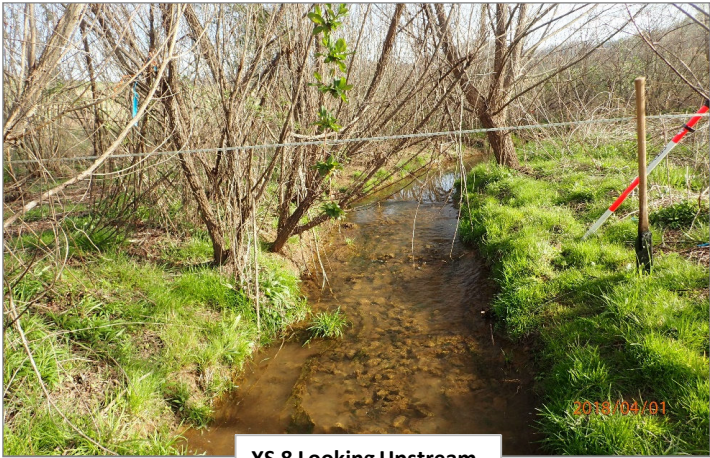
XS 8 Looking Upstream

<b>Site</b>	UT to Martins (Contreras)
<b>Project Number:</b>	92766
<b>XS ID</b>	XS - 8, Riffle
<b>Reach</b>	UT 1
<b>Date:</b>	4/1/2018
<b>Field Crew:</b>	Perkinson, Butler

SUMMARY DATA	
<b>Bankfull Elevation:</b>	99.6
<b>Bankfull Cross-Sectional Area:</b>	10.4
<b>Bankfull Width:</b>	12.5
<b>Flood Prone Area Elevation:</b>	101.0
<b>Flood Prone Width:</b>	50.0
<b>Max Depth at Bankfull:</b>	1.4
<b>Mean Depth at Bankfull:</b>	0.8
<b>W / D Ratio:</b>	15.0
<b>Entrenchment Ratio:</b>	4.0
<b>Bank Height Ratio:</b>	1.0

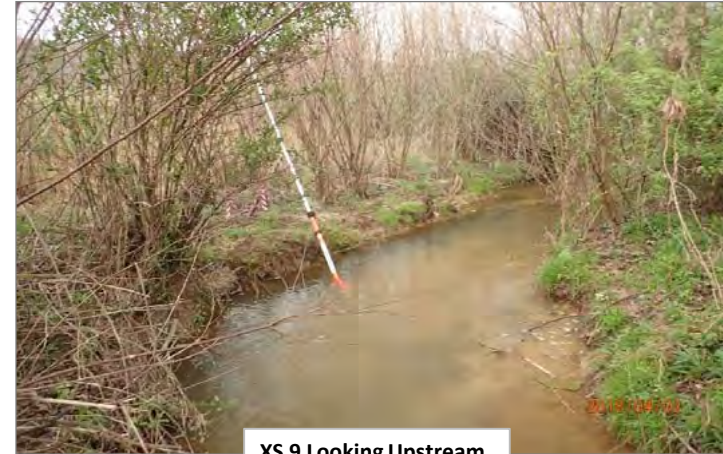
XS 9 Looking Upstream

<b>Site</b>	UT to Martins (Contreras)
<b>Project Number:</b>	92766
<b>XS ID</b>	XS - 9, Pool
<b>Reach</b>	UT 1
<b>Date:</b>	4/1/2018
<b>Field Crew:</b>	Perkinson, Butler

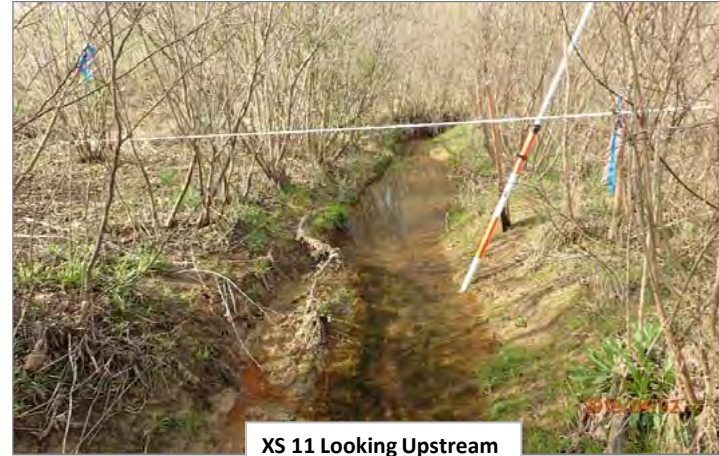
XS 11 Looking Upstream

<b>Site</b>	UT to Martins (Contreras)
<b>Project Number:</b>	92766
<b>XS ID</b>	XS - 11, Riffle
<b>Reach</b>	UT 1
<b>Date:</b>	4/1/2018
<b>Field Crew:</b>	Perkinson, Butler

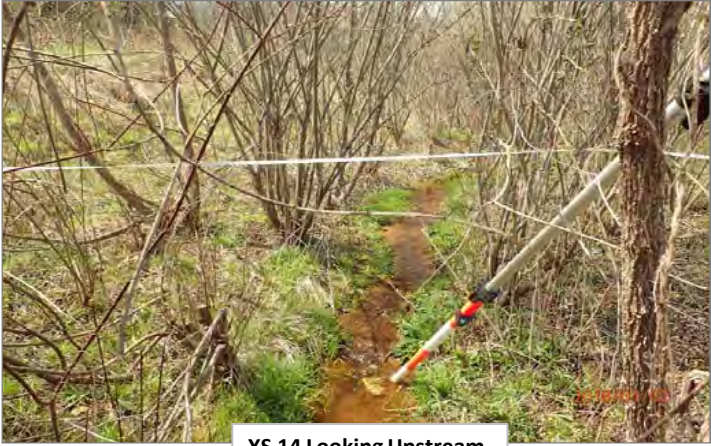
XS 14 Looking Upstream

Site	UT to Martins (Contreras)
Project Number:	92766
XS ID	XS - 14, Riffle
Reach	UT 1-3
Date:	4/1/2018
Field Crew:	Perkinson, Butler

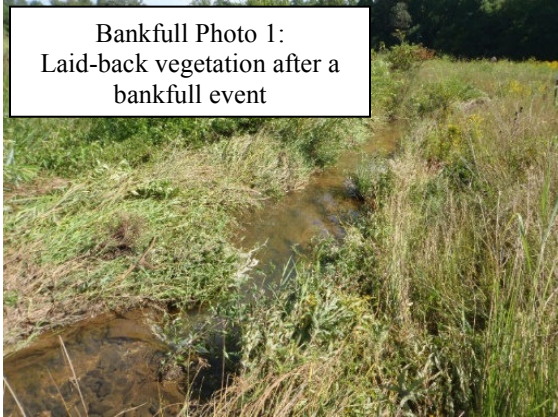
Bankfull Photo 1:  
Laid-back vegetation after a  
bankfull event

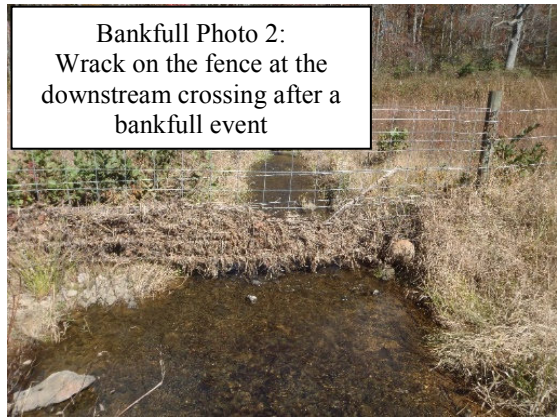
Bankfull Photo 2:  
Wrack on the fence at the  
downstream crossing after a  
bankfull event

The easement fencing at the downstream crossing of UT1 has been damaged by wrack and water during bankfull events, and the gate on the right bank of the crossing is damaged and is no longer able to prevent livestock access to the crossing. Additionally, easement fencing along the entire boundary, especially along the right bank of UT1-3, are becoming susceptible to damage from lack of maintenance. There was no evidence of livestock access to the easement observed during year 5 (2018).

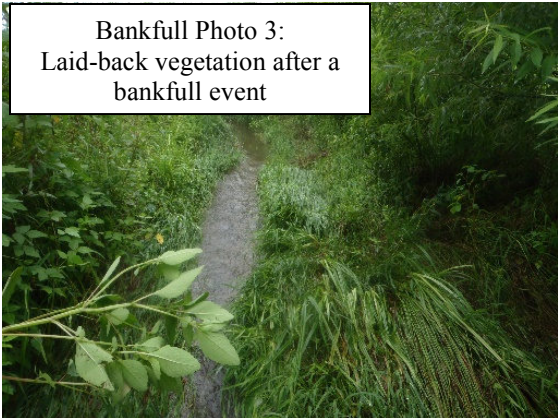
Bankfull Photo 3:  
Laid-back vegetation after a  
bankfull event

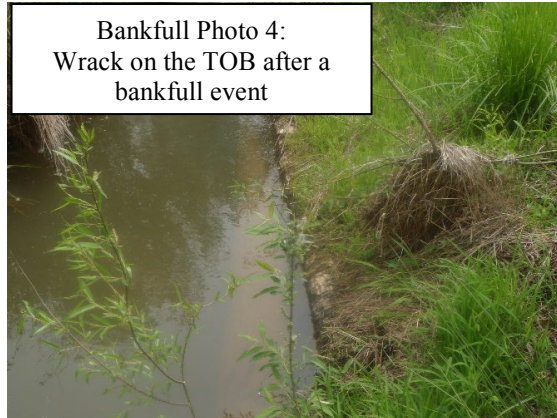
Bankfull Photo 4:  
Wrack on the TOB after a  
bankfull event

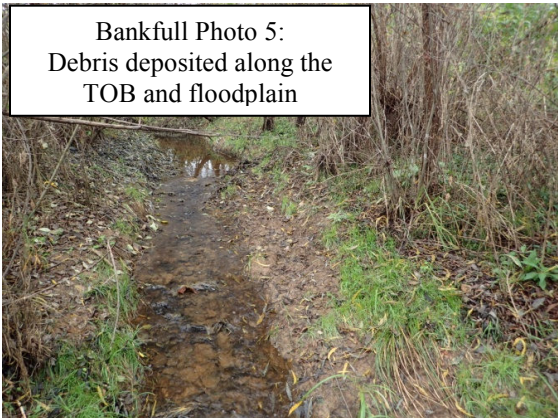
Bankfull Photo 5:  
Debris deposited along the  
TOB and floodplain

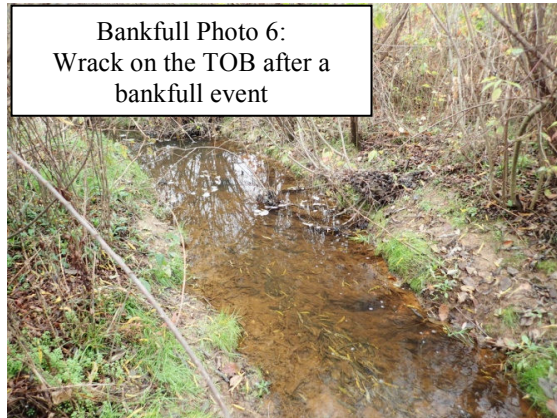
Bankfull Photo 6:  
Wrack on the TOB after a  
bankfull event

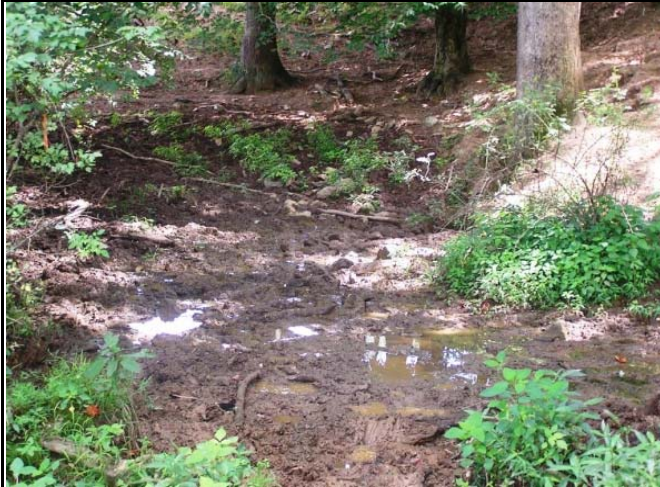
Source spring of UT1-1; also frequented by cattle

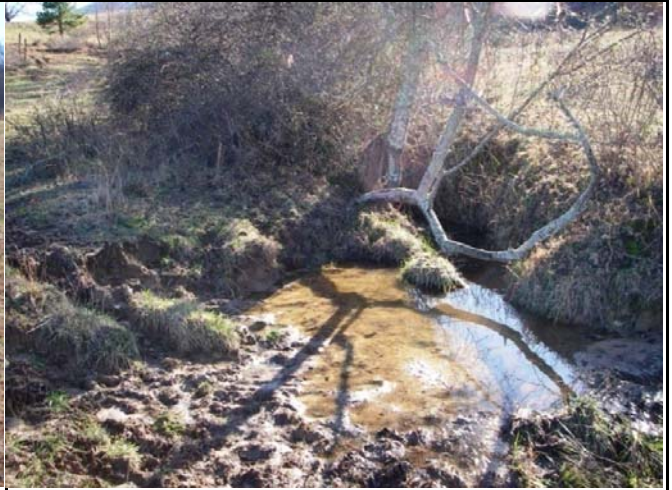
Typical view of banks trampled by cattle on-site

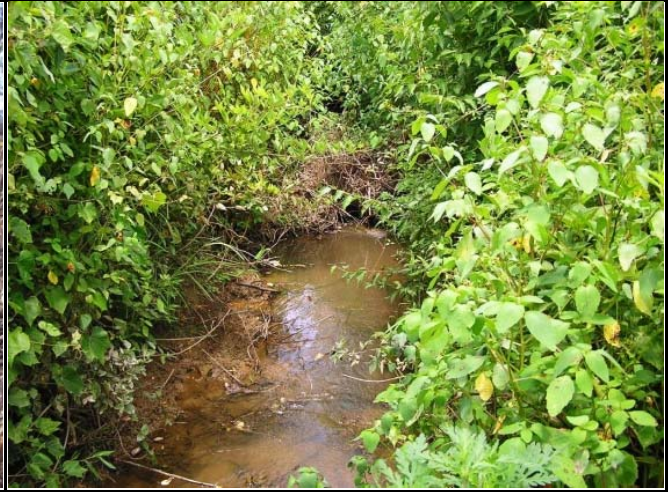
Debris jams are common on UT1 to Martin Creek below UT1-3

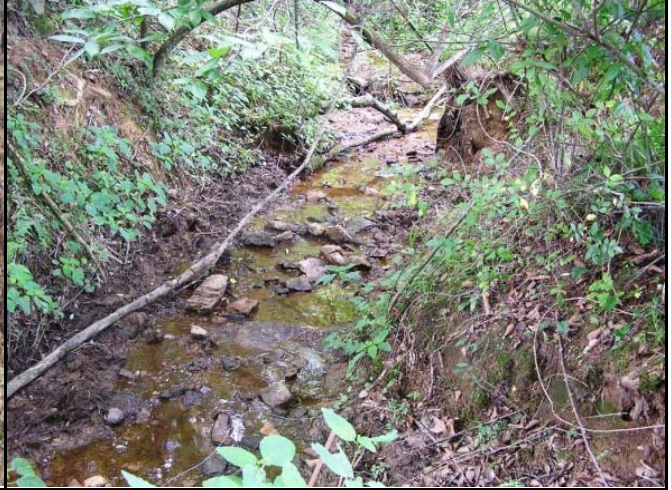
UT1-3 receives runoff from adjacent fields as well as nearby road

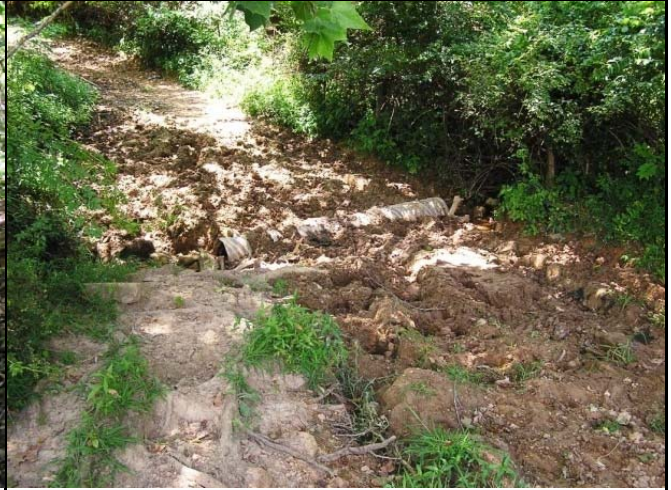
Inadequate culvert crossing on UT1-3

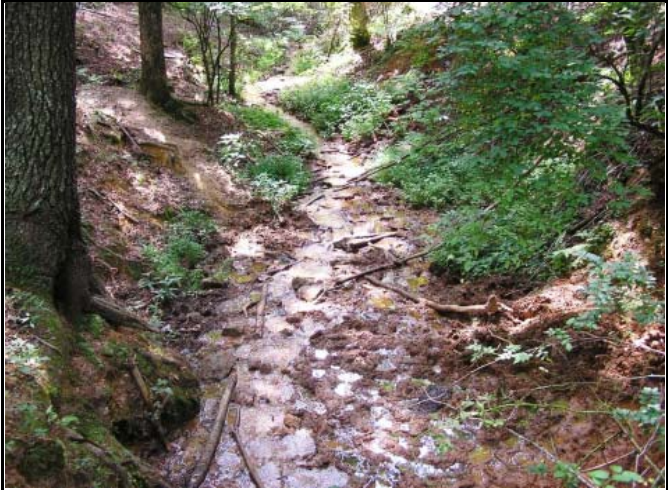
UT1-4 at spring looking downstream; cattle recently accessed site
