# Unnamed Tributary to Pembroke Creek Wetland and Stream Restoration

Chowan County, North Carolina, Project #D06102S

Final – Restoration Plan

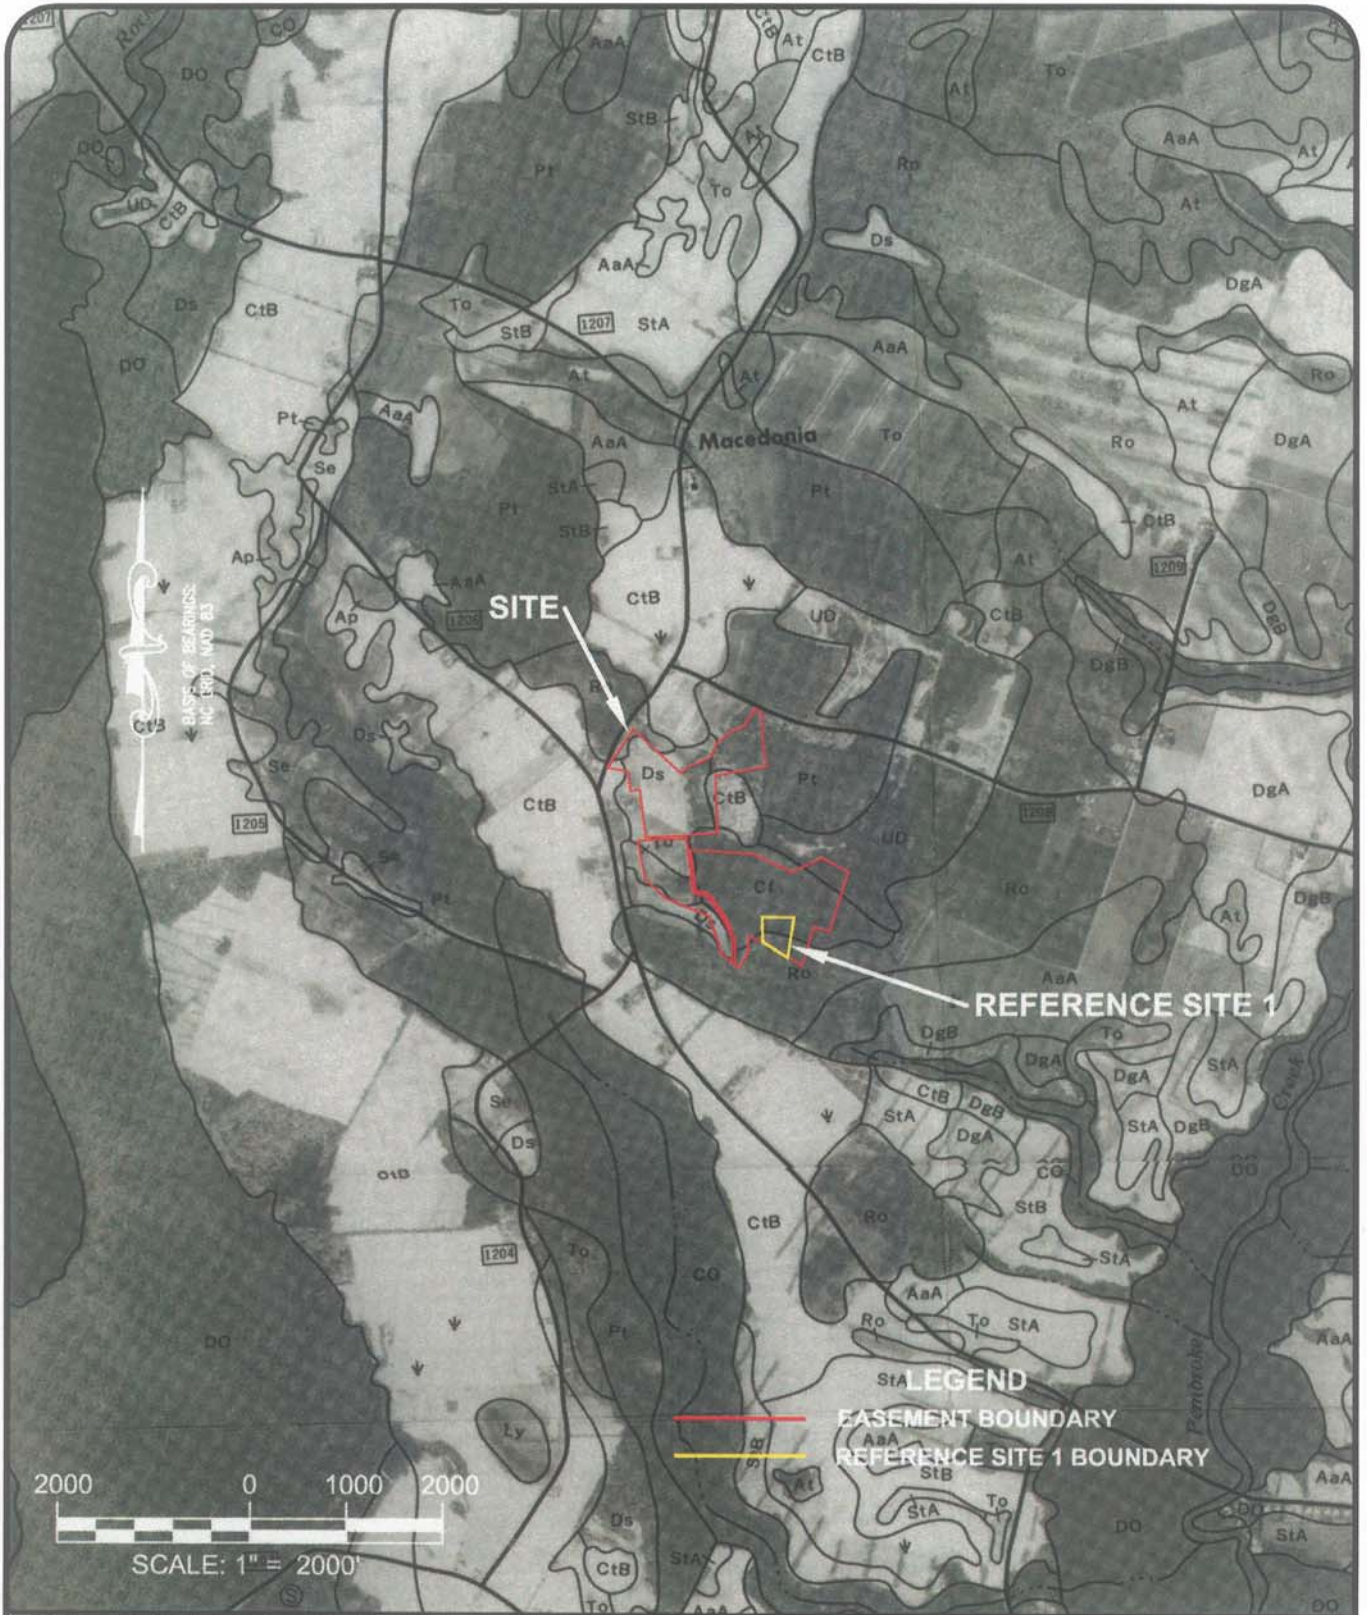
3

TITLE: PROJECT SITE AND REFERENCE 1  
 NRCS SOIL SURVEY MAP  
 PROJECT: UT PEMBROKE CREEK

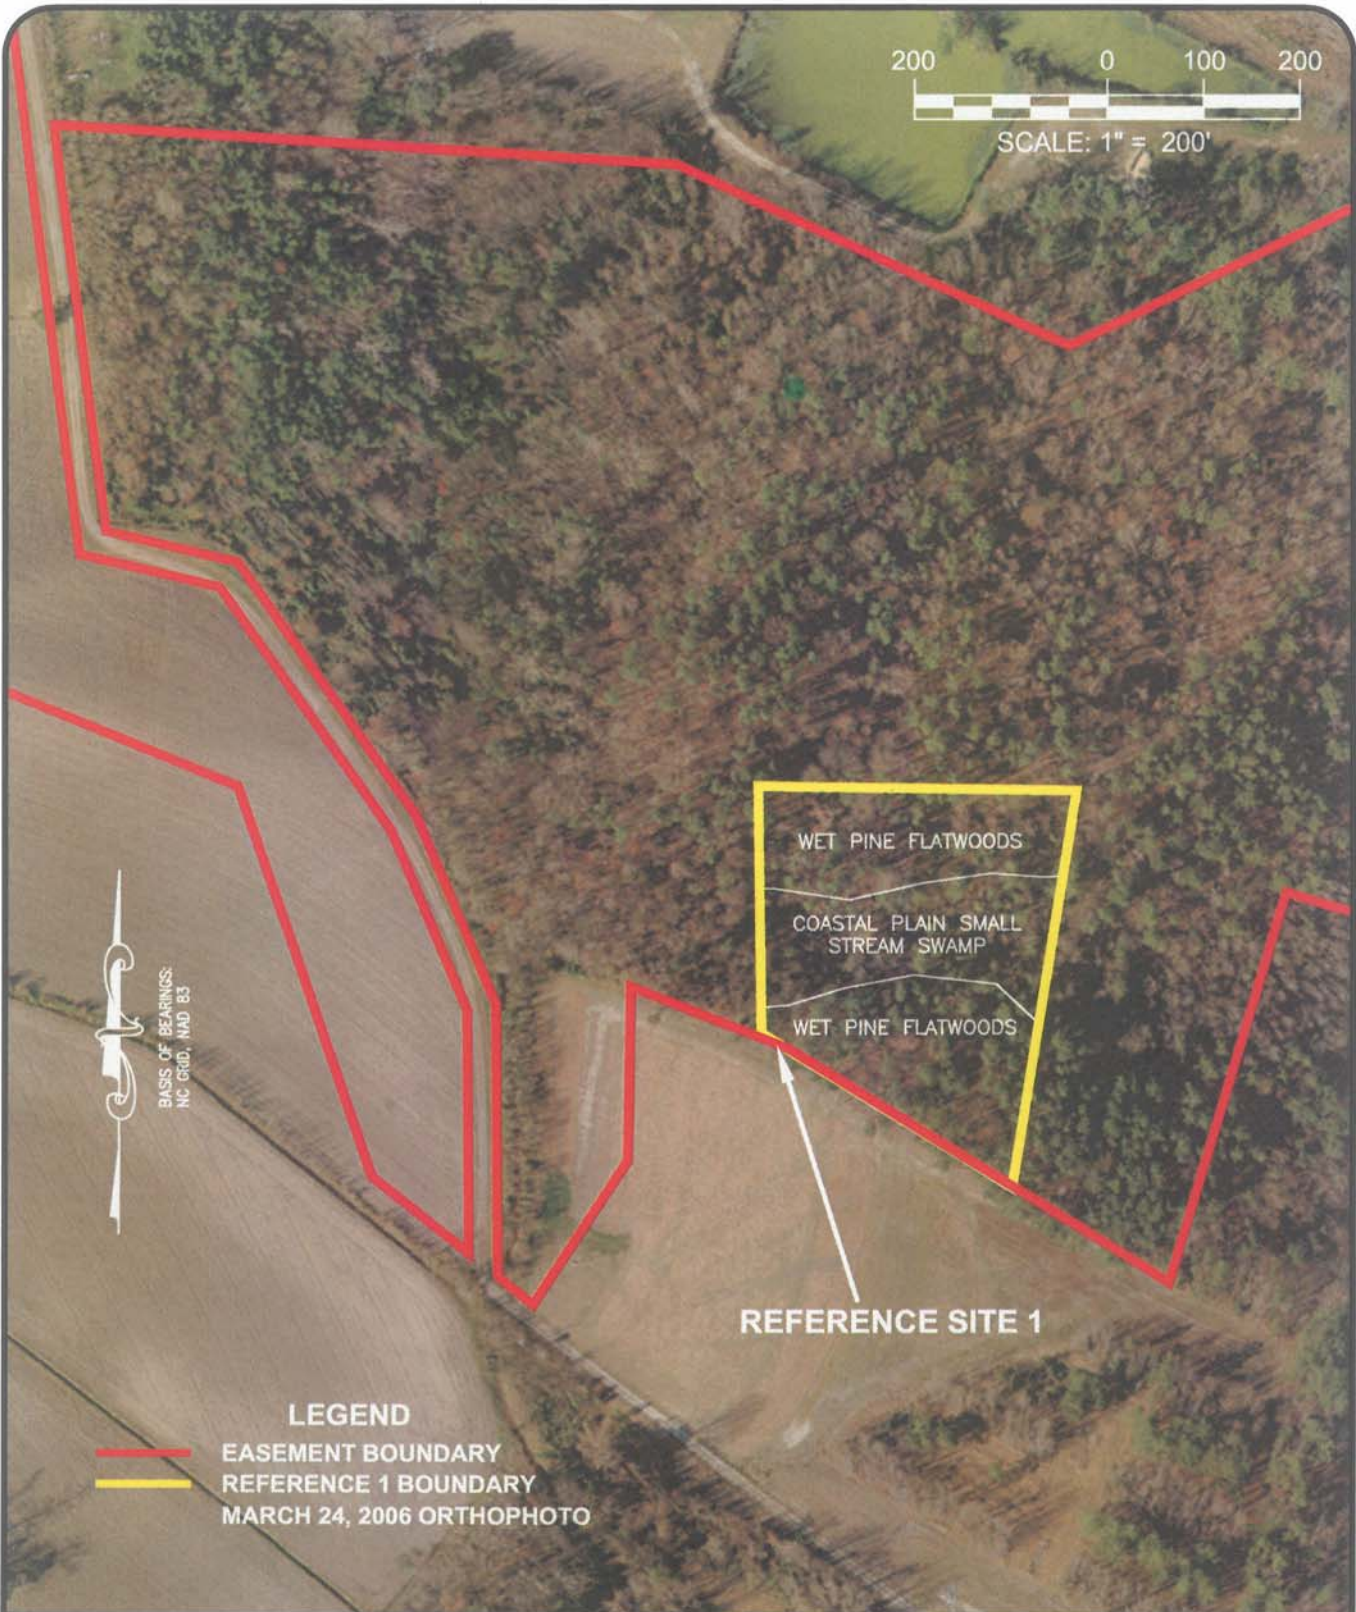
4

TITLE: REFERENCE SITE 1 WETLAND DETERMINATION  
 AND VEGETATIVE COMMUNITIES MAP  
 PROJECT: UT PEMBROKE CREEK

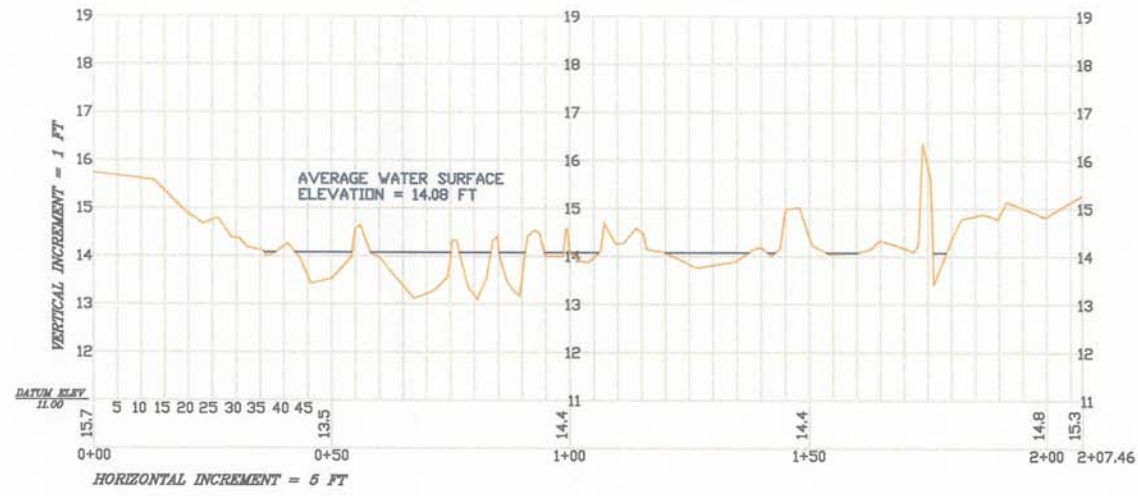
PROFILE REF1 X1

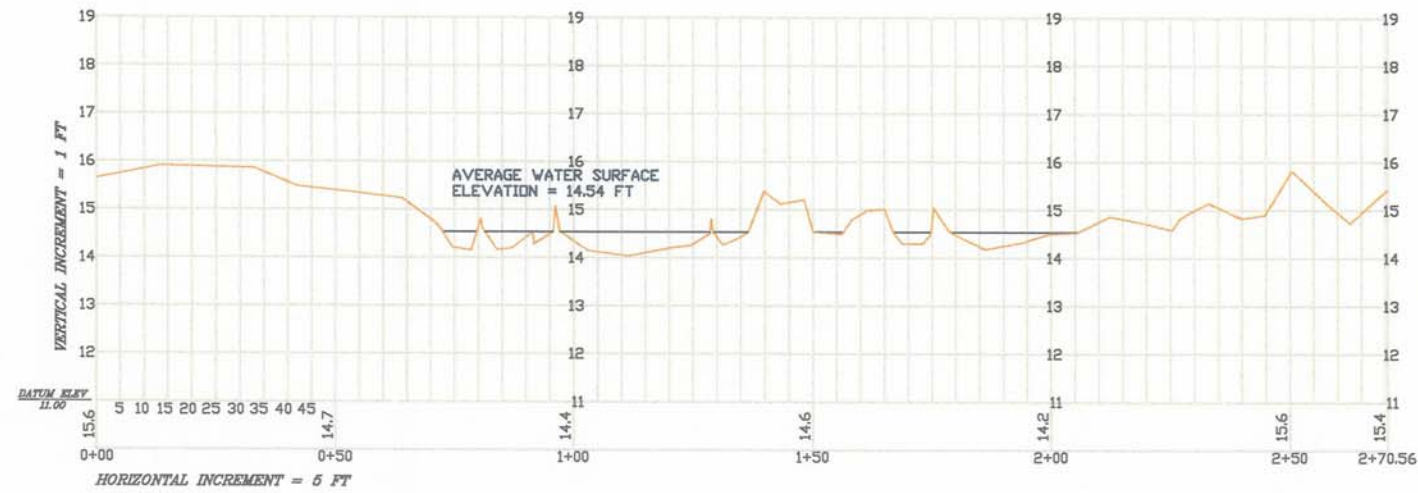
PROFILE REF1 X2

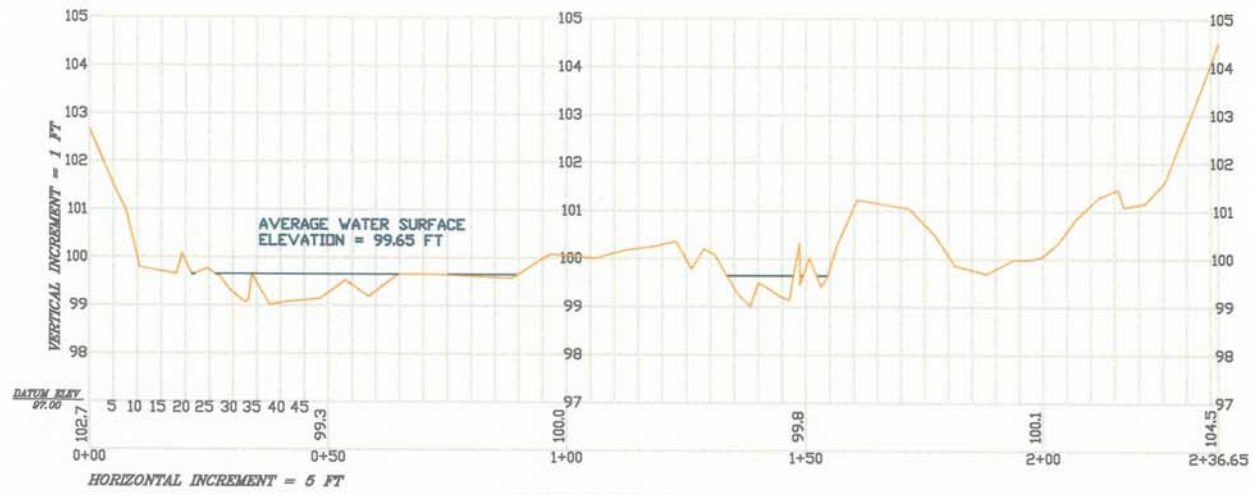
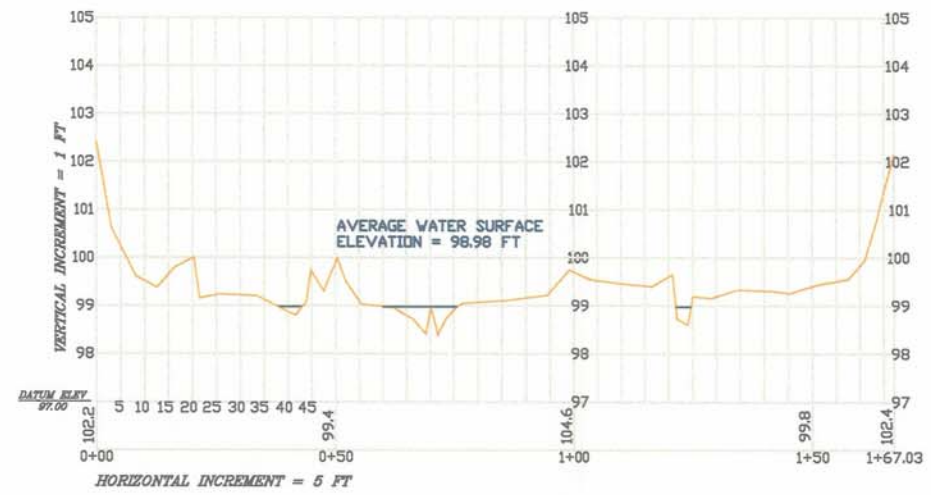
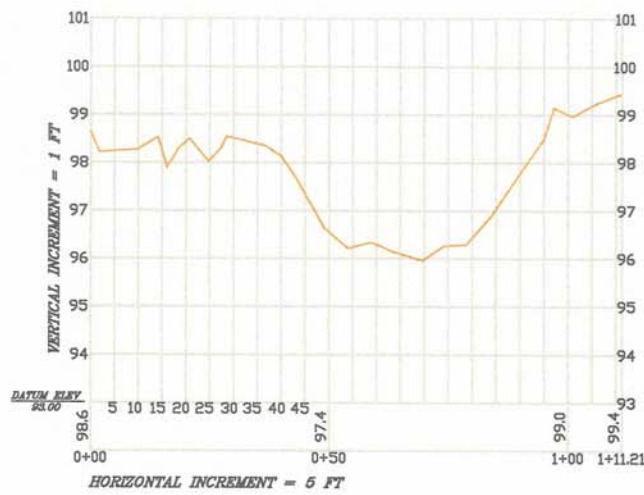
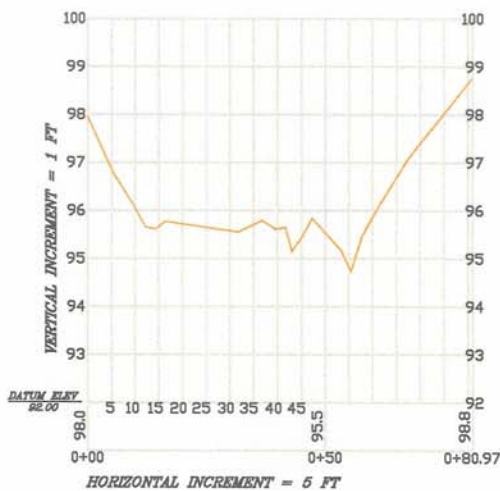
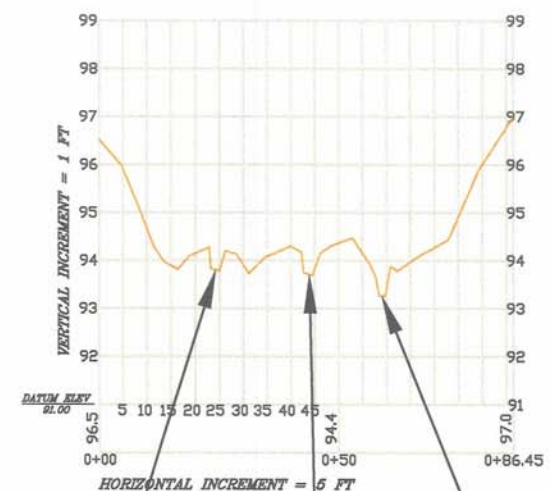
**REFERENCE SITE 2 & 3 CROSS-SECTIONS**  
 UT PEMBROKE STREAM AND WETLAND RESTORATION

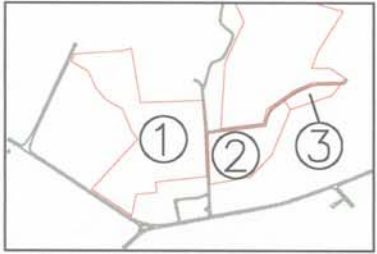
SHEET  
**2**

DESIGN TOPOGRAPHY WILL MAXIMIZE FLOW PATH, STORAGE VOLUME, AND WATER RETENTION ON SITE WHILE MINIMIZING EARTH MOVEMENT.

THROUGHOUT SITE 1 FT. DEPRESSIONS (POOLS) RANGING IN SIZE FROM 25-50 SQ. FT. WILL BE CREATED ON APPROXIMATELY 30% OF THE RESTORATION AREA. SOIL MATERIAL GENERATED FROM THIS ACTIVITY WILL BE PLACED TO CREATE HUMMOCKS. FEATURES BASED ON REFERENCE DATA.

SAMPLE ILLUSTRATION DEPICTING POOL AND HUMMOCK AREAS

SURFACE ROUGHENING TO CREATE 6-12" WIDE BY 6-12" DEEP CHANNELS IN SOIL.

**DESIGNED CHANNEL ALIGNMENT**  
 UT PEMBROKE STREAM AND WETLAND RESTORATION

This Restoration Plan for the UT Pembroke Creek site outlines a method for restoring the existing agricultural property into a natural headwater wetland feature. The project goal for this restoration plan is to modify the channelized water feature, based on reference conditions, with the intent to restore its primary wetland functions such as nutrient cycling, flood storage, and providing wildlife habitat. A pool and hummock complex will be restored at the site to disrupt flow and retain water on-site to the greatest extent possible. Native vegetation will be incorporated into the design using reference conditions as a guide. A schematic of the design concept is presented on **Sheet 2**.

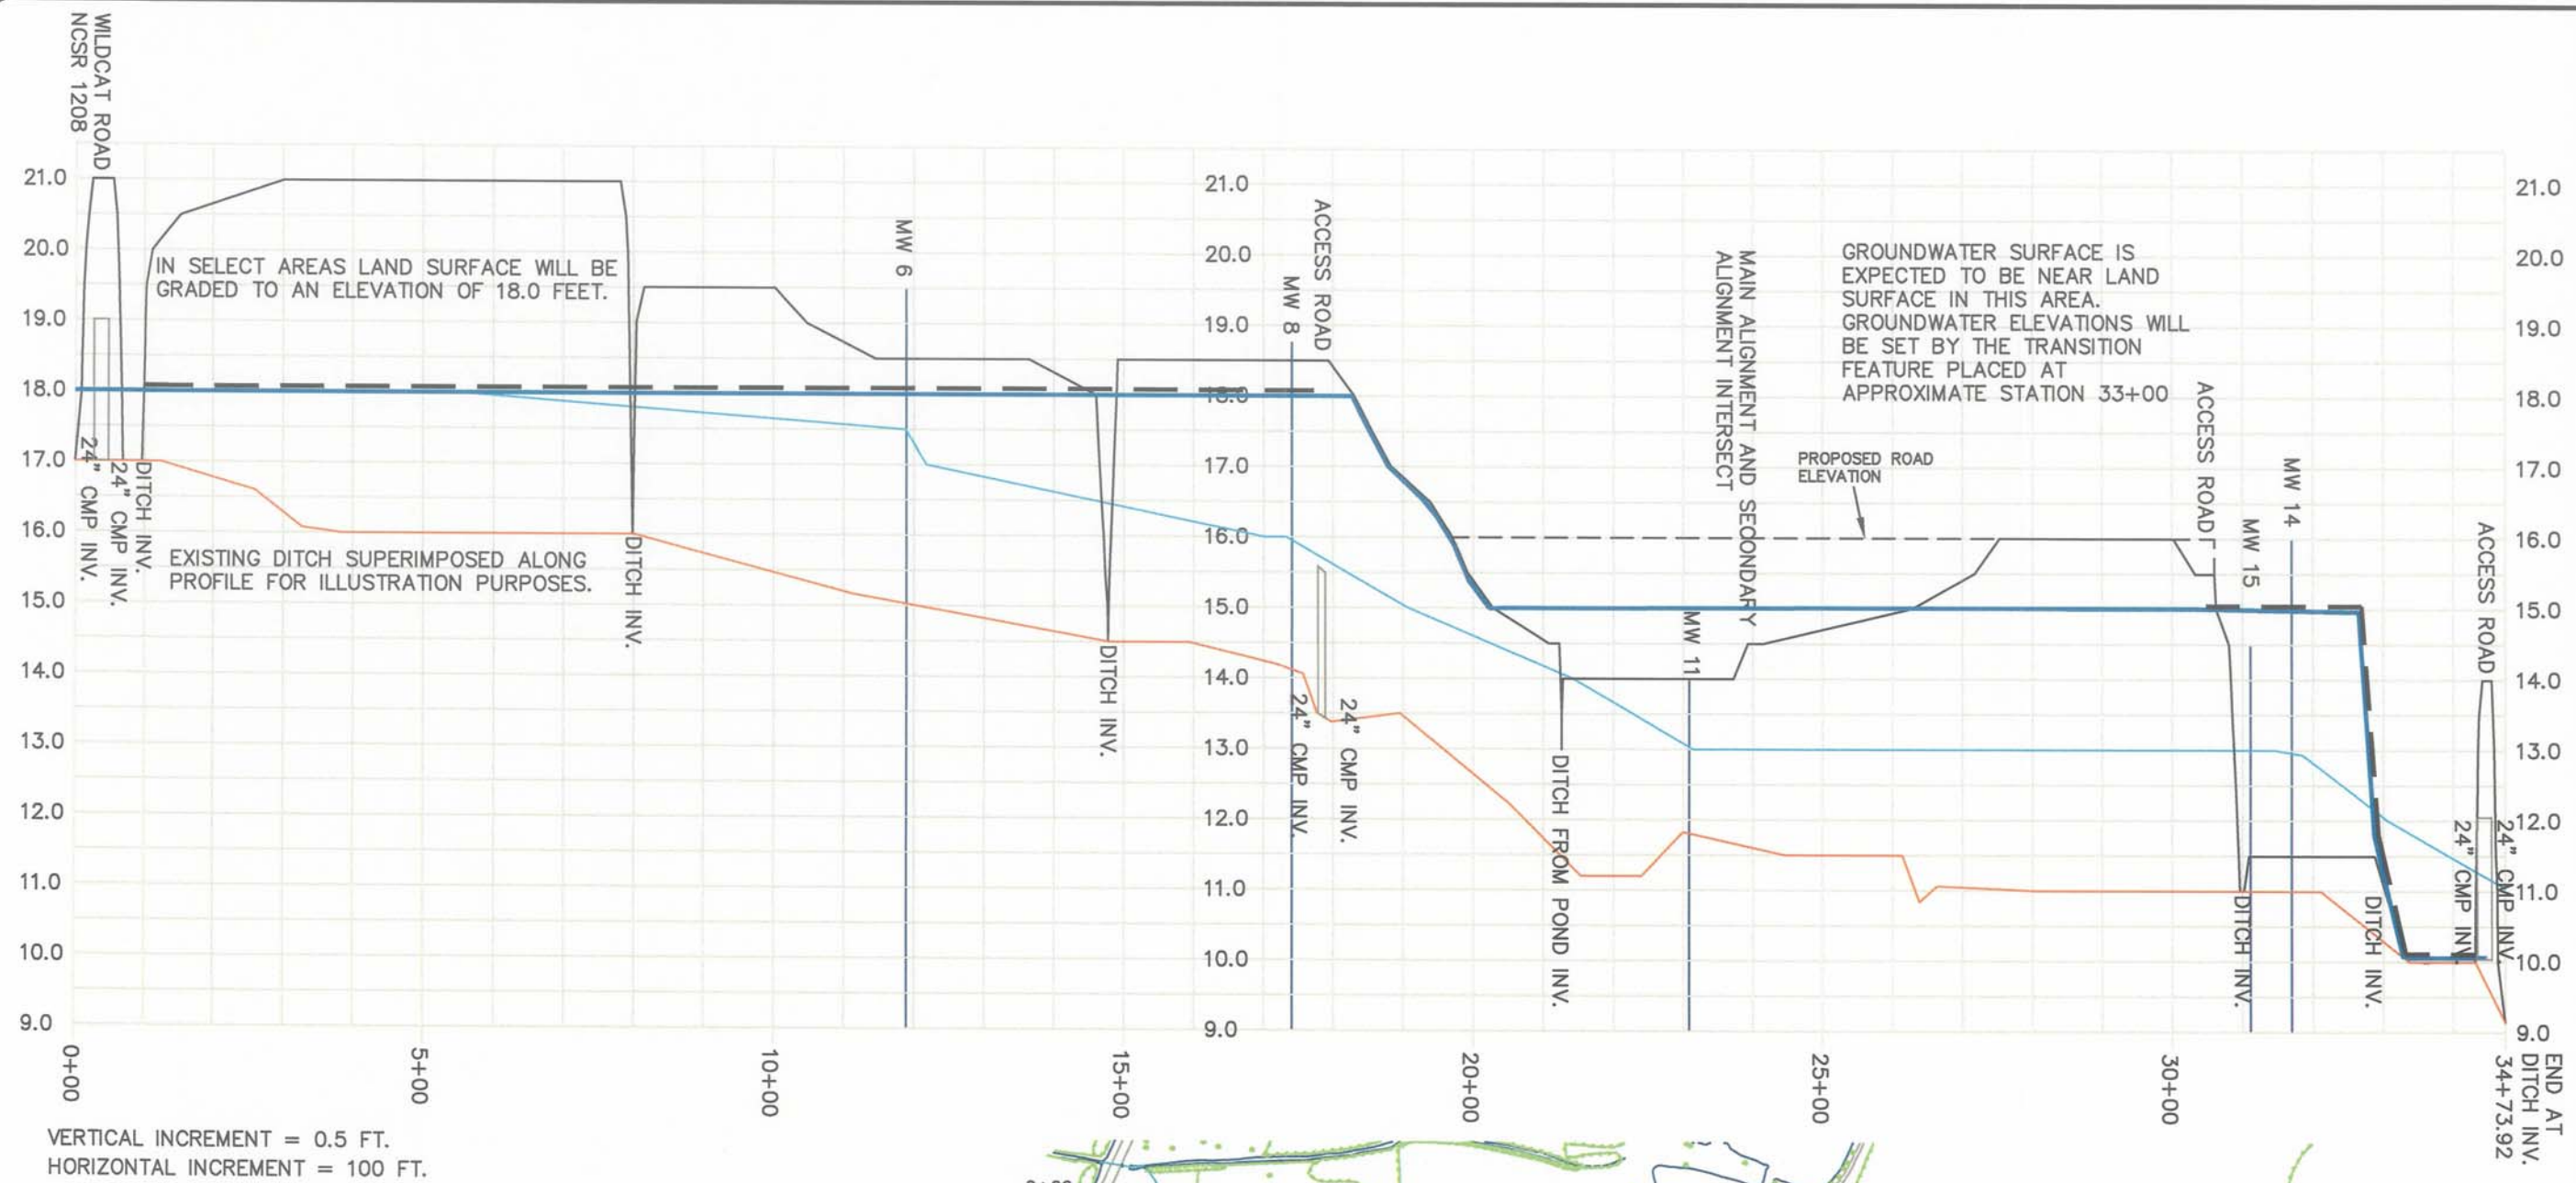
VERTICAL INCREMENT = 0.5 FT.  
 HORIZONTAL INCREMENT = 100 FT.

**LONGITUDINAL PROFILE**  
 UT PEMBROKE STREAM AND WETLAND RESTORATION

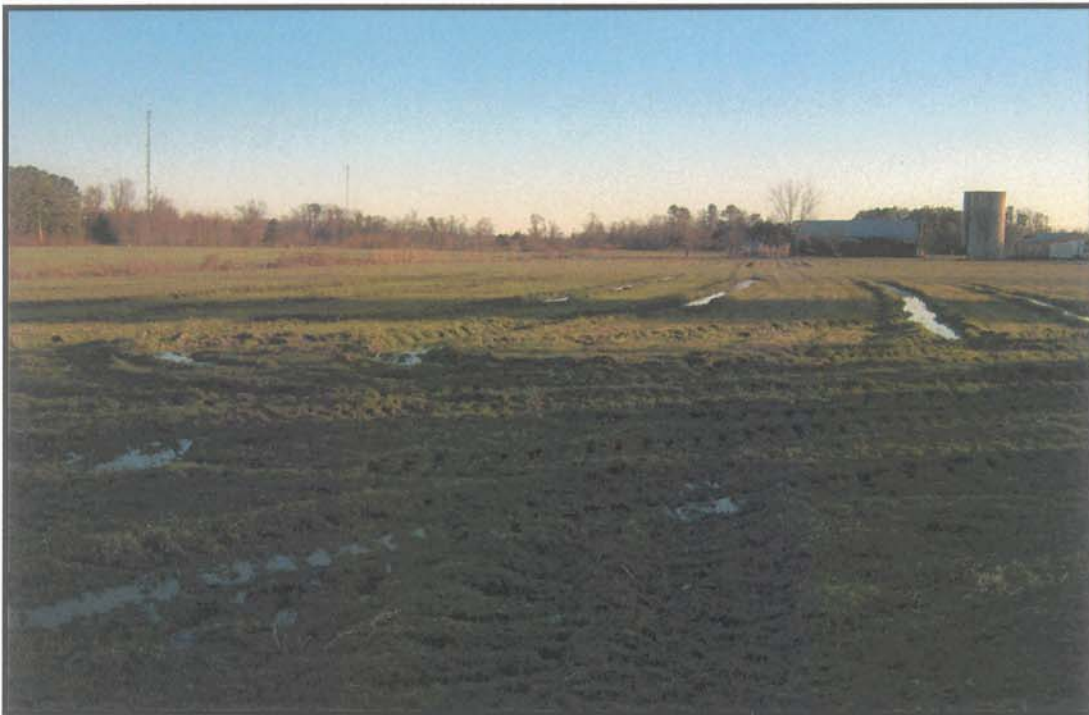
**Photo 8** – Photo taken near beginning of small ditch feature, looking almost due south. Project area is east of ditch feature shown on left of photo. Water in right of photo is collected in farm equipment tire ruts.

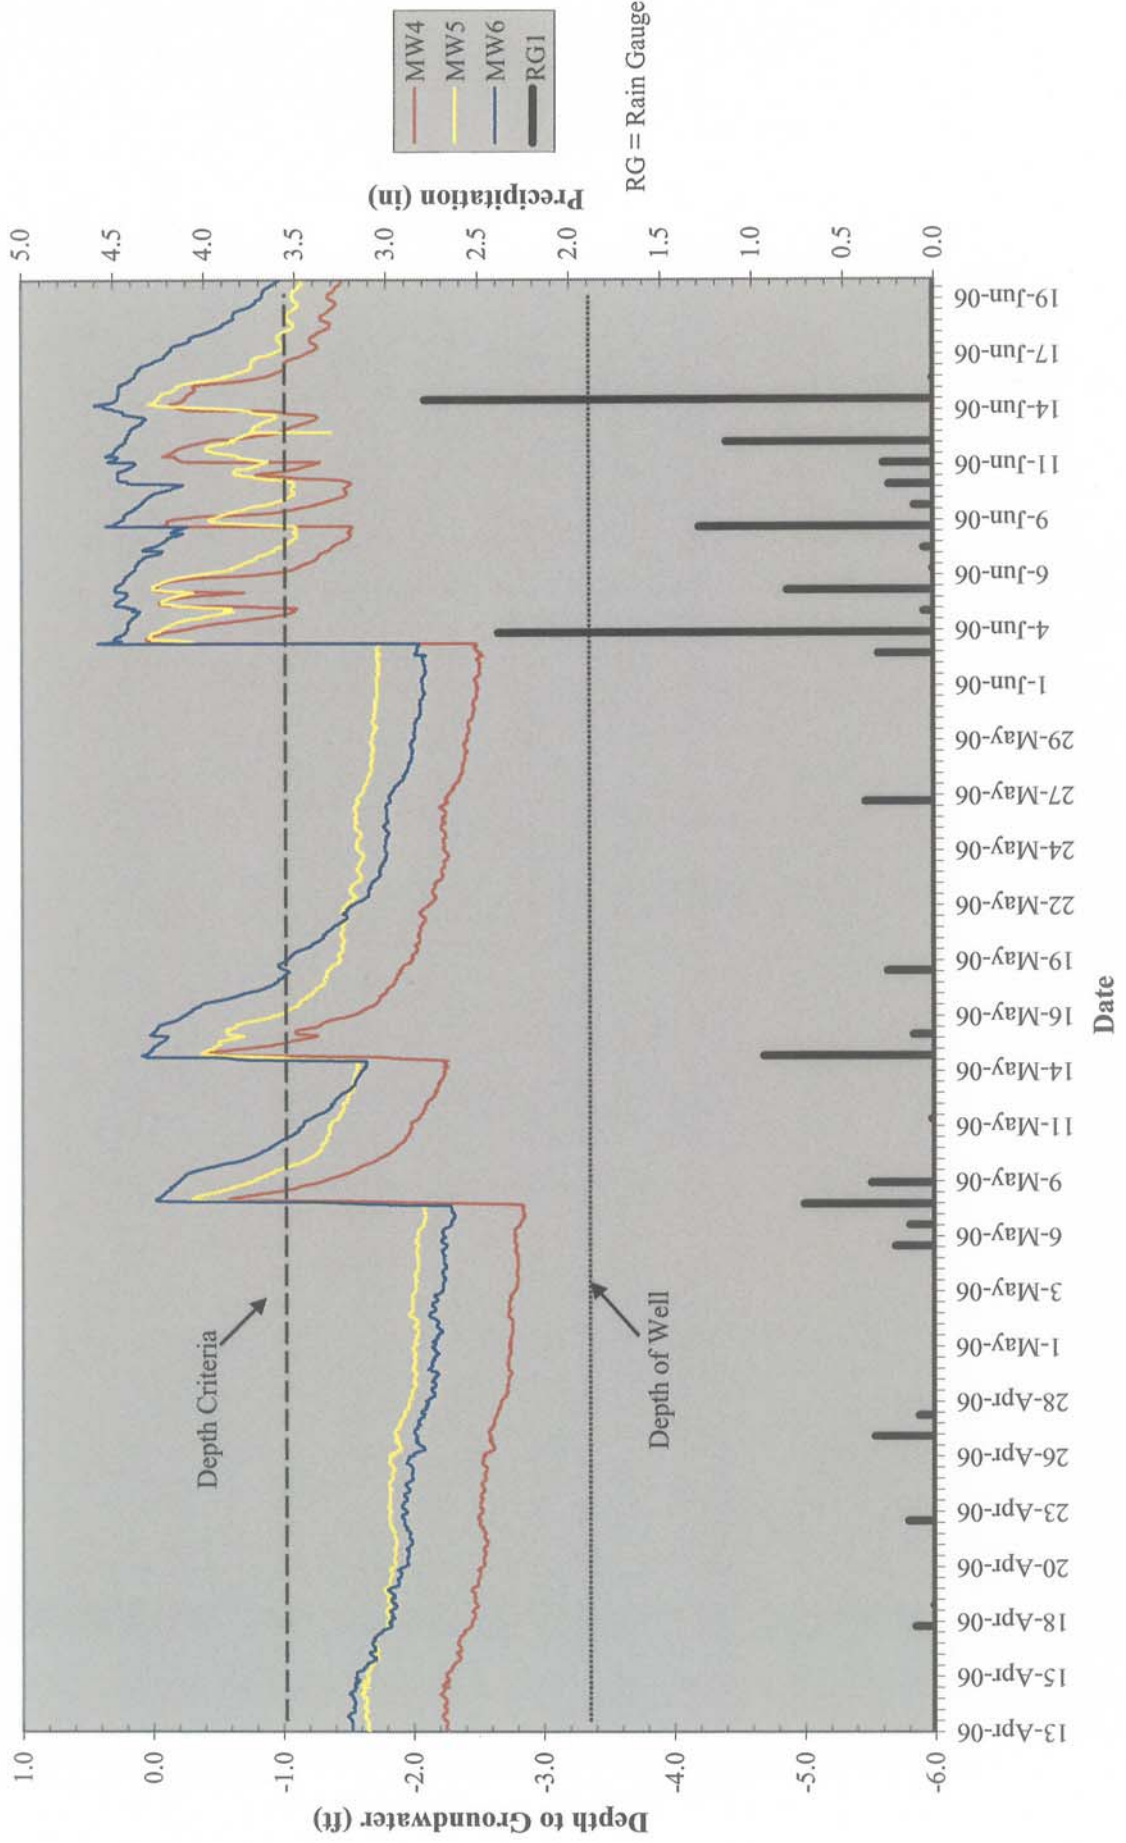
### Well Cross-Section 2 Groundwater Elevations and Rainfall Data

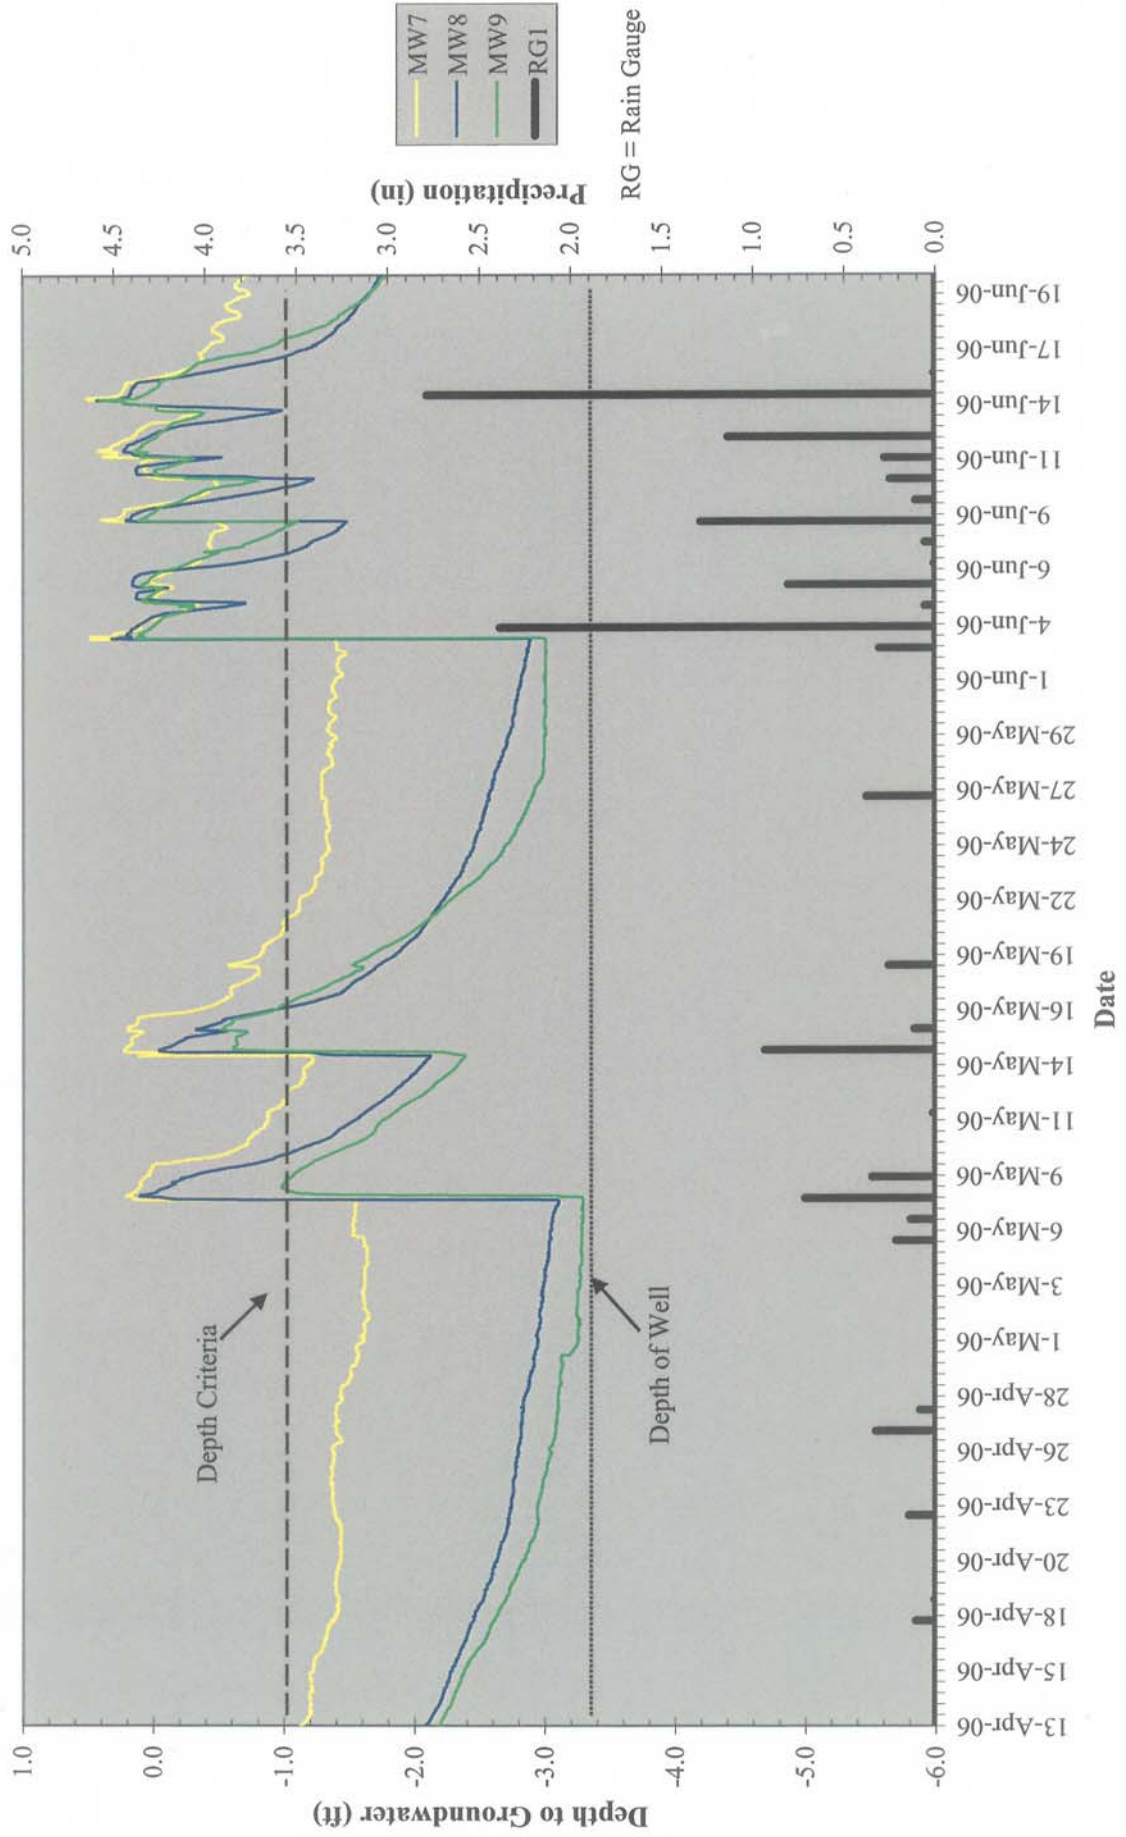
### Well Cross-Section 3 Groundwater Elevations and Rainfall Data

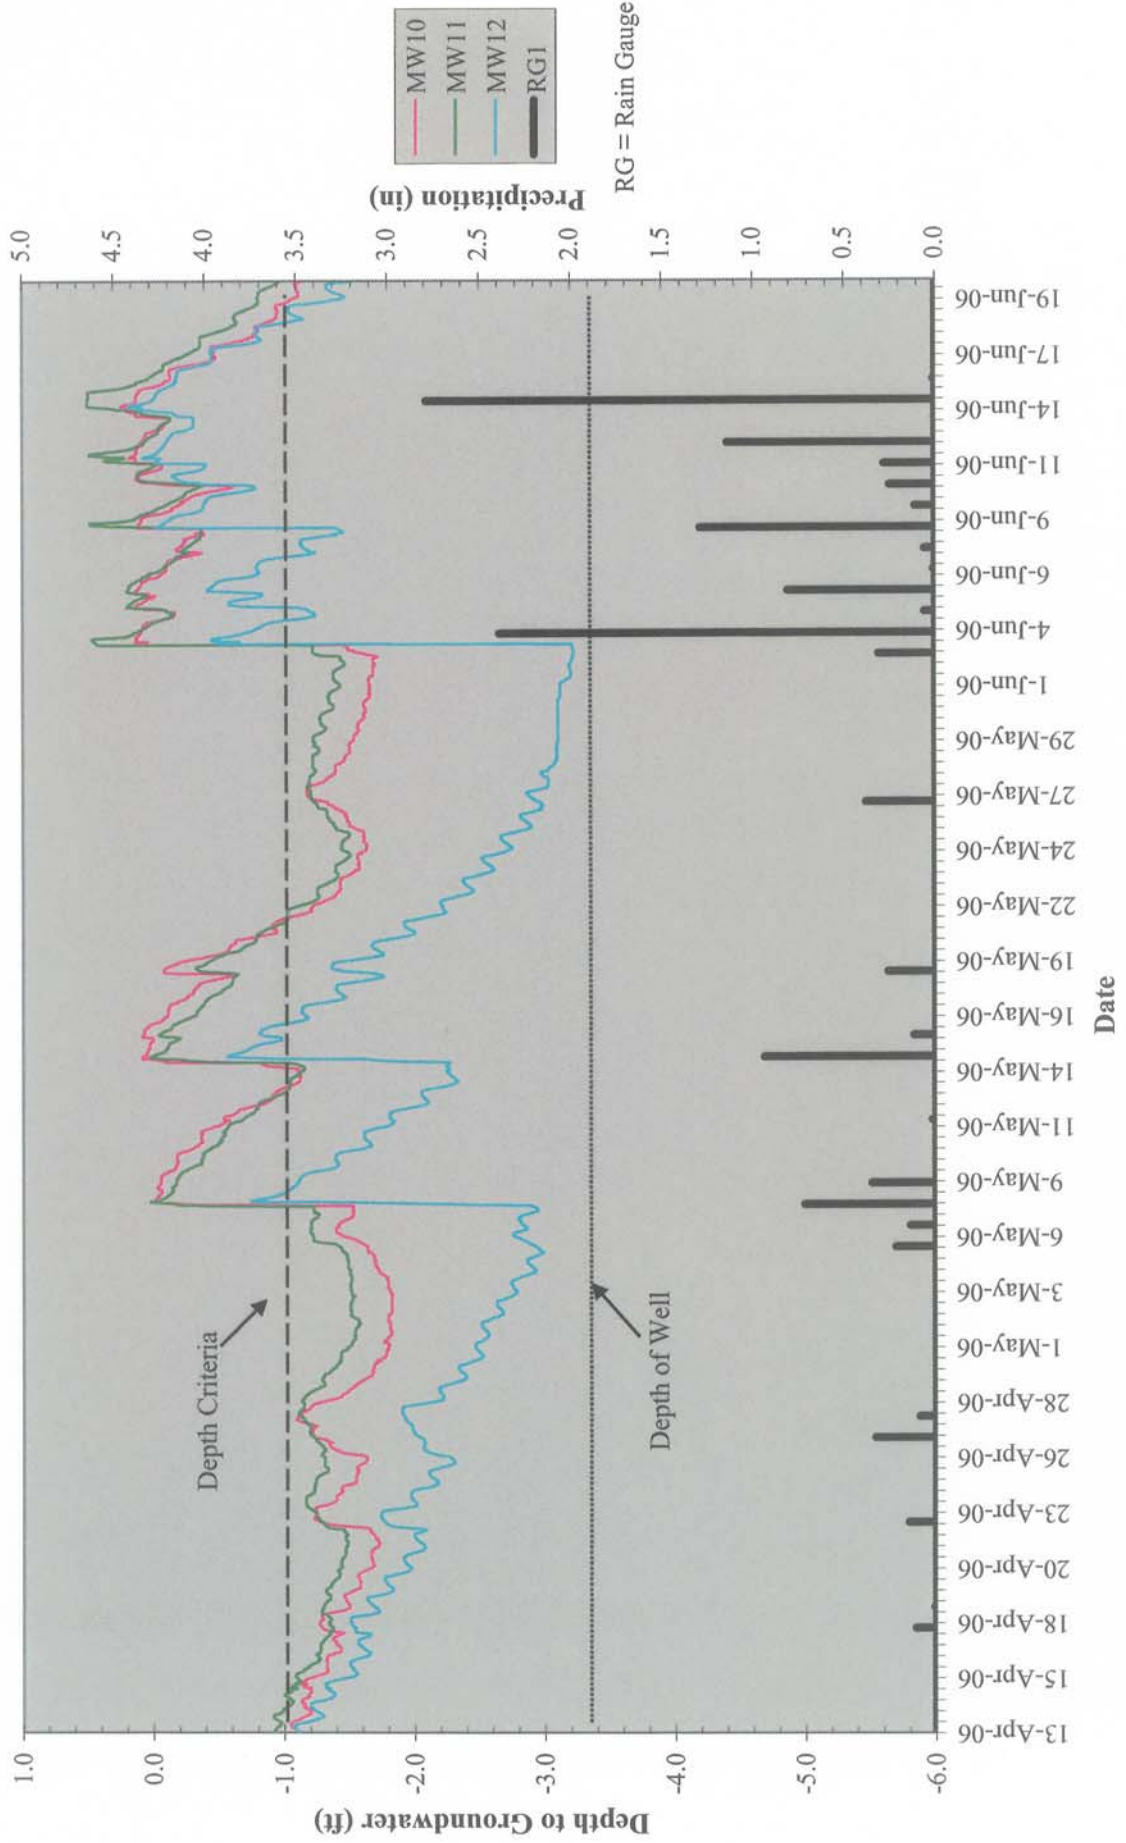
### Well Cross-Section 4 Groundwater Elevations and Rainfall Data

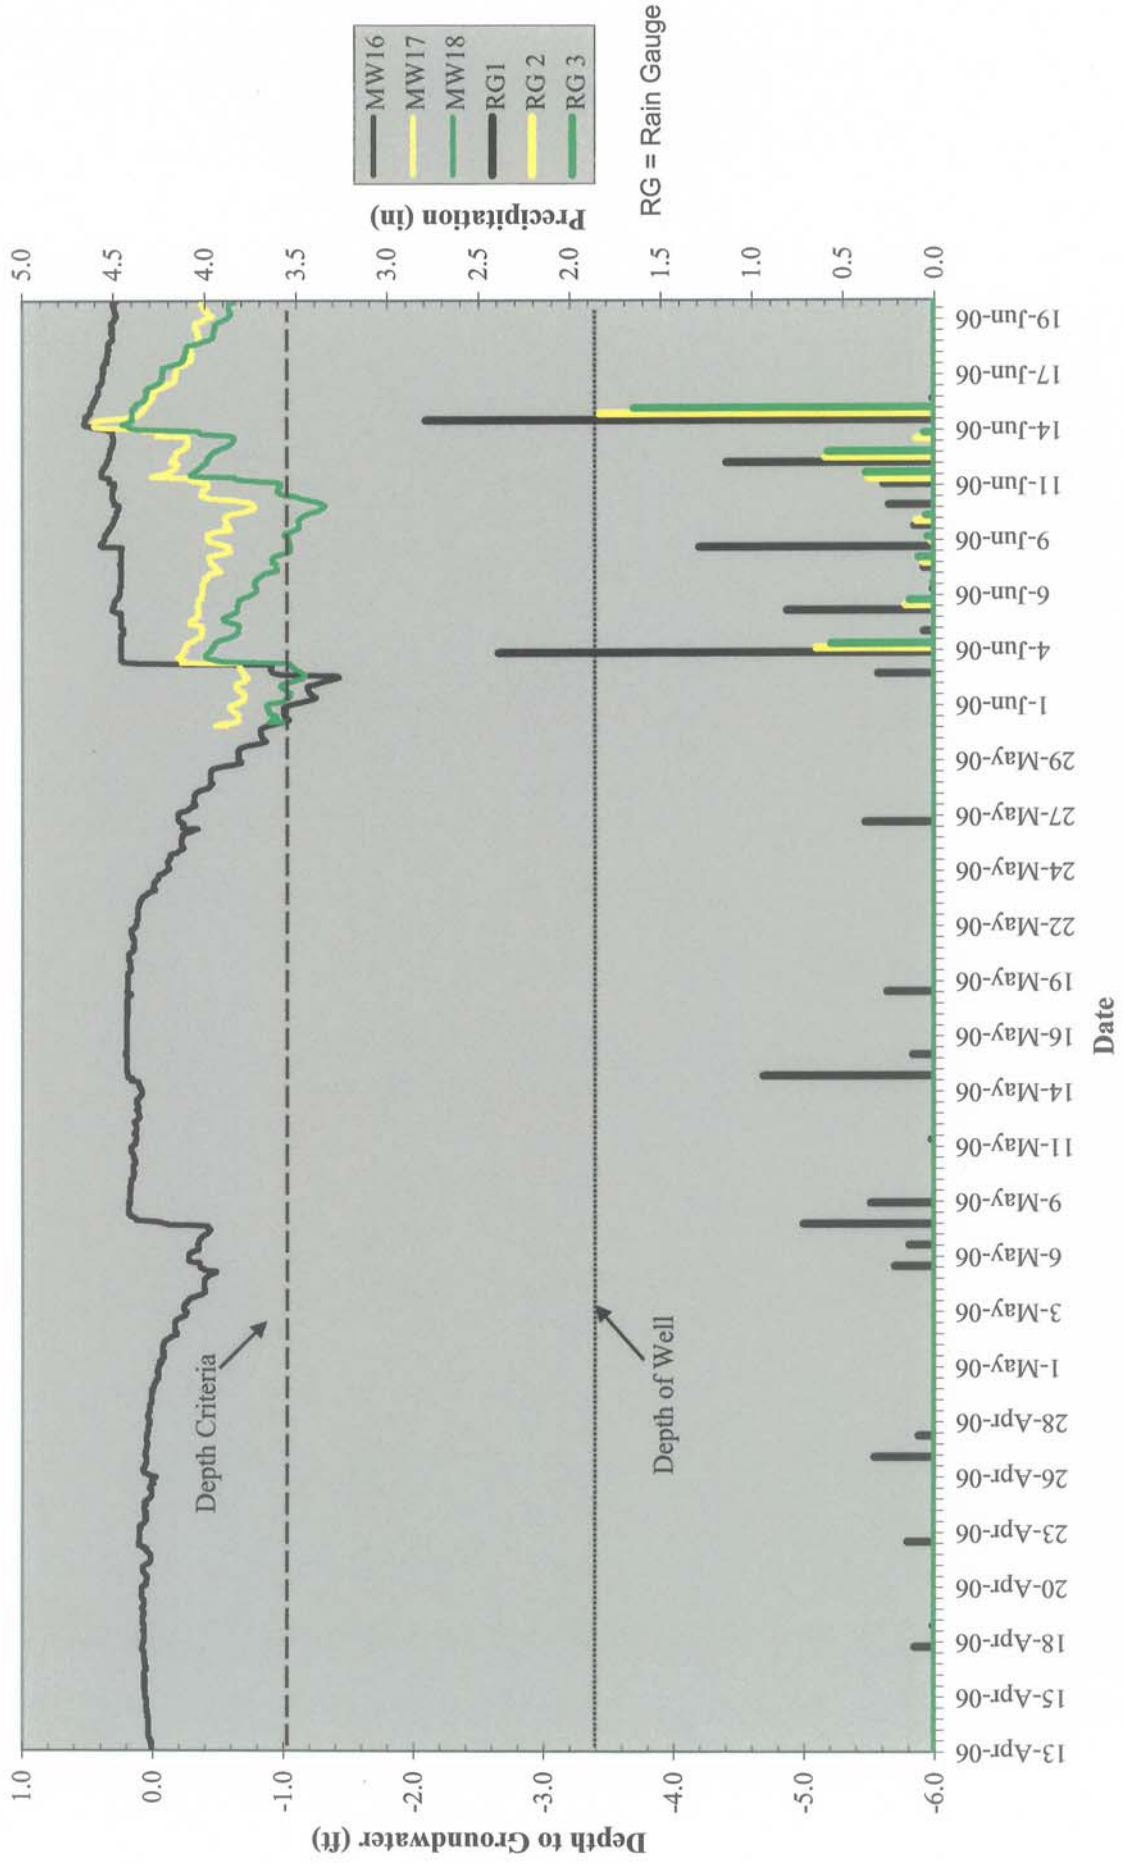
### Reference Sites Groundwater Elevations and Rainfall Data
