Unnamed Tributary to Pembroke Creek Wetland and Stream Restoration

Chowan County, North Carolina, Project #D06102S

Final – Mitigation Plan

**RECORD DRAWINGS - UT TO PEMBROKE CREEK
STREAM AND WETLAND RESTORATION PROJECT
EDENTON, CHOWAN COUNTY, NORTH CAROLINA
NC ECOSYSTEM ENHANCEMENT PROGRAM PROJECT
SCO# 050658801**

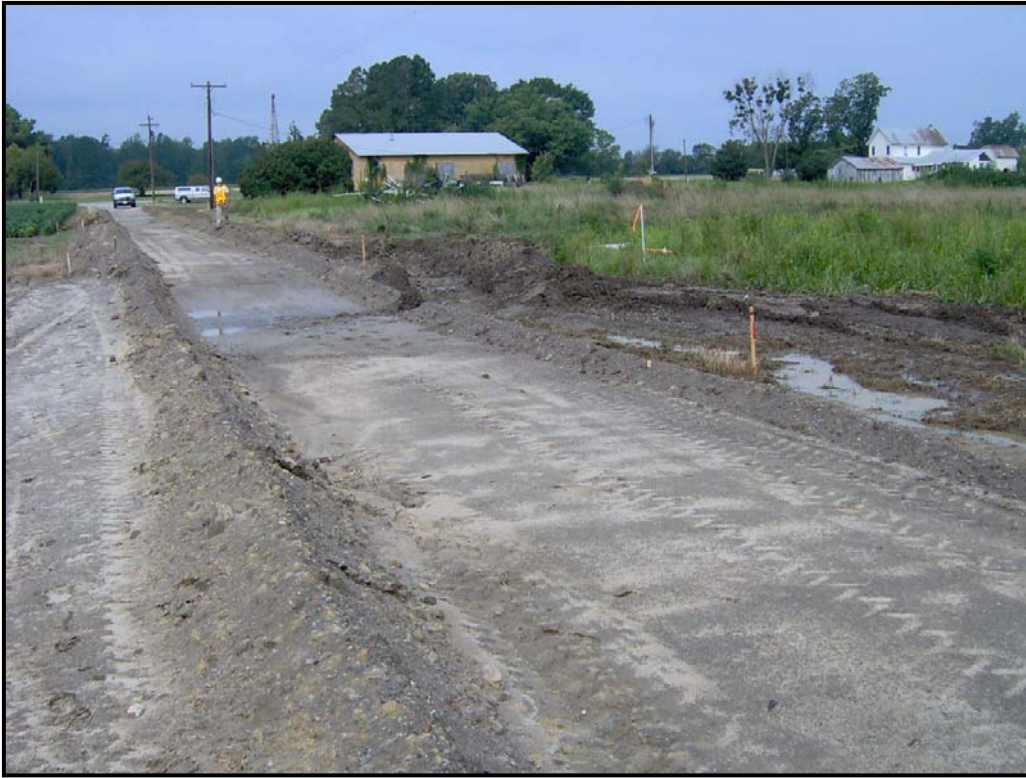
First Road Crossing Type A – Station 50+75 - Facing east toward Macedonia Rd.

At station 40+00 to 50+00 the surface was roughened and minor earthwork occurred to promote sheet flow. Small channels (6” to 12” deep by 6” to 12” wide) were created along the axis of Area 1B and also perpendicular across the valley. The conveyance of water across the valley will promote wetland hydrology near station 12+00 and possibly stations 11+00 and 10+00. The existing access road was modified to have a constant elevation with two (2) low areas that convey flow during large storm events. The elevation of these areas is 18.0 feet. Geoweb® material was used to reinforce the crossings and to also ensure the invert elevation of each crossing remains constant over time.

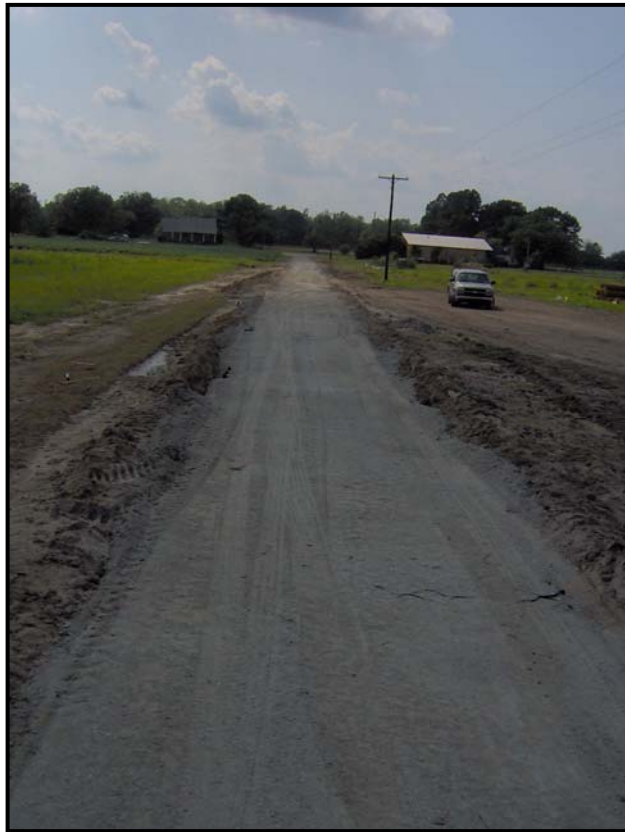
Second Road Crossing Type A – Station 17+75 – Facing east toward Macedonia Rd.

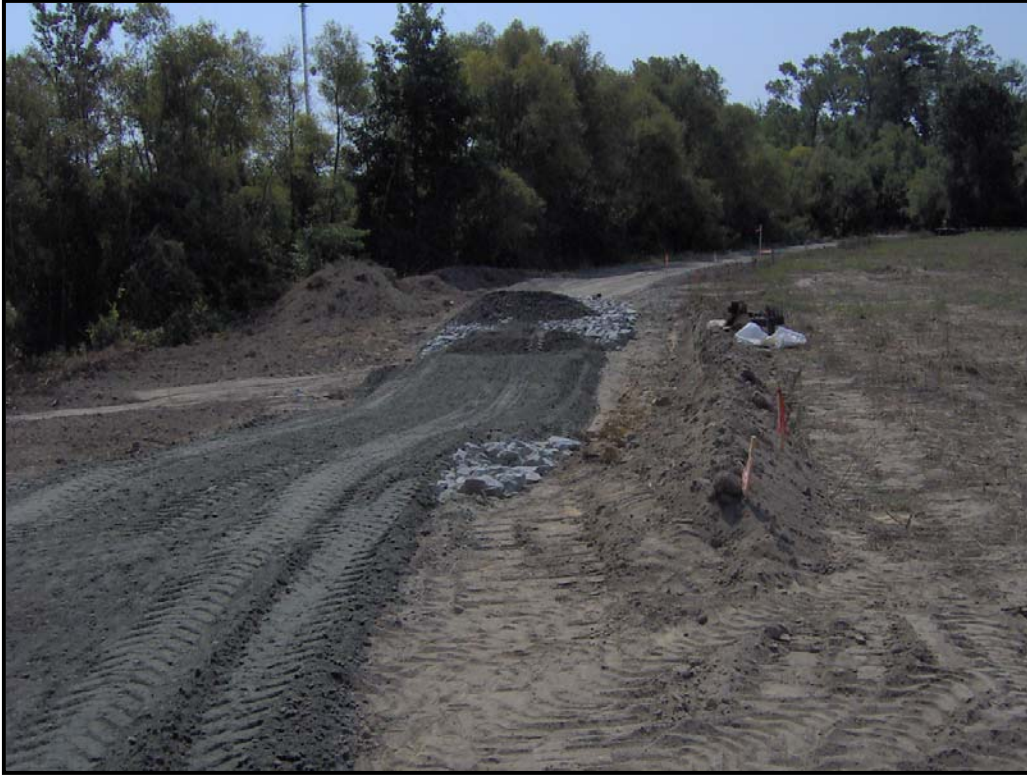
Road Crossing Type B – Station 30+50 – Immediately after completion

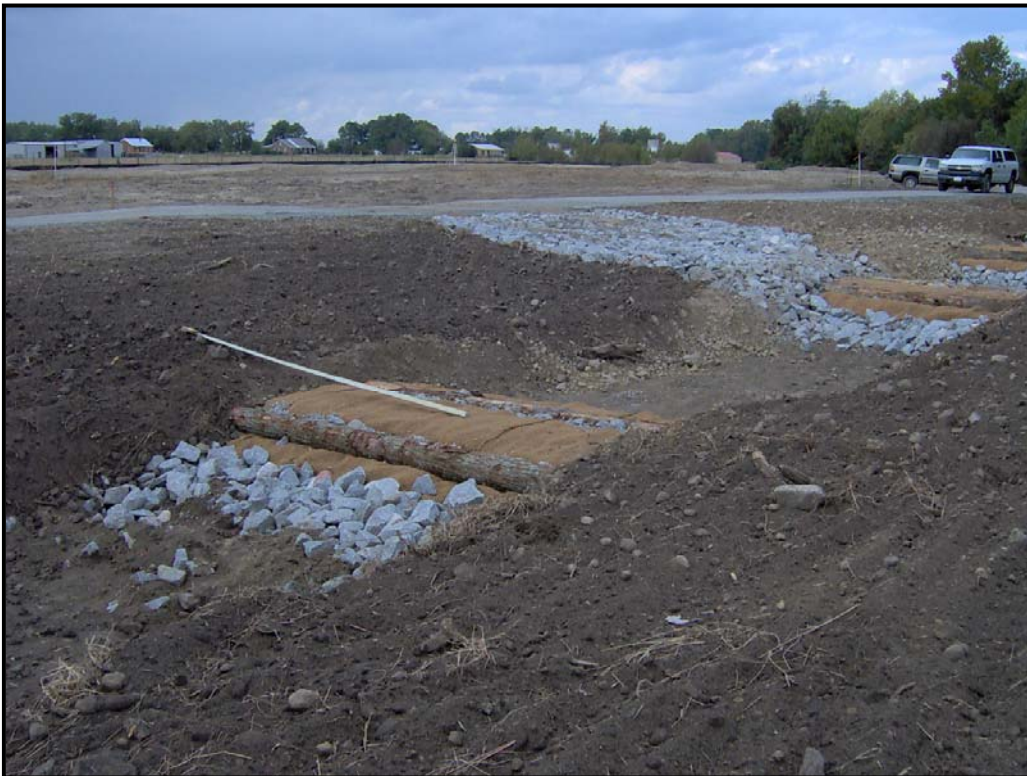
Road Crossing Type C – Station 32+50 – In background, immediately after completion

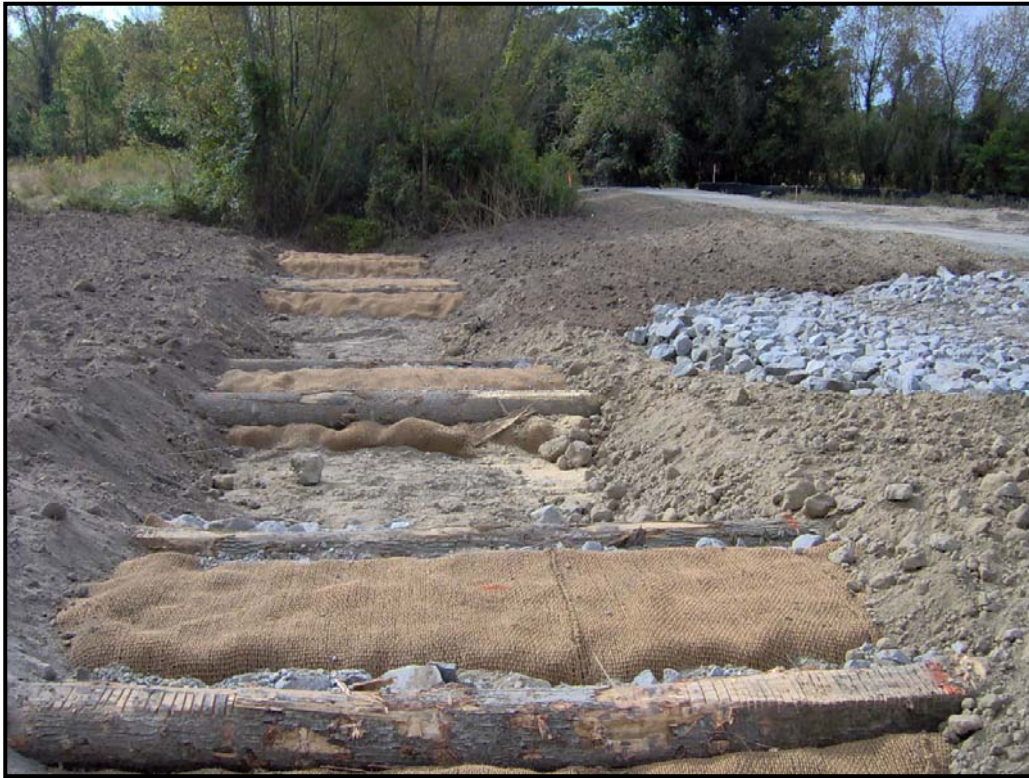
Grade Transition – Facing downstream

A structure constructed of rock, logs, and coir matting was installed at the downstream end of the project site to transition flow from the restored headwater wetland area to the lower elevation of the existing ditch. The structure consists of four (4) pairs of logs and a small rock structure that forms a series of steps that transition flow from elevation 15.0 feet to elevation 10.0 feet. The steps were constructed within a 100-foot section of channel and the structure was designed to allow the establishment of vegetation so that over time, the vegetation will mask the structure and promote a more natural appearance.

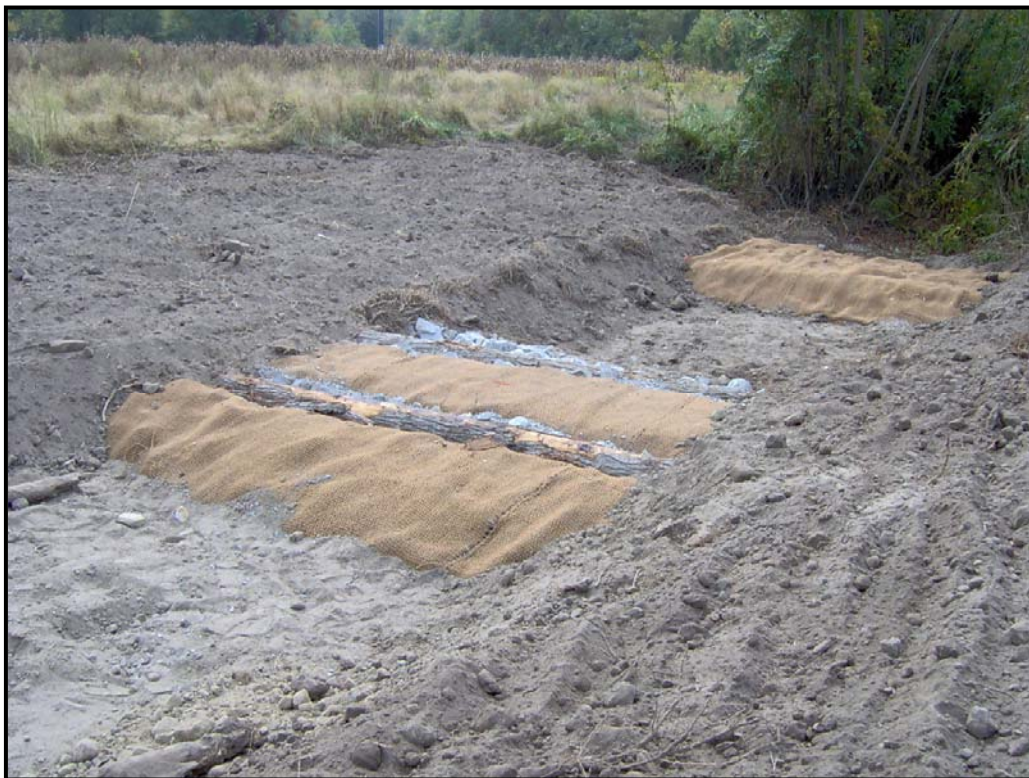
Grade Transition – Facing upstream
