**UT to Pembroke Creek Wetland and Stream
Restoration Monitoring Report
EEP Project # 283
Monitoring Year 03**

**Data Collection: 2010
Construction Completed: February 2008
Submitted: December 2010**

UT PEMBROKE CREEK
 WETLAND AND STREAM RESTORATION
 EEP PROJECT #283
 CHOWAN COUNTY, NORTH CAROLINA
 UT PEMBROKE, MONITORING YEAR 03

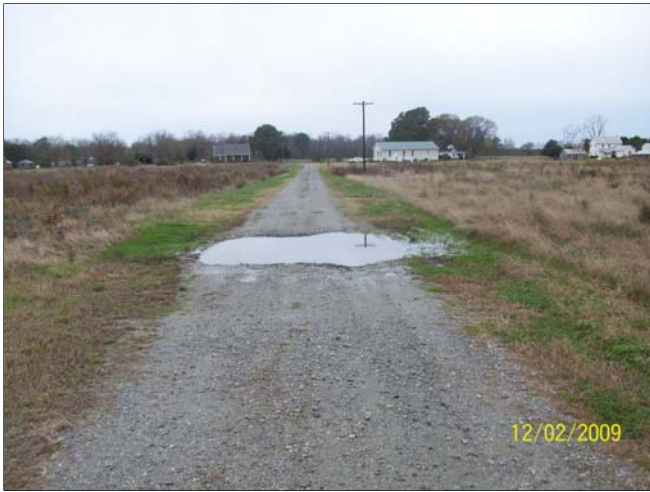
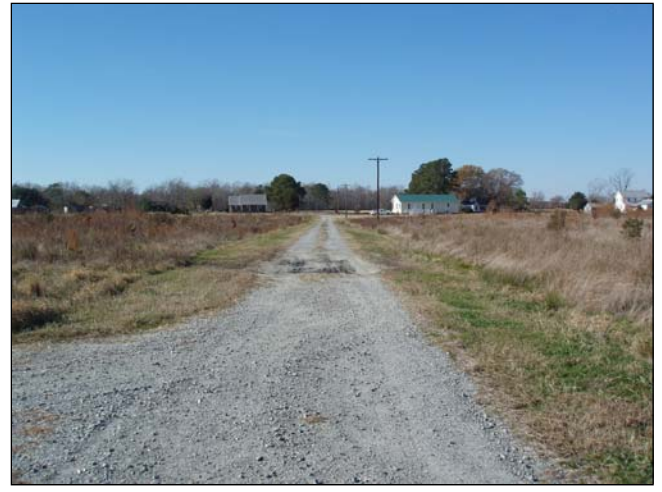
Photo Point 4 – 12/2/09 - MY 02 – Road Crossing Type A – Station 17+75 – Facing west toward Macedonia Road.

Photo Point 4 – 12/8/10 - MY 03 – Road Crossing Type A – Station 17+75 – Facing west toward Macedonia Road.

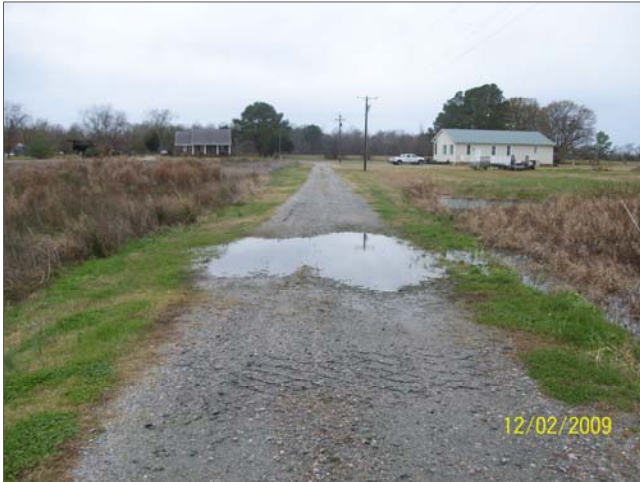
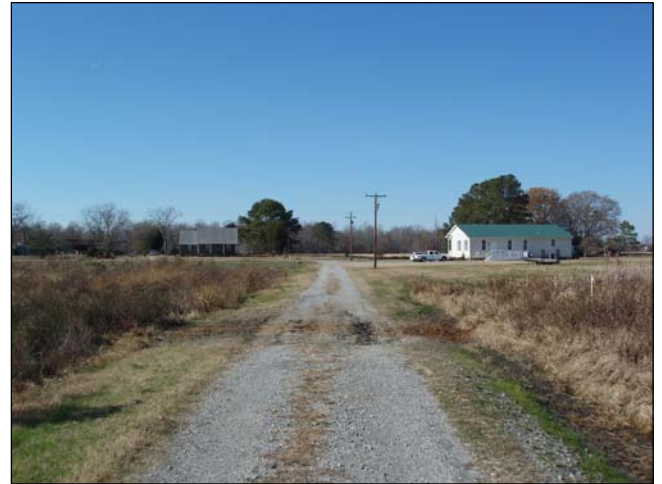
Photo Point 5 – 12/2/09 - MY 02 – Road Crossing Type A – Station 50+75 – Facing west toward Macedonia Road.

Photo Point 5 – 12/8/10 - MY 03 – Road Crossing Type A – Station 50+75 – Facing west toward Macedonia Road.

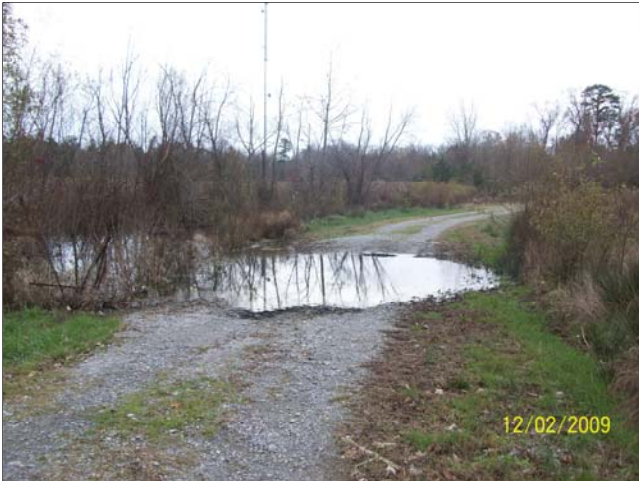
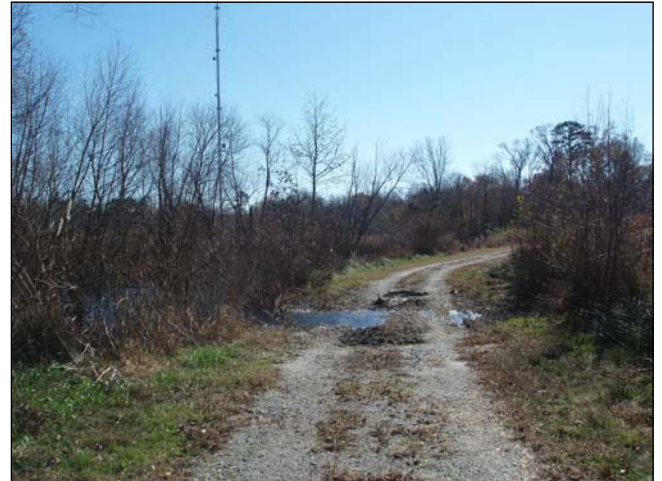
Photo Point 8 – 12/2/09 - MY 02 – Road Crossing Type B – Station 30+50

Photo Point 8 – 12/8/10 - MY 03 – Road Crossing Type B – Station 30+50

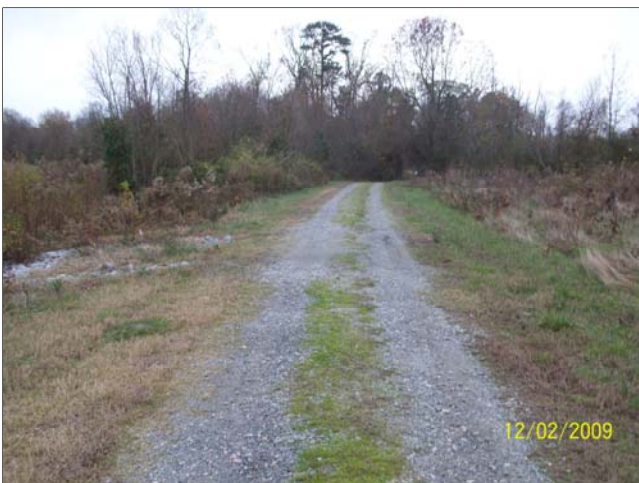
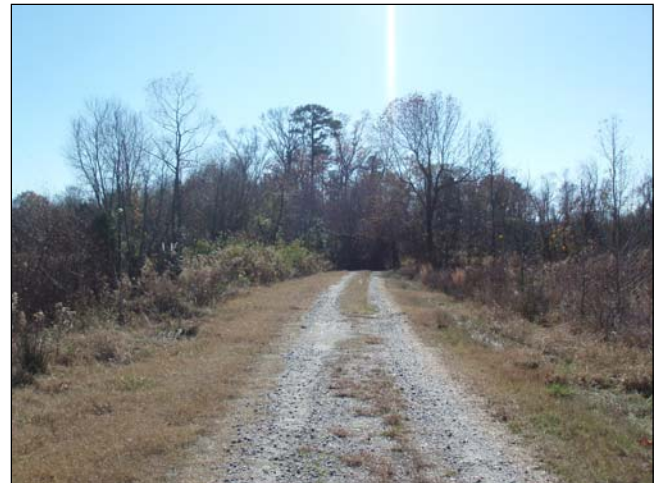
Photo Point 9 – 12/2/09 - MY 02 – Road Crossing Type C – Station 32+50

Photo Point 9 – 12/8/10 - MY 03 – Road Crossing Type C – Station 32+50

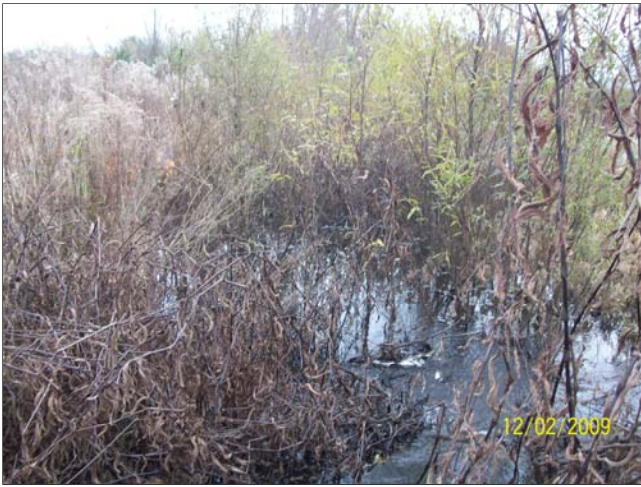
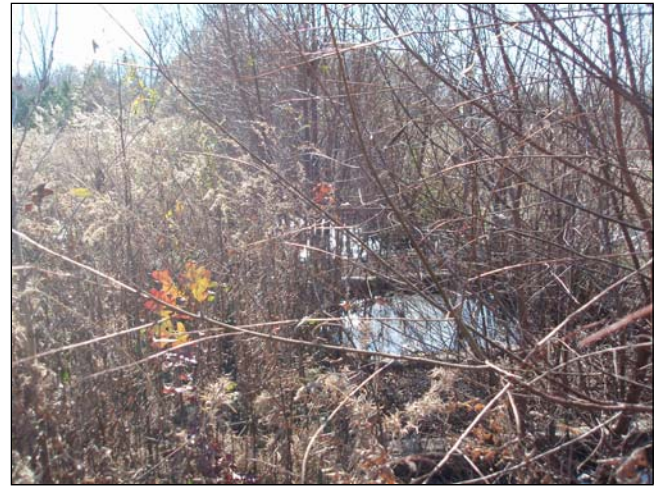
Photo Point 10 – 12/2/09 - MY 02 – Grade transition, facing downstream.

Photo Point 10 – 12/8/10 - MY 03 – Grade transition, facing downstream.

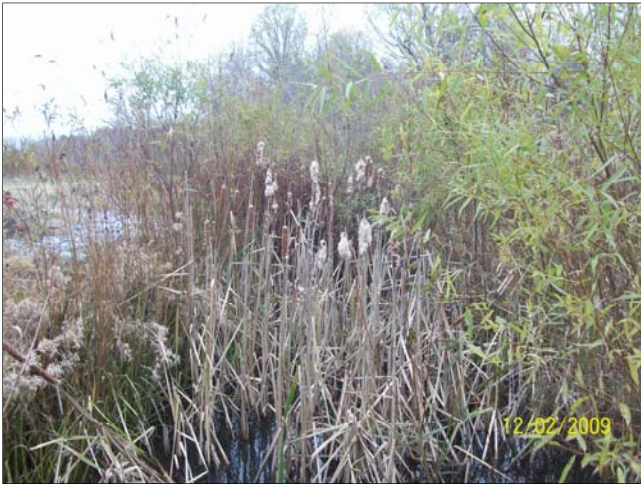
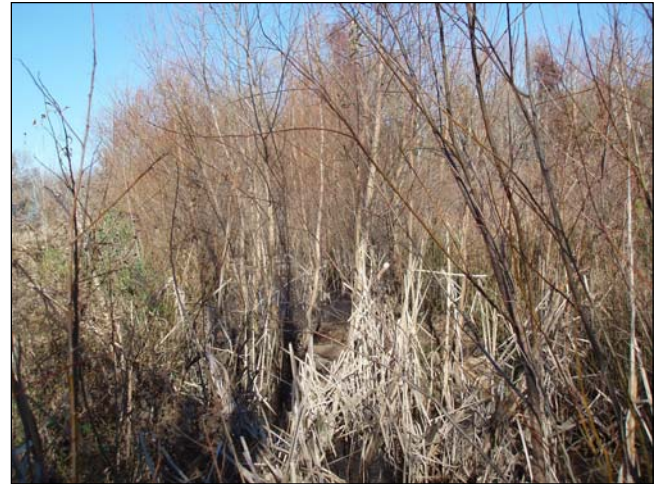
Photo Point 11 – 12/2/09 - MY 02 – Grade transition, facing upstream

Photo Point 11 – 12/8/10 - MY 03 – Grade transition, facing upstream.

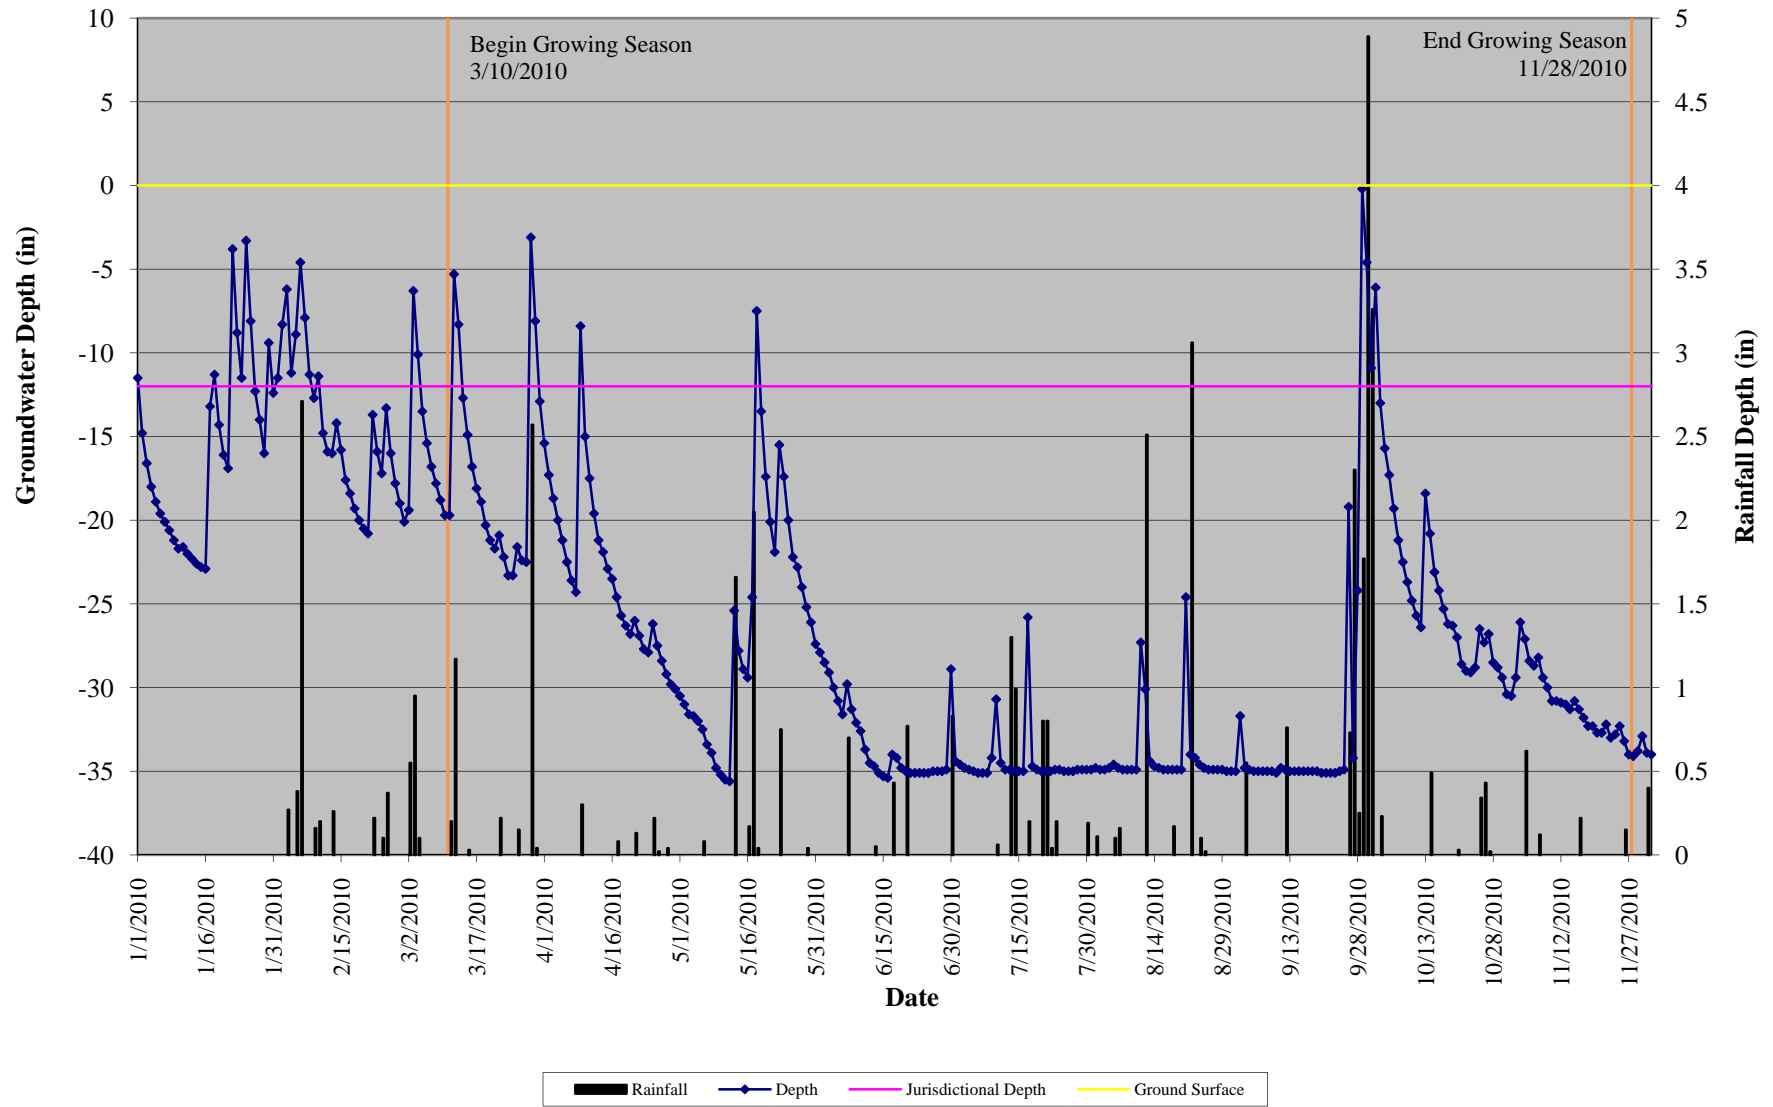
UT Pembroke MY03 Ground Water Monitoring Well #2

in depressions and Wells 19 and 21 are on hummocks. During the site's third growing season, 14 of the 17 wells in the restoration and enhancement areas met the success criterion of having saturated soil conditions occurring within 12 inches of the ground surface for a minimum continuous period of 5% (13 days) of the 263 day growing season (March 10 to November 28) during average climatic conditions. The daily rainfall data obtained from a local weather station shows that the area had average rainfall during the 2010 growing season. The wells that did not meet the success criteria - Wells 2, 3, and 4 - each had water above the jurisdictional depth for a maximum of four, five, and six days, respectively. Monitoring Wells 2 and 3 are in the enhanced wetland and Well 4 is in the restored non-riparian wetland.
