UT to Pembroke Creek Wetland and Stream Restoration Monitoring Report

EEP Project # 283
EEP Contract # 004475
Monitoring Year 06

Data Collection: 2013
Construction Completed: February 2008
Submitted: December 2013

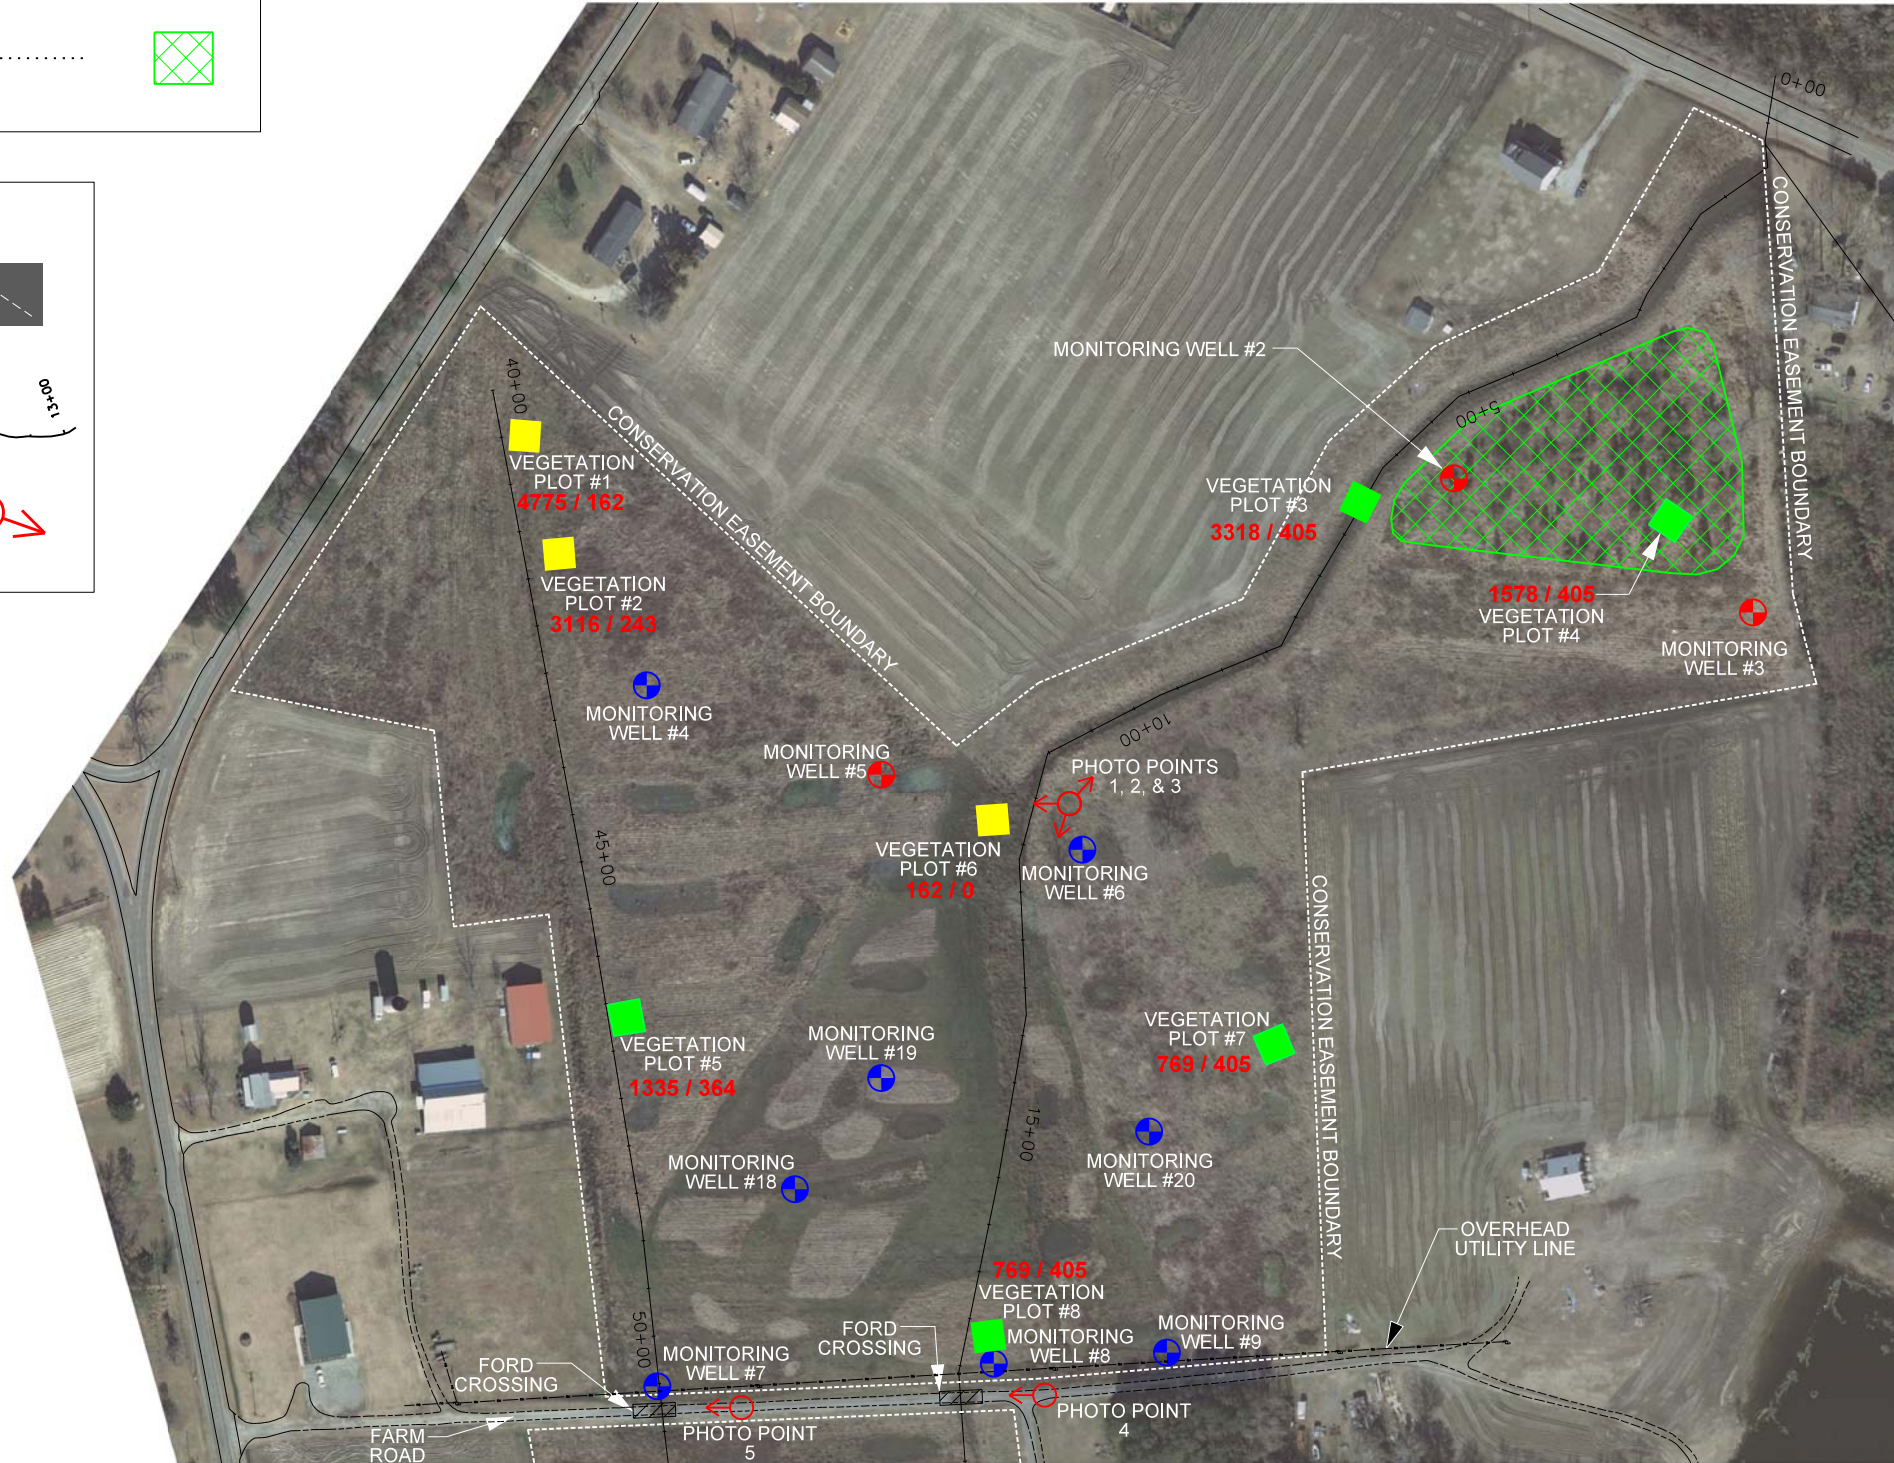
DATE: DEC 2013
SCALE: 1" = 200'
CURRENT
CONDITION
PLAN VIEW
SHEET 1 OF 2

- VEG PLOT ACHIEVING DENSITY CRITERION ■
- VEG PLOT BELOW DENSITY CRITERION ■
- WETLAND GAUGE ACHIEVING HYDROLOGIC CRITERION ⊕
- WETLAND GAUGE BELOW HYDROLOGIC CRITERION ⊗
- INVASIVE SPECIES (PRIVET)

VEG PLOT TOTAL / PLANTED STEM DENSITY **2565 / 240**

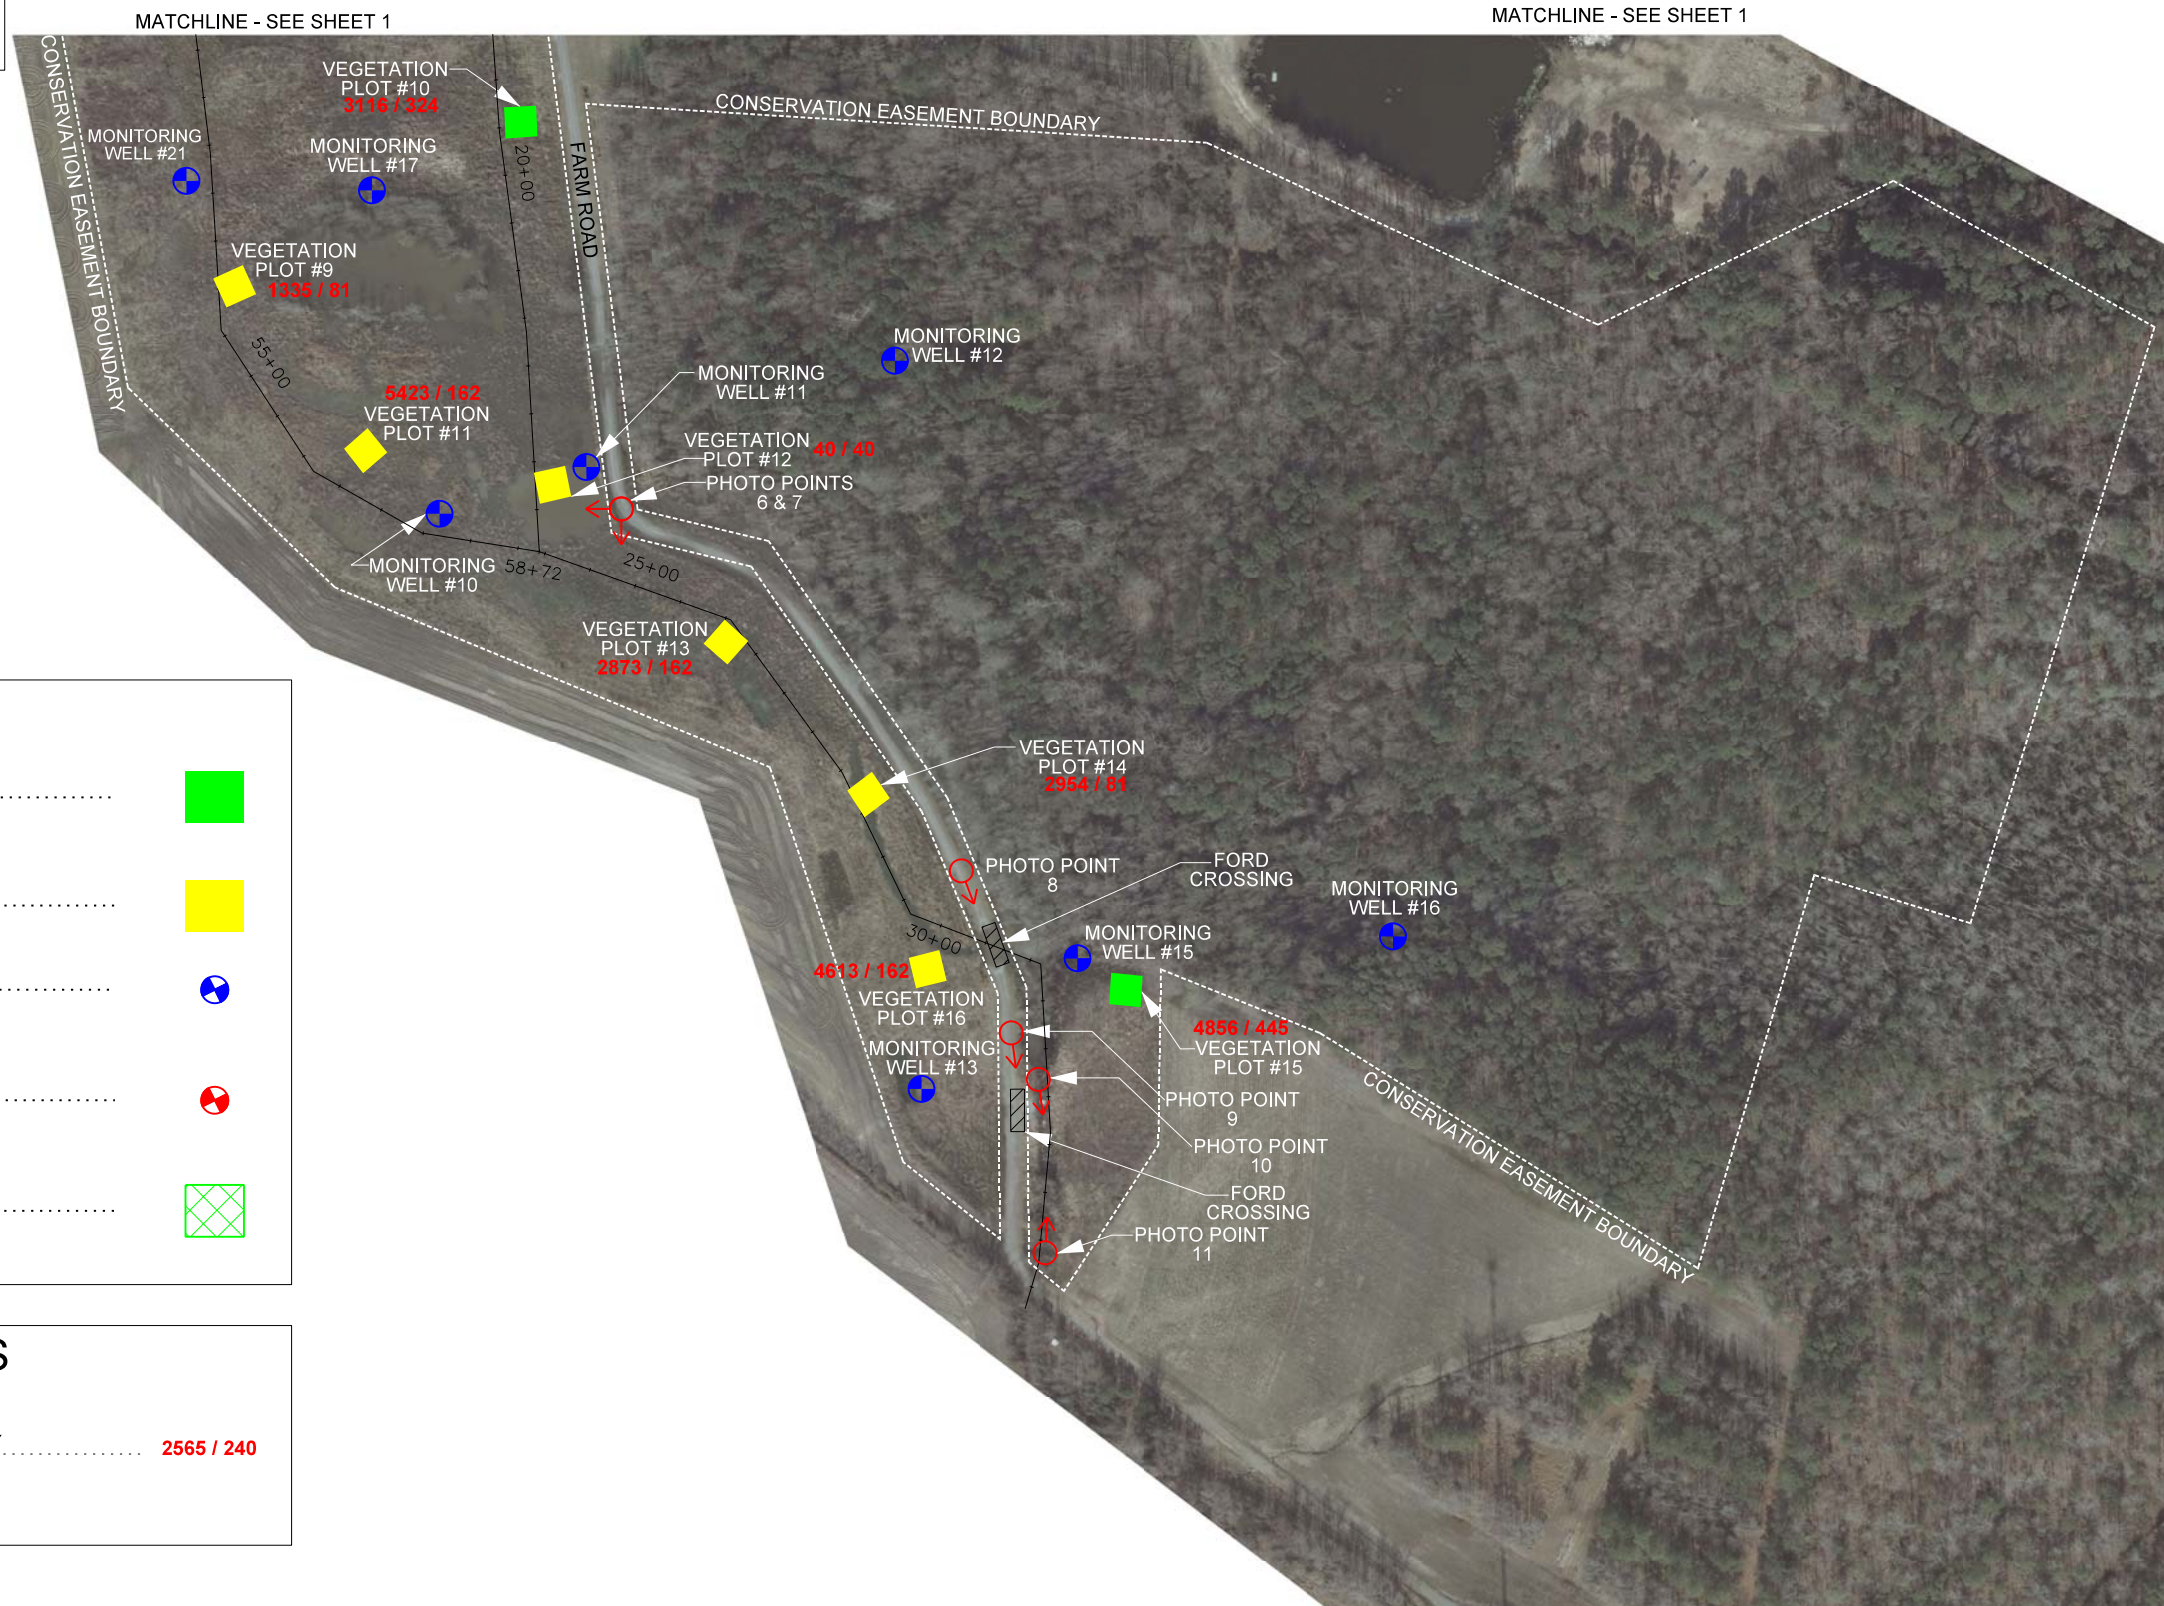
DATE: DEC 2013
SCALE: 1" = 200'
CURRENT CONDITION PLAN VIEW
SHEET 2 OF 2

VEG PLOT TOTAL / PLANTED STEM DENSITY 2565 / 240

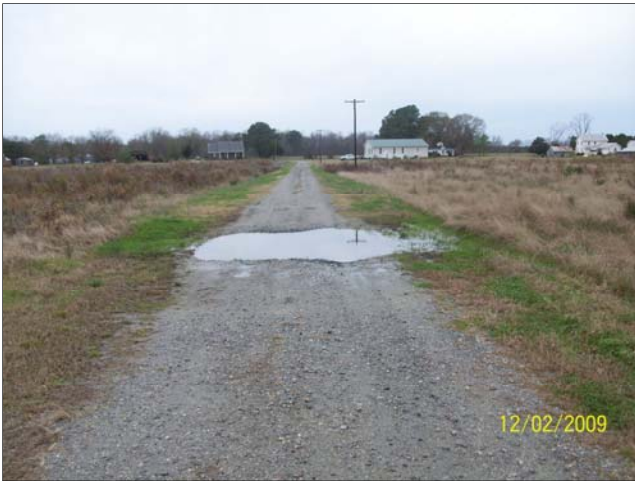
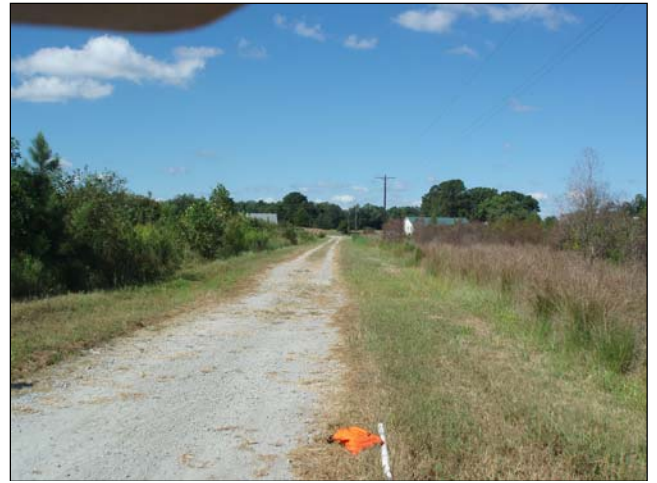
Photo Point 4 – 12/2/09 - MY 02 – Road Crossing Type A – Station 17+75 – Facing west toward Macedonia Road.

Photo Point 4 – 9/17/13 - MY 06 – Road Crossing Type A – Station 17+75 – Facing west toward Macedonia Road.

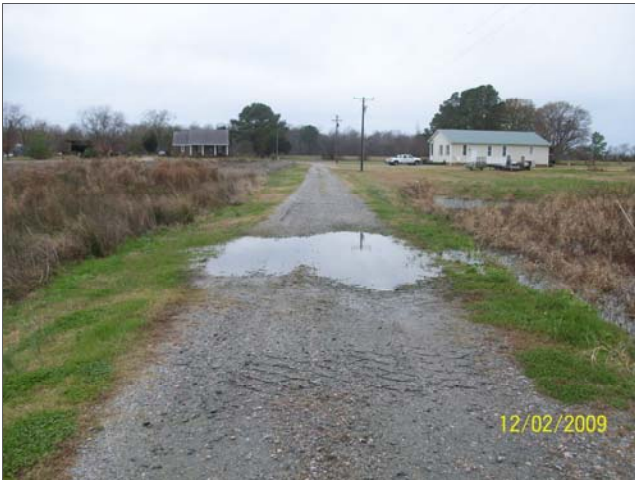
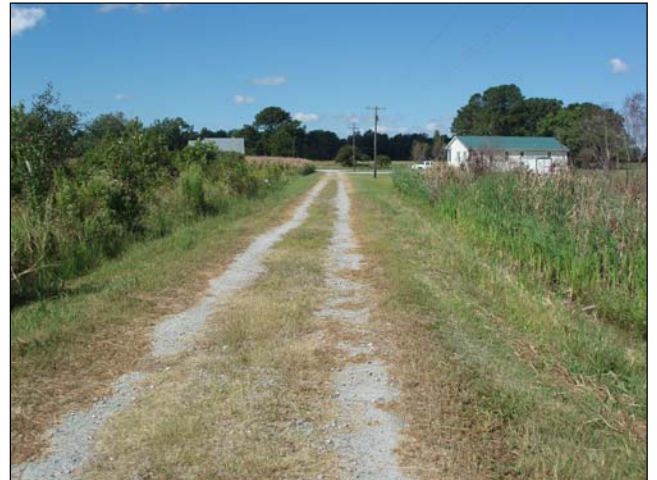
Photo Point 5 – 12/2/09 - MY 02 – Road Crossing Type A – Station 50+75 – Facing west toward Macedonia Road.

Photo Point 5 – 9/17/13 - MY 06 – Road Crossing Type A – Station 50+75 – Facing west toward Macedonia Road.

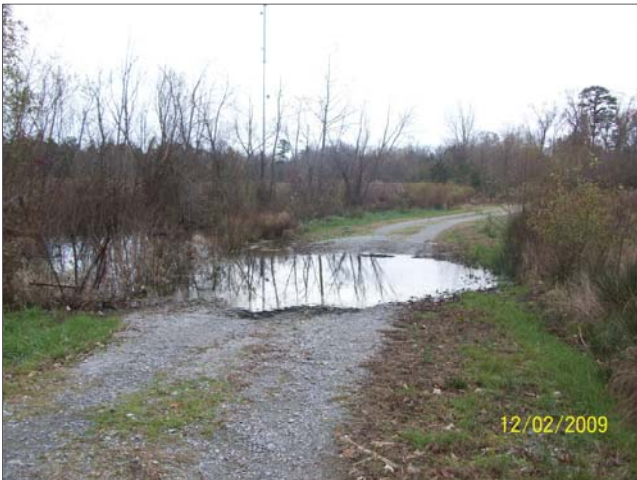
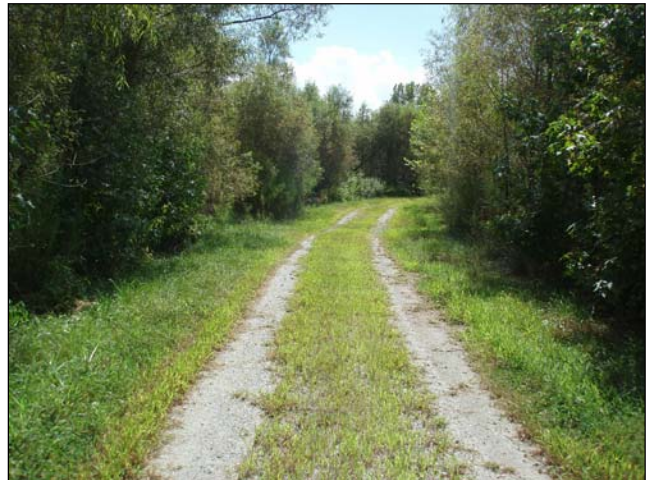
Photo Point 8 – 12/2/09 - MY 02 – Road Crossing Type B – Station 30+50

Photo Point 8 – 9/17/13 - MY 06 – Road Crossing Type B – Station 30+50

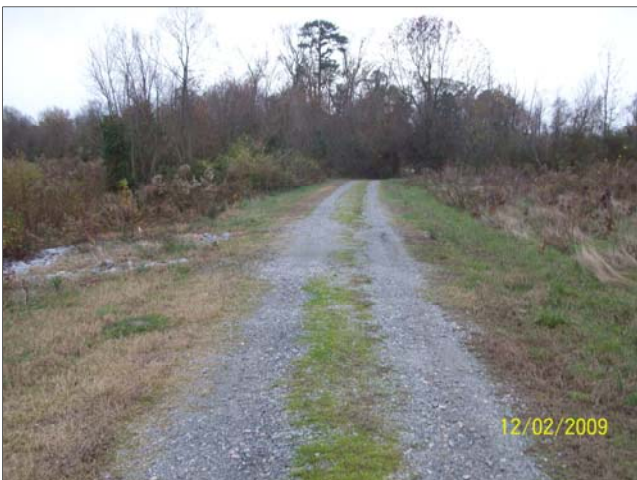
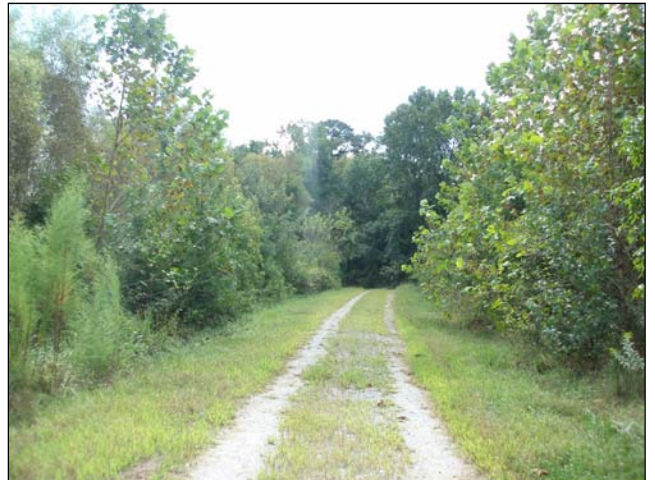
Photo Point 9- 12/2/09 - MY 02 – Road Crossing Type C – Station 32+50

Photo Point 9 – 9/17/13 - MY 06 – Road Crossing Type C – Station 32+50

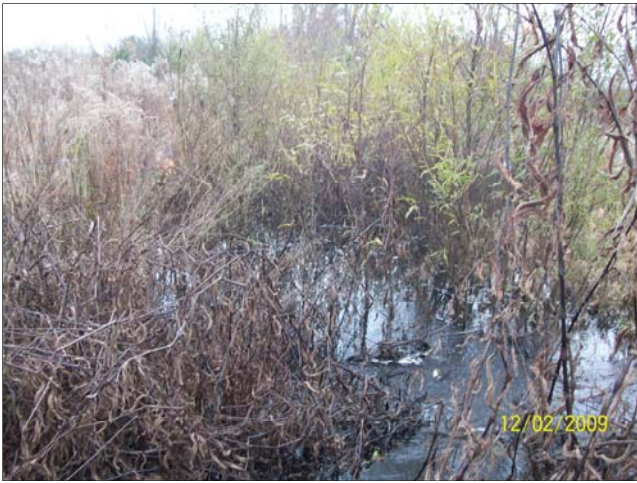
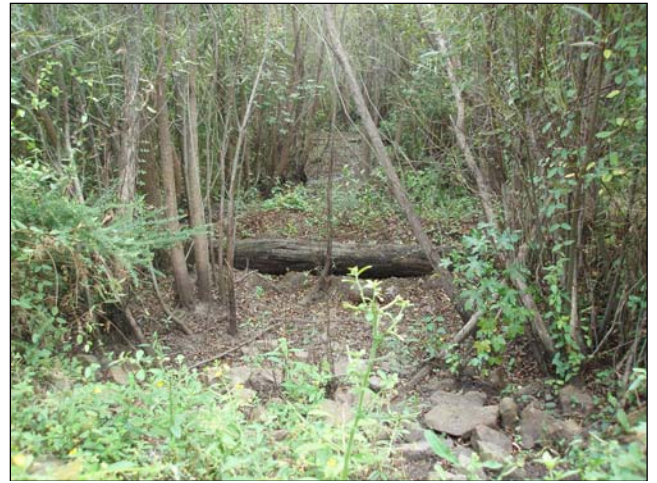
Photo Point 10 – 12/2/09 - MY 02 – Grade transition, facing downstream.

Photo Point 10 – 9/17/13 - MY 06 – Grade transition, facing downstream.

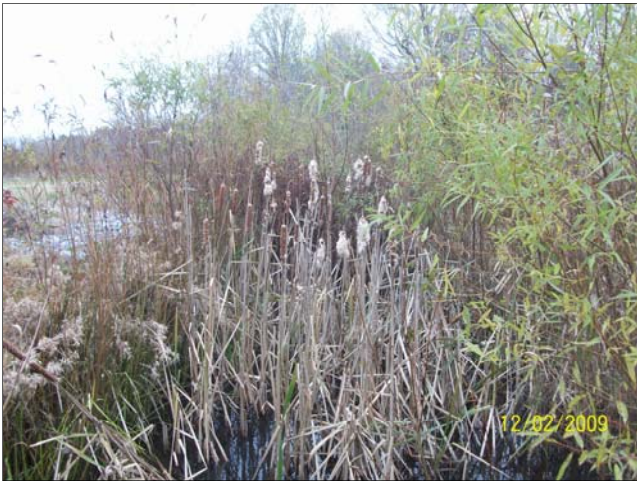
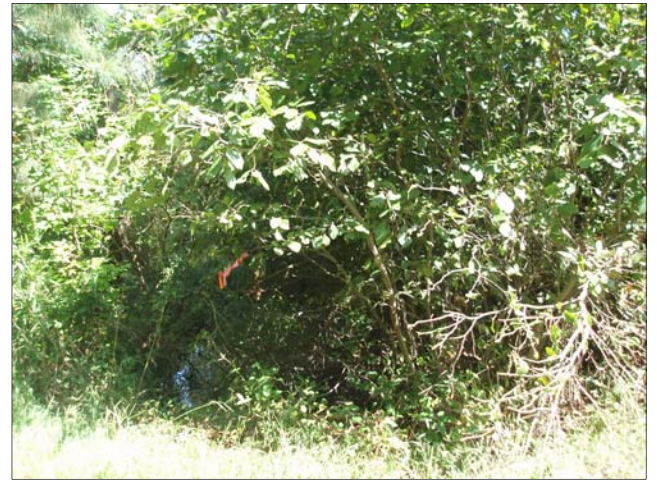
Photo Point 11 12/2/09 - MY 02 – Grade transition, facing upstream

Photo Point 11 – 9/17/13 - MY 06 – Grade transition, facing upstream.
