RESTORATION PLAN

UT TO ROCKY RIVER STREAM RESTORATION SITE

Cabarrus County, North Carolina
Contract No. 070708001

September 9, 2008

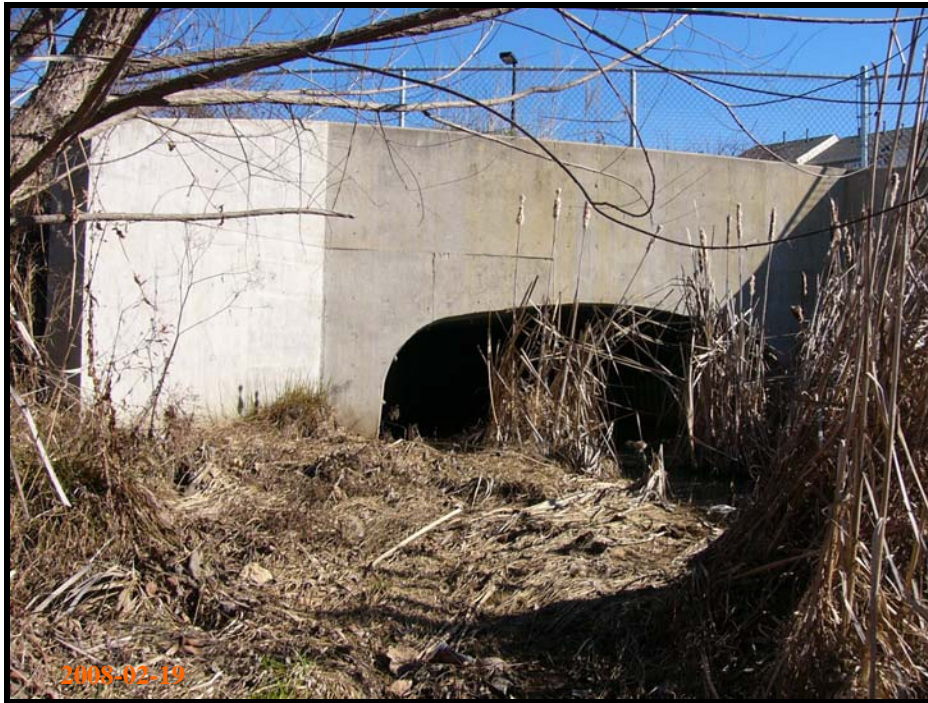
Silted in culvert at upstream end of Site.

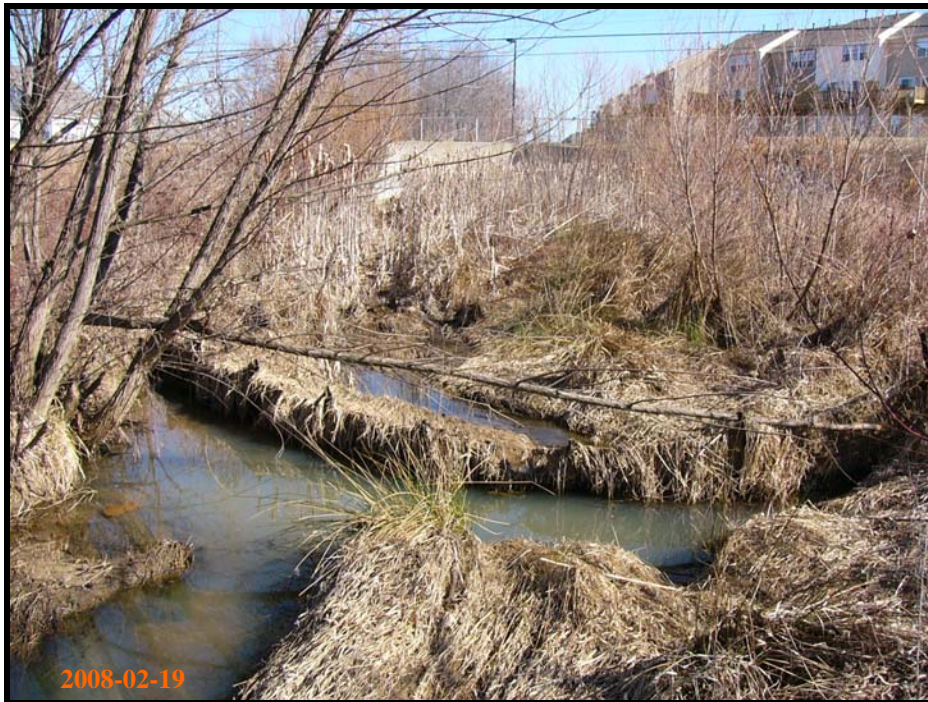
Silt fence traversing channel causing backwater through upstream culvert.

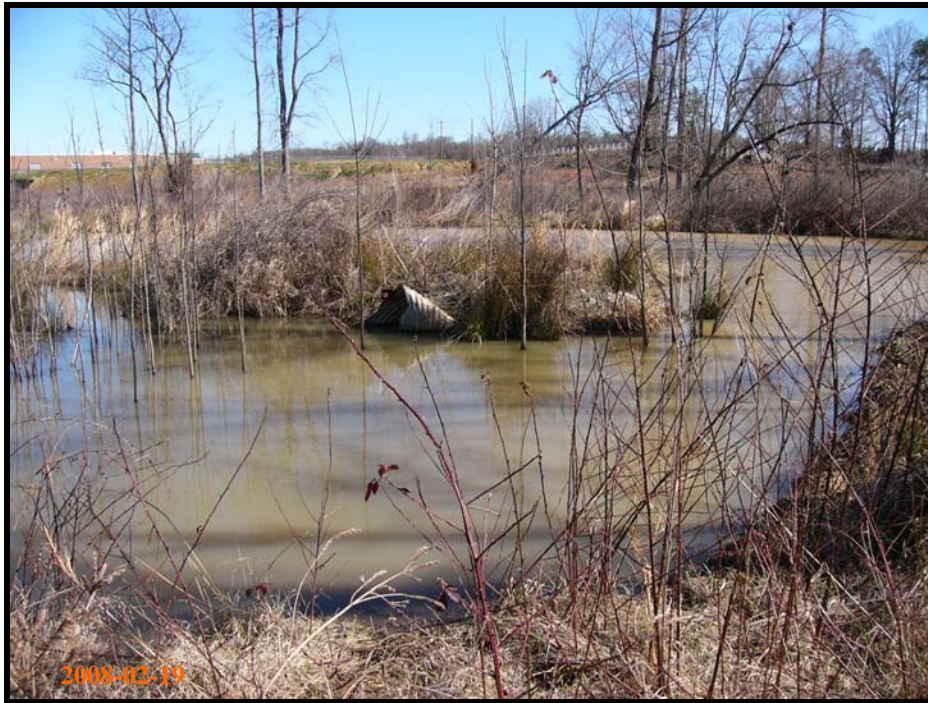
Sediment basin inline with UT Rocky River's channel. Also, beavers have built a large dam that can be seen on far right side of picture.

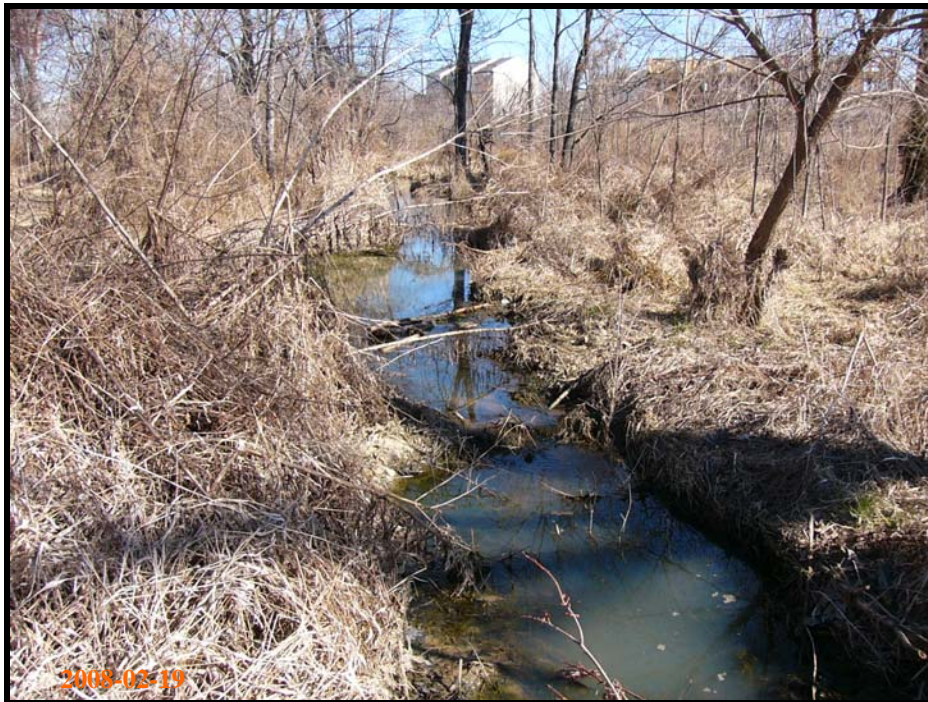
Remnant beaver dam and backwater influence its causing.

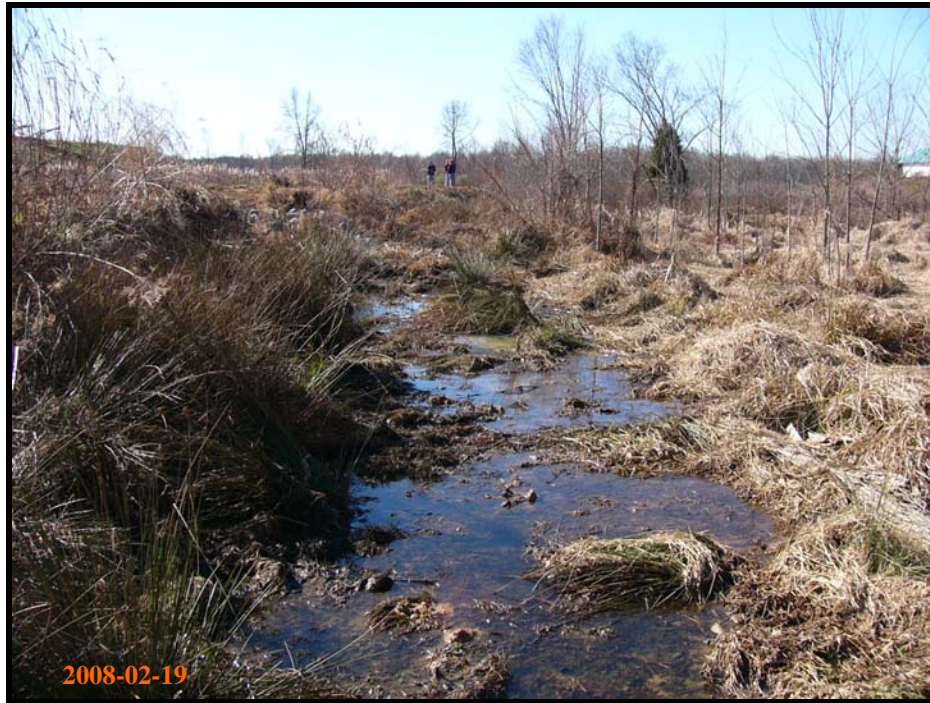
Floodplain flow from less than bankfull event.

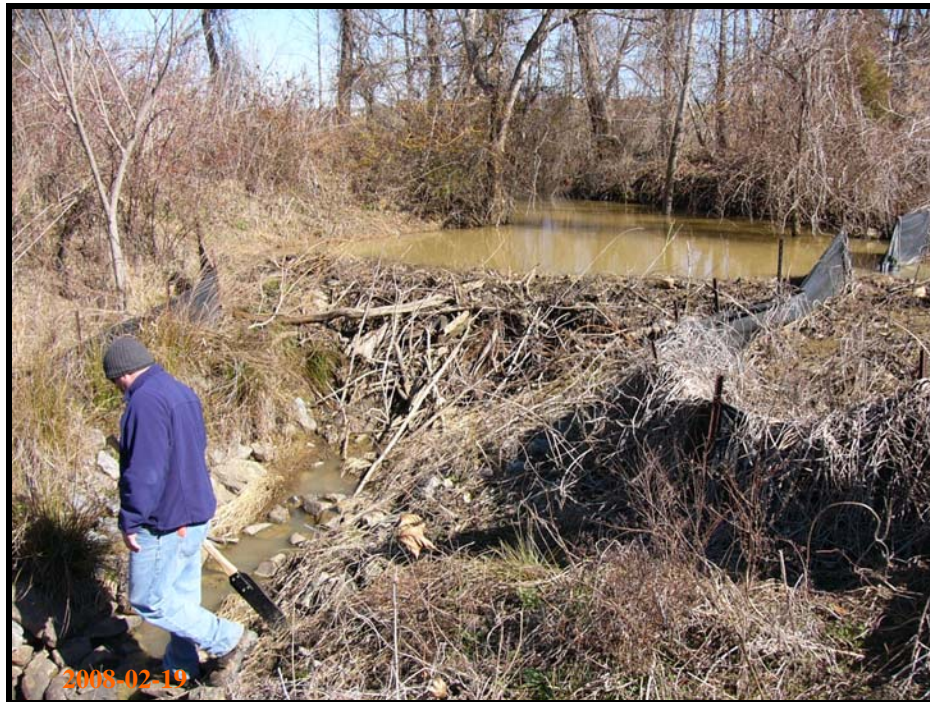
Beaver dam near confluence with Rocky River

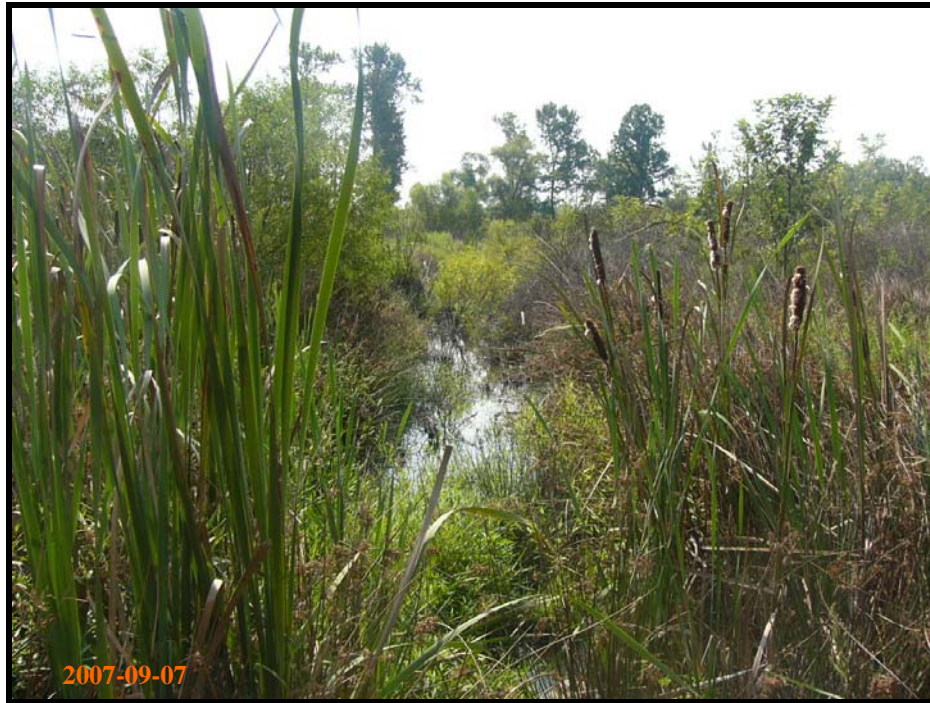
Backwater effect from sediment basin and beaver dams.

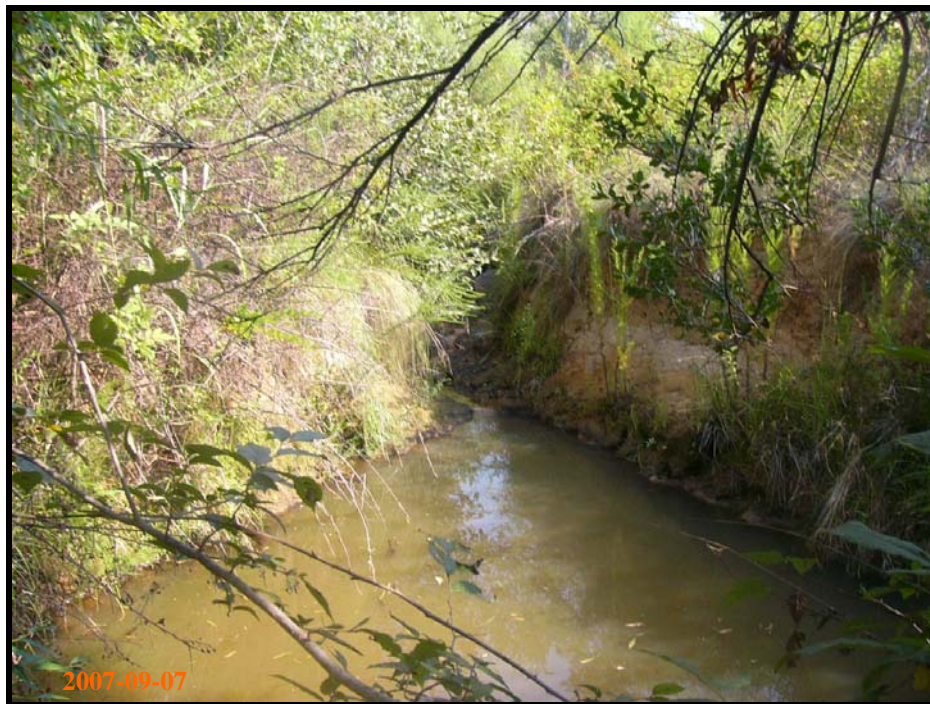
Mass wasting of channel banks through a gully reach.

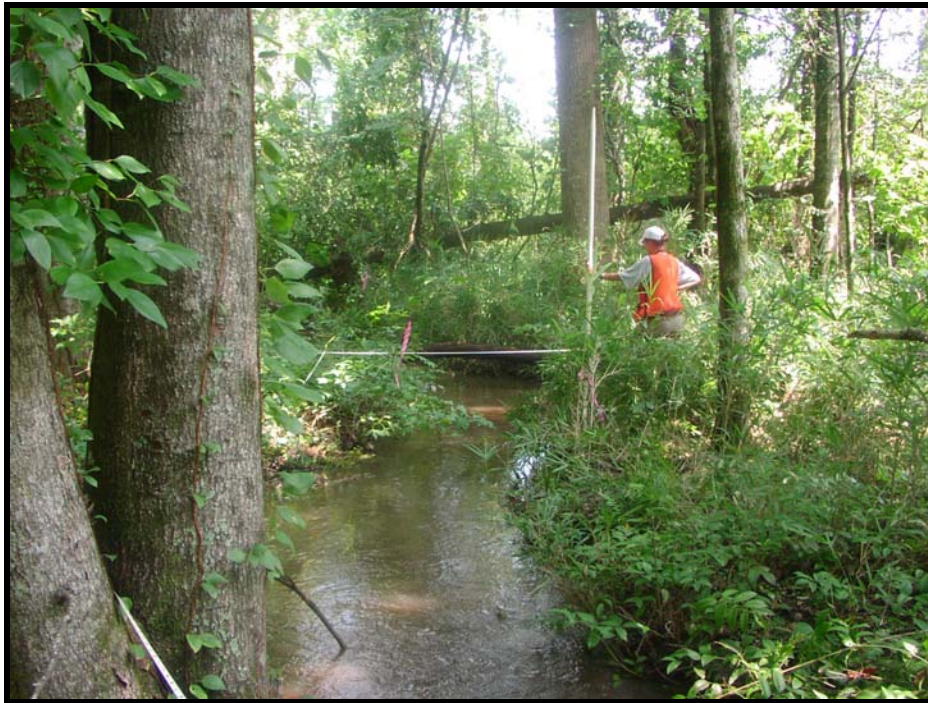
UT to Wildcat Branch looking upstream. Notice mature vegetated riparian buffer.

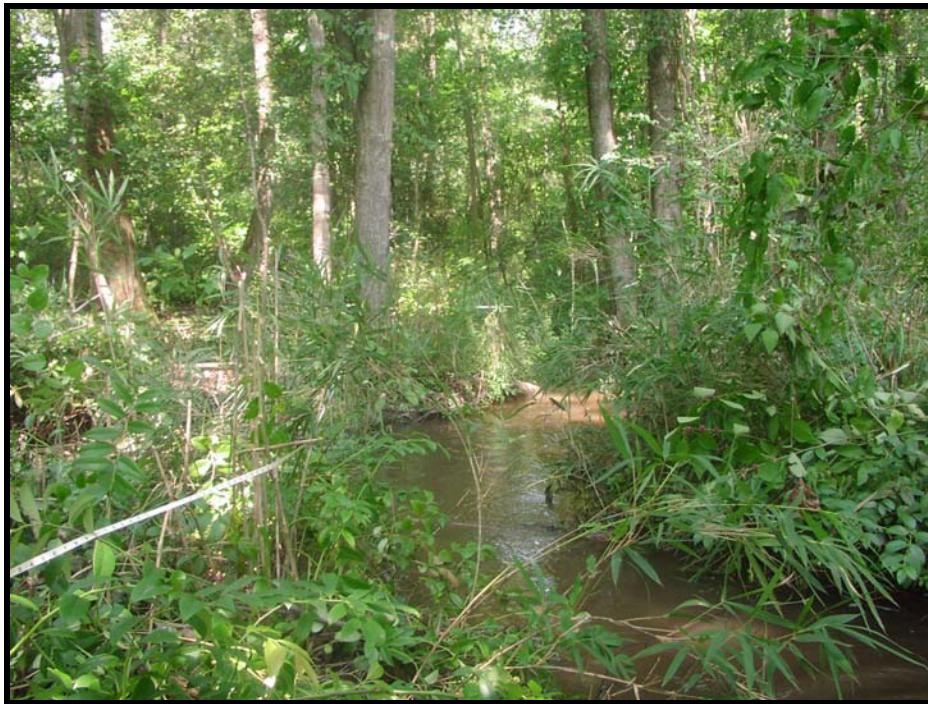
UT to Wildcat Branch looking upstream. Notice stable meandering pattern.

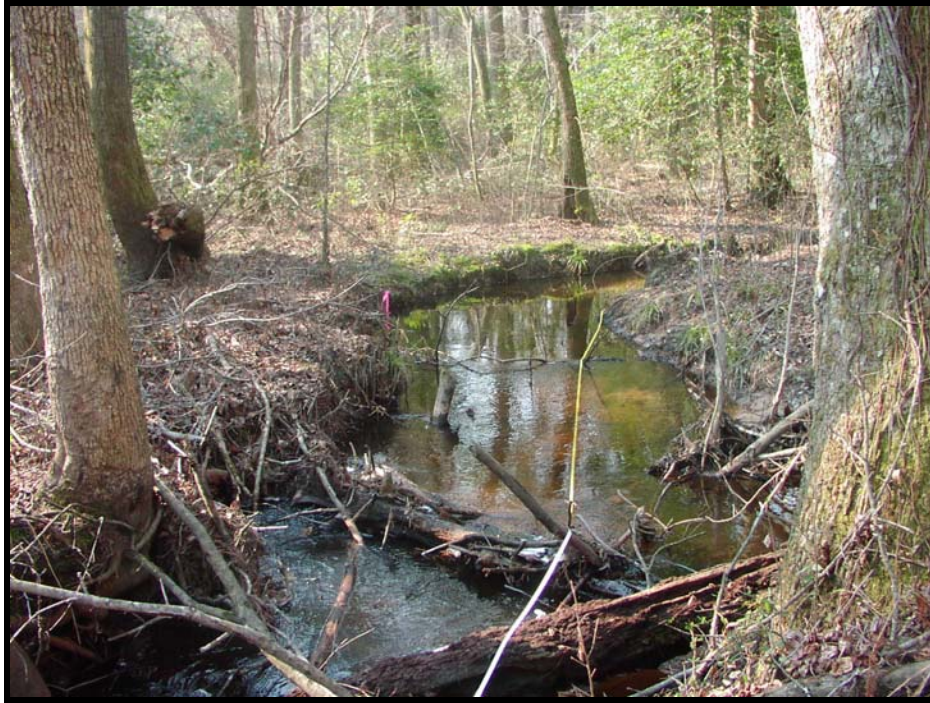
Mill Creek looking upstream. Notice mature vegetated riparian buffer and gently meandering pattern.

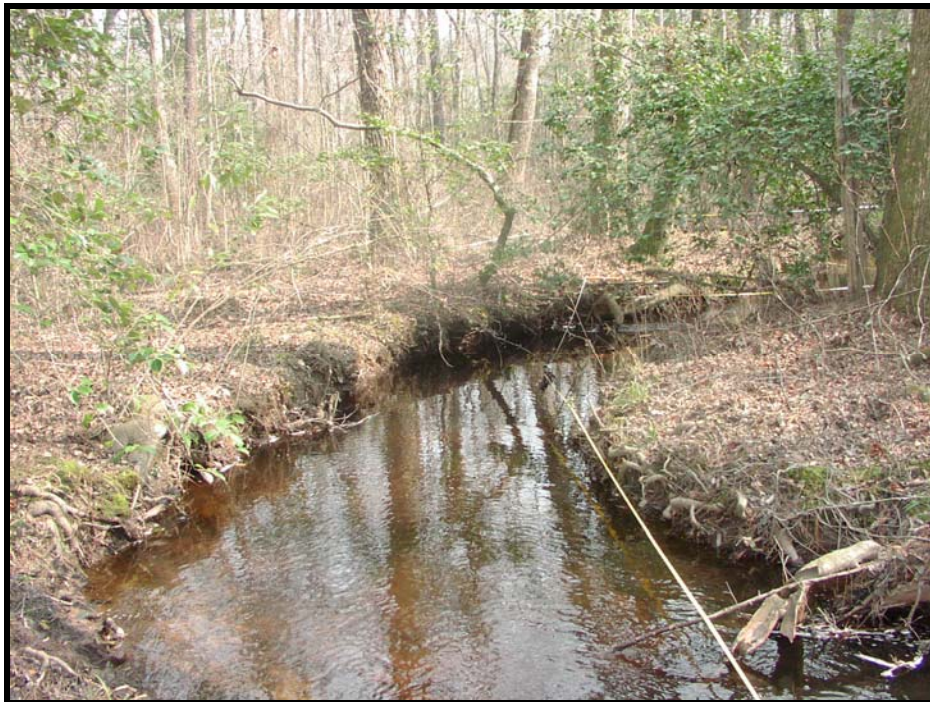
Mill Creek looking upstream. Notice roots along the banks which help to stabilize soils.
