***BASELINE MONITORING DOCUMENT &
AS-BUILT BASELINE REPORT***

UT ROCKY RIVER – HARRIS ROAD MIDDLE

Cabarrus County, North Carolina

EEP Project # 92383

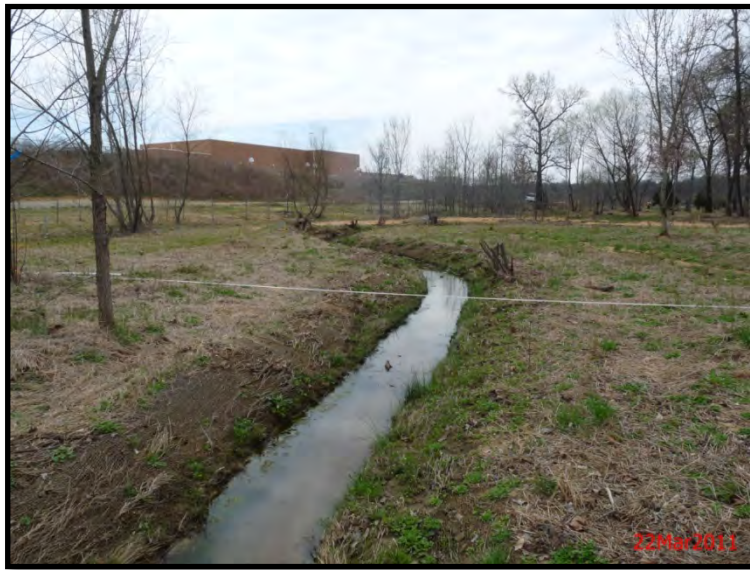
Bankfull Width (ft)	10.1
Floodprone Width (ft)	185.0
Bankfull Mean Depth (ft)	0.9
Bankfull Max Depth (ft)	1.6
Bankfull Cross Sectional Area (ft ²)	9.2
Bankfull Width/Depth Ratio	11.1
Bankfull Entrenchment Ratio	18.3
Bankfull Bank Height Ratio	1.0

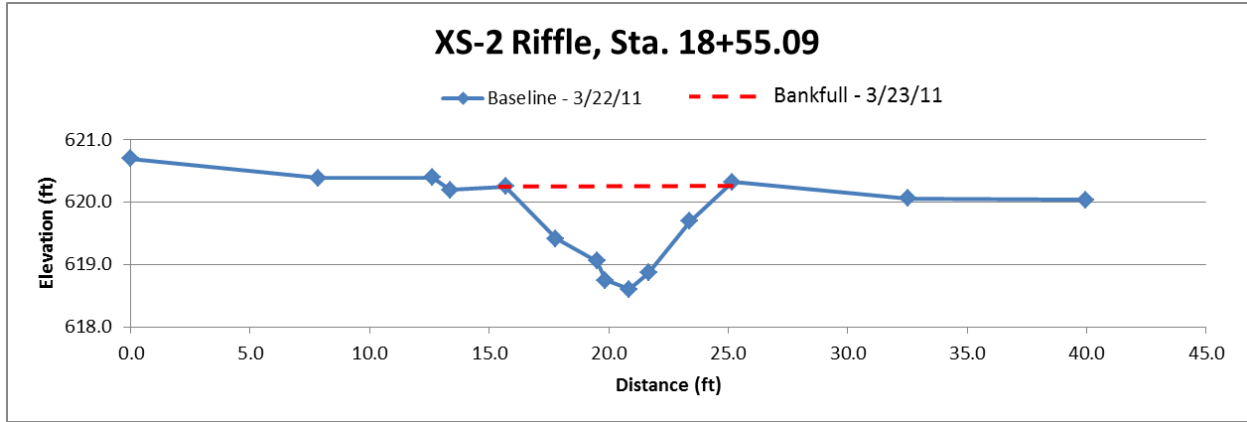
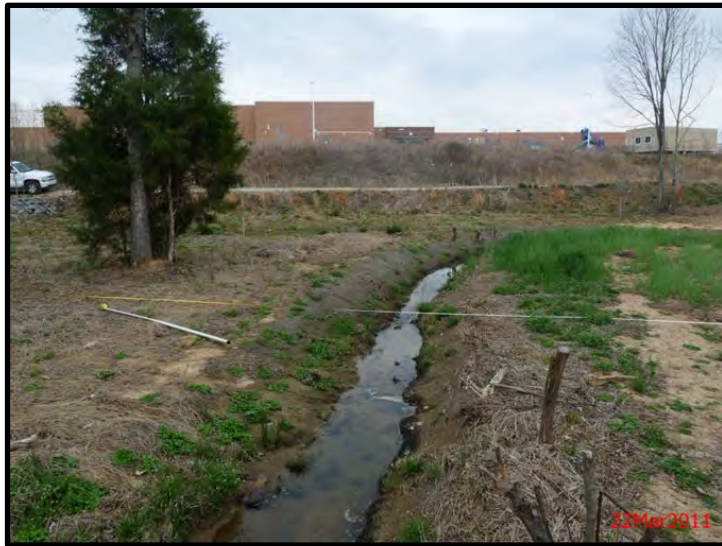
Bankfull Width (ft)	9.3
Floodprone Width (ft)	175.0
Bankfull Mean Depth (ft)	0.9
Bankfull Max Depth (ft)	1.7
Bankfull Cross Sectional Area (ft ²)	8.0
Bankfull Width/Depth Ratio	10.8
Bankfull Entrenchment Ratio	18.8
Bankfull Bank Height Ratio	1.0

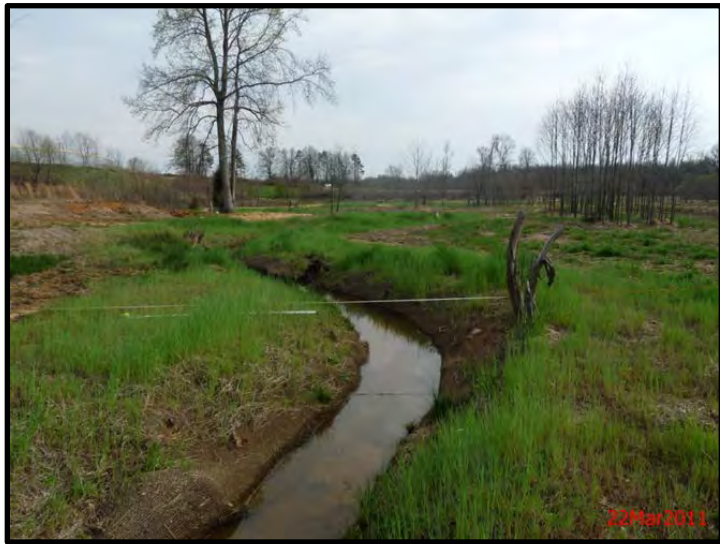
Bankfull Width (ft)	11.02
Floodprone Width (ft)	132.0
Bankfull Mean Depth (ft)	1.0
Bankfull Max Depth (ft)	2.0
Bankfull Cross Sectional Area (ft ²)	10.7
Bankfull Width/Depth Ratio	11.4
Bankfull Entrenchment Ratio	12.0
Bankfull Bank Height Ratio	1.0

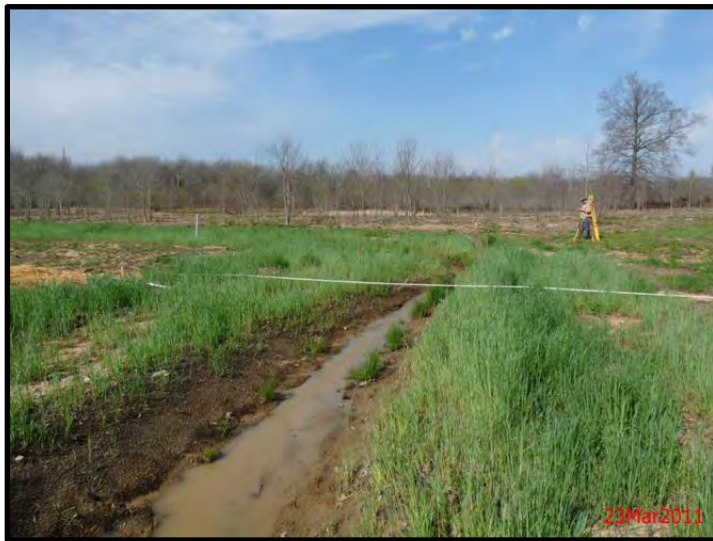
Bankfull Width (ft)	8.5
Floodprone Width (ft)	292.0
Bankfull Mean Depth (ft)	0.8
Bankfull Max Depth (ft)	1.4
Bankfull Cross Sectional Area (ft ²)	6.7
Bankfull Width/Depth Ratio	10.7
Bankfull Entrenchment Ratio	34.3
Bankfull Bank Height Ratio	1.0

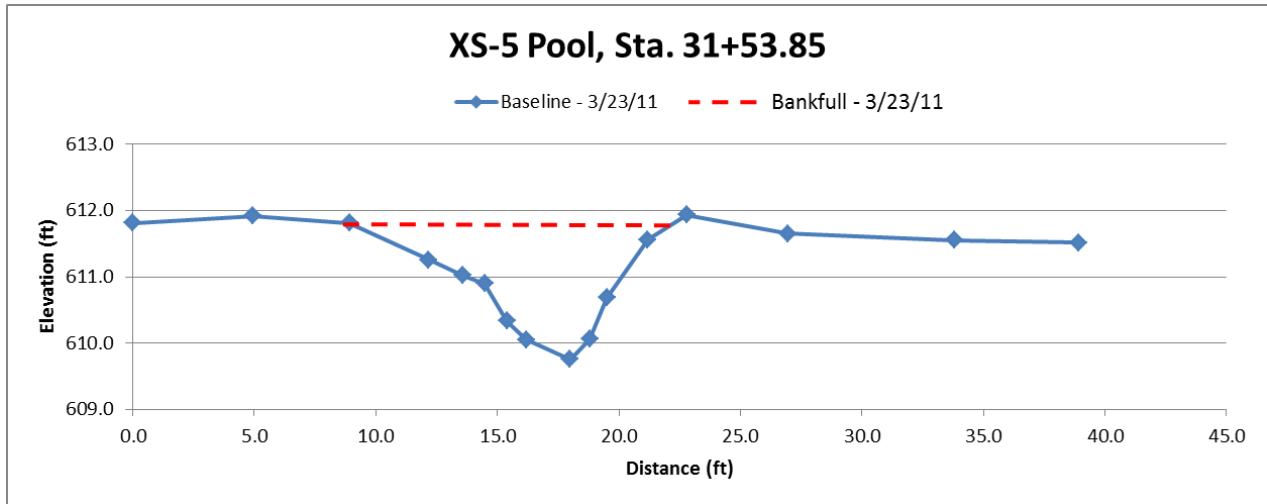
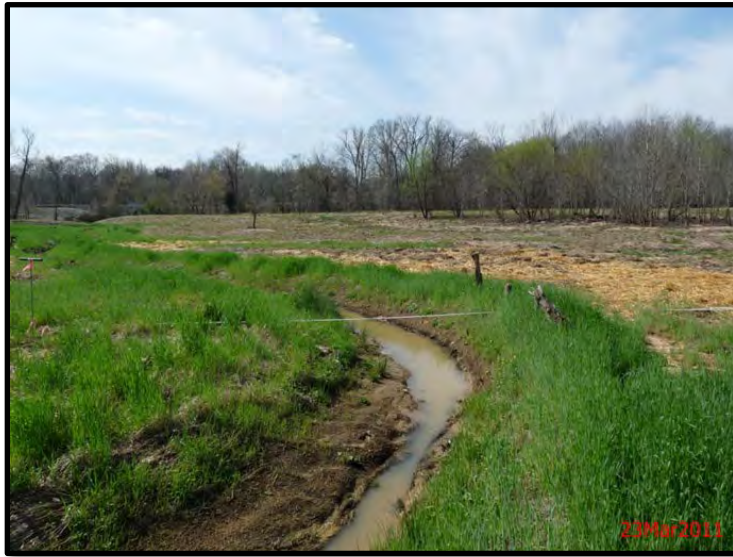
Bankfull Width (ft)	13.3
Floodprone Width (ft)	300.0
Bankfull Mean Depth (ft)	0.9
Bankfull Max Depth (ft)	2.1
Bankfull Cross Sectional Area (ft ²)	12.3
Bankfull Width/Depth Ratio	14.5
Bankfull Entrenchment Ratio	22.6
Bankfull Bank Height Ratio	1

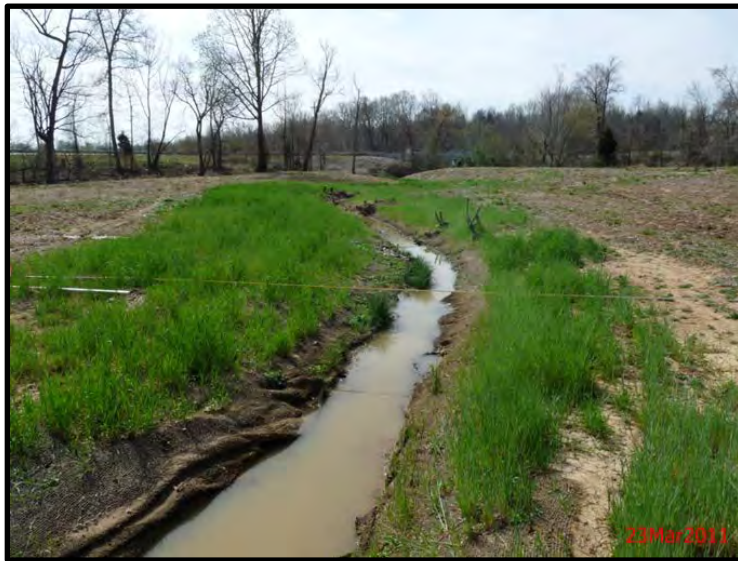
Bankfull Width (ft)	11.6
Floodprone Width (ft)	250.0
Bankfull Mean Depth (ft)	0.9
Bankfull Max Depth (ft)	1.9
Bankfull Cross Sectional Area (ft ²)	10.7
Bankfull Width/Depth Ratio	12.6
Bankfull Entrenchment Ratio	21.6
Bankfull Bank Height Ratio	1.0
