YEAR 4 MONITORING REPORT

UT ROCKY RIVER – HARRIS ROAD MIDDLE

Cabarrus County, North Carolina

DMS IMS No. 92383, Contract No. 004346

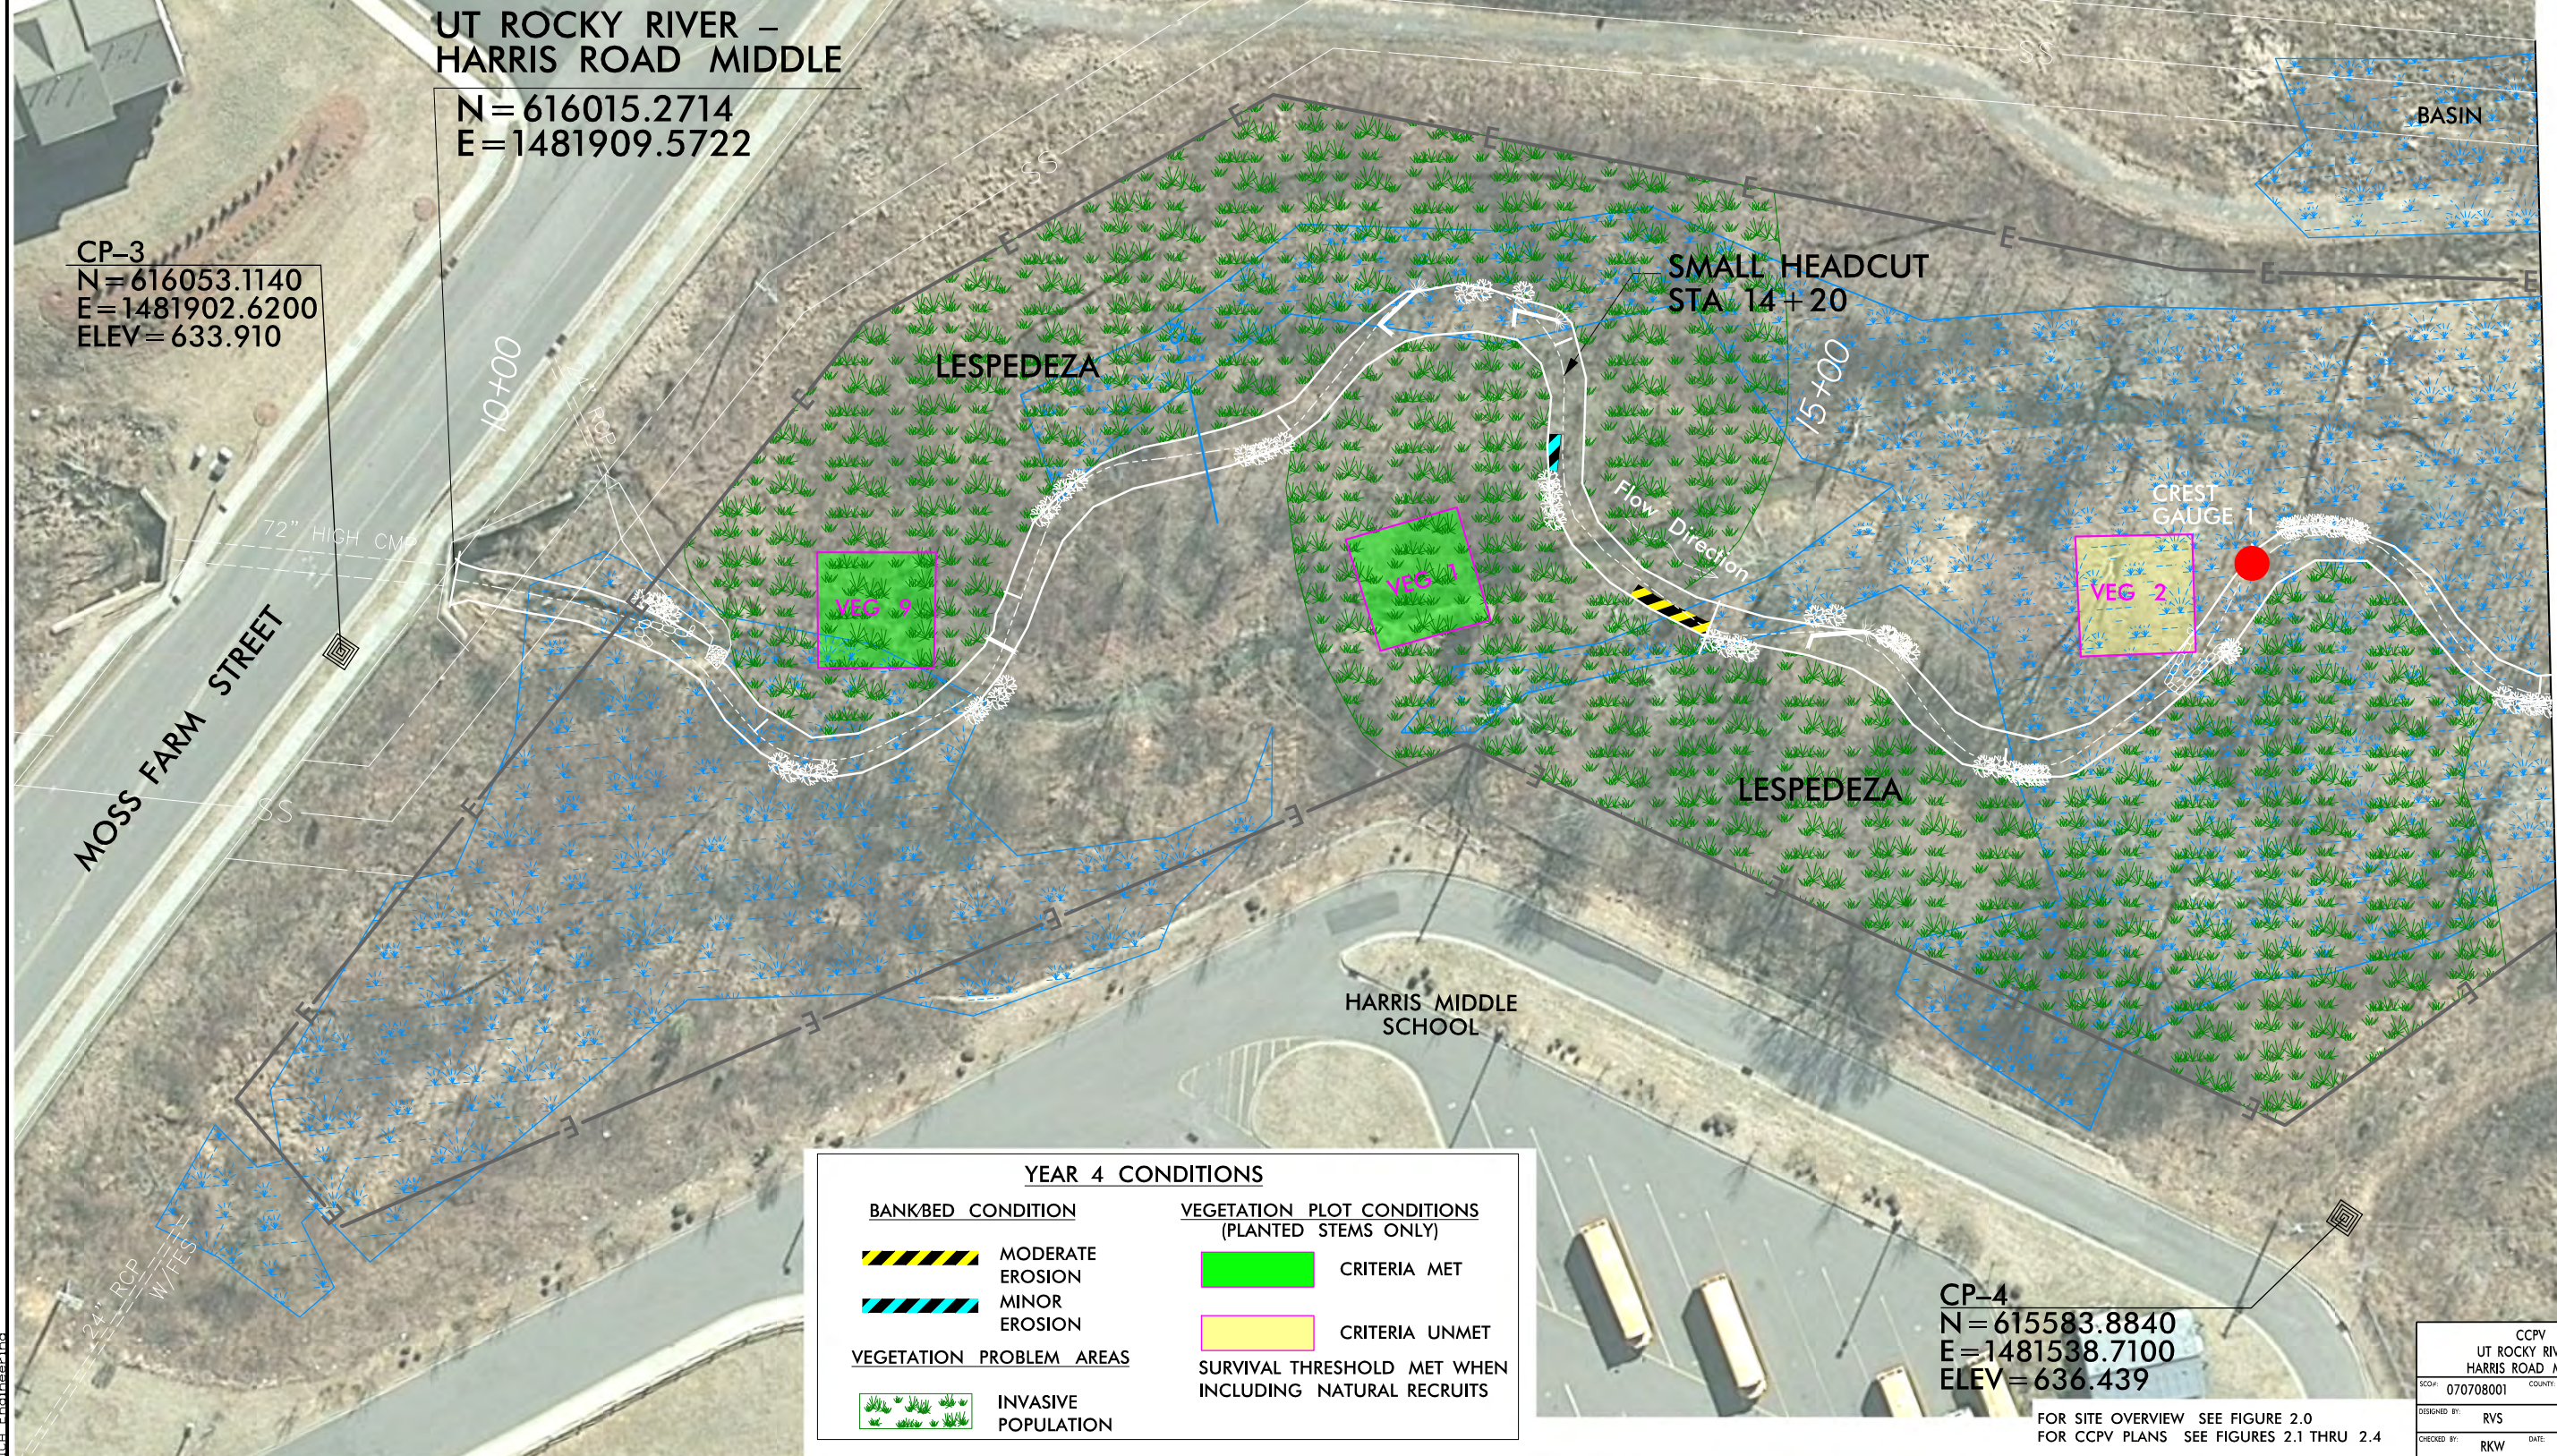
YEAR 4 CONDITIONS			
	MODERATE EROSION		CRITERIA MET
	MINOR EROSION		CRITERIA UNMET
	INVASIVE POPULATION		SURVIVAL THRESHOLD MET WHEN INCLUDING NATURAL RECRUITS

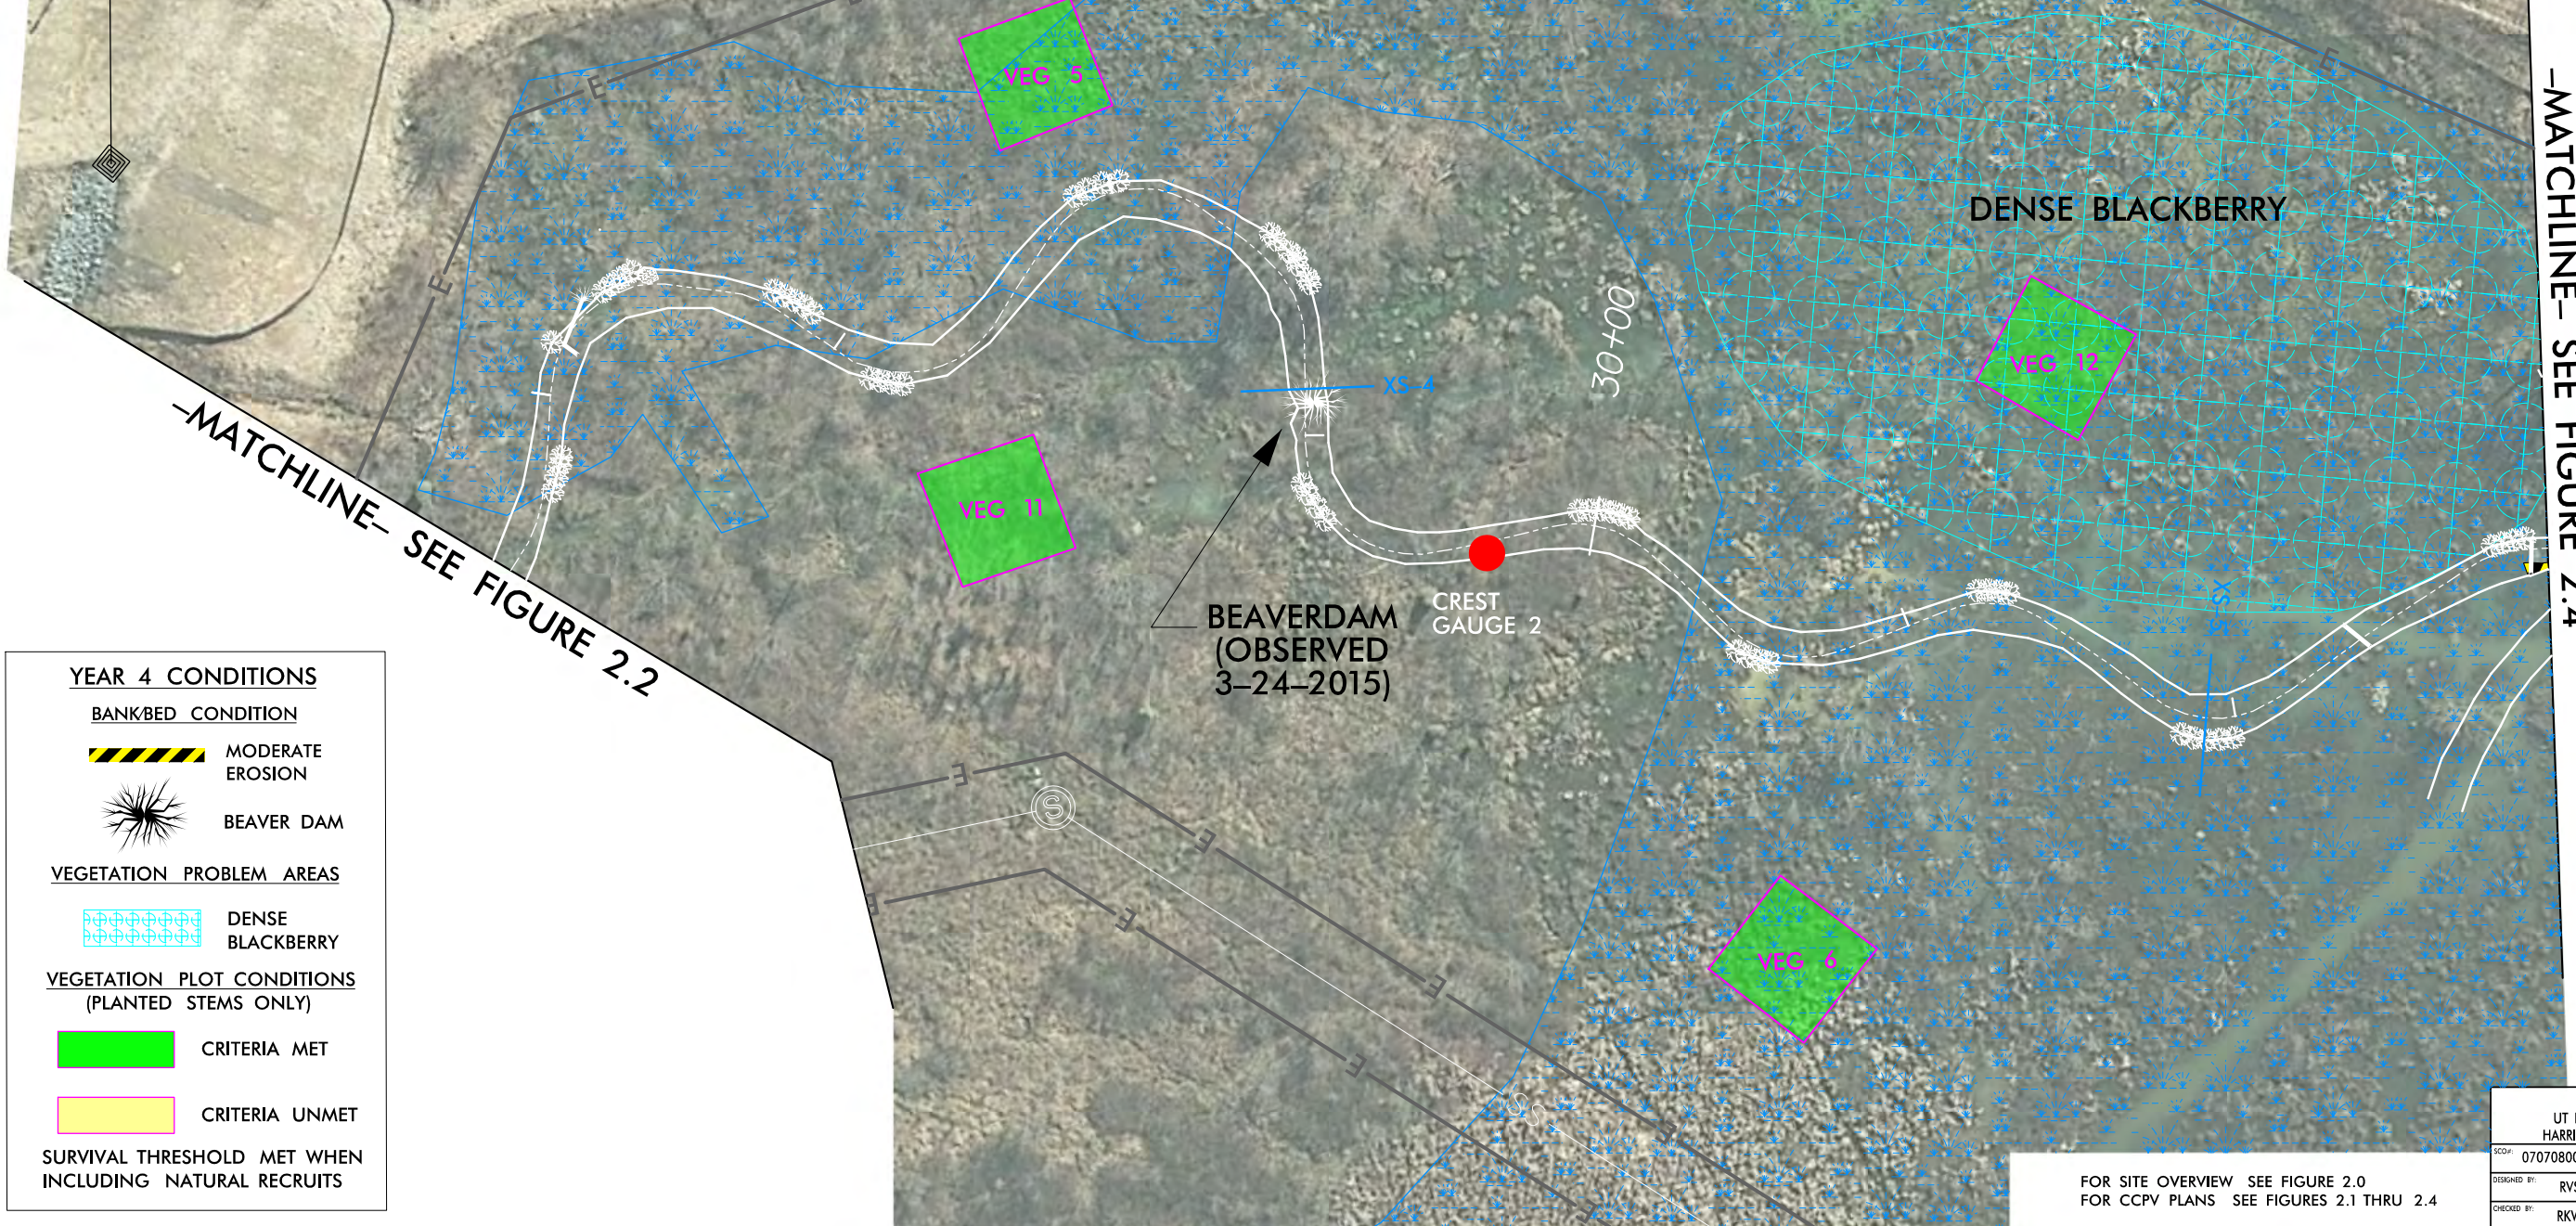
MODERATE EROSION
	BEAVER DAM

DENSE BLACKBERRY
--	------------------

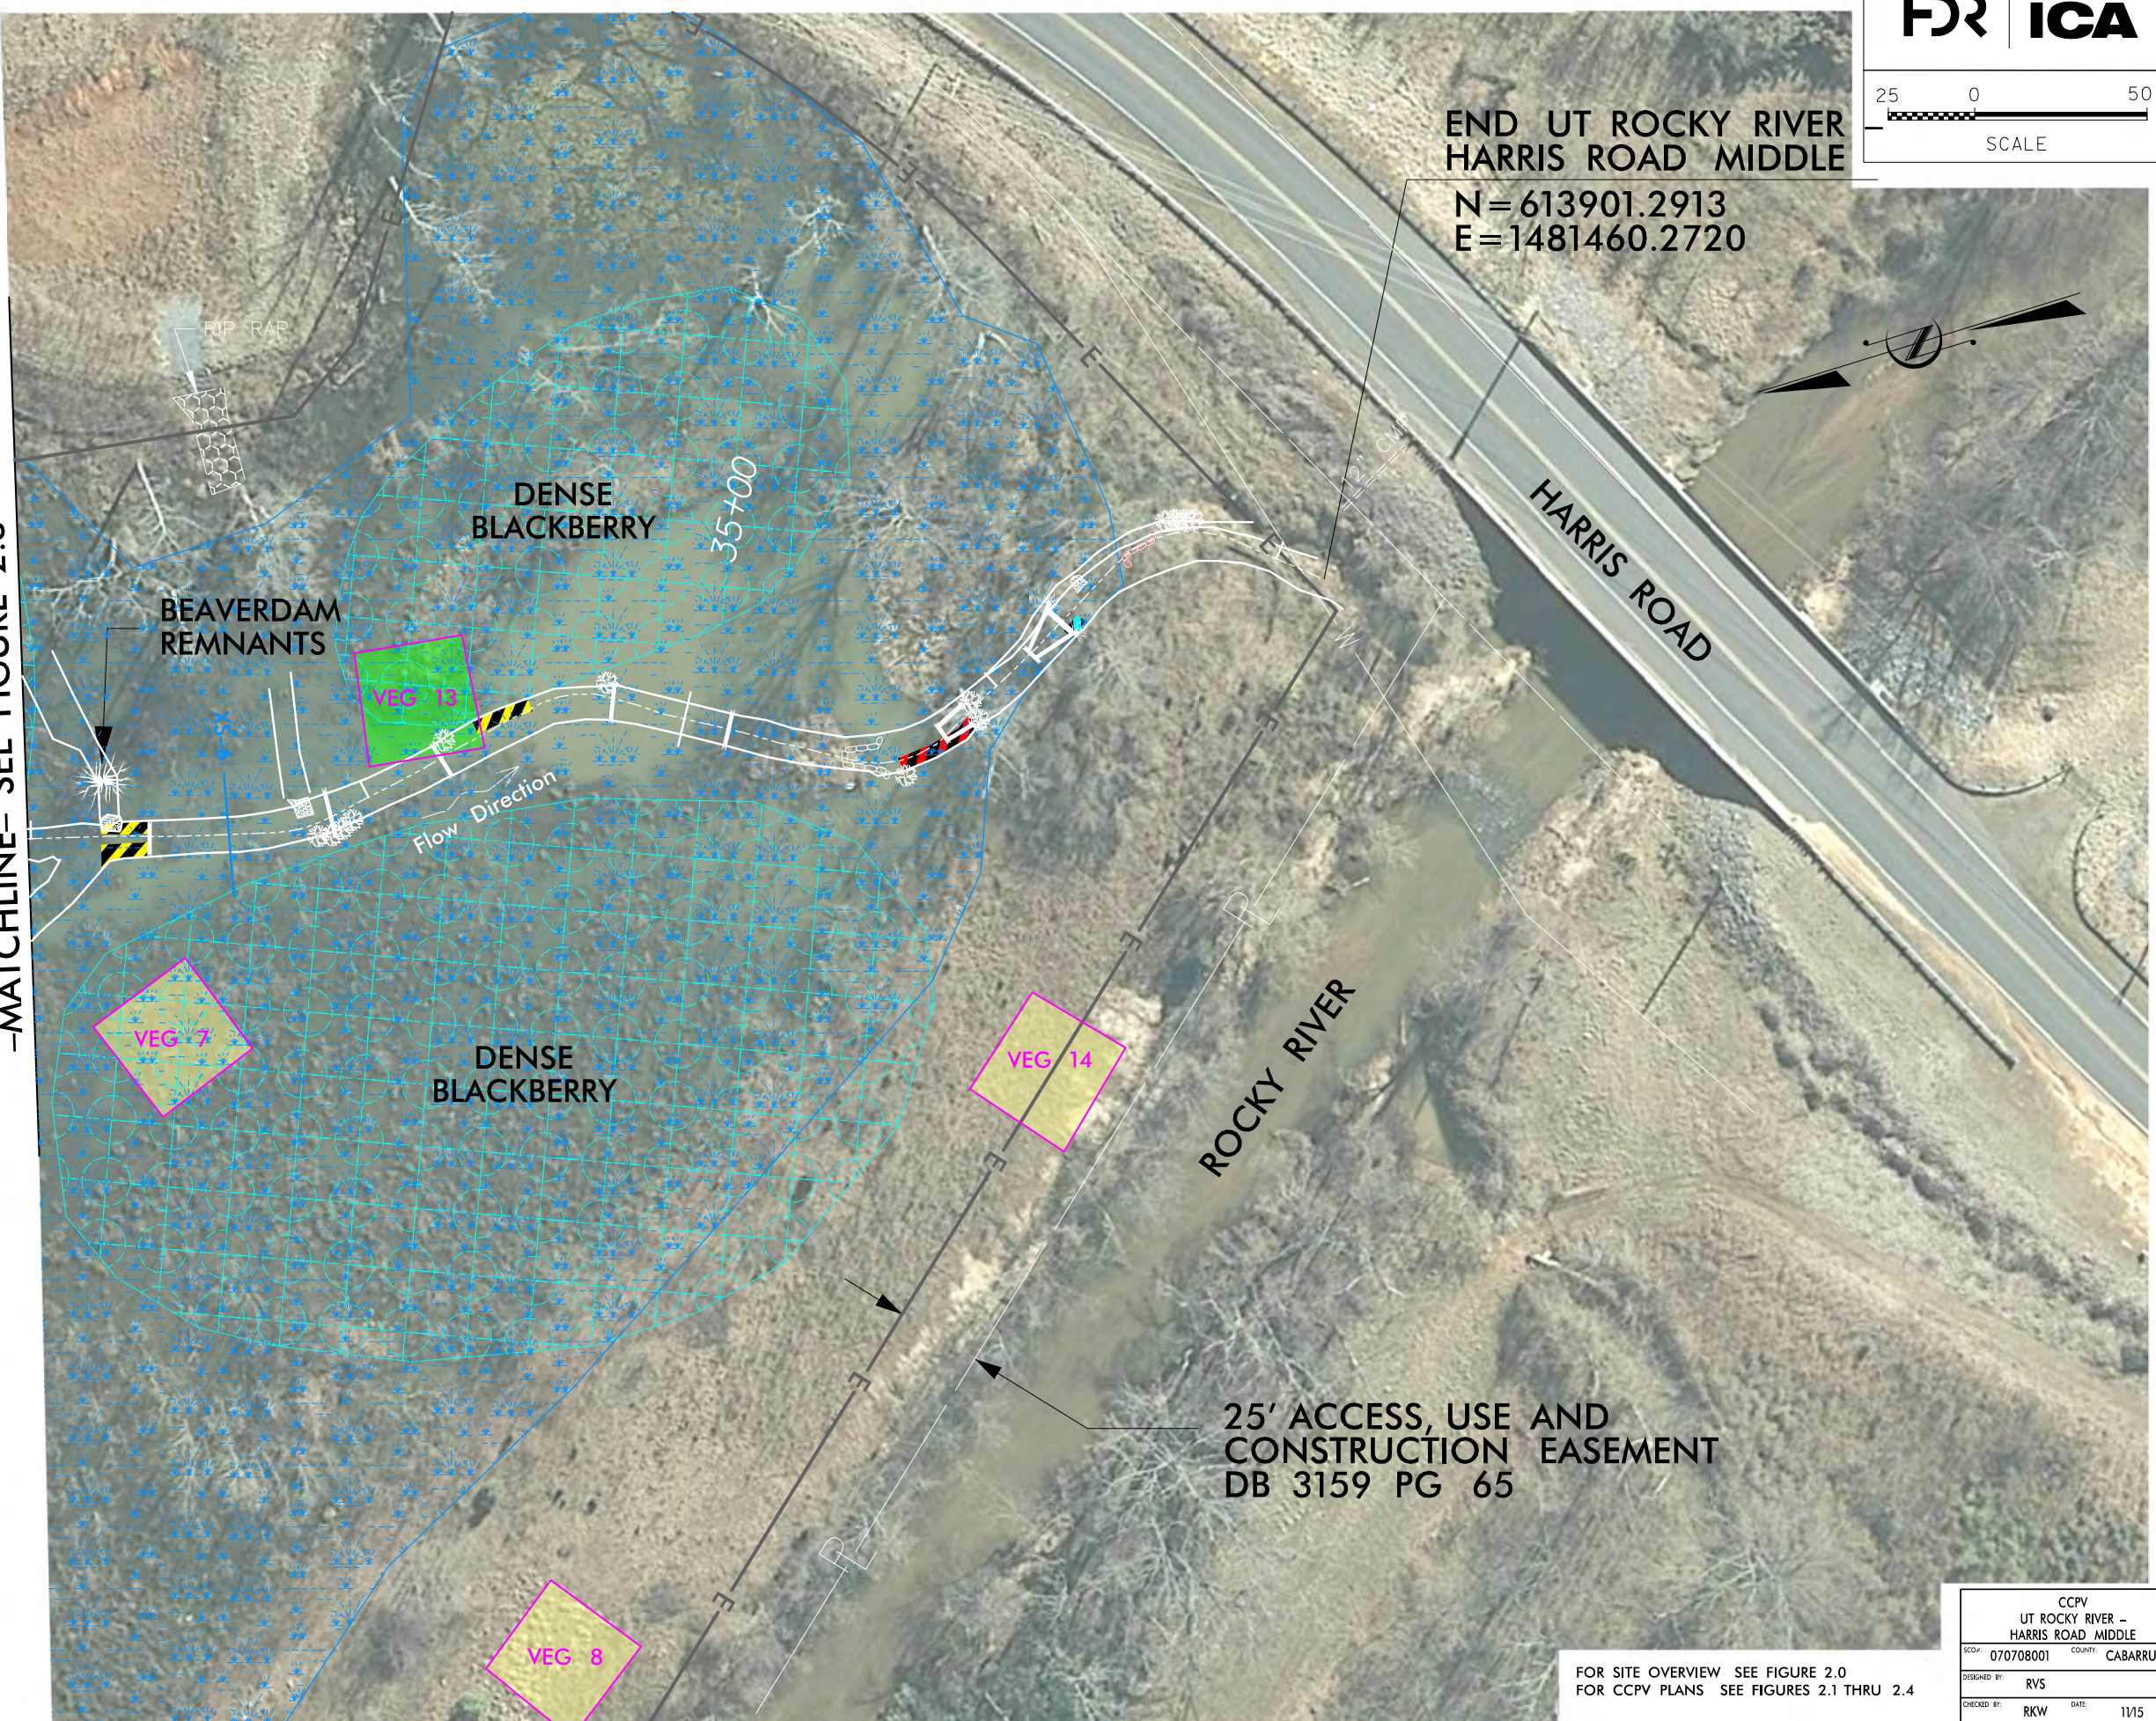
- YEAR 4 CONDITIONS**
- BANKBED CONDITION**
- MAJOR EROSION
 - MODERATE EROSION
 - MINOR EROSION
 - BEAVER DAM
- VEGETATION PROBLEM AREAS**
- DENSE BLACKBERRY
- IN-STREAM STRUCTURE CONDITION**
- FAILED
- VEGETATION PLOT CONDITIONS (PLANTED STEMS ONLY)**
- CRITERIA MET
 - CRITERIA UNMET
- SURVIVAL THRESHOLD MET WHEN INCLUDING NATURAL RECRUITS**

The log cross vane below station 35+00 failed before Year 2 Monitoring. The structure could not be surveyed during Year 3 or 4 monitoring due to back water from Rocky River. If the failed structure compromises overall channel stability in upcoming monitoring years repairs may be necessary.
