**UT ROCKY RIVER STREAM RESTORATION – NCEEP Project #402**  
2010 FINAL MONITORING REPORT – YEAR 4

CONDUCTED FOR THE NORTH CAROLINA DEPARTMENT OF ENVIRONMENT  
AND NATURAL RESOURCES

North Carolina Department of  
Environment and Natural Resources  
Ecosystem Enhancement Program  
1652 Mail Service Center  
Raleigh, NC 27699-1652

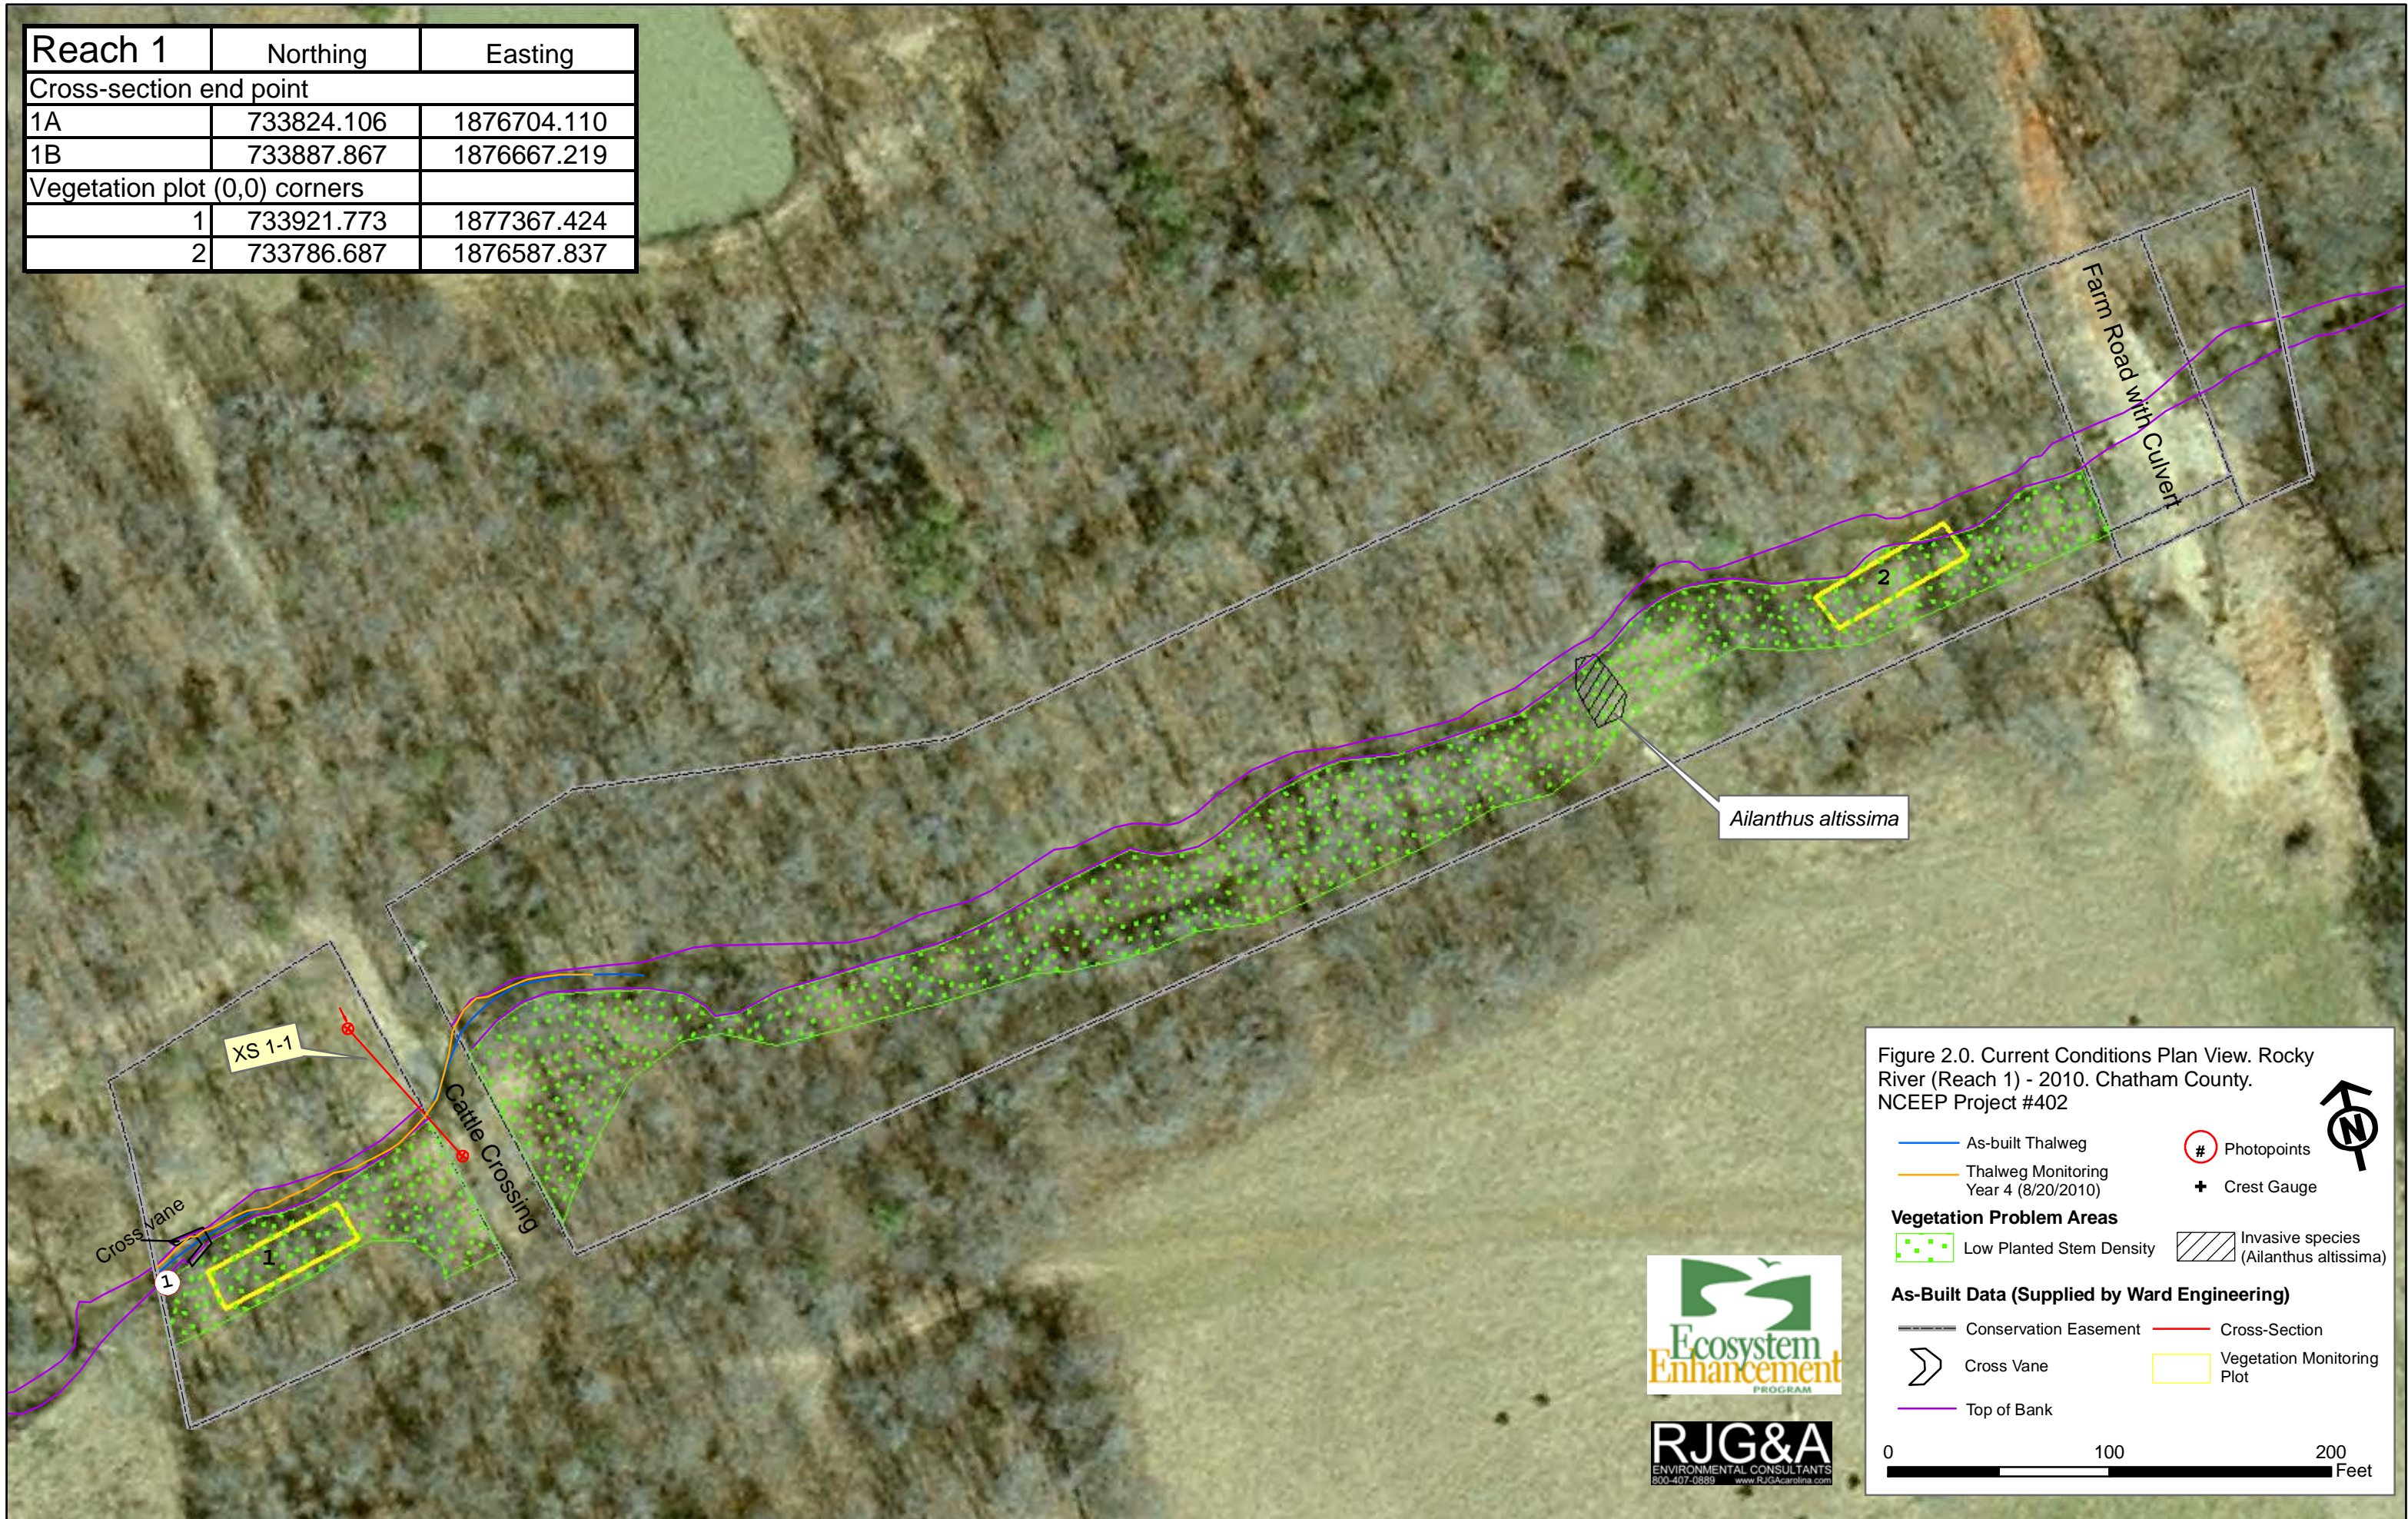
Figure 2.0. Current Conditions Plan View. Rocky River (Reach 1) - 2010. Chatham County. NCEEP Project #402

- As-built Thalweg
- Thalweg Monitoring Year 4 (8/20/2010)
- Vegetation Problem Areas
  - Low Planted Stem Density
  - Invasive species (*Ailanthus altissima*)
- As-Built Data (Supplied by Ward Engineering)
  - Conservation Easement
  - Cross Vane
  - Top of Bank
  - Cross-Section
  - Vegetation Monitoring Plot
- Photopoints
- Crest Gauge

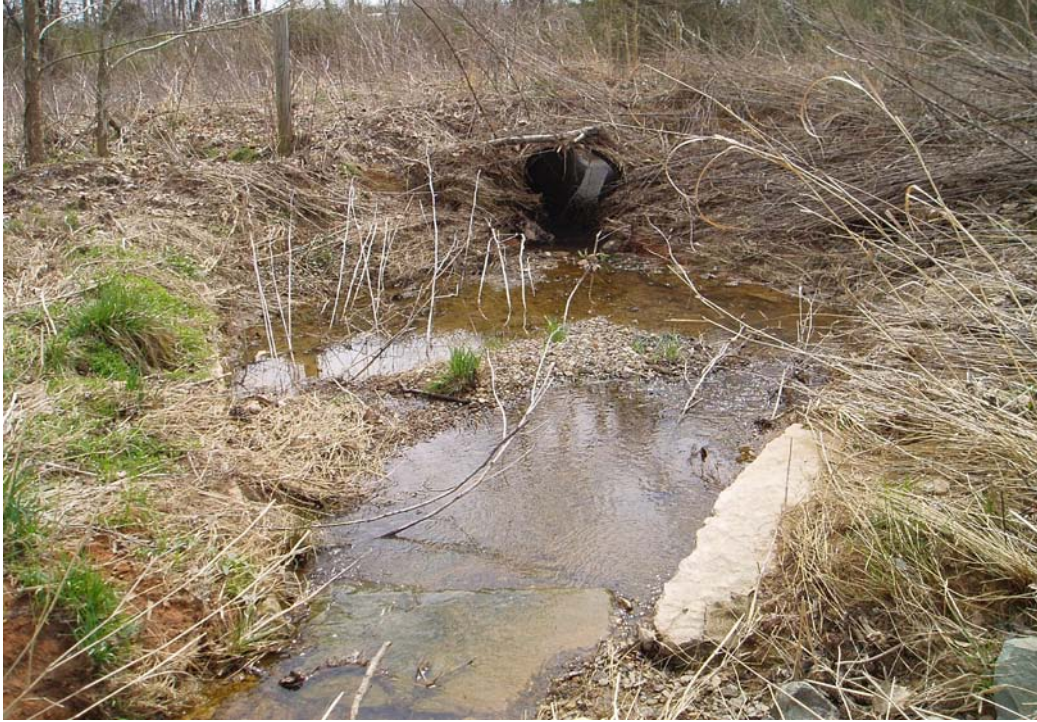
Stream Problem Areas (electronic submission only)			
UT to Rocky River Stream Restoration - EEP Project #402			
Feature Issue	Station Numbers	Suspected Cause	Photo #
Reach 1. No stream problems identified.			
Reach 2.			
Aggradation/bar formation	1100-1105	Undersized culvert at bottom of restoration	SP1-2

SP1. Aggradation/bar formation downstream of last cross vane at Station 1096. Looking downstream.

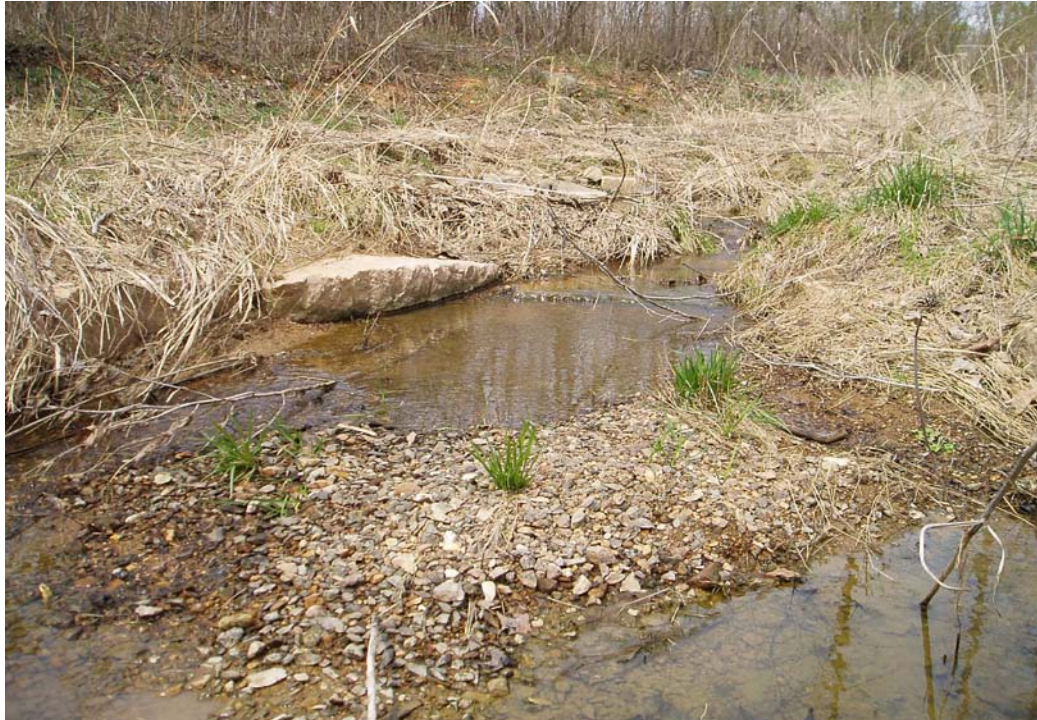
SP2. Aggradation/bar formation downstream of last cross vane at Station 1096. Looking upstream.

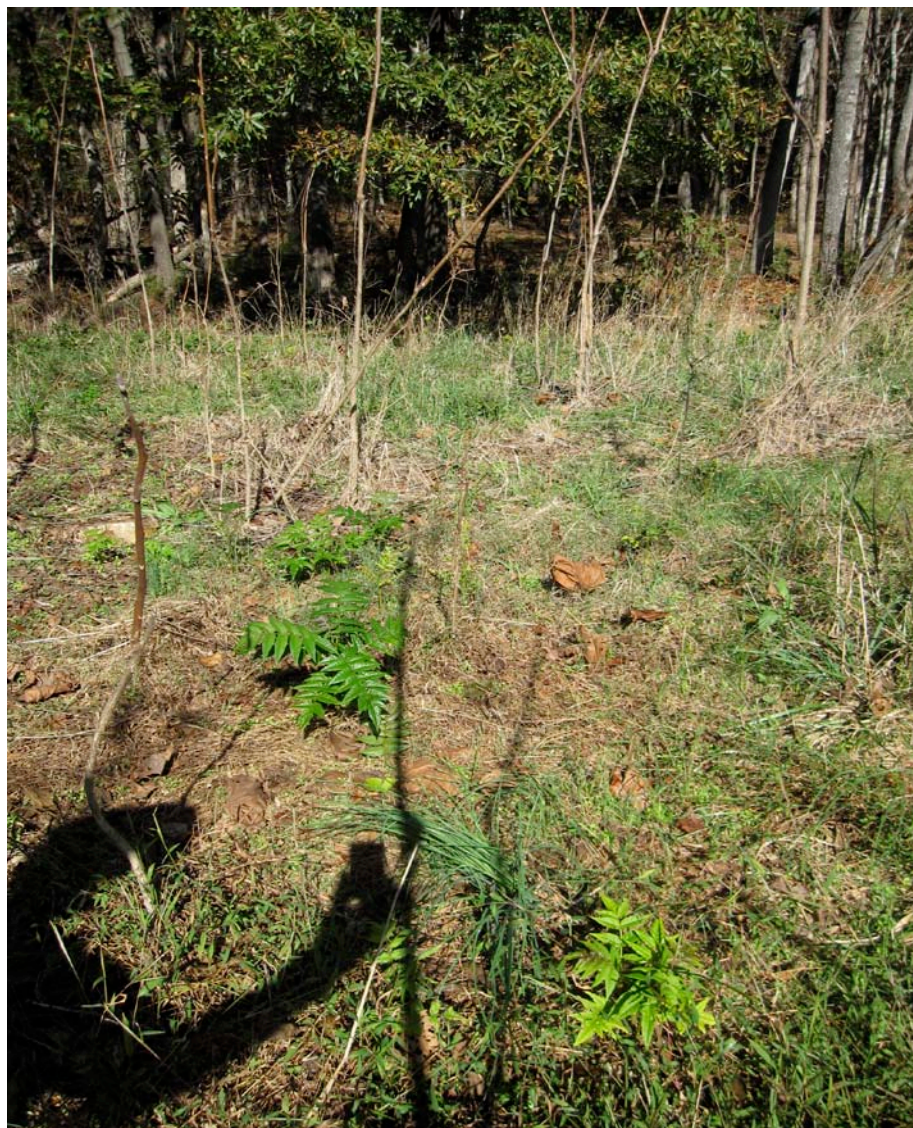
VP1. *Ailanthus altissima* resprouts.

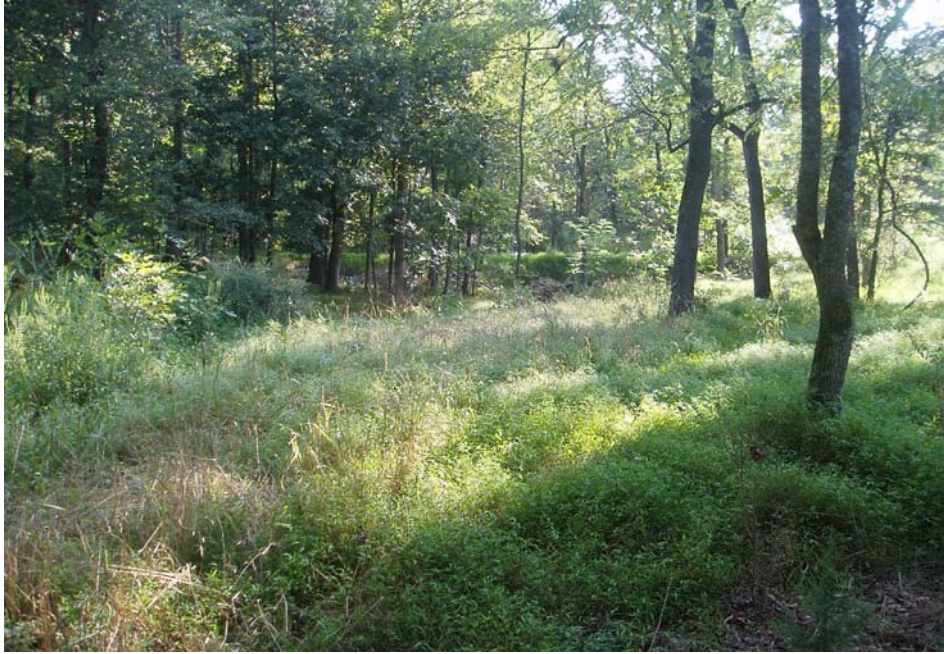
VP2. Low planted stem density along Reach 1.

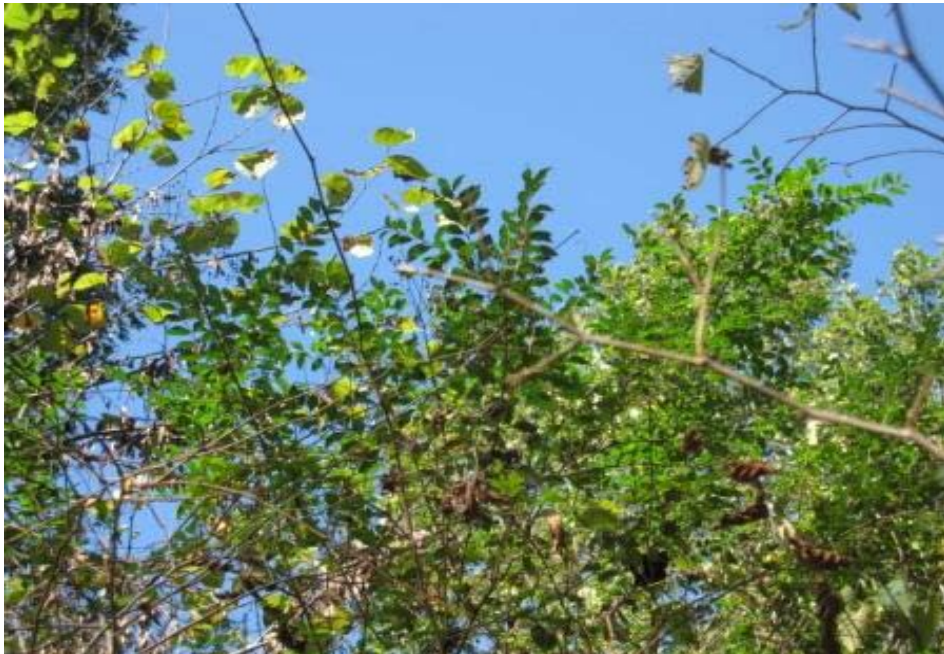
VP3. *Ligustrum sinense* that survived 2010 invasive species treatment

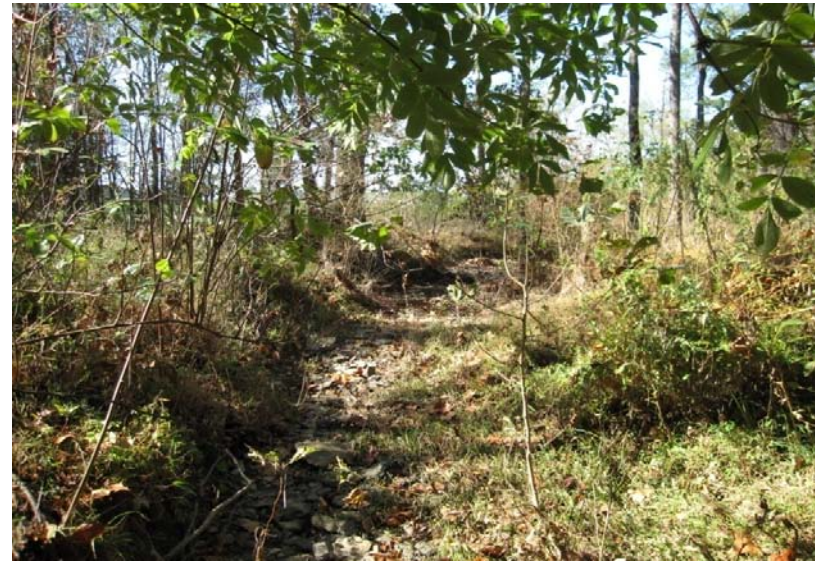
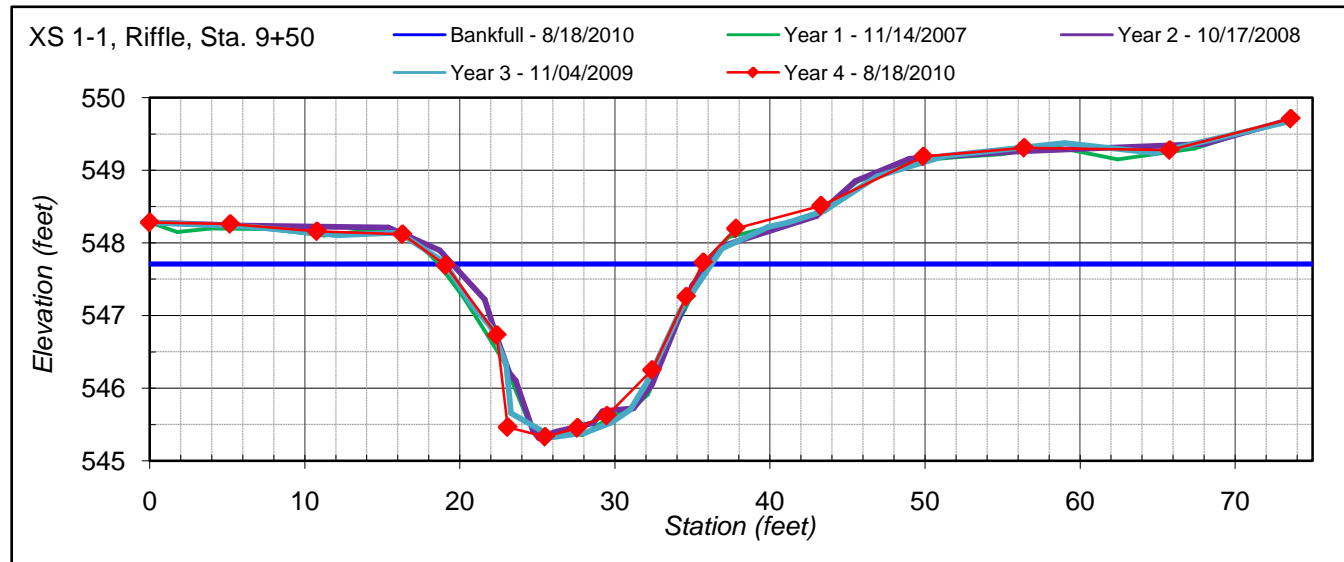
**River Basin:** Cape Fear  
**Watershed:** UT to Rocky River  
**XS ID** XS 1-1 (Riffle)  
**Reach:** 1  
**Date:** 8/18/2010  
**Field Crew:** SD & CH

View of XS 1-1 looking downstream

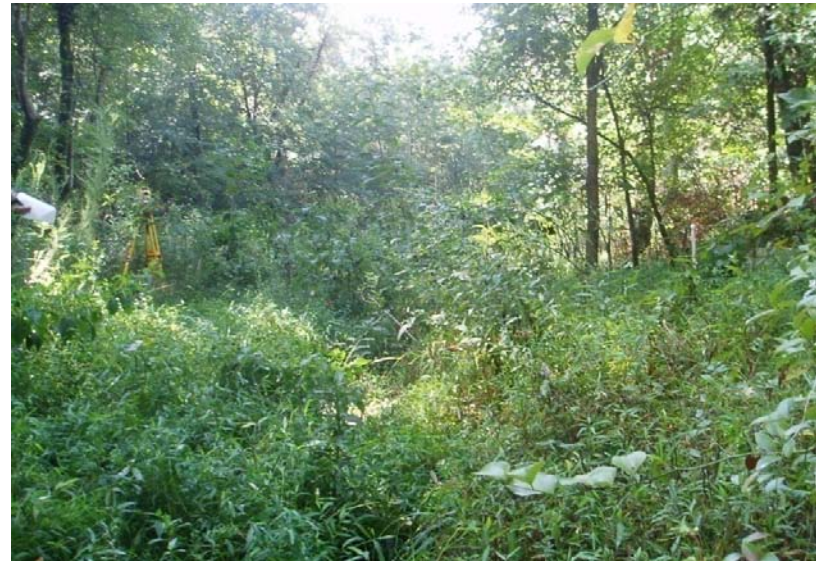
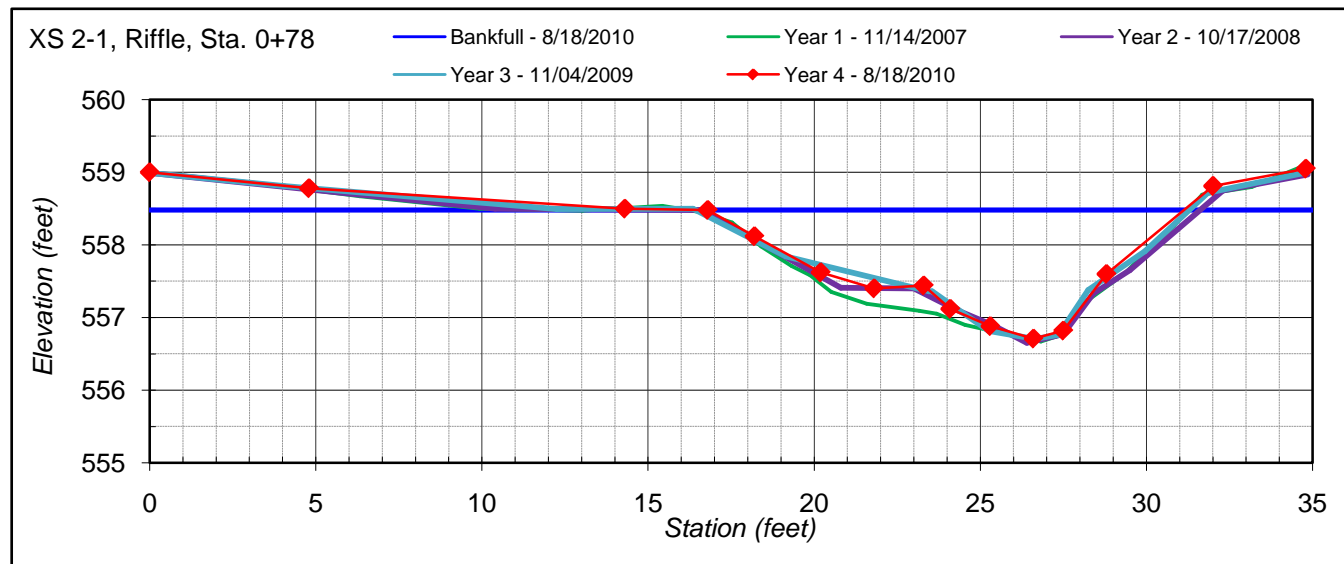
**River Basin:** Cape Fear  
**Watershed:** UT to Rocky River  
**XS ID** XS 2-1 (Riffle)  
**Reach:** 2  
**Date:** 8/18/2010  
**Field Crew:** SD & CH

Bankfull Width (ft)	14.33
Floodprone Width (ft)	104.00
Bankfull Mean Depth (ft)	0.96
Bankfull Max Depth (ft)	1.77
Bankfull Area (ft <sup>2</sup> )	13.76
Bankfull Width/Depth Ratio	14.92
Bankfull Entrenchment Ratio	7.26
Bankfull Bank Height Ratio	1.00
d50 (mm)	6.01

View of XS 2-1 looking downstream

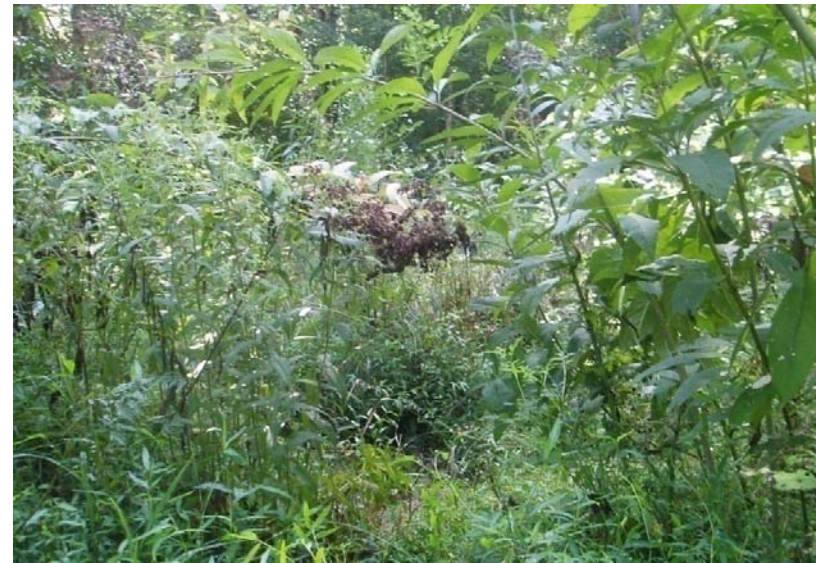
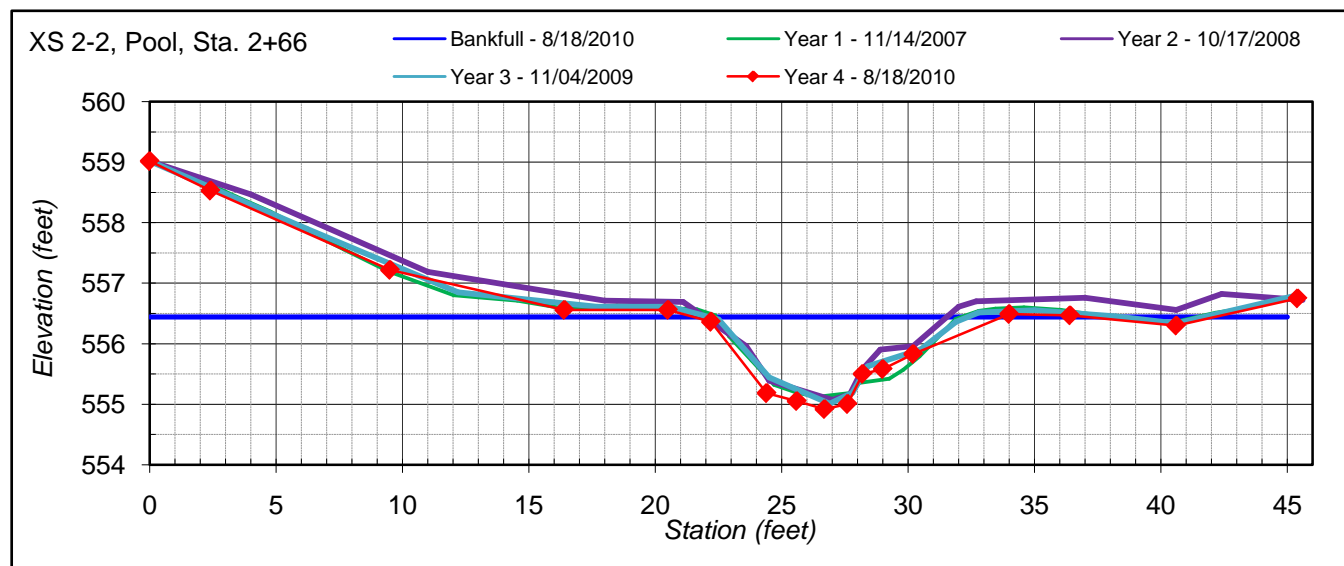
**River Basin:** Cape Fear  
**Watershed:** UT to Rocky River  
**XS ID** XS 2-2 (Pool)  
**Reach:** 2  
**Date:** 8/18/2010  
**Field Crew:** SD & CH

Bankfull Width (ft)	12.91
Floodprone Width (ft)	112.00
Bankfull Mean Depth (ft)	0.78
Bankfull Max Depth (ft)	1.57
Bankfull Area (ft <sup>2</sup> )	10.04
Bankfull Width/Depth Ratio	16.59
Bankfull Entrenchment Ratio	8.68
Bankfull Bank Height Ratio	1.00
d50 (mm)	0.04

View of XS 2-2 looking downstream

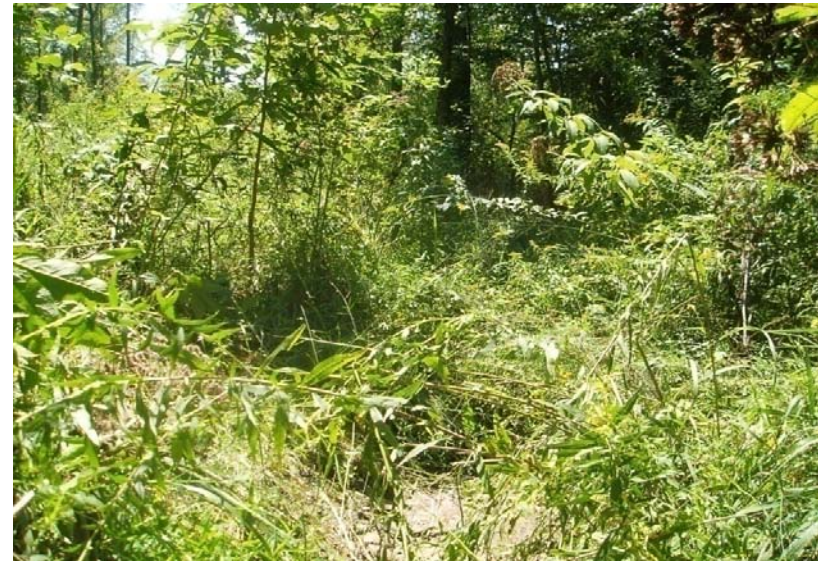
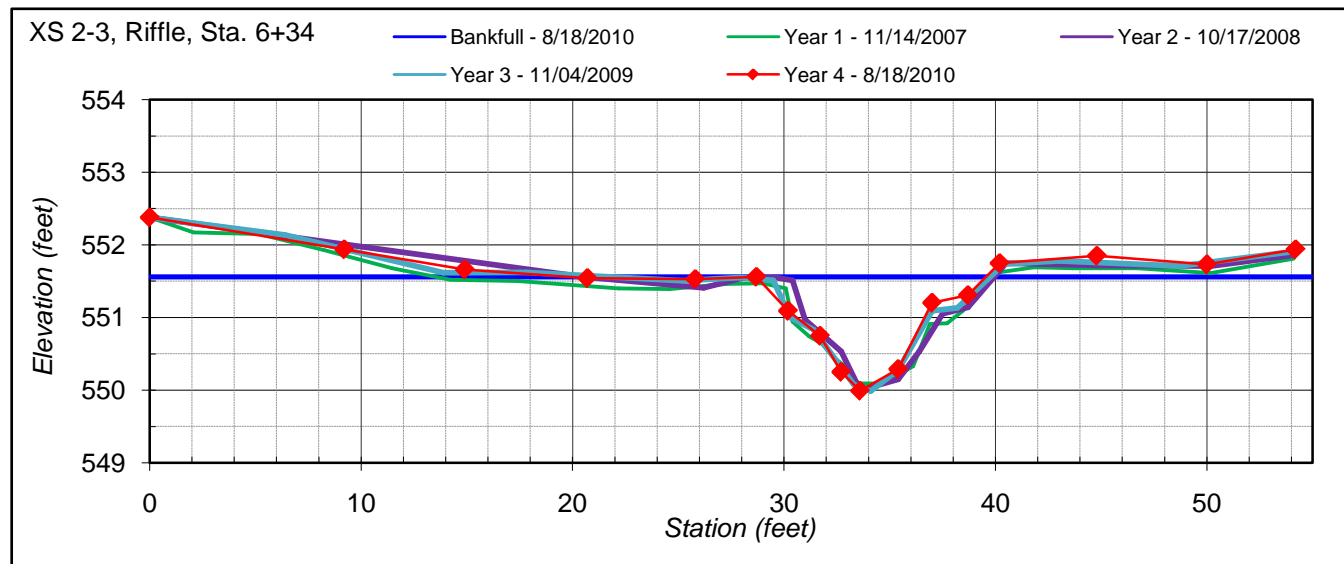
**River Basin:** Cape Fear  
**Watershed:** UT to Rocky River  
**XS ID** XS 2-3 (Riffle)  
**Reach:** 2  
**Date:** 8/18/2010  
**Field Crew:** SD & CH

Bankfull Width (ft)	10.85
Floodprone Width (ft)	200.00
Bankfull Mean Depth (ft)	0.75
Bankfull Max Depth (ft)	1.57
Bankfull Area (ft <sup>2</sup> )	8.15
Bankfull Width/Depth Ratio	14.44
Bankfull Entrenchment Ratio	18.43
Bankfull Bank Height Ratio	1.00
d50 (mm)	0.03

View of XS 2-3 looking downstream

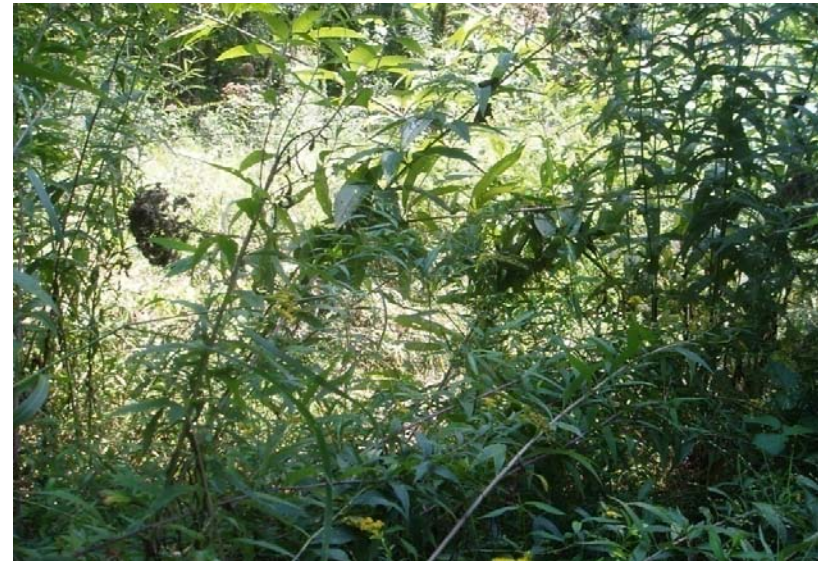
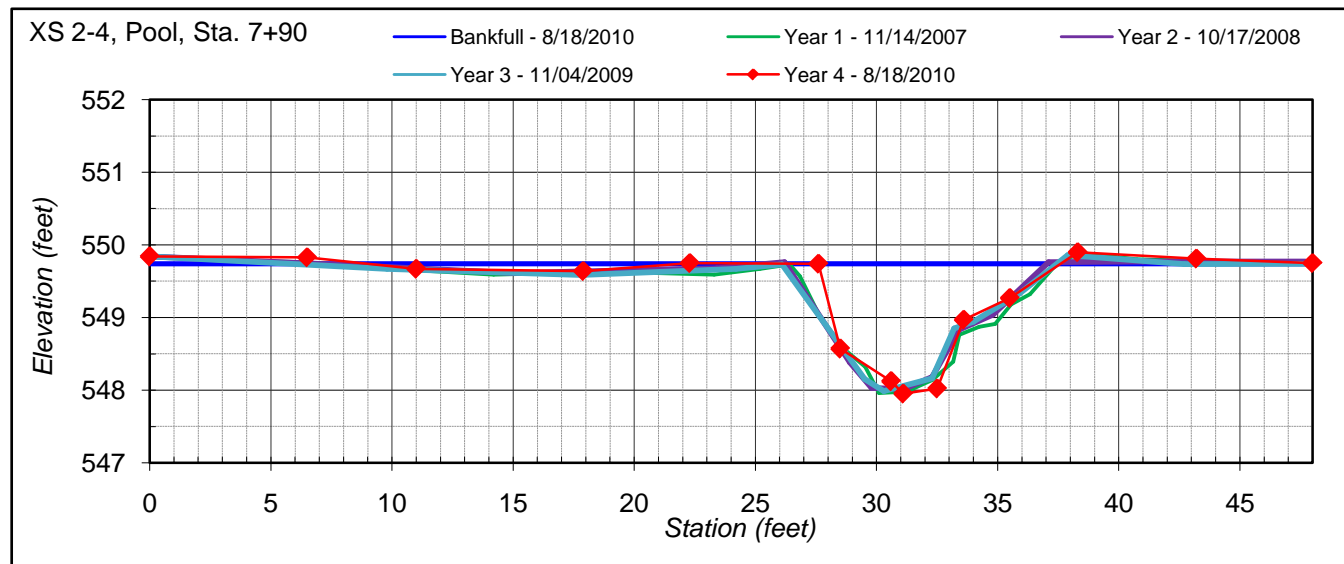
**River Basin:** Cape Fear  
**Watershed:** UT to Rocky River  
**XS ID** XS 2-4 (Pool)  
**Reach:** 2  
**Date:** 8/18/2010  
**Field Crew:** SD & CH

Bankfull Width (ft)	9.99
Floodprone Width (ft)	160.00
Bankfull Mean Depth (ft)	0.98
Bankfull Max Depth (ft)	1.79
Bankfull Area (ft <sup>2</sup> )	9.80
Bankfull Width/Depth Ratio	10.18
Bankfull Entrenchment Ratio	16.02
Bankfull Bank Height Ratio	1.00
d50 (mm)	0.11

View of XS 2-4 looking downstream

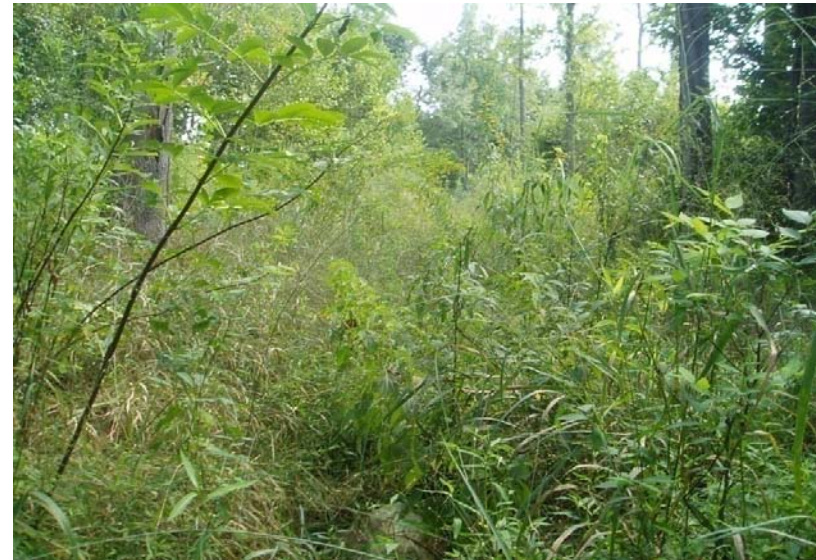
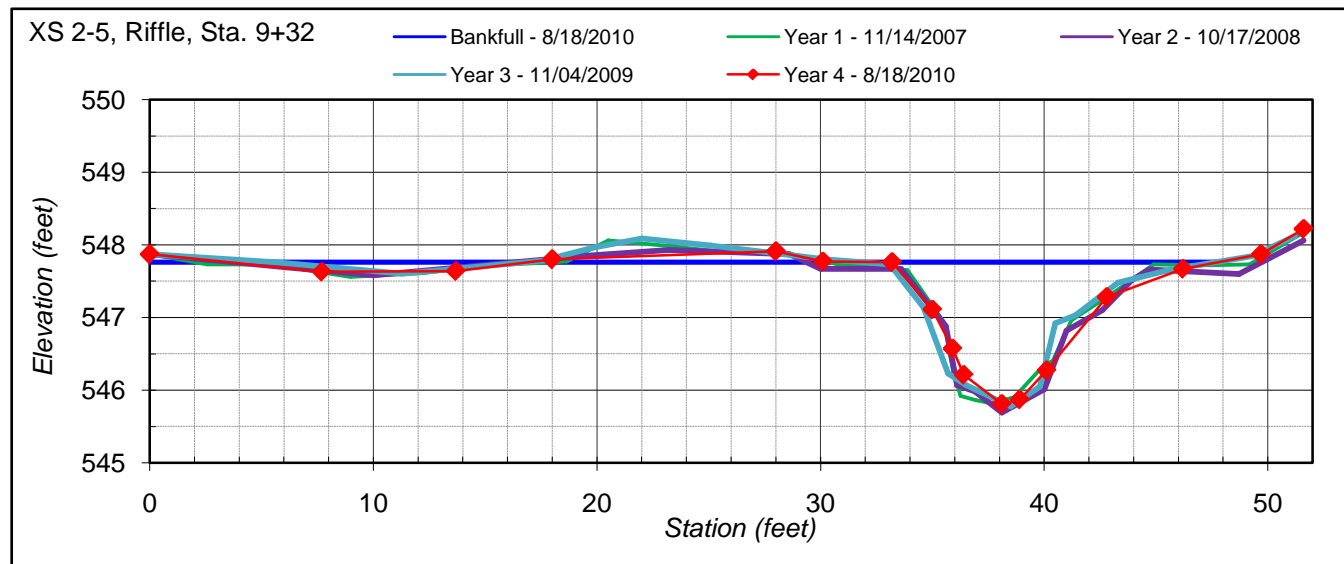
**River Basin:** Cape Fear  
**Watershed:** UT to Rocky River  
**XS ID** XS 2-5 (Riffle)  
**Reach:** 2  
**Date:** 8/18/2010  
**Field Crew:** SD & CH

Bankfull Width (ft)	14.58
Floodprone Width (ft)	130.00
Bankfull Mean Depth (ft)	0.85
Bankfull Max Depth (ft)	1.95
Bankfull Area (ft <sup>2</sup> )	12.34
Bankfull Width/Depth Ratio	17.22
Bankfull Entrenchment Ratio	12.34
Bankfull Bank Height Ratio	1.05
d50 (mm)	19

View of XS 2-5 looking downstream
