FINAL
Stream Mitigation Plan
UT to Cane Creek Restoration Project

Alamance County, North Carolina
NCEEP Project ID No. 95729
Cape Fear River Basin: 03030002-050050
USACE Action ID No: SAW-2012-01907

Michael Baker Engineering, Inc.
8000 Regency Parkway
Suite 600
Cary, North Carolina 27518
Phone: 919.463.5488
Fax: 919.463.5490

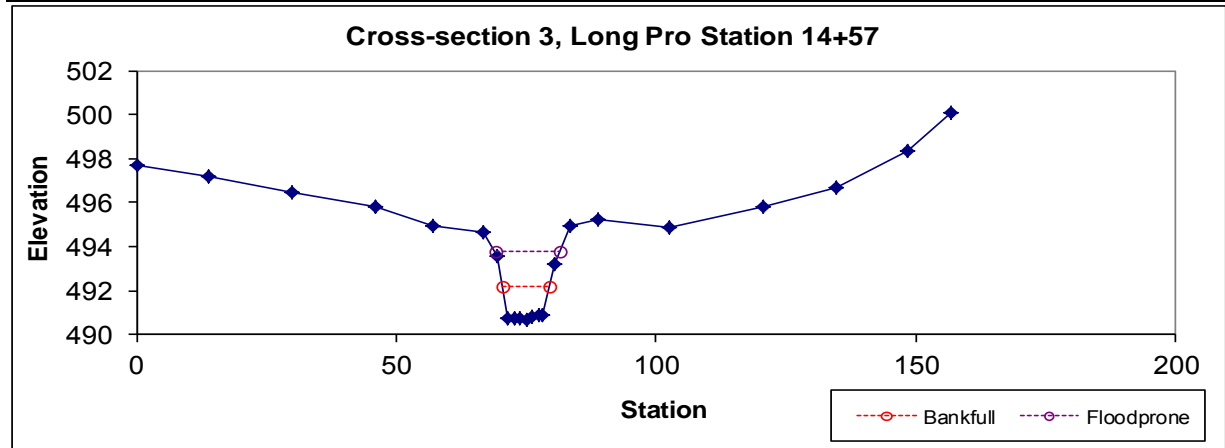
| Feature | Stream Type | BKF Area | BKF Width | BKF Depth | Max BKF Depth | W/D | BH Ratio | ER | BKF Elev | TOB Elev |
|---|---|---|---|---|---|---|---|---|---|---|
| Riffle | G | 10.9 | 8.87 | 1.23 | 1.55 | 7.2 | 2.6 | 1.3 | 492.2 | 494.64 |

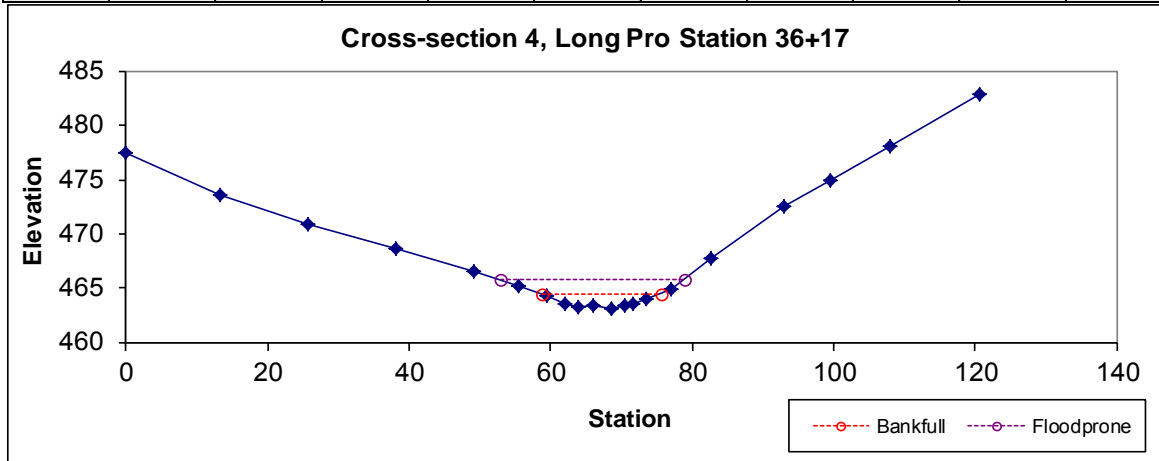
| Feature | Stream Type | BKF Area | BKF Width | BKF Depth | Max BKF Depth | W/D | BH Ratio | ER | BKF Elev | TOB Elev |
|---|---|---|---|---|---|---|---|---|---|---|
| Riffle | Bc | 14.8 | 16.74 | 0.88 | 1.33 | 18.99 | 1.3 | 1.6 | 464.5 | 464.84 |
