Stream and Wetland Mitigation Plan

UT to Town Creek Restoration Project - Option A

Stanly County, North Carolina
NCEEP Project ID No. 94648, Contract No. 003277
Yadkin Pee-Dee River Basin: 03040105060-040
USACE Action ID No: SAW-2013-01280

December 2014

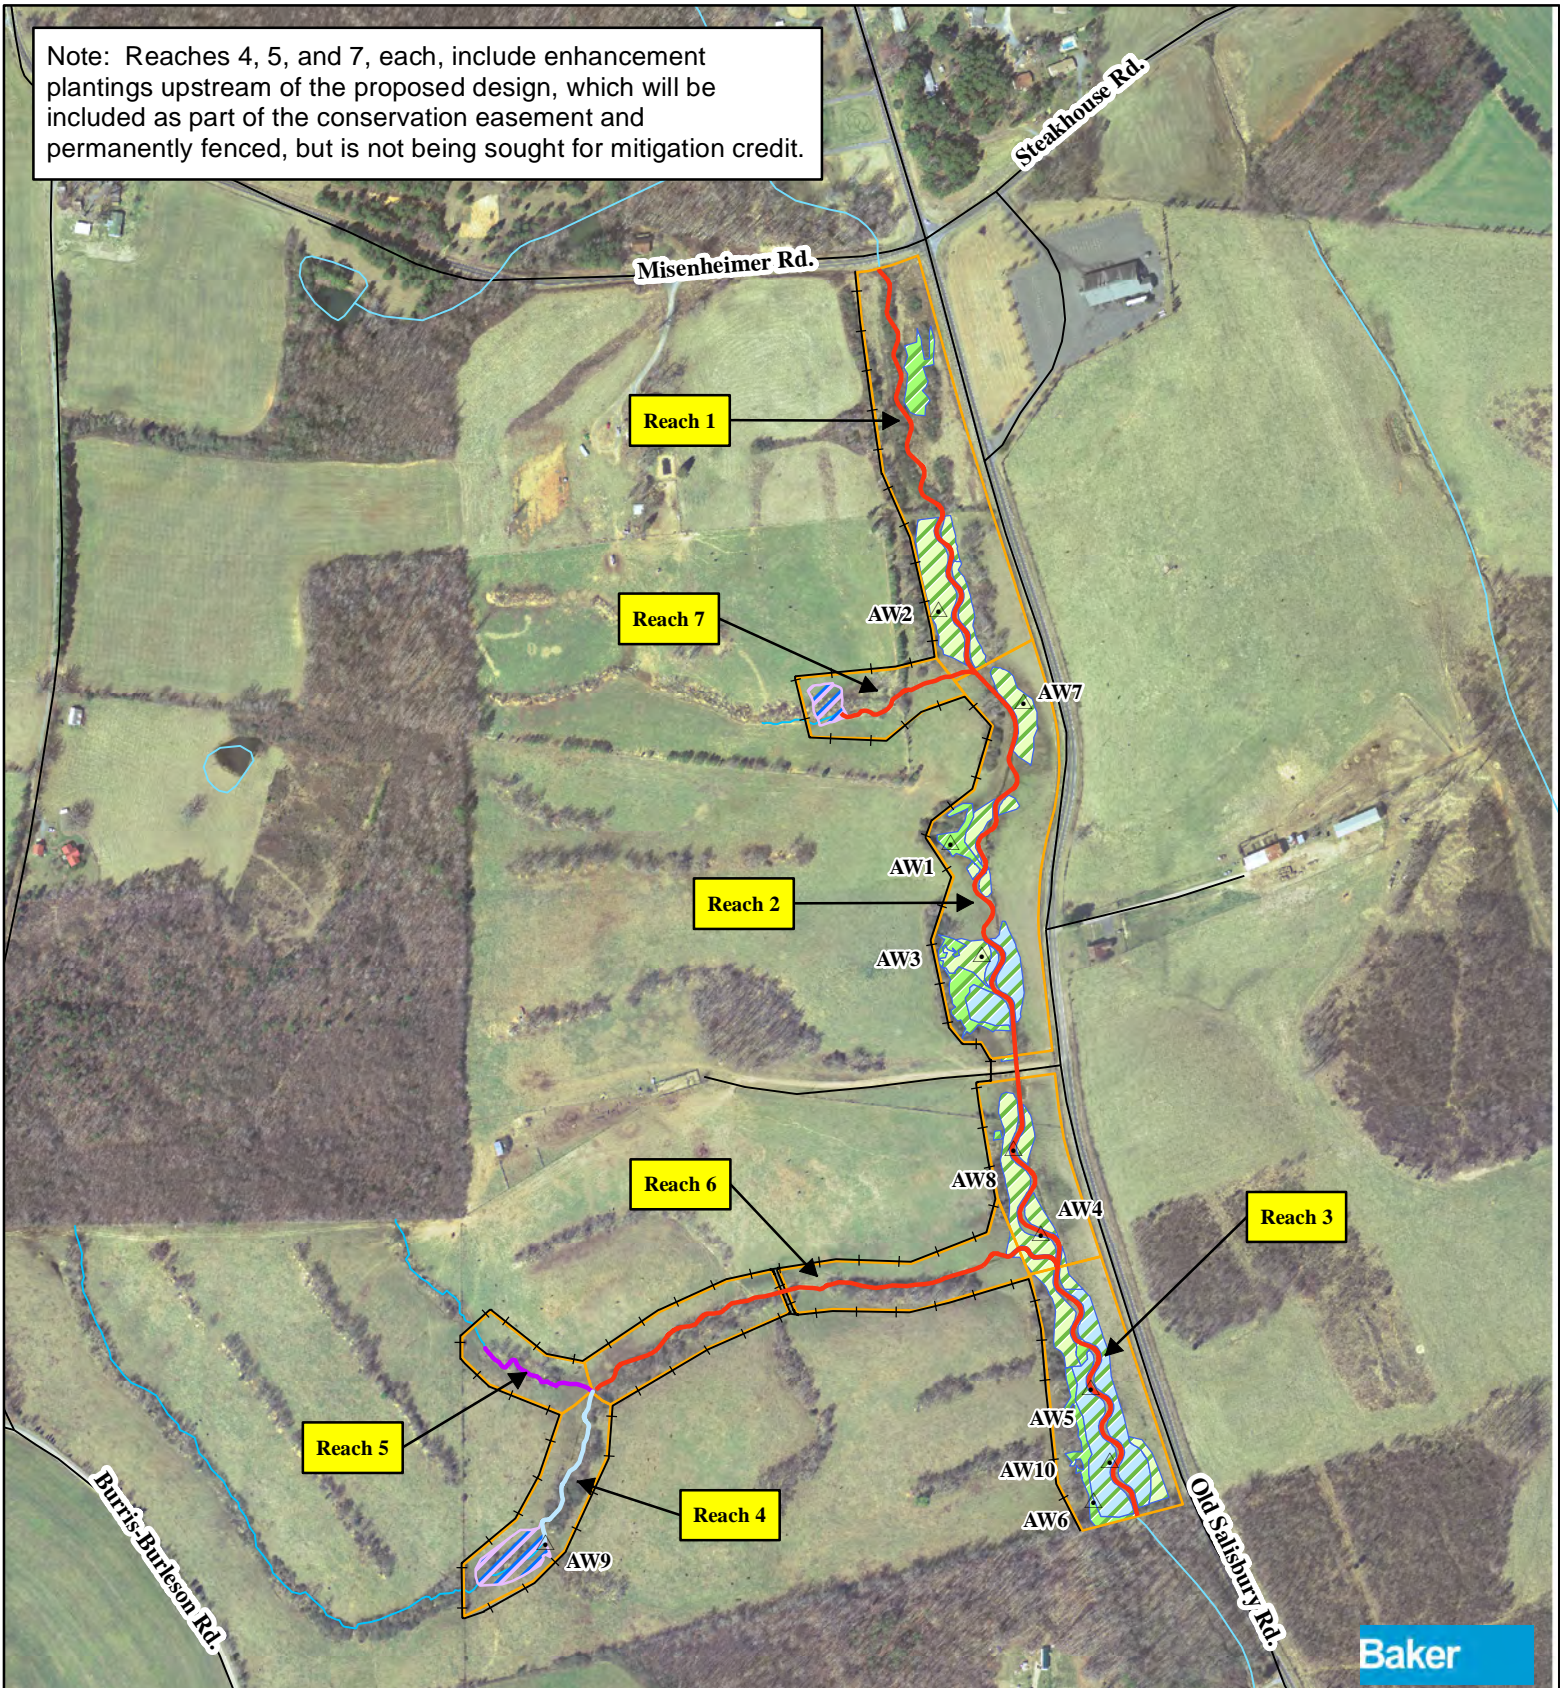
Note: Reaches 4, 5, and 7, each, include enhancement plantings upstream of the proposed design, which will be included as part of the conservation easement and permanently fenced, but is not being sought for mitigation credit.

Figure 6. Proposed Conditions Map
 UT to Town Creek Restoration Site - Option A
 Stanly County, NC

1. Notate on Figure 6 that area upstream of Reach 4, 5, and 7 is non-credited preservation as noted on pg 7-5 in Notes section.
2. Wetland indicator status listed on pages 7-31 and 7-32 should be updated to current National Wetland Plant List for the EMP region for 2014 which does not have “+” and “-” designations. Please correct the following: *Liriodendron tulipifera* to FACU, *Quercus phellos* to FAC, *Alnus serrulata* to OBL, *Sambucus Canadensis* to *Sambucus nigra* FAC, *Nyssa sylvatica* to FAC, *Hibiscus moscheutos* to FACW, *Elymus virginicus* to FACW, *Tripsacum dactyloides* to FACW, *Coreopsis lanceolata* to FACU, *Dichanthelium clandestinum* to FAC. http://rsgisias.crrel.usace.army.mil/nwpl_static/viewer.html#

1. Notate on Figure 6 that area upstream of Reach 4, 5, and 7 is non-credited preservation as noted on pg 7-5 in Notes section.

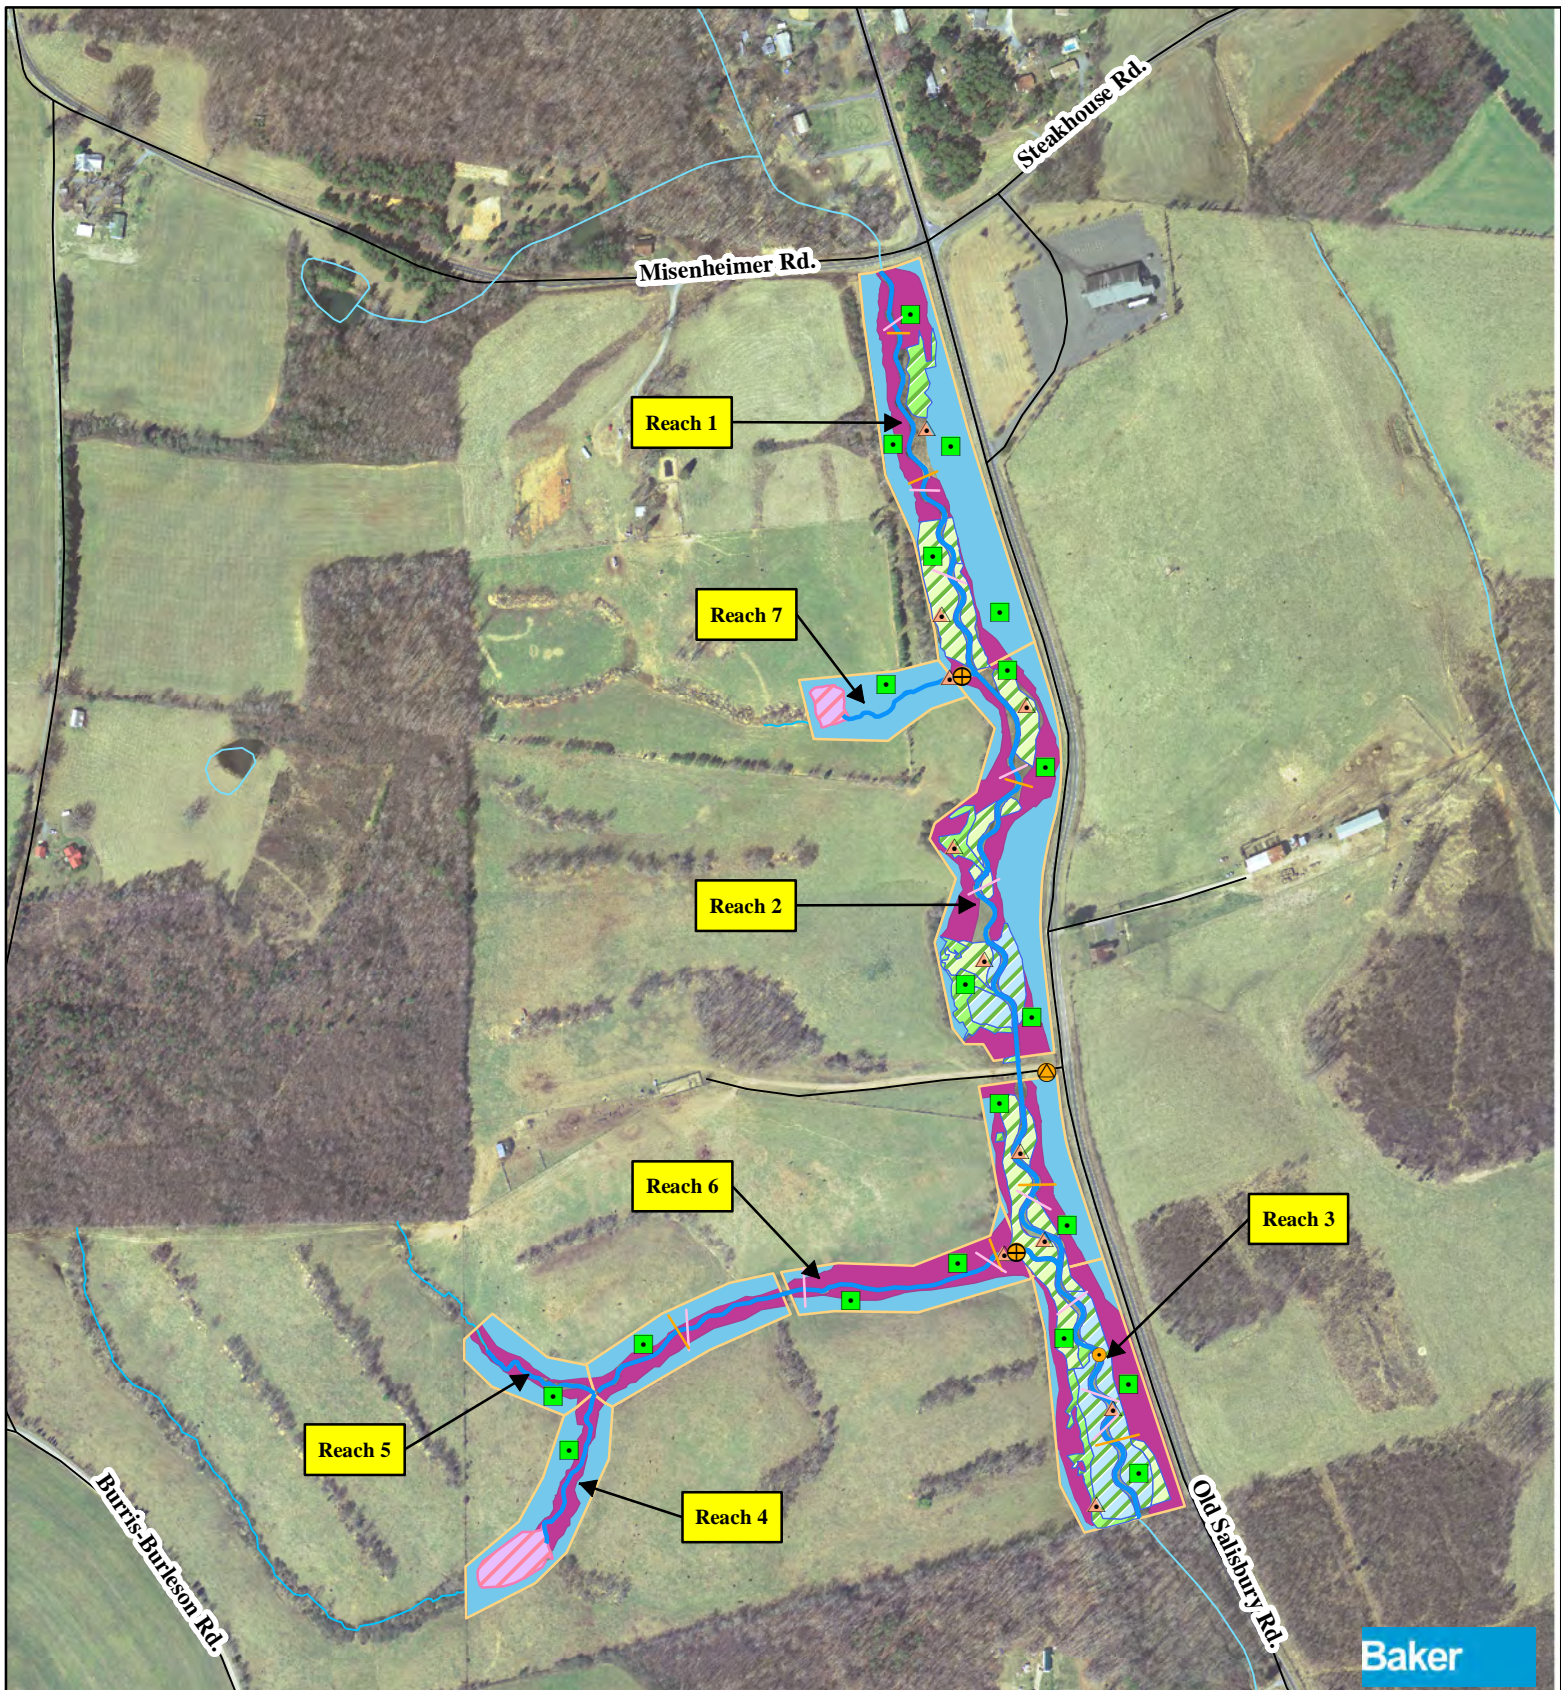
Figure 7. Proposed Monitoring Device Locations
 UT to Town Creek Restoration Site - Option A
 Stanly County, NC
