ANNUAL MONITORING REPORT
YEAR 1 (2010)
VICKI'S THICKET RIPARIAN BUFFER MITIGATION SITE
CRAVEN COUNTY, NORTH CAROLINA
(EEP Contract No. 002283)
[DWQ Reference No. 10-0652]

MONITORING PLAN VIEW
VICKI'S THICKET
RIPARIAN BUFFER MITIGATION SITE
Craven County, North Carolina

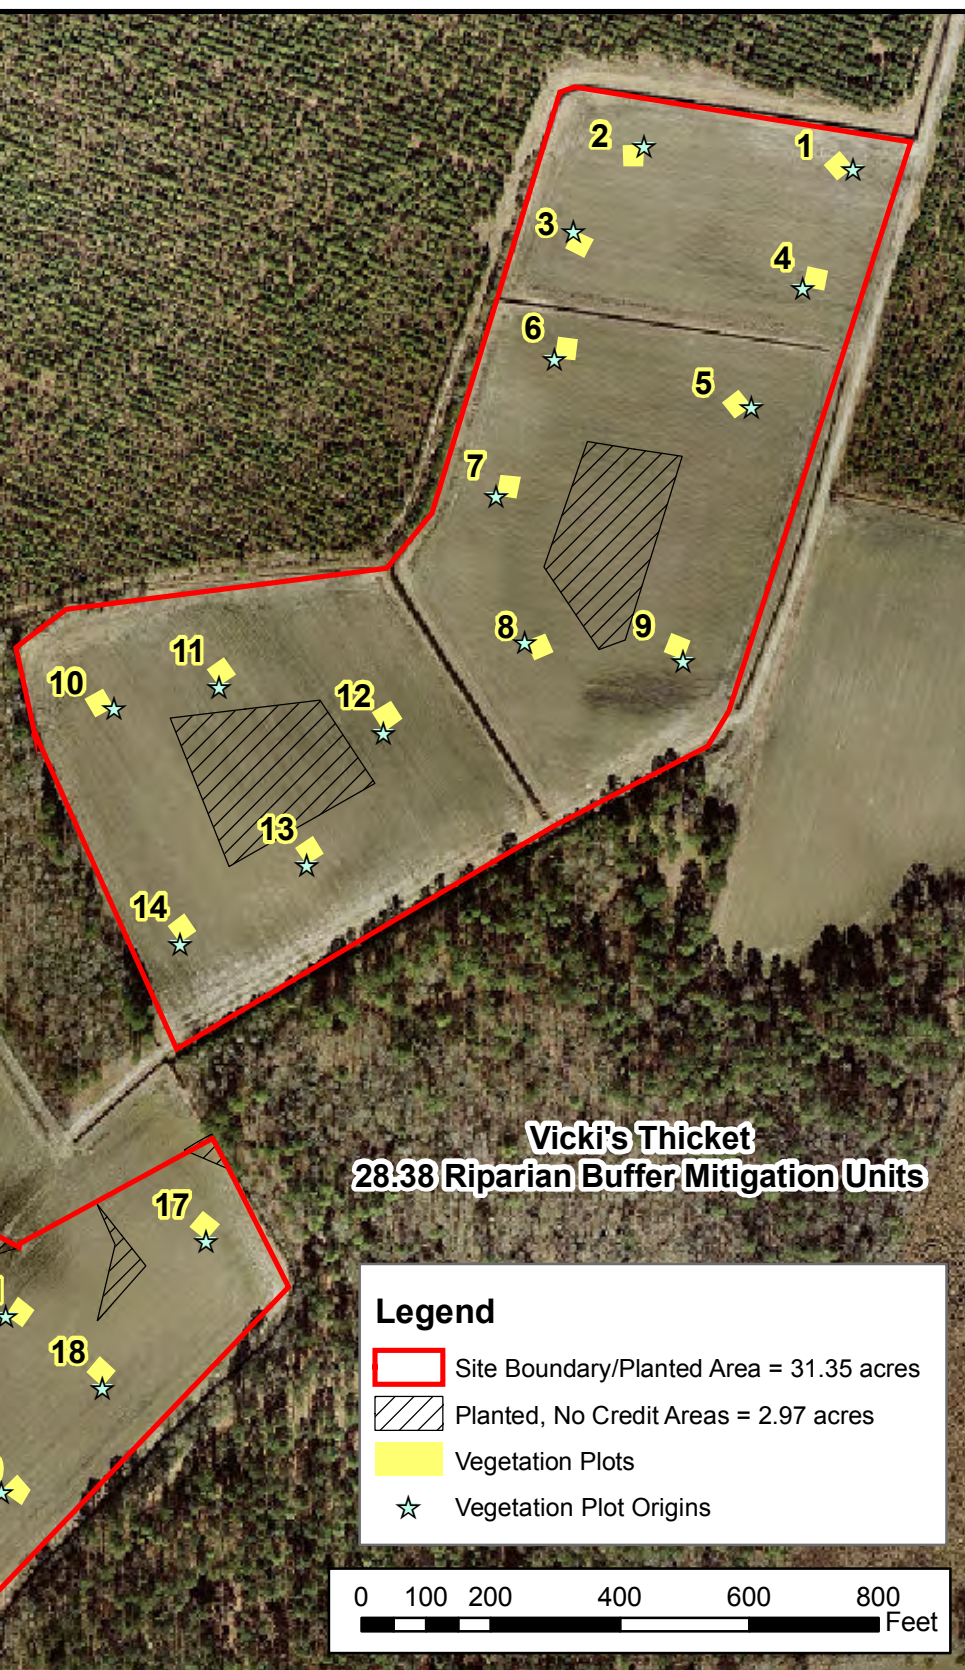
FIGURE
2

**Vicki's Thicket
28:38 Riparian Buffer Mitigation Units**

As constructed, Site activities restored historic riparian buffer functions by planting the entire 31.35-acre Site with native riparian vegetation. This resulted in 28.38 Riparian Buffer Mitigation Units (Table 1, Appendix B and Figure 2, Appendix A). Riparian Buffer Mitigation Units were verified by North Carolina Division of Water Quality (NCDWQ) representative Lia Myott Gilleski during a field visit conducted on June 17, 2010. A copy of the verification letter is included in Appendix D. Approximately 2.97 acres of the Site exist outside of the 200-foot buffer area. These areas were planted; however, the area is not eligible to provide credit. The target natural community consisted of Coastal Plain Bottomland Hardwood

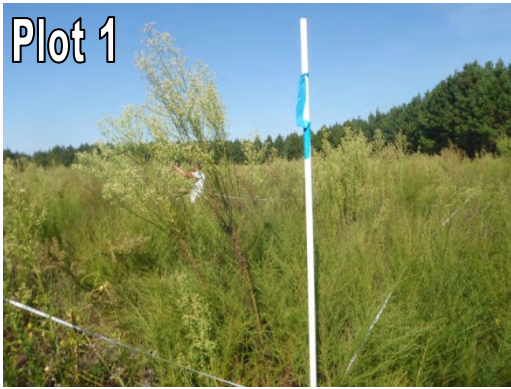
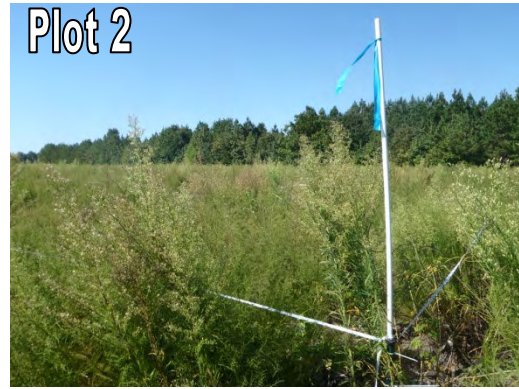
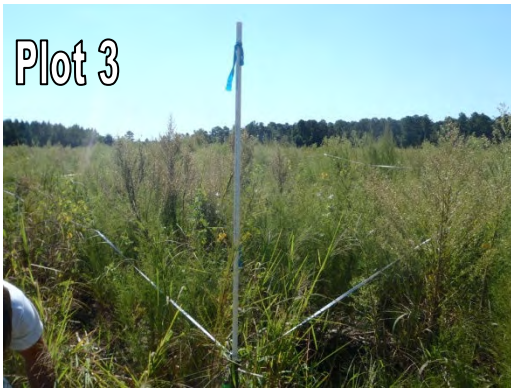
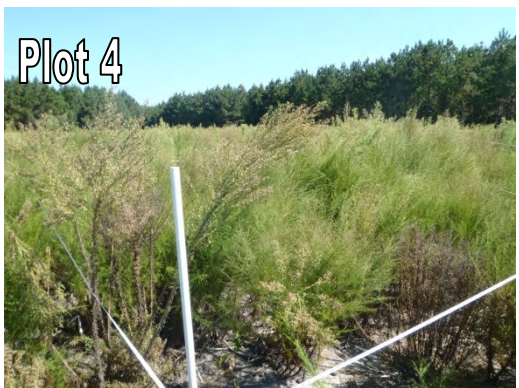
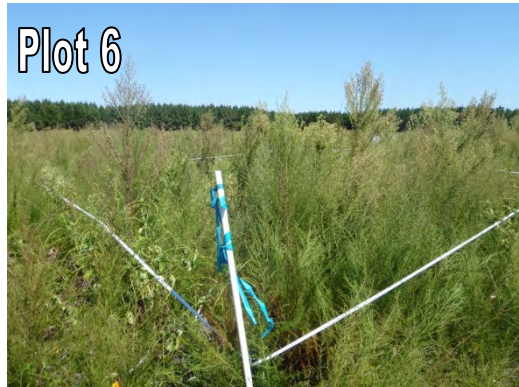
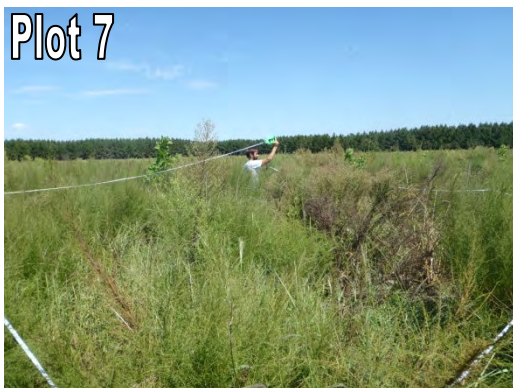
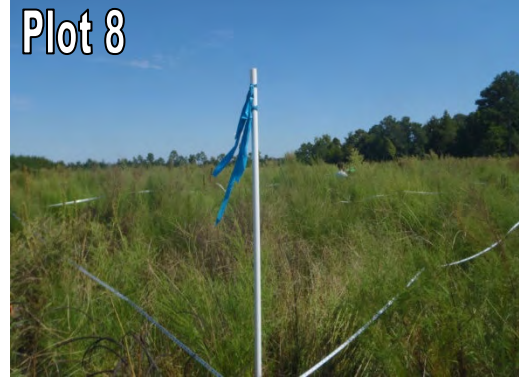
**Vickies Thicket
Year 1 (2010)
Vegetation Monitoring Plot Photos
Taken September 2010**

Quantitative sampling of vegetation was conducted in September 2010. Results are provided in Appendix C. Vegetation success criteria for year 1 (320 stems per acre) were exceeded for the 2010 annual monitoring year with an average density of 728 planted stems per acre across the Site. In addition, each individual plot met success criteria based on planted stems alone.
