**ANNUAL MONITORING REPORT**  
**YEAR 4 (2013)**  
**VICKI'S THICKET RIPARIAN BUFFER MITIGATION SITE**  
**CRAVEN COUNTY, NORTH CAROLINA**  
**(EEP Contract No. 002283)**  
**[DWQ Reference No. 10-0652]**

**November 2013**

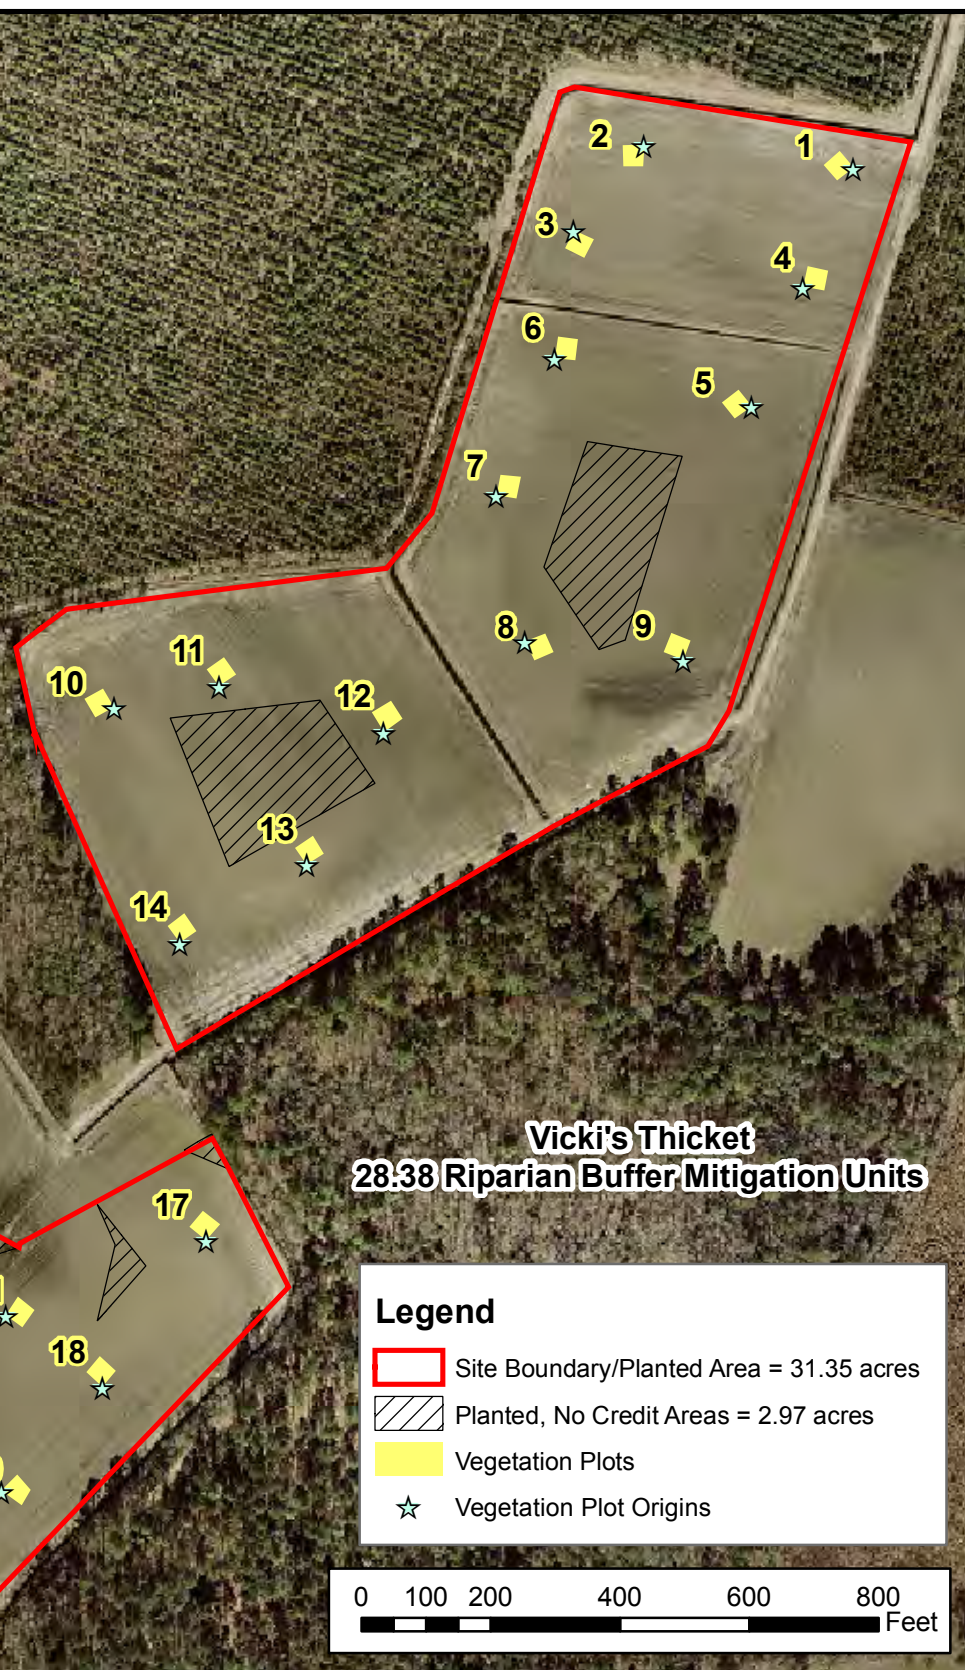
FIGURE  
**2**

**Vicki's Thicket  
28:38 Riparian Buffer Mitigation Units**

MONITORING PLAN VIEW  
VICKI'S THICKET  
RIPARIAN BUFFER MITIGATION SITE  
Craven County, North Carolina

As constructed, Site activities restored historic riparian buffer functions by planting the entire 31.35-acre Site with native riparian vegetation. This resulted in 28.38 Riparian Buffer Mitigation Units (Table 1, Appendix B and Figure 2, Appendix A). Riparian Buffer Mitigation Units were verified by North Carolina Division of Water Quality (NCDWQ) representative Lia Myott Gilleski during a field visit conducted on June 17, 2010. A copy of the verification letter is included in Appendix D. Approximately 2.97 acres of the Site exist outside of the 200-foot buffer area. These areas were planted; however, the area is not eligible to provide credit. The target natural community consisted of a Coastal Plain Bottomland
